Comprehensive Bridge Deck Deterioration Mapping of Nine Bridges by Nondestructive Evaluation Technologies

Final Report
January 2011

Iowa Highway Research Board (IHRB Project SPR-NDEB(90)--8H-00)
Iowa Department of Transportation
Federal Highway Administration

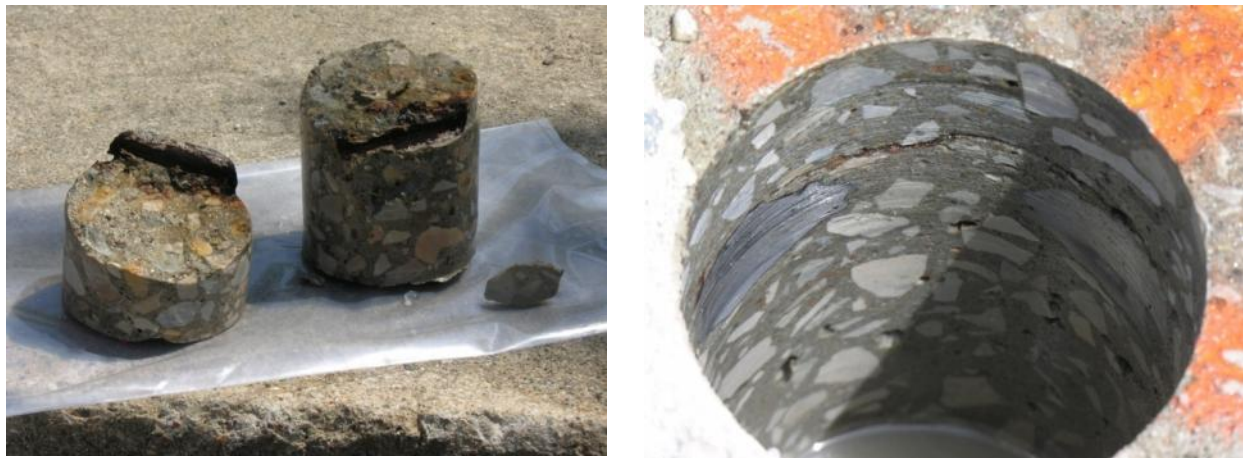
Figure 5: Corroded rebar in a deteriorated drill core (left) and delamination in a bore hole in a deck (right).

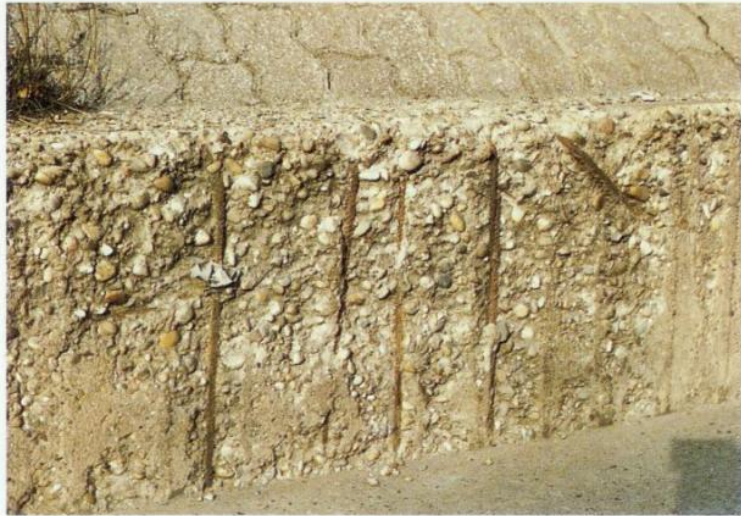
Figure 6. Crumbling and scaling of a concrete surface after freeze and thaw cycles (Nuernberger, 1995).

Freeze and Thaw. The medium to high use of deicing substances in the winter introduces about 1kg of salts into 1m² of a horizontal bridge deck area used for traffic. Even though other deicing agents have been investigated, none has been found that does not harm the concrete in any way and is just as effective. The main freeze-thaw related damage mechanisms are hydraulic pressure increase, temperature shock and freezing of single concrete layers. The repeated freezing and thawing of the topmost layers damages the concrete structure. When water freezes in concrete it will expand around 9% in volume and generate hydraulic pressures in the capillaries and pores of the cement paste and aggregates. Once the pressure exceeds the tensile strength of the concrete, it will rupture and, if exposed to several freeze-thaw cycles, ultimately cause extensive deterioration in the form of cracking, scaling or crumbling (Figure 6).

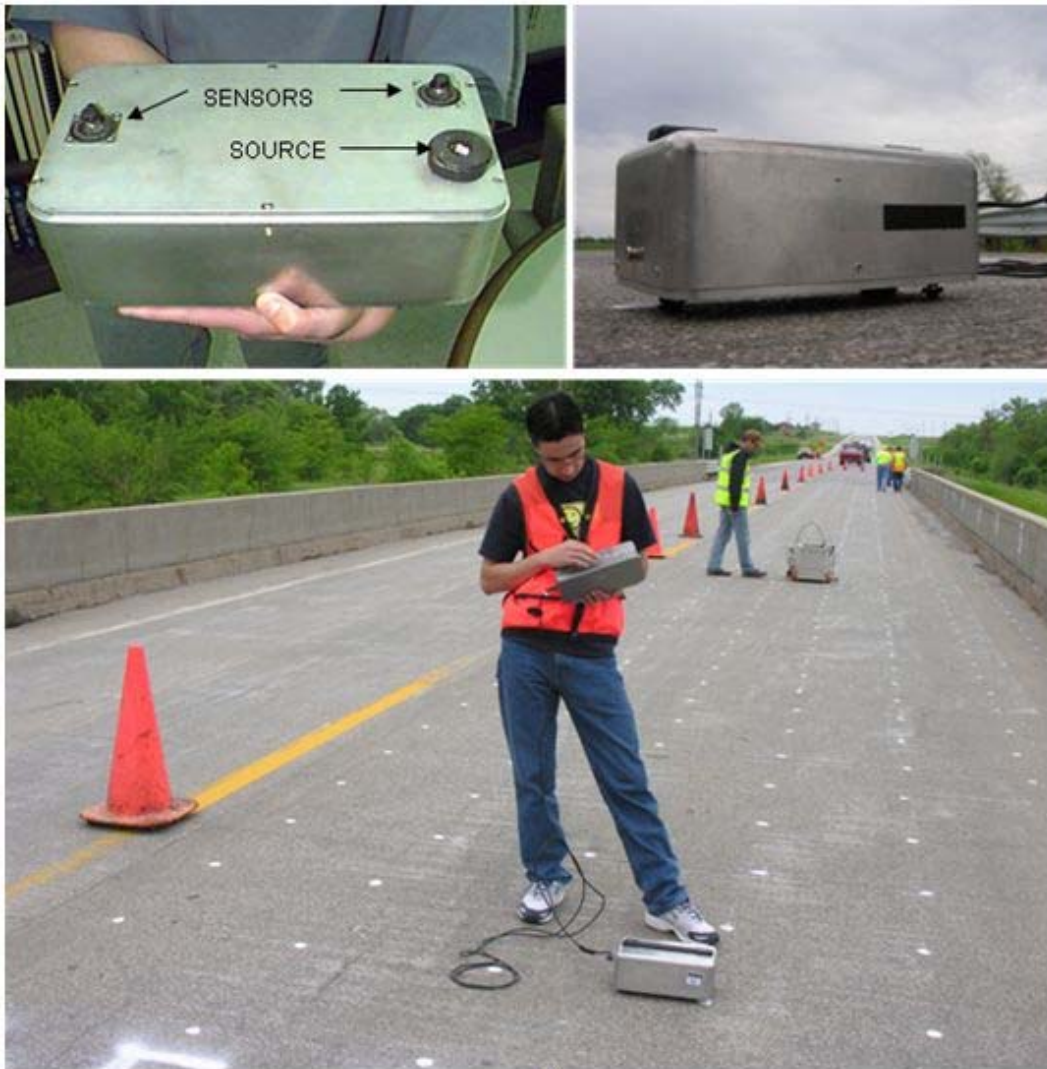
IE method is commonly implemented in deck evaluation by conducting point testing on a grid of a selected spacing. The testing is conducted using impact echo devices, which in some cases integrate other ultrasonic seismic methods. One of such devices is the portable seismic property analyzer (PSPA), shown in Figure 14, that has a sole purpose of evaluation of surface pavement layers and bridge decks. The device integrates all three previously described ultrasonic techniques (UBW, USW, IE). Bridge deck evaluation is typically done on grids of 0.6 m x0.6 m to 0.9 m x0.9 m (Figure 14). Impact echo testing is simple and typically takes less than 30 seconds per test point. On an average, about 50 m² of a deck can be tested per hour using a 0.9 m spacing, or about 20 m² using a 0.6 m spacing. The testing is relatively insensitive to traffic induced vibrations, because those are in a much lower frequency range than the IE test range, which is typically 2-30 kHz.

Figure 14. IE and USW sensor box (top) and field implementation (bottom).

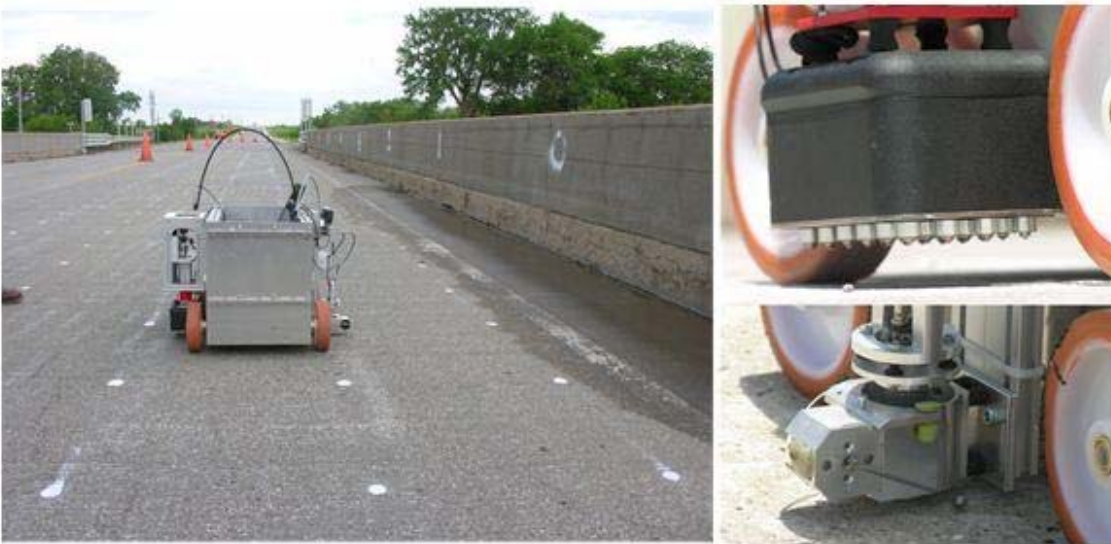
Figure 16. Stepper (left) with ultrasonic (top right) and impact echo probes (bottom right).

As described earlier, the manual approach in impact echo data collection is a relatively slow one, conducted on a sparse grid and thus does not provide data of high spatial resolution. To overcome this limitation an automated system for data collection called Stepper was used in this project (Figure 16). The Stepper was developed at BAM (German Federal Institute for Material Research and Testing). The Stepper allows continuous data collection at a prescribed spacing between data points at a speed of about 10-15 points per minute for closely spaced points (few inches apart). In addition, the Stepper can carry and collect data simultaneously using another or multiple probes: impact echo, ultrasonic echo or GPR antenna.

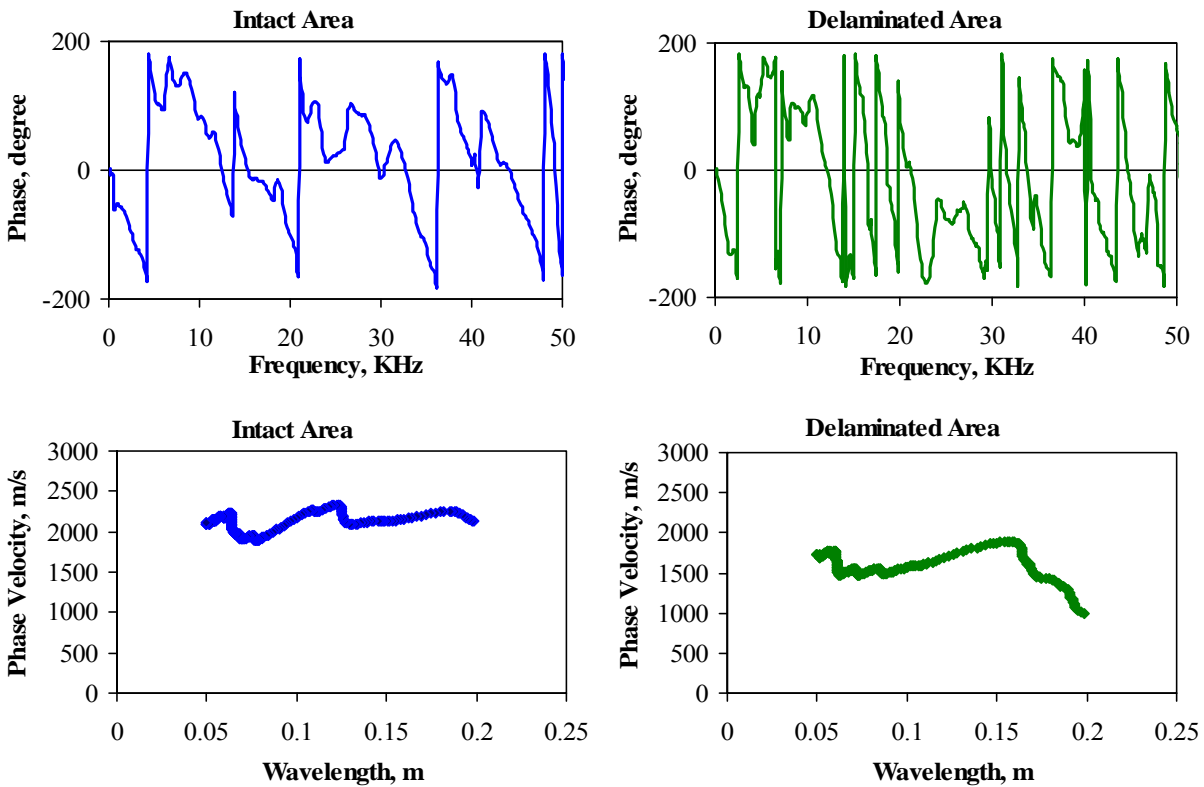
be an indication of delamination in the concrete deck. Figure 20 shows the comparison of field results from a reinforced concrete pavement. The rebar-induced mid-depth delamination existed in the concrete in some areas of the pavement.

Figure 20. Comparison of USW measurements from intact and delaminated areas: phase of the cross power spectrum (top) and dispersion curves (bottom) (from Yuan et al., 1999).

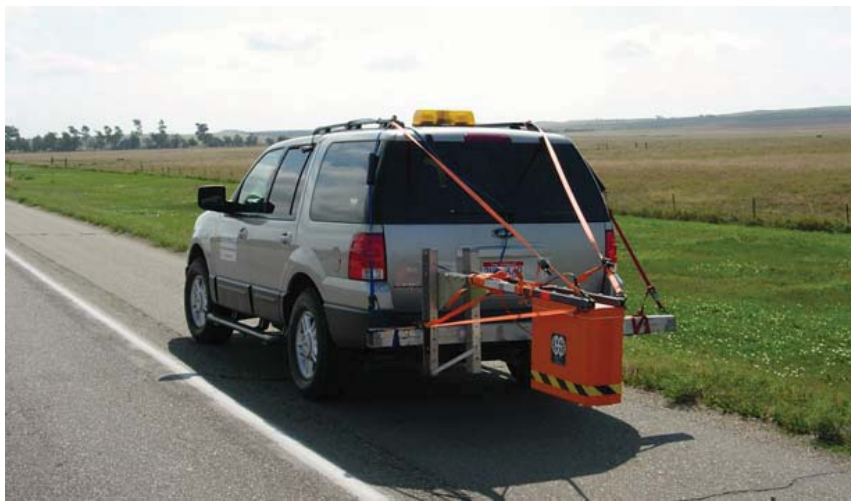
Figure 23. Single-polarization (1.0GHz or 2.2GHz) horn antenna deployment.

In general, horn (air coupled) antennas have been used in the past to primarily provide a fast overview of the condition of the deck with an attempt to also provide a detailed condition assessment. A single-polarization air-coupled antenna deployment used for a more general condition assessment is shown in Figure 23, and the limited level of detail in the quality of the GPR data when rapid deck condition assessments are performed is illustrated in Figure 24. Note that approximately 20 ft of high spatial density data are collected with a high-resolution ground coupled antenna in Figure 22, which should be compared to the approximately 200ft of more sparse, spatially sampled data shown in Figure 24, collected with a lower frequency air-coupled (horn) sensor. While ground coupled antennas provide more detailed imaging and analysis of the deck condition, one patented GPR data collection and analysis methodology employs a dual-polarization horn antenna deployment to overcome some of the limitations of lower-resolution air-coupled sensors (Romero, Roberts, 2002a and 2002b).

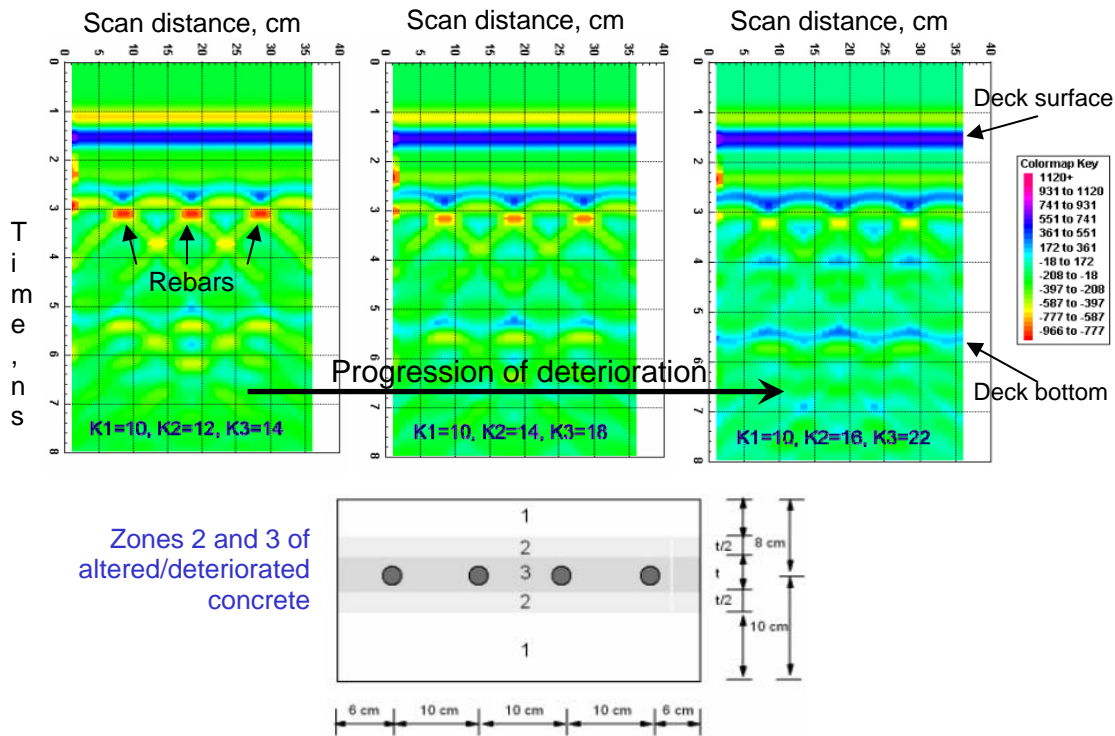
When the antenna is centered directly above the rebar, the highest amplitude return for the area near the rebar is obtained. This amplitude will be the highest when the deck is in a good condition. It will be weak when internal deck environmental conditions are favorable for formation of delamination and corrosion of the reinforcing steel are present, as illustrated by the results from numerical simulation of effects of concrete deterioration on GPR signal attenuation in Figure 25. Amplitudes for all points are normalized with respect to the best possible condition to obtain the plot of attenuation.

Figure 25. Results of numerical simulation of effects of corrosion on GPR signal attenuation.

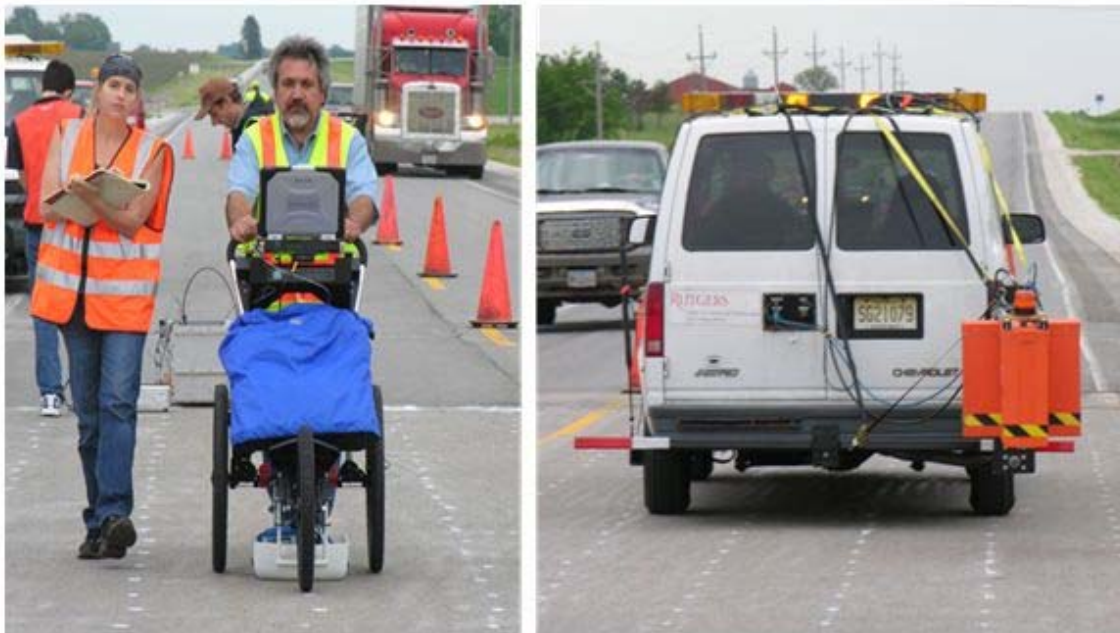
Figure 26. Data collection using 2.6 GHz ground coupled (GC) and 1.0 GHz dual polarization air coupled (AC) antennas, left and right, respectively.

Ground-Coupled GPR Antennas (Sensors). Data from 1.5 GHz and 2.6 GHz ground coupled antennas (Figure 26 left), taken at scan density of 79 scans/m (24 scans/foot), are shown in the upper two data sets in Figure 27. Qualitatively, at a glance it appears that the 2.6 GHz antenna provides significantly more detail compared to the 1.5 GHz sensor. Sometimes more detail is good, as when imaging for defects such as honeycombing or cracking or in attempting to resolve thin layers, such as deck overlays, so that their potential performance (condition) may be assessed and compared to GPR data indicative of concrete deterioration (Romero *et al.*, 2009). However, at other times too much high-resolution (such as the strong scatter from the aggregate, clearly visible in the 2.6GHz data, upper right of Figure 27) can obfuscate the imaging and processing of the desired signal. In this particular case accurate measurement of the strength (or attenuation) of the upper rebar/concrete interface reflection, which provides us with a clear indication of the relative degree of concrete deterioration throughout the upper portion of the deck, can be adversely affected by heterogeneous concrete material properties. This effect would be minimized, if a lower frequency sensor, say 1.5GHz, were used.

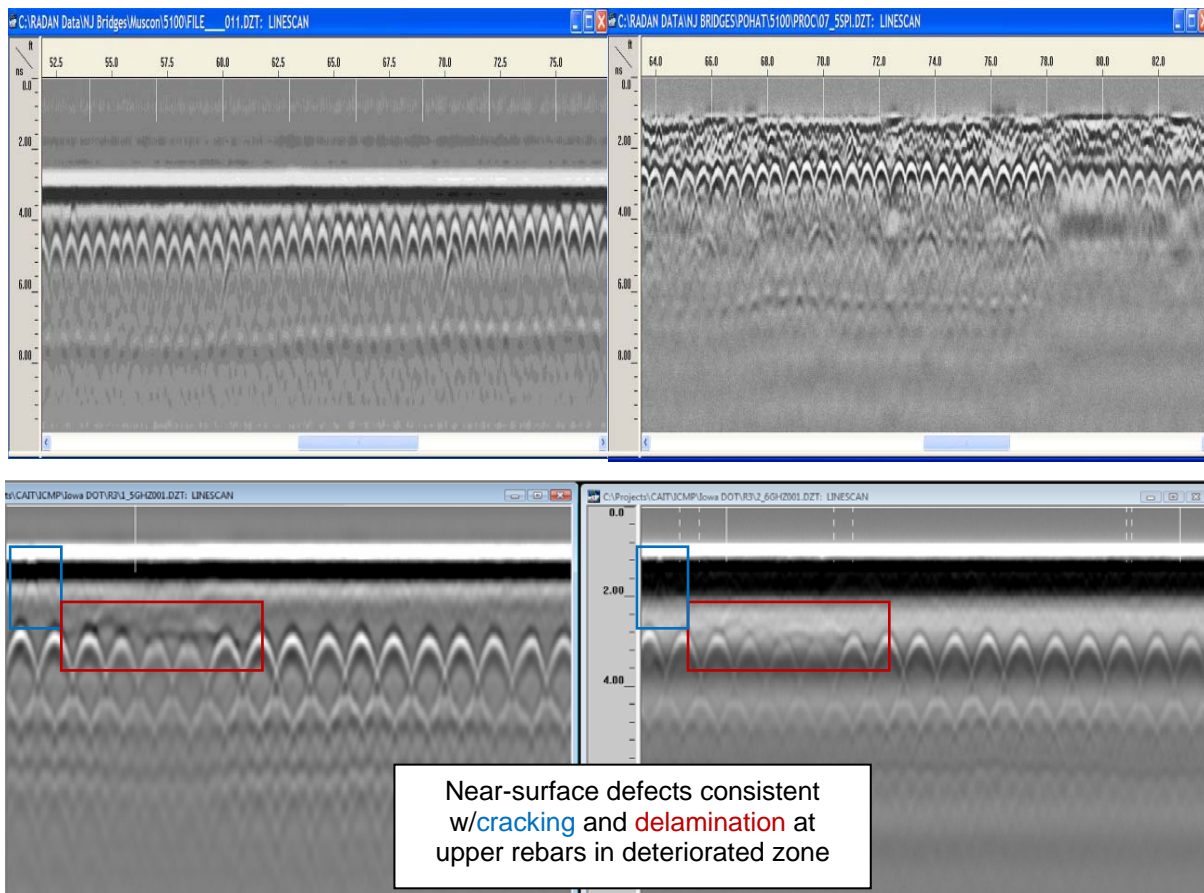
Figure 27. Raw data comparisons: 1.5GHz and 2.6GHz GC sensors, left and right, respectively.

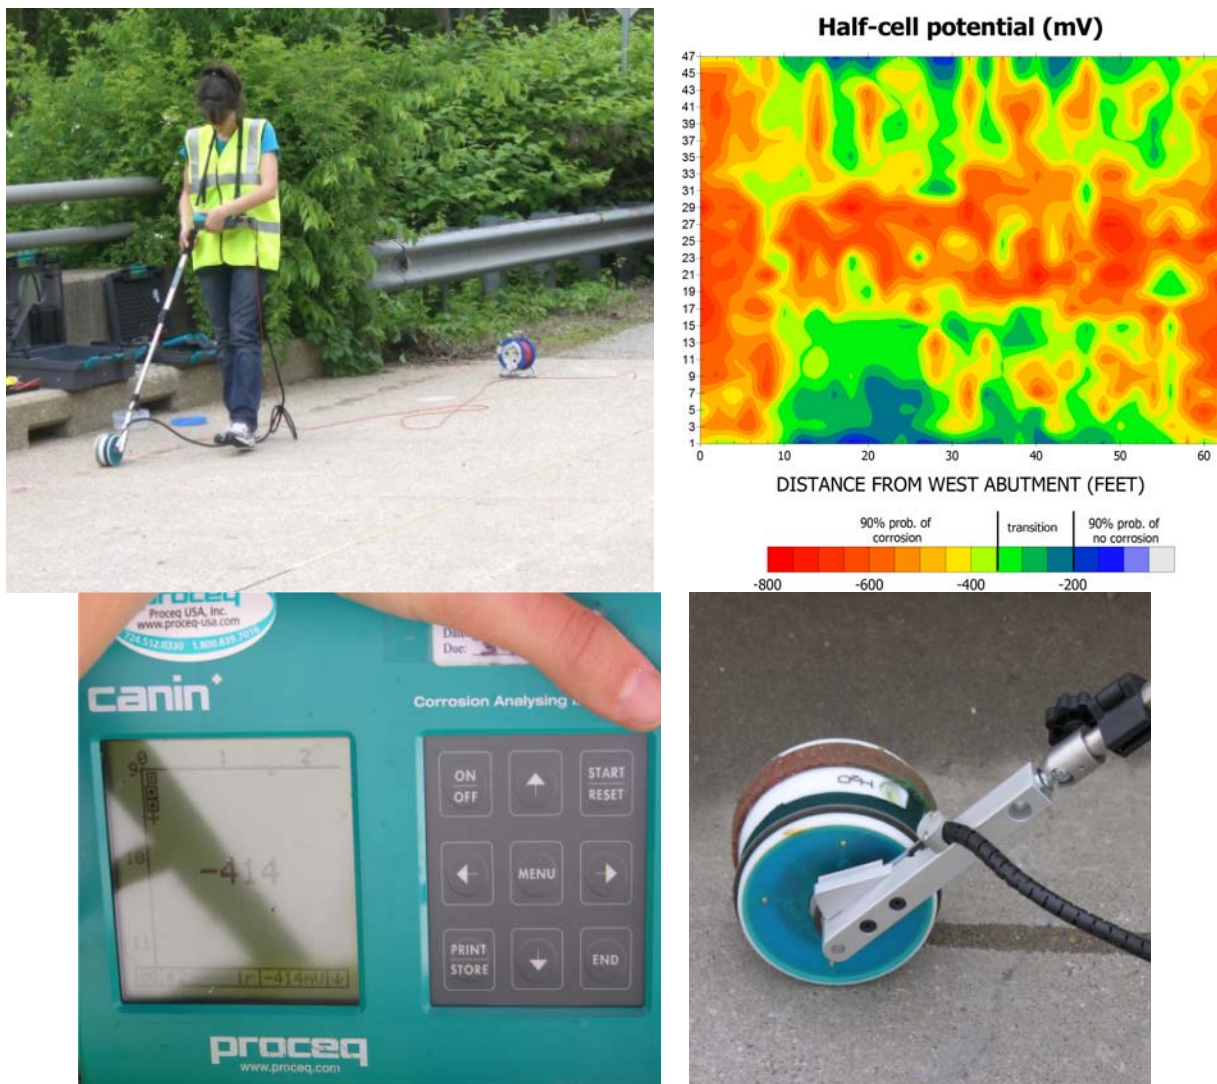
Figure 37. Half-cell potential measured on bridge deck (top left), example of mapped results (top right), images of control/display (bottom left) and electrode wheel (bottom right).

The primary advantage of the method is the speed at which large areas of a structure can be tested to locate more active areas of corrosion activity, particularly when a rolling half-cell measurement system – shown in Figure 37 – is implemented. If possible the half-cell potential data should always be compared to other methods. Most useful and reliable interpretations of half-cell data will be: visual inspection, delamination survey, chloride content analysis and concrete resistivity measurements. The best results are obtained when the reinforcement is accessible and one electrode has electrical contact with it. But if the reinforcement is not accessible, the potential mapping can still be performed in a nondestructive way by using two reference electrodes. One electrode is fixed to one position, while the second one maps the surface. The drawback of this method is that it only detects spatial potential variations instead of the real reinforcement potential. Therefore, an almost uniformly corroding reinforcement would show the same small potential differences like a fully passive reinforcement.

A field example of half-cell potential measurements collected with a Canin+ wheel electrode (Proceq Inc.) on a concrete bridge deck is shown in Figure 37 (left). The ground electrode of the measurement device is connected galvanically to the reinforcement, and a Cu/CuSO₄ electrode maps the half-cell potential along the bridge surface. When records are taken along grid lines the data can be presented as contour plots. Potential values obtained on a concrete bridge deck in Iowa are shown in Figure 37 (right). Steep potential gradients and high negative potentials identify a high risk of corrosion. According to the ASTM thresholds, potentials above 350 mV indicate serious areas, where corrosion is more than 90% probable. Potentials less than 200 mV, mark sound areas with a probability of 90% for no corrosion. Intermediate potentials mark transition zones.

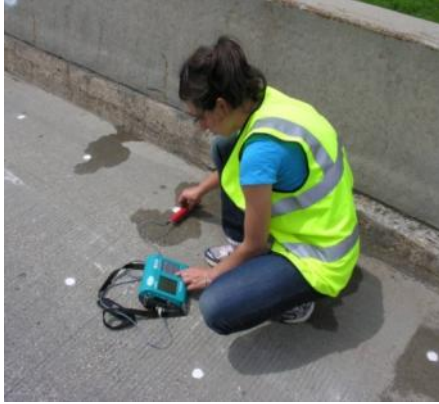
Figure 39. Resistivity measurement using Wenner probe on concrete bridge deck (left), and sample holder for CR measurements built by BAM (right) (Kruschwitz, 2007).

Electrical resistivity measurements in the Wenner layout can be taken in the field or the laboratory. When taken in the field, probes, like the one shown in Figure 39 (left), can be applied that use wet foam pads at the end of the four steel rods (probes) to establish galvanic contact to the concrete surface. One example of a laboratory set up is shown in Figure 39 (right). German silver wires placed in PVC chambers serve as potential leads. Stainless steel caps at the front and end of the cell are used as current electrodes. All electrodes are coupled with agar gel to the specimen.

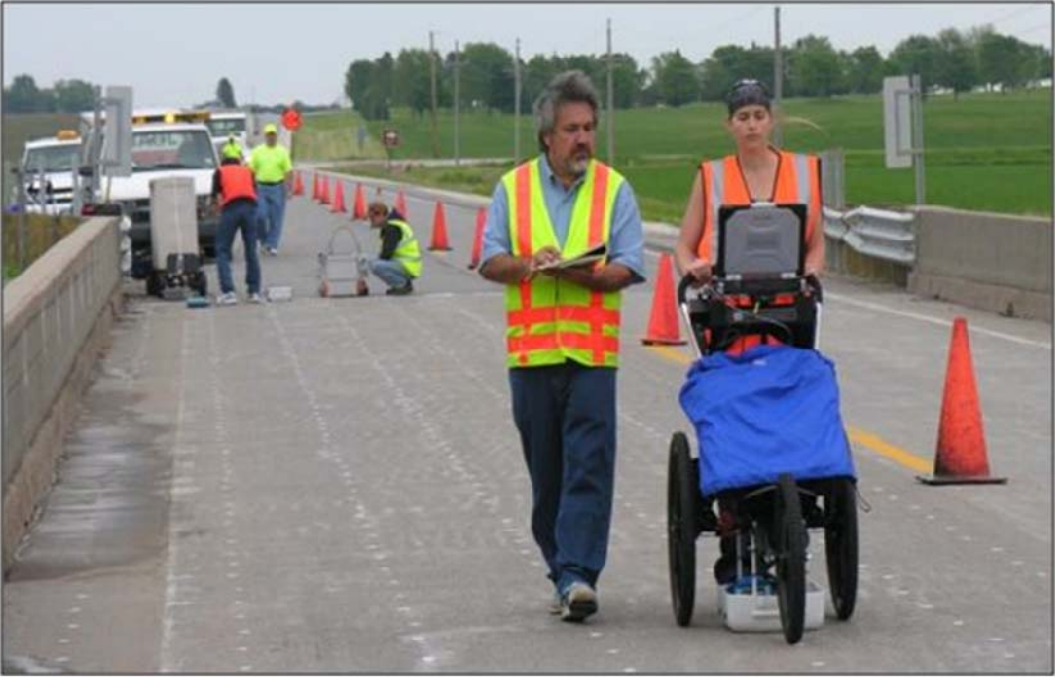
Figure 48. Ground coupled (GC) GPR data collection using 1.5GHz or 2.6GHz sensor.

GPR data were obtained from ground-coupled (GC) 1.5GHz or 2.6 GHz GPR sensors, mounted in a cart (Figure 48). A built-in distance measuring instrument (wheel encoder device) was used for triggering distance-based GPR scans by the GSSI SIR-20 acquisition system (covered w/blue raincoat to protect from light rain). Field notes and deck sketches are updated as other NDE measurements are performed in the background.

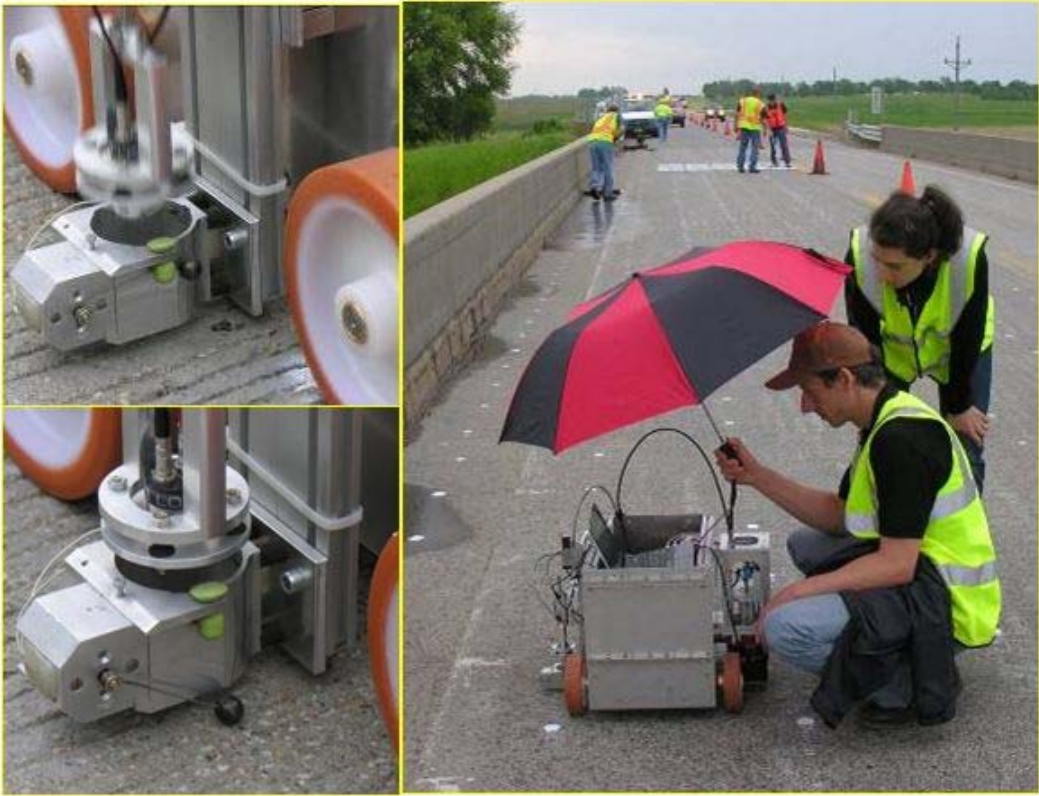
Figure 49. Robotic Stepper™ with impact-echo (IE) and ultrasonic pulse-echo (US) devices mounted at left and right, respectively, during data collection on deck.

Impact-echo data collection (Figure 49, right) is also performed along longitudinal, gridded lines spaced 2ft apart, though individual impact-echo samples are taken every foot along each of these two-foot spaced lines. In this figure, the Stepper™ (robotic cart) with impact-echo (IE) is shown at (a) upper left, with the sensor lowered and the hammer (small ball) still in the "up" position and (b) lower left, with the impact hammer in the "strike" position on the tined concrete surface. At right, both the impact-echo instrument (left side of the Stepper) and ultrasonic pulse-echo (US) device (right side) are shown during deployment.

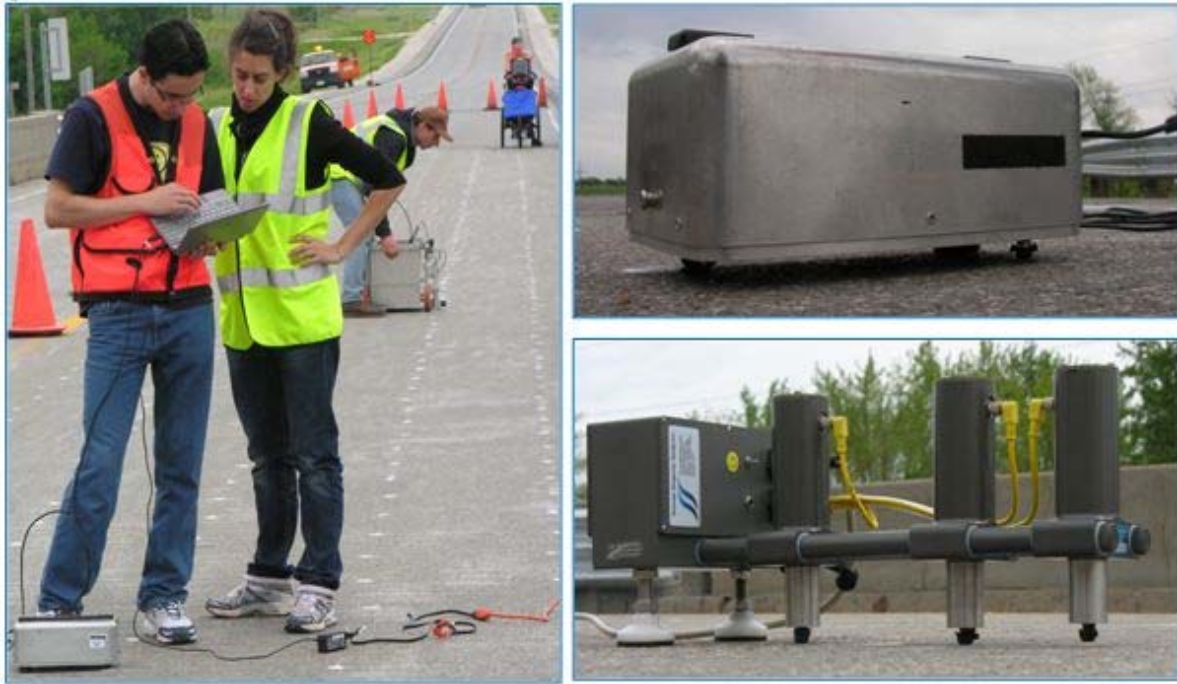
Figure 50. Portable seismic property analyzer (PSPA) data collection on deck, with two models of the device shown.

In Figure 50, ultrasonic surface wave (USW) measurements are shown being taken using two different models of a portable seismic property analyzer (PSPA). Shown on left and upper right is the original PSPA device mounted within a “lunch box”-type housing. On the lower right, the newer model of the PSPA is being used to collect USW data. Either instrument can be also used as an impact-echo device to identify deck delamination when only one sensor is used to measure the response from the impact hammer.

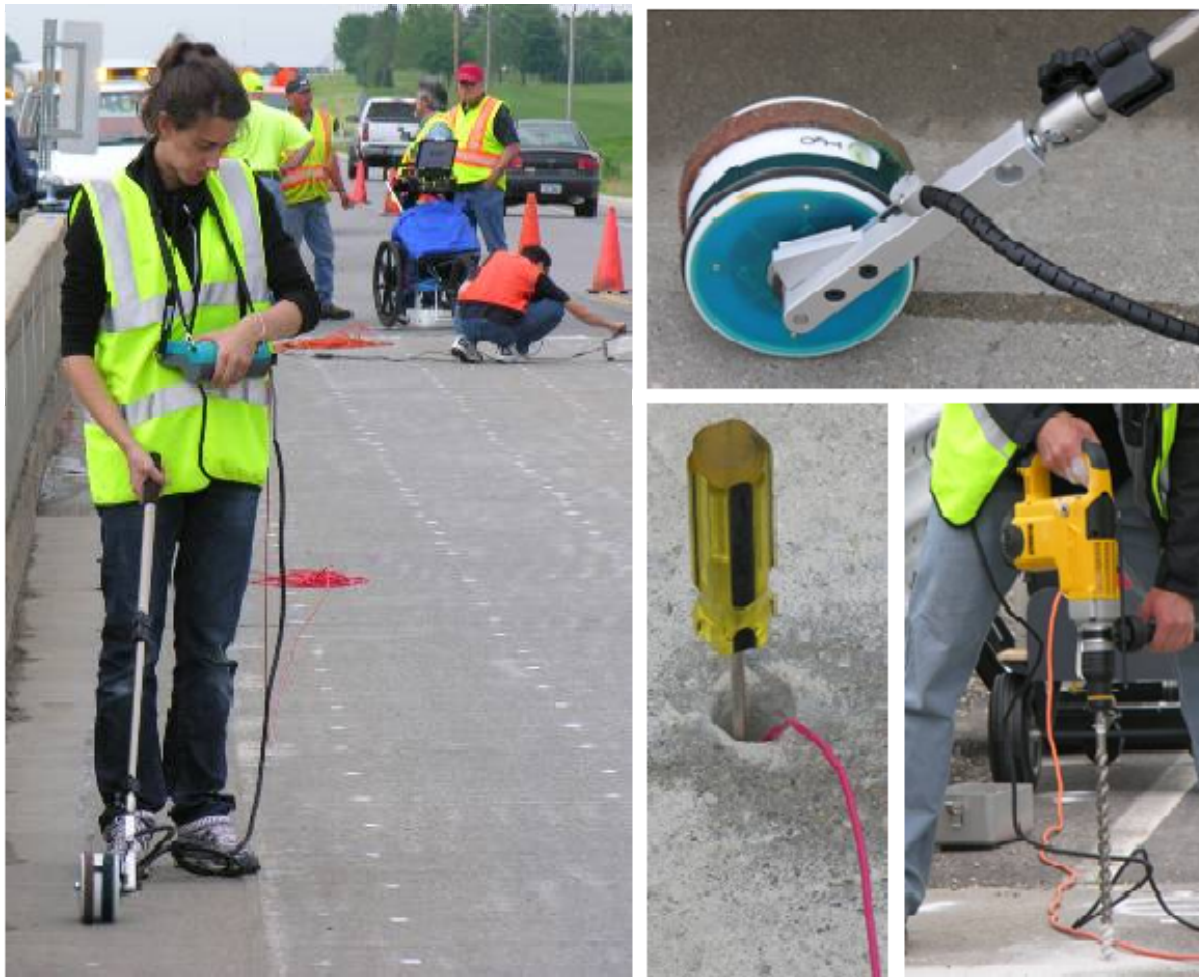
Figure 51. Half-cell (HC) potential measurement on deck; showing probe detail, drilled hole and wire lead connected electrically to the upper rebar mat.

Figure 51 shows data collection on the same 2ft x 2ft grid on a deck, using a Proceq™ data logger and rolling, half-cell probe, as well as a hammer drill used to prepare a hole in the concrete. This allows an electrical connection to be fastened with a wire lead (alligator clamp) onto an exposed rebar located in the upper reinforcement mat. This figure shows the detail of a transparent probe housing filled with copper sulfate solution, which wets an absorbent blue strip along rolling surface. However, the blue strip itself is not in direct contact with concrete. Instead, a thicker, more absorbent strip on the rolling surface is continuously maintaining contact with concrete surface, while applying water to wet the deck. This same strip is also in contact with another absorbent dark blue strip bridging between the “copper sulfate” strip and the “water” strip. This “bridging” strip, just visible in the image at right near the location where the electrical cables mount onto the handle, provides both physical and electrical contact between the copper sulfate strip/supply reservoir and the water-soaked strip.

Together these electrically-connected strips form the Cu/CuSO_4 electrode that rides along the surface, measuring the electrical potential, which is displayed and stored on the logger. At a distance, which might equal the total deck length from the instrument operator, the physically connected wire lead (the alligator clamp galvanically fastened to the rebar in the drilled hole)

forms the ground electrode – as discussed previously. Voltage readings between the concrete surface and the upper rebar mat, accessed with an electrical connector (lower center image) directly attached to a rebar after drilling through the concrete (lower right), are obtained via the electrical connectors at the rolling instrument head. The connector between the instrument head and the logger feeds the data logger with potential readings (generally ranging between -100 and -800mV, on most decks) measured between the rebar cage and the deck surface at each grid node. These readings are stored on a pre-set grid matching the deck’s areal dimensions, then transferred to a computer for mapping.

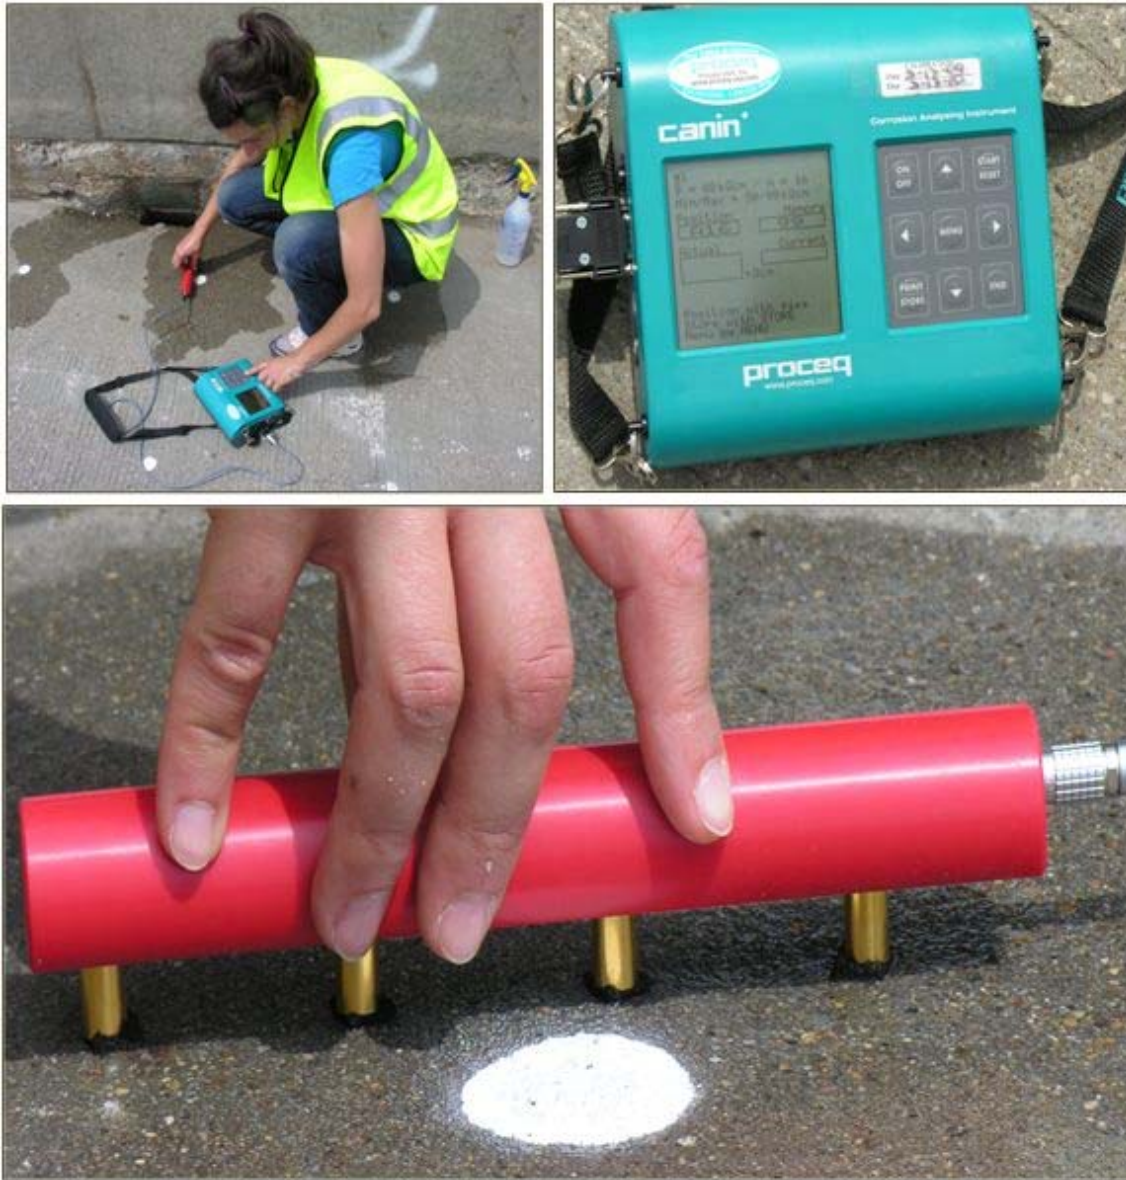
Figure 52. Electrical resistivity (ER) measurements obtained using a four-probe Wenner array.

Figure 52 shows electrical resistivity (ER) measurements obtained using a Wenner probe, which also feeds data into the same Proceq™ data logger used for HC measurements. Unlike the HC device, which wets the deck with a weak copper sulfate solution (as some copper sulfate is continuously absorbed by the “water-fed” strip), only a light coating of water needs to be sprayed at each grid node in order to take a resistivity measurement. The water must wet a large enough surface so that each of the four, compressible probe heads comes into direct contact with the wet concrete. Care should be taken, however, not to “puddle” the deck surface with the sprayed water

because there is concern that there may be current leakage from probe to probe, which may adversely affect the measurement. As is the case with the half-cell testing, ER measurements are collected on the same 2ft x 2ft grid and mapped using contour-mapping software.

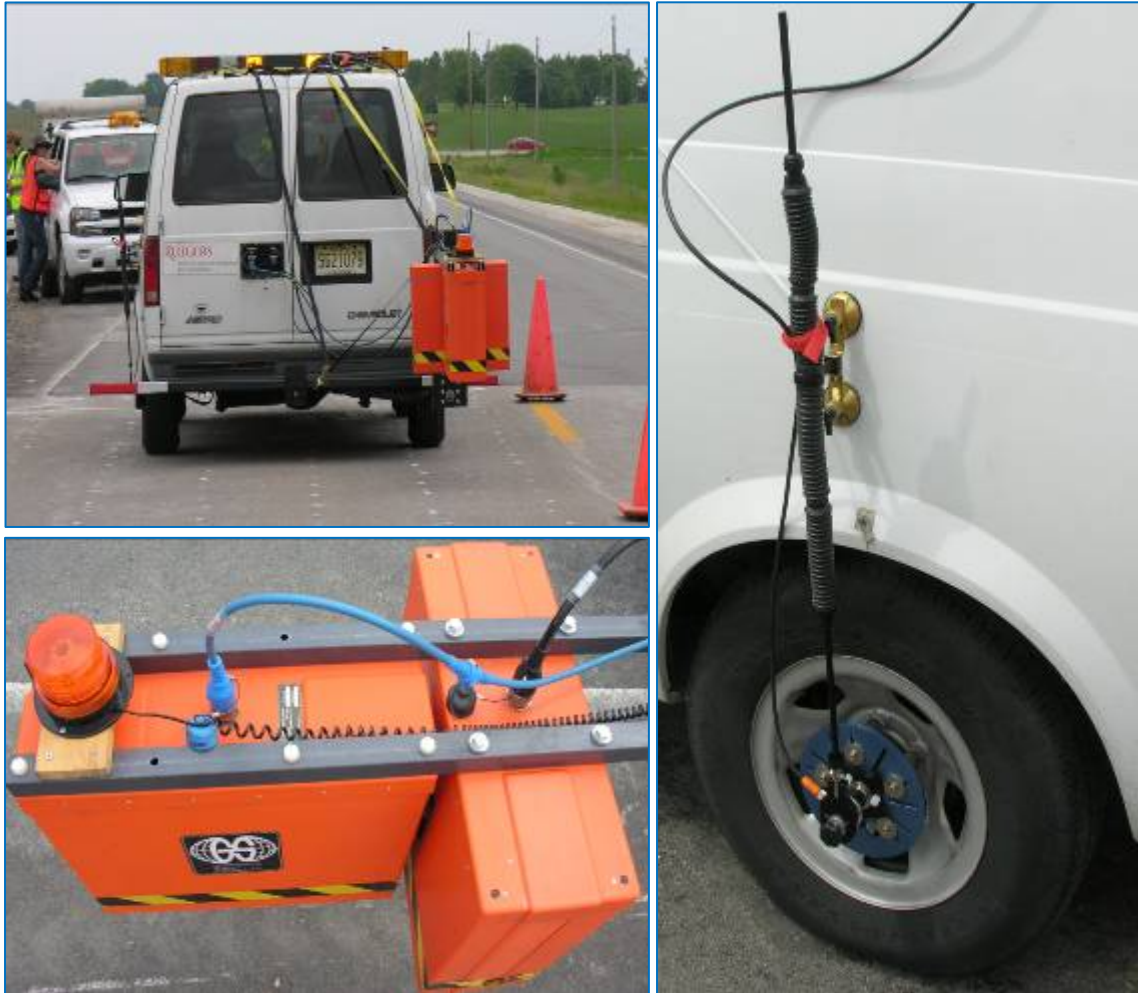
Figure 53. Air-coupled (AC) GPR data collected in dual-polarization configuration.

Air-coupled (AC) GPR data collected (Figure 53) is shown on a vehicle-mounted frame in line with the right wheel path (upper left). GPR scans are collected using two separate sensors (lower left), configured in a dual-polarization deployment and controlled by a GSSI SIR-20 data acquisition unit that is mounted inside the survey vehicle. The wheel-mounted distance measuring instrument (DMI) on the rear driver's side wheel (lower right) is used to trigger GPR scans from both antennas (sensors) at equally-spaced intervals of one inch.

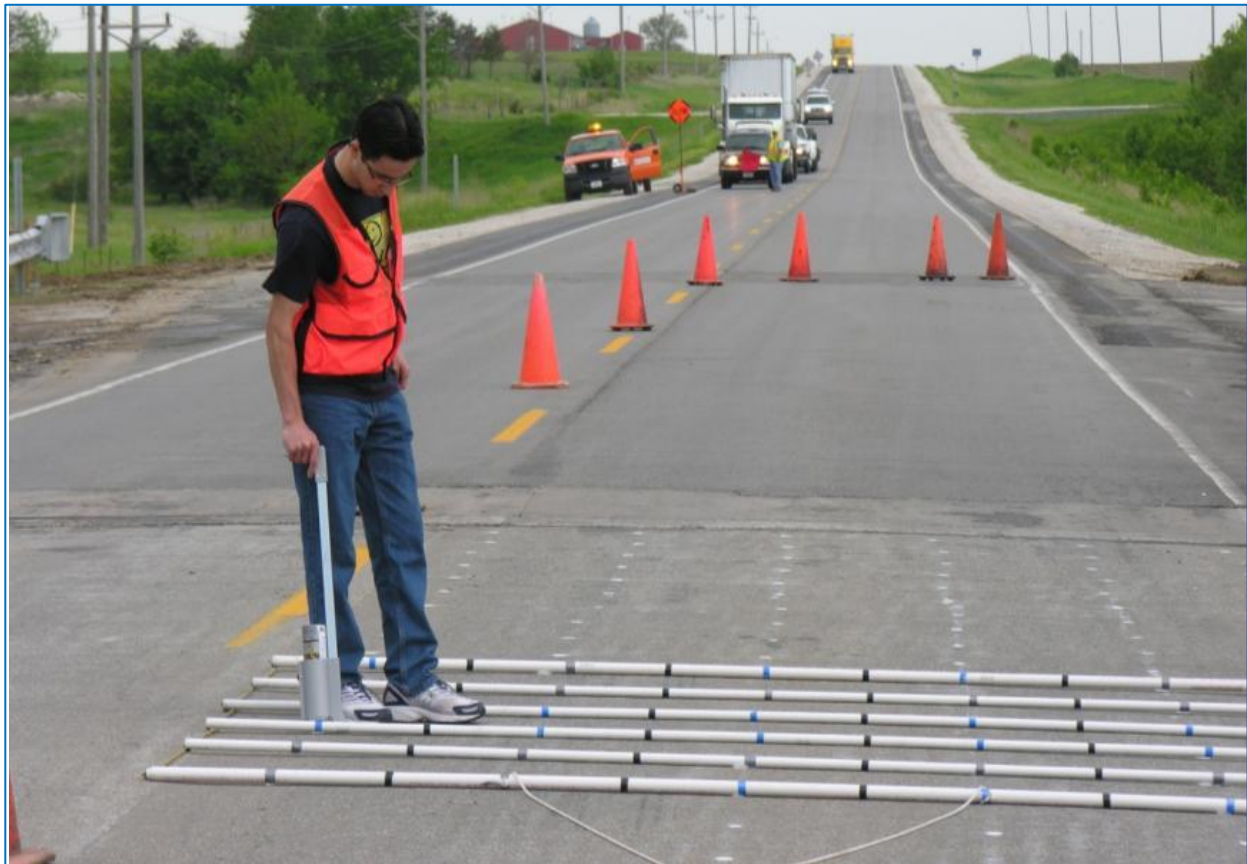
Figure 54. 10ft x 10ft “jig” used to quickly mark 2ft x 2ft testing grid on bridge deck.

A 2ft x 2ft, orthogonal grid pattern was laid out in “dots” on the entire bridge deck using marking paint beginning with the first grid point at the expansion joint and all others 2ft apart, along a line spaced 1ft from the curb (or parapet wall). All other grid nodes are similarly spaced 2ft apart along lines that are both spaced 2ft apart and parallel to both the curbs and lane markings. In order to quickly mark the deck with a minimal number of physical measurements, a 10ft x 10ft jig was devised and built. This enabled the NDE crew to mark an orthogonal grid in 2ft x 2ft increments by simply stretching out the jig, aligning it to both the curbs and a series of

pre-measured dots spaced 10ft apart along the length of the deck on lines parallel to the curbs/lane markers (Figure 54). Because this particular deck had no skew (positive or negative), no accommodations for placement of the grid nodes on skewed portions of the deck had to be made. On skewed decks grid nodes (dots) were painted on the skewed portions of the deck so that they conformed to an orthogonal grid. This grid is based on the same convention for locating the origin at the joint and curb or parapet intersection, as defined by the primary travel direction

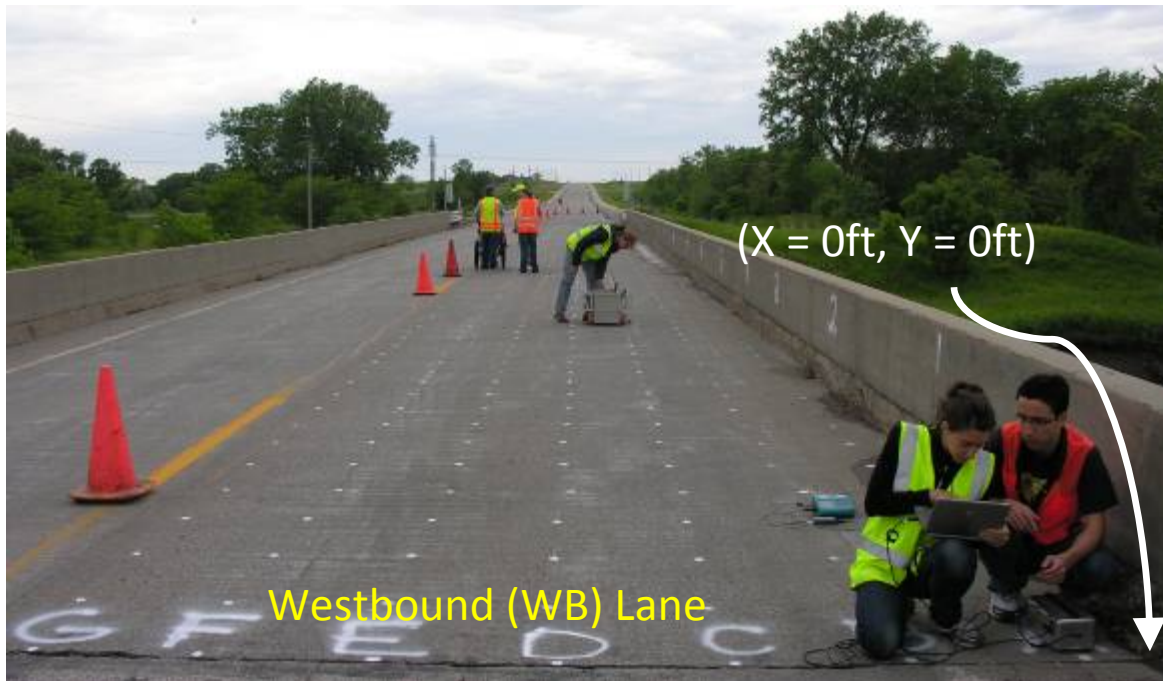
Figure 55. Location of origin on Deck O1 is at NW corner, where approach ramp and deck intersect the curb at the expansion joint, as shown.

The origin ($x = 0\text{ft}$, $y = 0\text{ft}$) for Deck O1, as shown in Figure 55, was marked at the NW corner of the deck, where the east abutment meets the curb (shoulder lane) at the expansion joint between the deck and the approach ramp. The 2ft x 2ft grid pattern was marked on the deck and labeled as follows:

1. Starting at the origin, the line closest to the curb/parapet (Line A) was marked with a series of dots placed two feet apart, with this line spaced a distance of one foot away from the curb/parapet.
2. Continuing every two feet from Line A, at distances of 3, 5, 7, 9, 11, 13ft, etc., from the curb/parapet, grid lines parallel to the curb/parapet were marked with the letters “B”, “C”, “D”, “E”, “F”, “G”, etc.
