Comprehensive Bridge Deck Deterioration Mapping of Nine Bridges by Nondestructive Evaluation Technologies

Final Report
January 2011

Iowa Highway Research Board (IHRB Project SPR-NDEB(90)--8H-00)
Iowa Department of Transportation
Federal Highway Administration

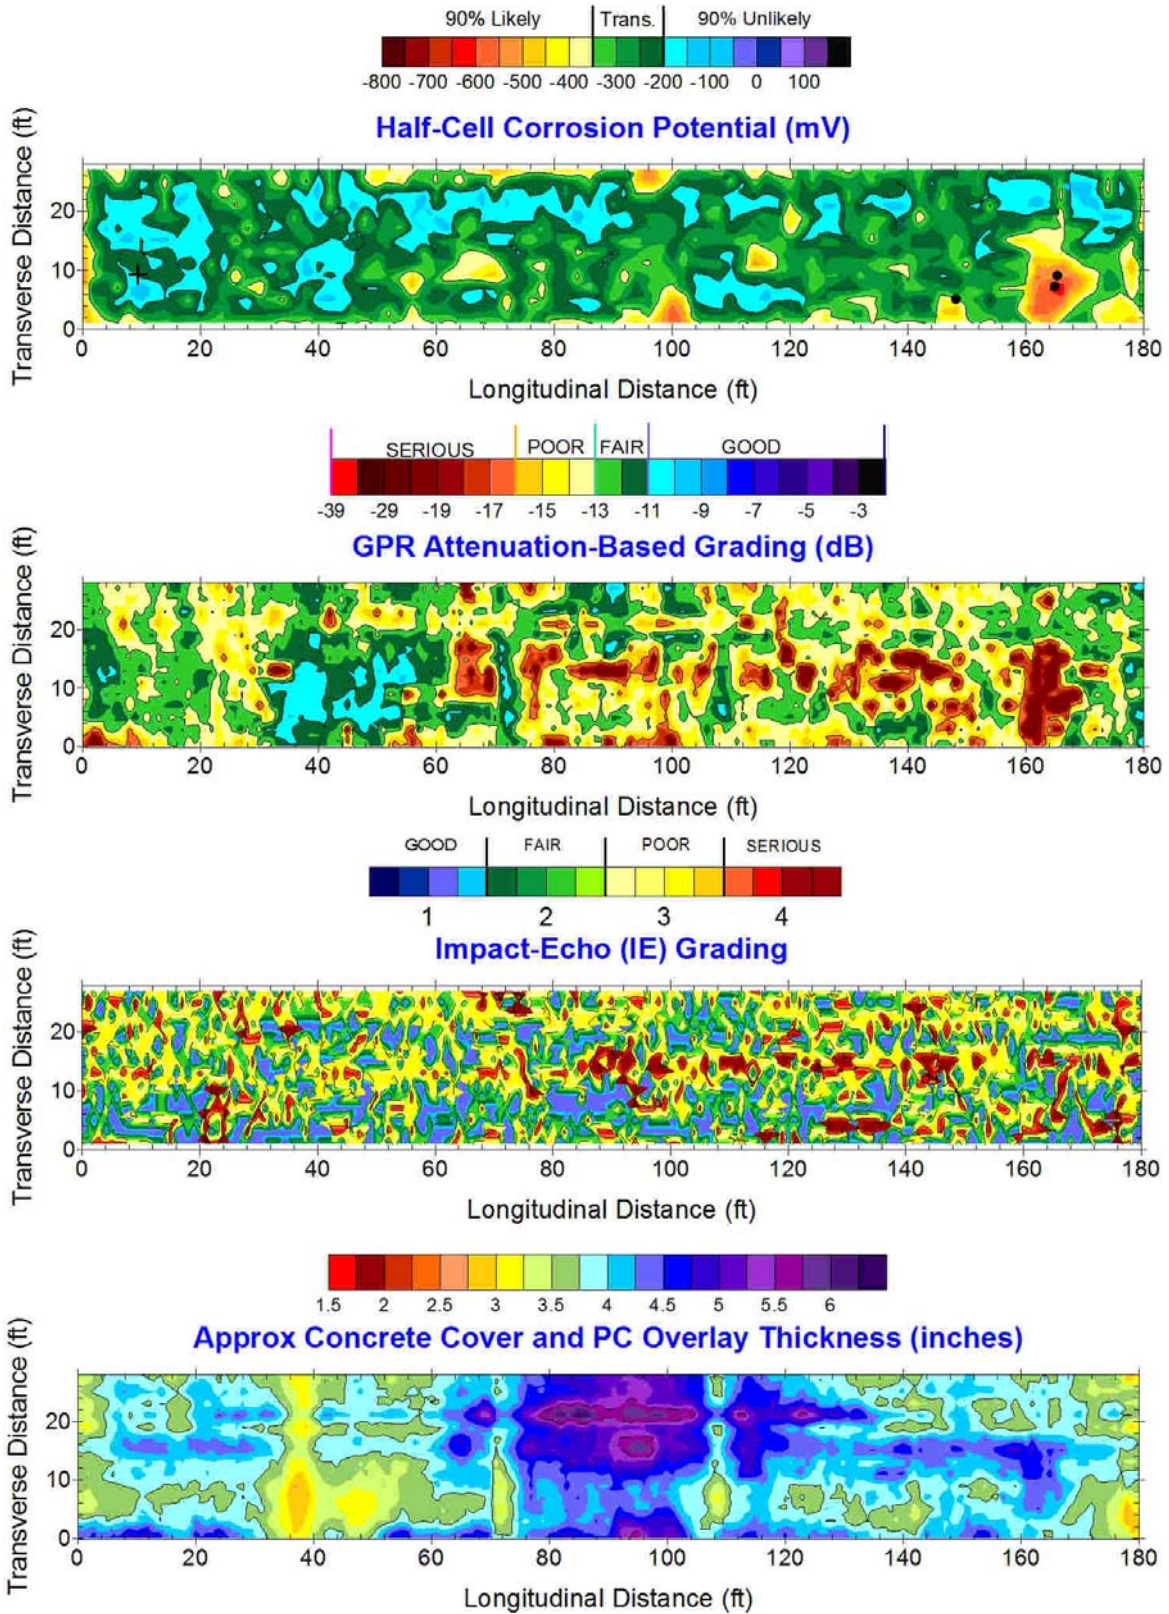
Figure 56. Concrete cover (CC), impact-echo (IE) from Stepper, half-cell (HC), and GPR maps.

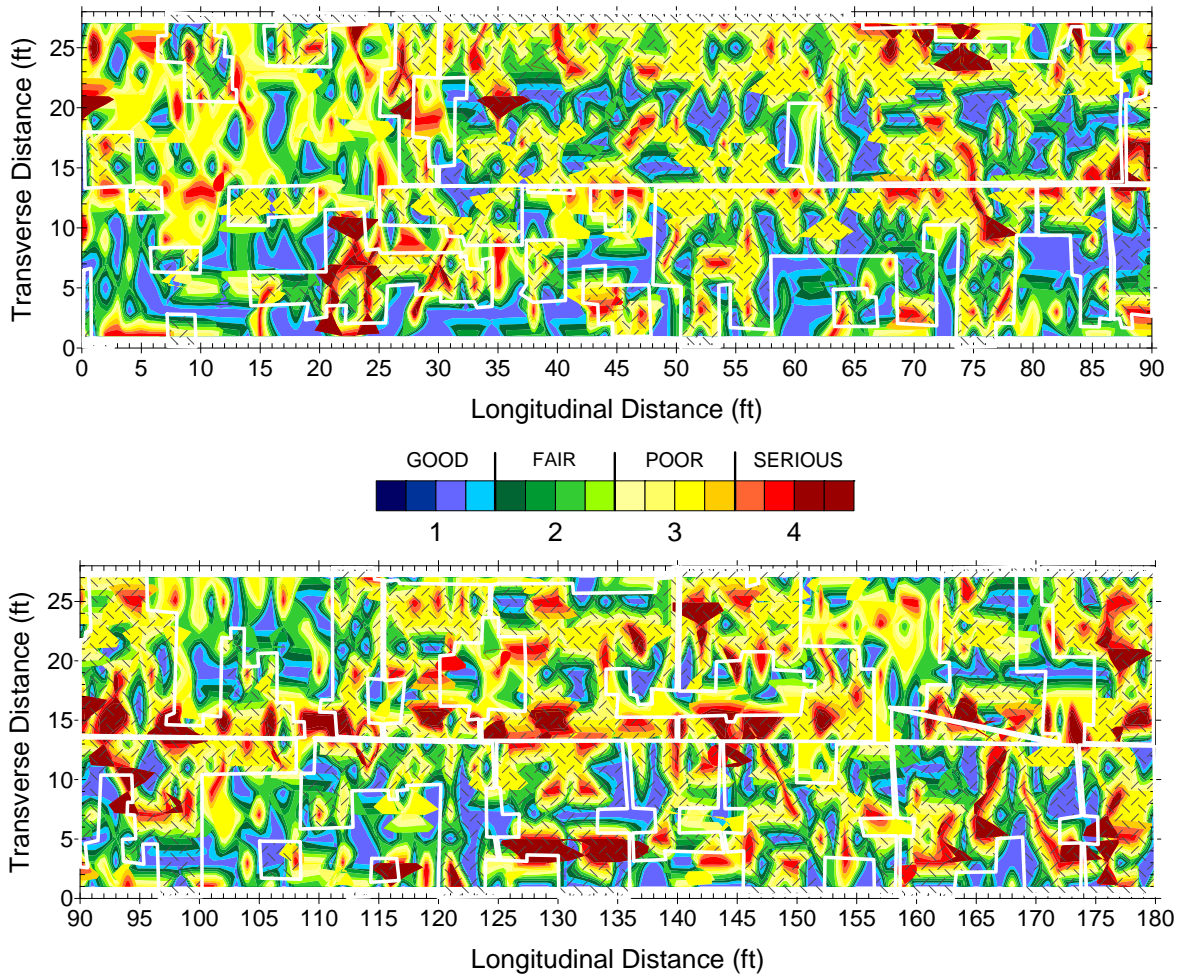
Figure 57. Impact-echo map with overlaid repair areas.

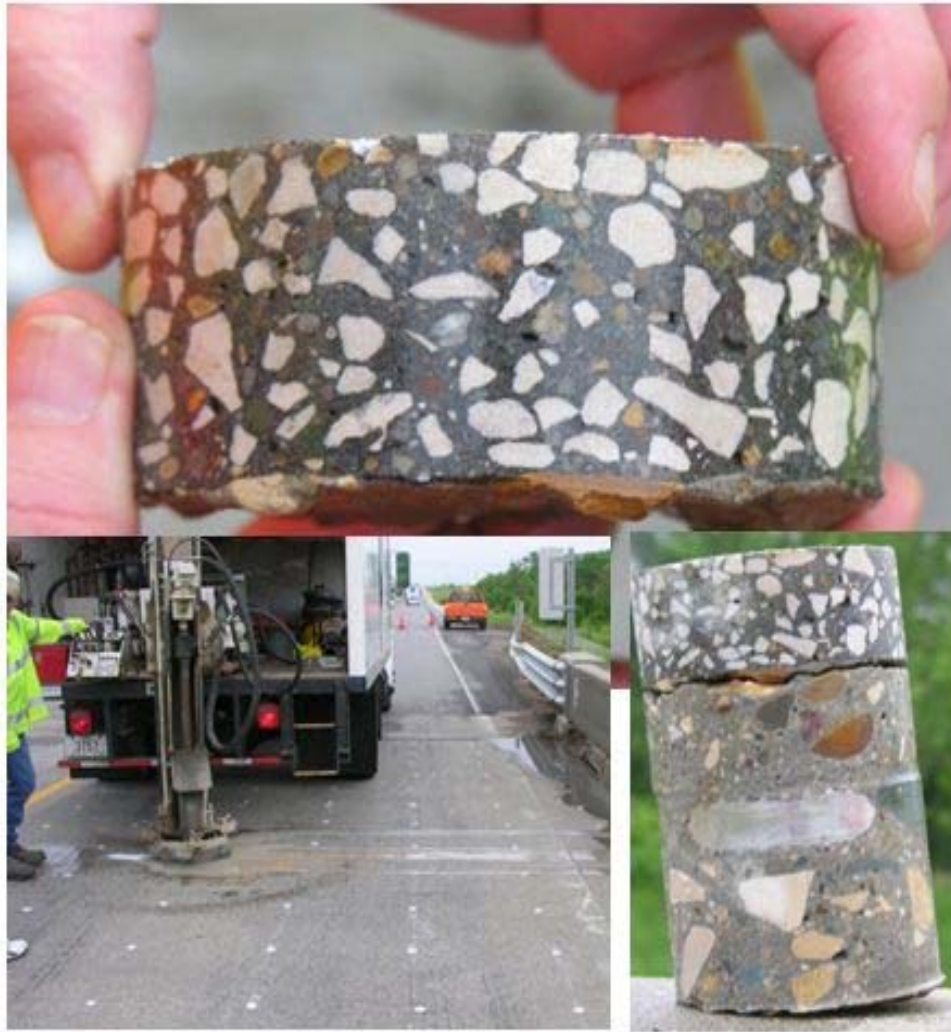
Figure 59. Core 1, showing debonding, but no obvious evidence of concrete deterioration at the rebar level, though raw GPR data used to select core location indicates such.

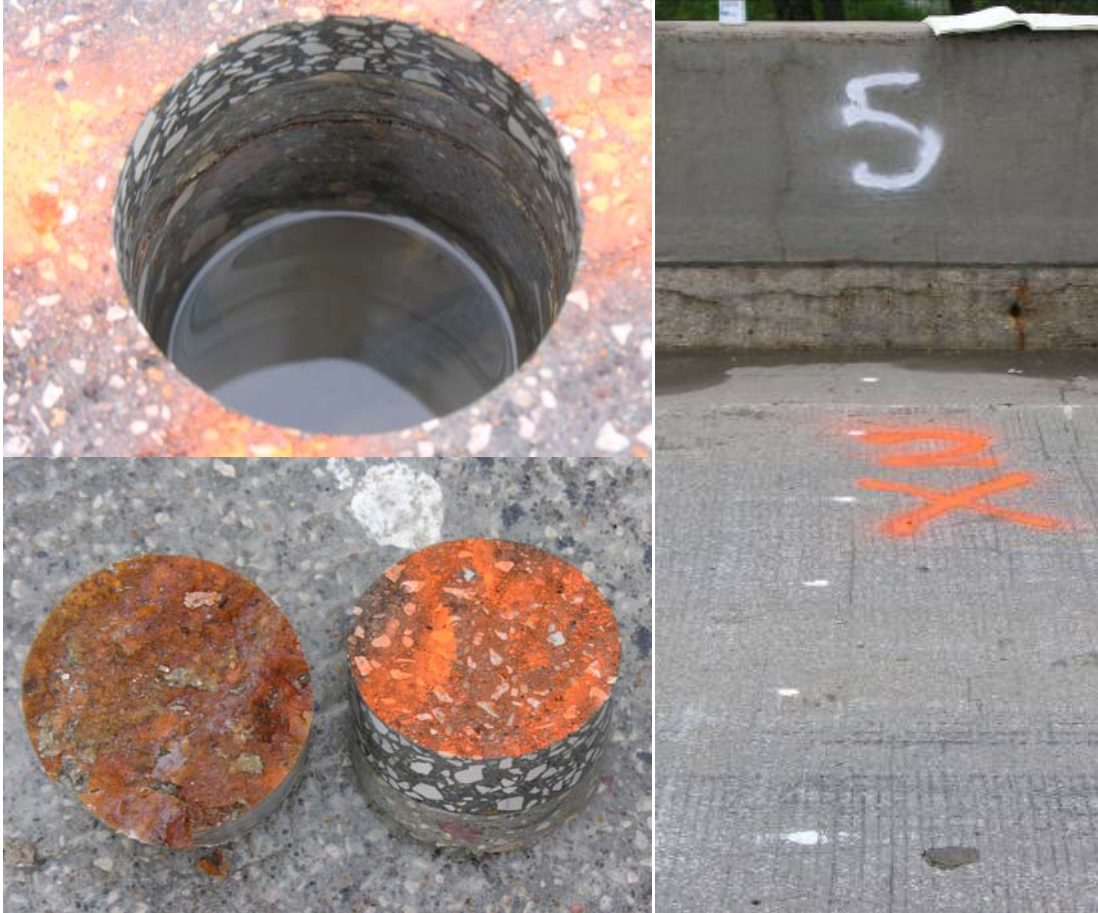
Figure 62. Photos of Core #2 location, showing extracted core, epoxy-filled delamination in core hole, and bonded overlay.

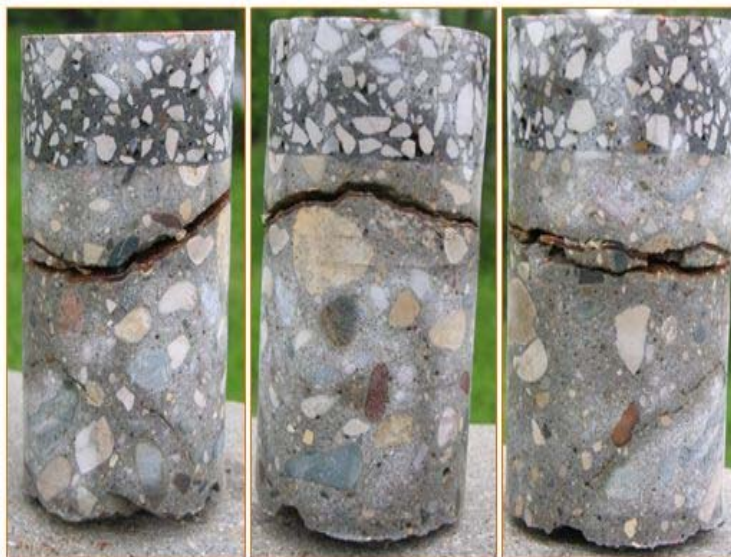
Figure 65. Three views of Core #2, which appeared as “epoxy-filled delamination” in field (raw) GPR data.

be seen on the surface. Thus, the core was targeted as an epoxy-filled delamination, and the extracted sample validated the interpretation. The Core #2 photos shown in Figure 65 from three views indicate that the delamination formed at the rebar level and propagated upward toward the concrete surface (overlay interface), consistent with known behavior for delamination-induced spalls.

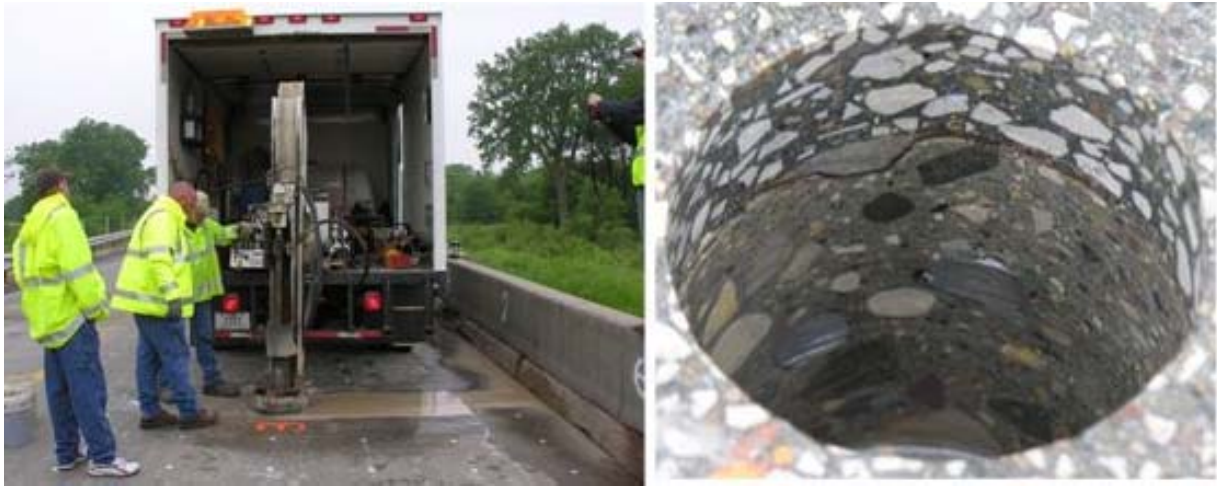
Figure 67. Core # 3 during extraction, where upper edge of delamination meets the debonded overlay just below the overlay, with both longitudinal and transverse rebar seen in the photo.

Finally, at Core #3 (identified as a potential “water-filled” delamination at the rebar level), the scan density of 60 scans/foot also provided just enough resolution to view an anomaly intersecting between two rebars. This time it was with a fairly abrupt, but positive polarity signal, which again deflected diagonally upward again from the rebars like a crack propagating toward the surface (Figure 66). Additionally, there was a strong horizontal interface at the overlay level, and a strong local reflection at one of the bars where the “crack-like” interface deflected upward. This position was marked as the location for extracting Core #3. This caused the NDE Team to suspect an unusual event: an actual “sighting” in the GPR data of a water-filled deck delamination, which appeared only for a distance of about 6 in along the GPR profile before quickly propagating upward toward the epoxy overlay. On both ends of this short delamination, however, the overlay signal was very strong, appearing to be de-bonded from the concrete. The core location was marked to attempt to “hit” exactly where the black arrowhead is positioned, at the apex of a hyperbolic, rebar pattern. At this location, the upward-dipping feature quickly rose and intersected with the indication in the signal that is consistent with a debonded overlay. The hope was to extract a core that was not only debonded, but also showed delamination in the parent concrete.

The “proof” came when this core was drilled and removed, and then the dirty water that always accompanies core extraction began to be replaced with clean water. A visible delamination just beneath the overlay was present not only in the core sample, but also within the core hole now in the deck (Figure 67), and clean water began emptying from the delamination to

quickly fill the core hole. This experience clearly showed that, based solely on a review of the raw GPR data, a water-filled delamination could actually be identified under the right circumstances and signal settings.

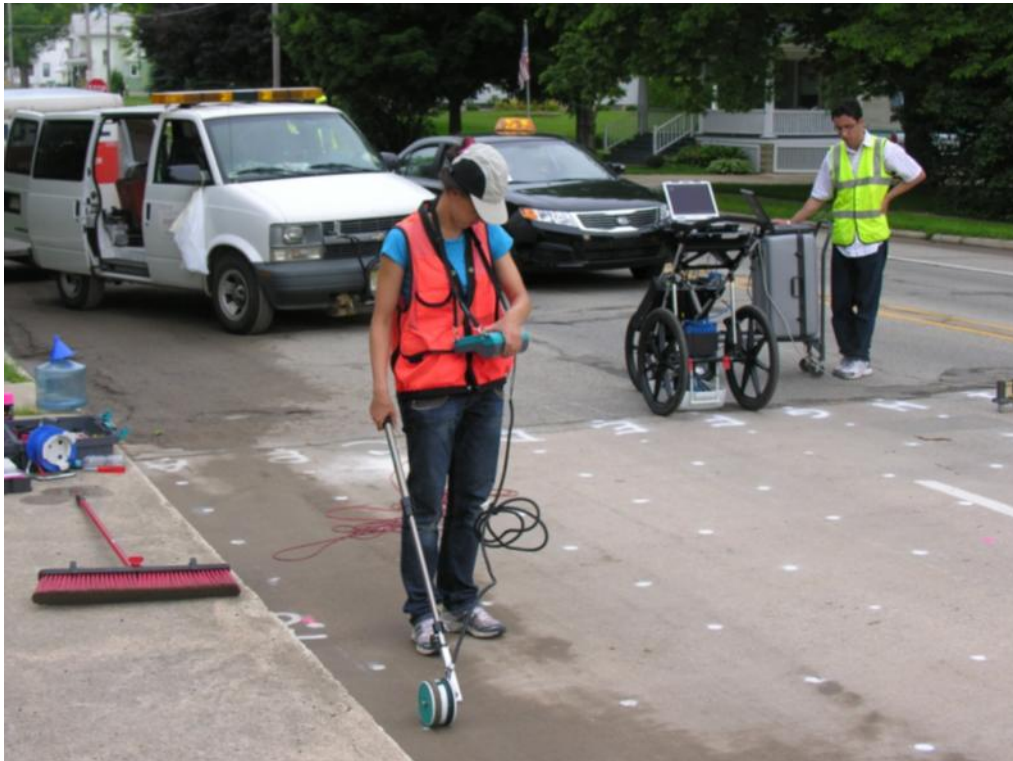
Figure 70. Simultaneous data collection on Deck O2 using various NDE instruments.

NDE methods used for collecting condition data on Deck O2 included (a) both GC and AC (ground- and air-coupled) GPR deployments; (b) the impact-echo (IE) and ultrasonic (US) devices on the robotic Stepper™; (c) the Proceq™ rolling half-cell (HC) instrument; (d) the Wenner electrical resistivity (ER) probe; as well as (e) a portable seismic property analyzer (PSPA). Some of NDE technologies deployed on Deck O2 are shown in Figure 70.

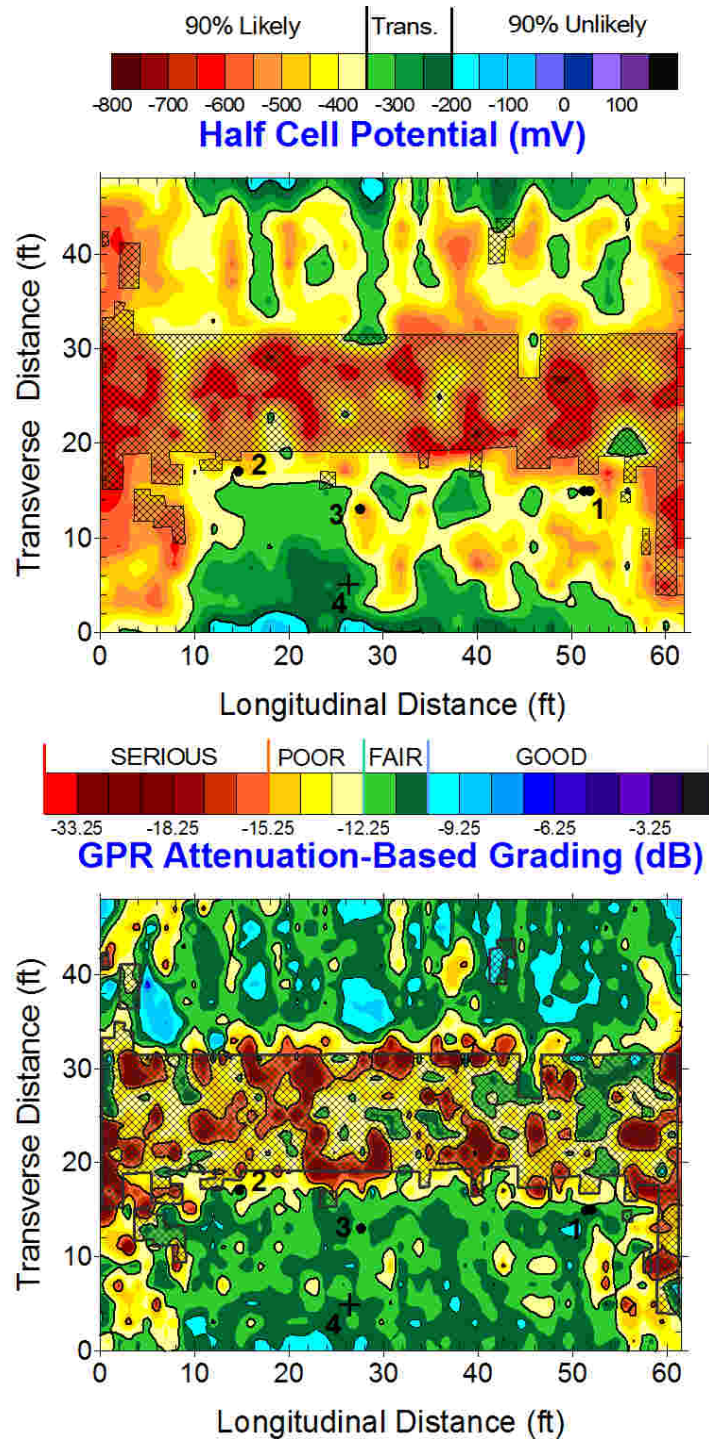
Figure 71. Cores 1 through 4 shown on the GPR and half-cell (HC) maps, with "+" sign indicating control core location and cross-hatched areas showing repairs.

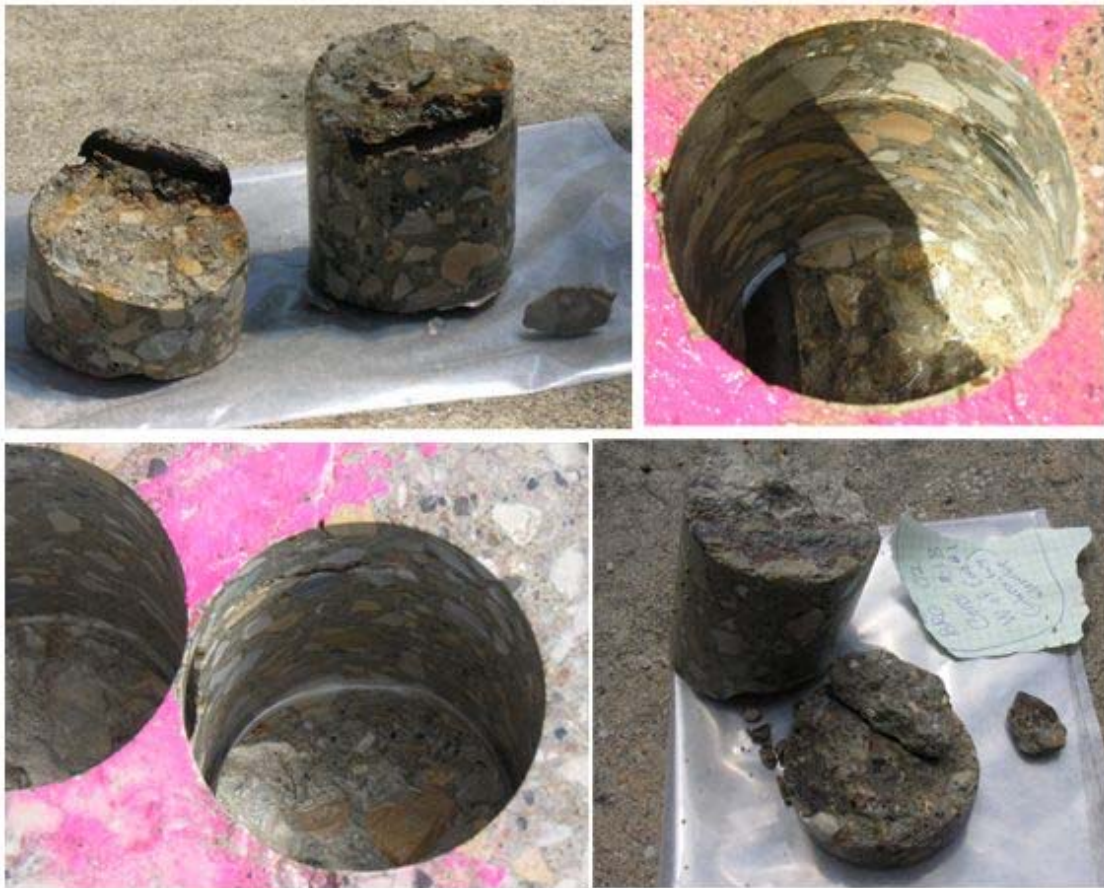
Figure 72. Core #2 and its hole (top) shown with Core #1b hole and its extracted core (bottom), immediately adjacent to the hole for Core #1a (half shown in photo).

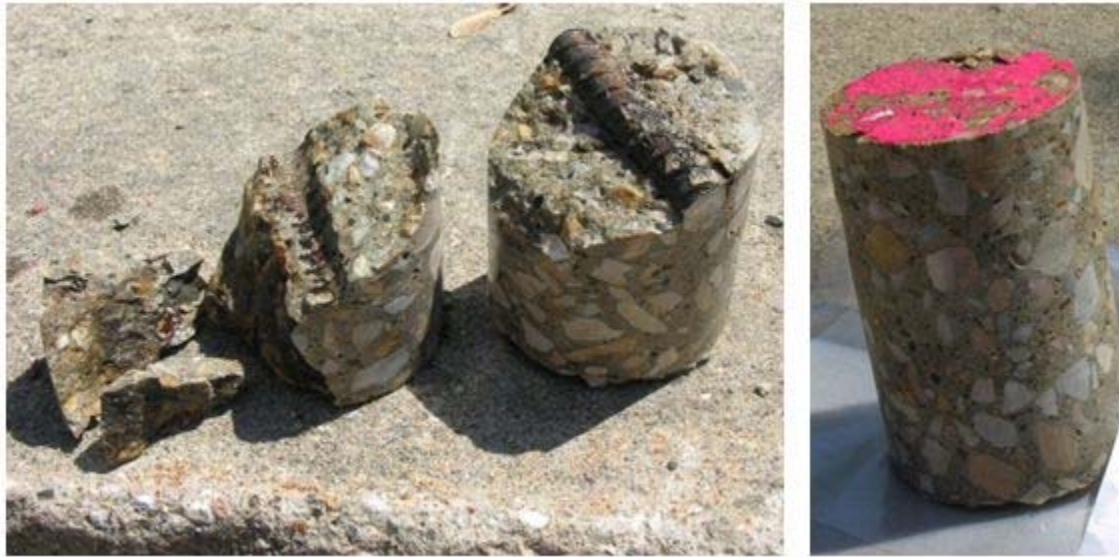
Figure 73. Cores #3 (left) and 4 (right), selected as “deteriorated” and “control” (sound) specimens for Deck O2.

All three cores suspected to be deteriorated broke during removal and/or were delaminated and/or split at the rebar. Also, the steel was either severely or moderately corroded. The control core

was also visibly sound and had to be broken from the deck to remove it. Cores #3 and #4, the third core targeted as “deteriorated” and the fourth as “control” core, respectively, are shown in Figure 73.

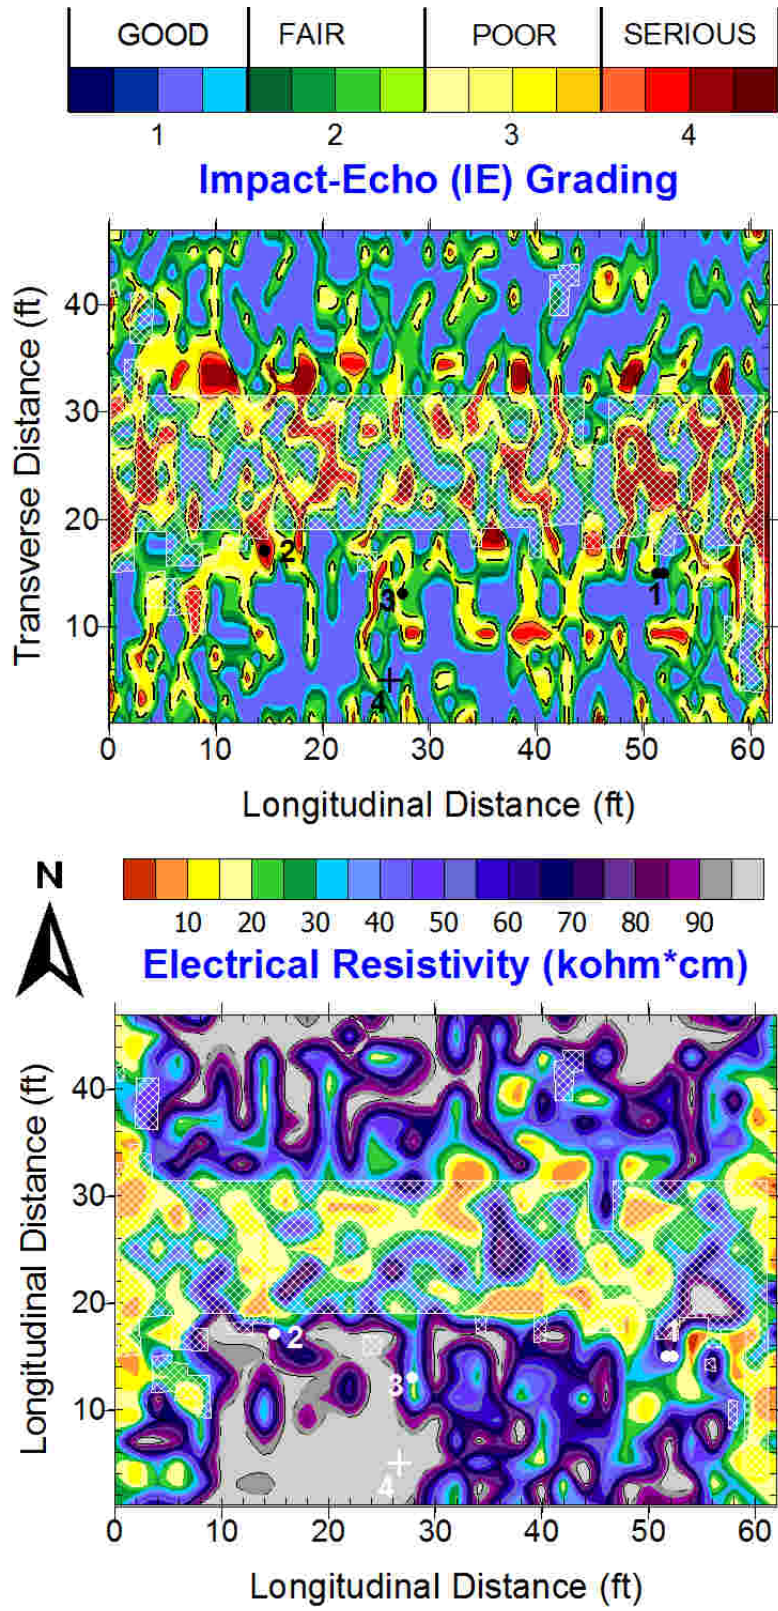
Figure 74. Repaired areas overlaid on impact-echo (IE) and electrical resistivity (ER) results.

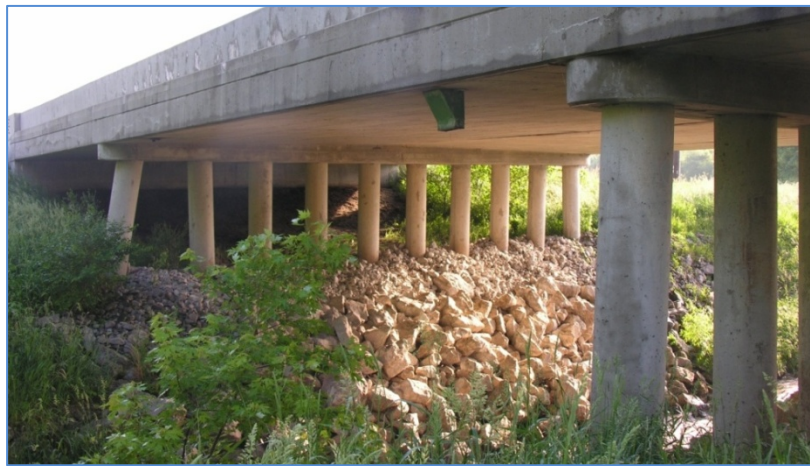
Figure 75 Side view of Bridge O3 showing full-depth (slab) deck construction between piers

The deck on Bridge O3 consists of a 123ft x 44ft continuous concrete slab carrying Iowa #14 over Warren Grove Creek and located 5.5 miles north of Monroe, IA. . The bridge was designed in November 1969 and constructed in 1971 (Figures 75 and 76). The most recent bridge inspection report, dated May 31, 2006, indicated that the deck is PC concrete. The top of the deck has some hairline transverse, and a few hairline diagonal and longitudinal cracks. There are a few scattered small and large hollow areas and some large and small PC concrete patches. The bridge was analyzed and found to be adequate for two lane legal loads. Corrective recommendations, based on reporting of the deck spalling and deterioration, was to recommend the deck for a complete PC overlay scheduled for completion in 2009. On both figures, through-deck deterioration (rust staining) can be seen between two of the piers close to the deck centerline (shown in detail, on inset of Figure 76).

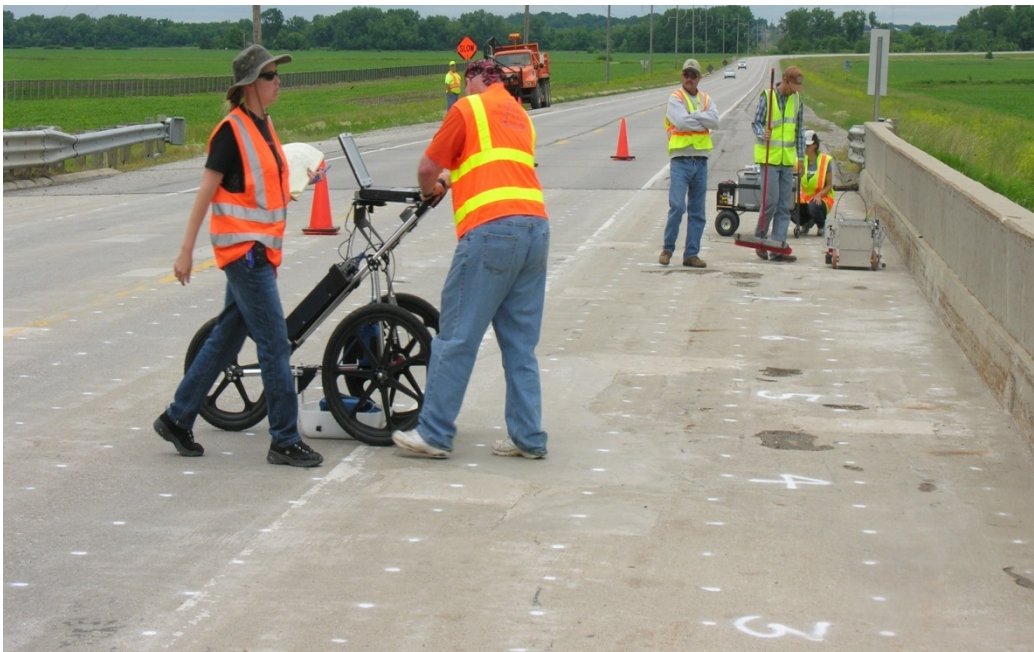
Figure 77. GPR data collection oriented perpendicular to traffic direction on slab decks, with other NDE methods unaffected by rebar orientation in upper mat.

GPR data collected on the deck confirmed that the shallowest steel in the upper mat of reinforcement was oriented in the longitudinal direction, parallel with traffic flow, while transverse bars are tied to the bottom of the longitudinal steel. It is well established that the best way to collect data is to orient GPR lines perpendicular to the shallowest steel in the deck, preventing erroneous data analysis and interpretation. This rebar configuration required GPR data collection across traffic lanes, in lines oriented perpendicular to traffic flow (Figure 77). Data on one-half the deck was collected up to the point where the antenna (in tub between rear and front wheels of GPR cart) could just cross the centerline, when no traffic was approaching. This mode of data collection was applied not only to Deck O3, but also the remainder of the slab decks with longitudinal steel tied on top of transverse rebars in the upper mat (O5, O6, R1 and R3). Data collection was unaffected for the other NDE methods (Figure 77, upper right), where Stepper™ is moving along Line A (1ft from curb) and PSPA data collection is taking place behind it. On this deck, exposed rebar (Figure 78) allowed steel to simply be cleaned and drilled with a small hole for a positive electrical connection during half-cell (HC) measurement preparation (not shown).

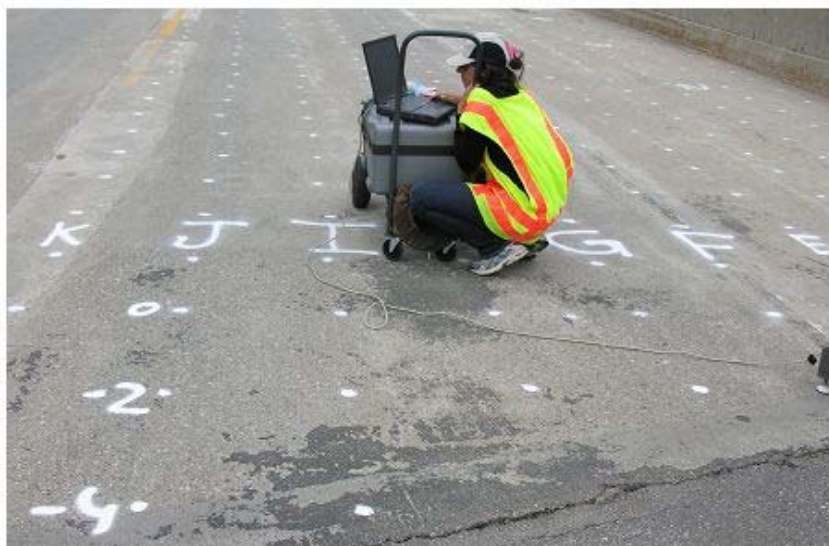
Figure 79. Gridded area near origin, showing negative coordinates used for mapping.

Traffic control and gridding were performed in the same manner as on Deck O2, except that the region near the origin, also located at the SE corner of the gridded deck, is shown in Figure 79 (off right side of photo frame). Because of the negative deck skew (obtuse angle between the curb and abutment at the origin), an orthogonal grid the length and width of the deck surface was marked for NDE data collection, using negative x-coordinates within the negatively skewed region near the south abutment.

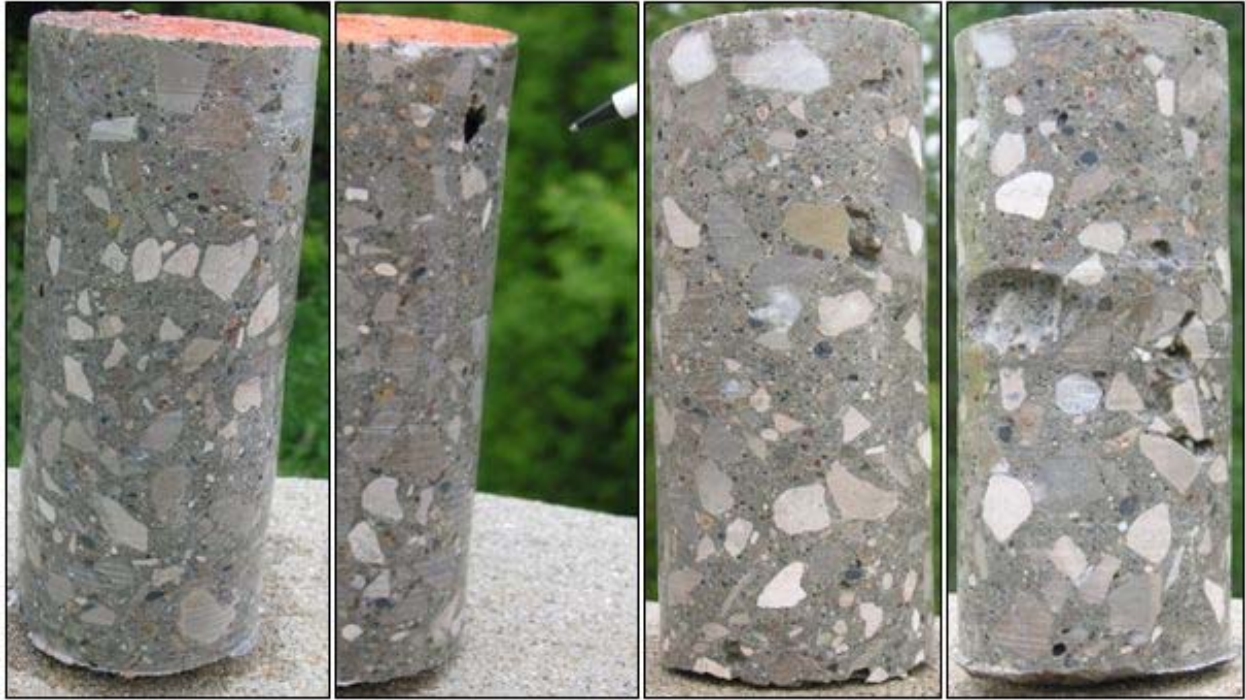
Figure 82. Cores 1 through 4 (left to right), where Core 1 is “control” and Cores 2 to 4 selected where GPR signal looked “slightly worse”, yet not obviously deteriorated. Note pen-sized vug in Core #2.

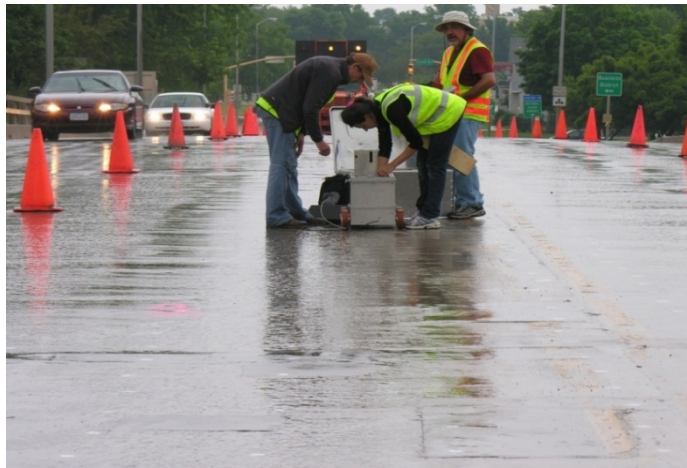
Figure 84. Data collection during light rain using Stepper™, on EB and WB passing lanes on Deck O4.

NDE methods used for collecting condition data on Deck O4 included (a) both GC and AC (ground- and air-coupled) GPR deployments; (b) the impact-echo (IE) and ultrasonic (US) devices on the robotic Stepper™; (c) the Proceq™ rolling half-cell (HC) instrument and Wenner electrical resistivity probe; and (d) ultrasonic surface wave (USW) measurements of in-situ concrete modulus using a portable seismic property analyzer (PSPA). Simultaneous data collection using various methods took place on Deck O4, as described previously and shown in Figures 84 and 85. Data collection took place over a three day period, first on EB and WB travel (outer) lanes and then on EB and WB passing (inner) lanes. Data collection in both Figures 84 and 85 are shown in the inner (passing) EB and WB lanes.

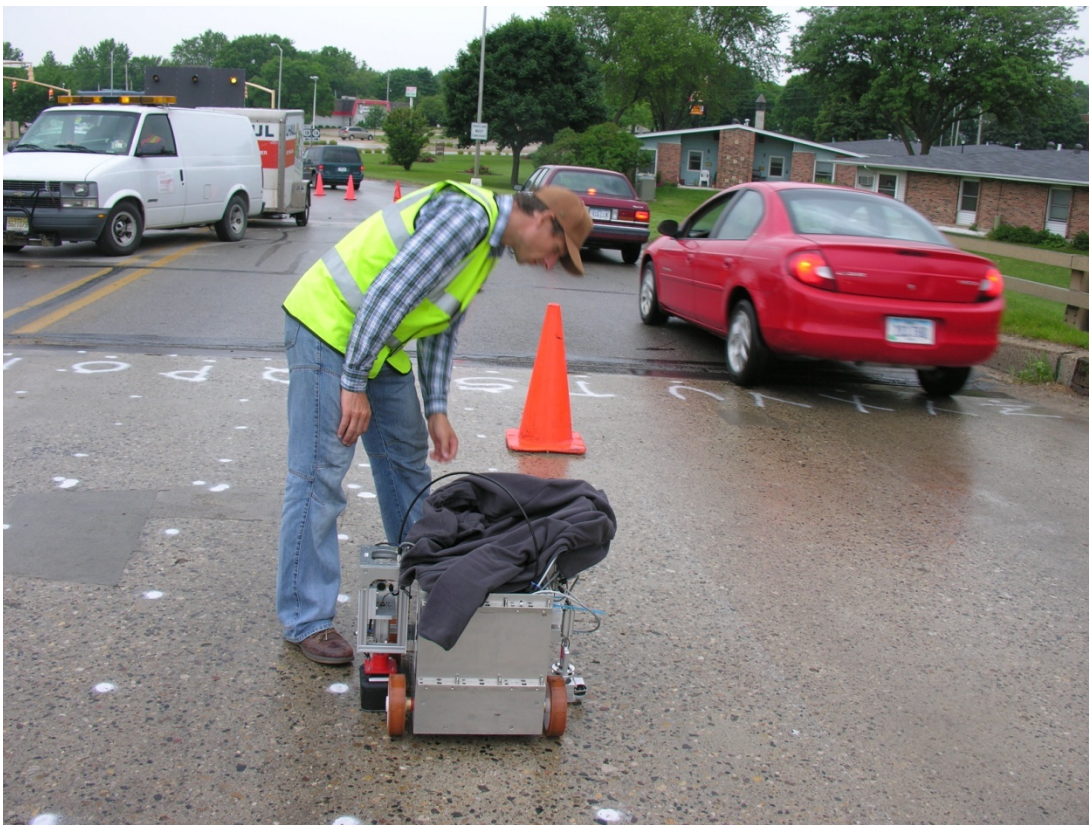
Figure 86. Gridded area of deck near northwest corner, Stepper™ shown in foreground.

Traffic control and gridding were performed in the same manner as for Decks O1 and O2, with the origin located at the SW corner of the gridded deck, as shown in previous figures. There is no skew on Deck O4, so an orthogonal grid the length and width of the deck surface was marked for NDE data collection as described previously. The major difference on how this deck was gridded and marked is that traffic control was provided on outer (travel) lanes, in both the EB and WB directions. The deck width had to be pre-measured to verify where each of the grid lines (A through Z) would have to be located, since the first day of gridding would allow only marking the deck on lines H through S (inner lanes). The remainder of the deck (outer, passing lanes in EB and WB directions) would be gridded on day 2 of data collection on lines T through Z. Figure 86 shows part of the resulting grid on the northwest end of the grid across the width of the deck from the origin, as marked on day 1 of data collection.

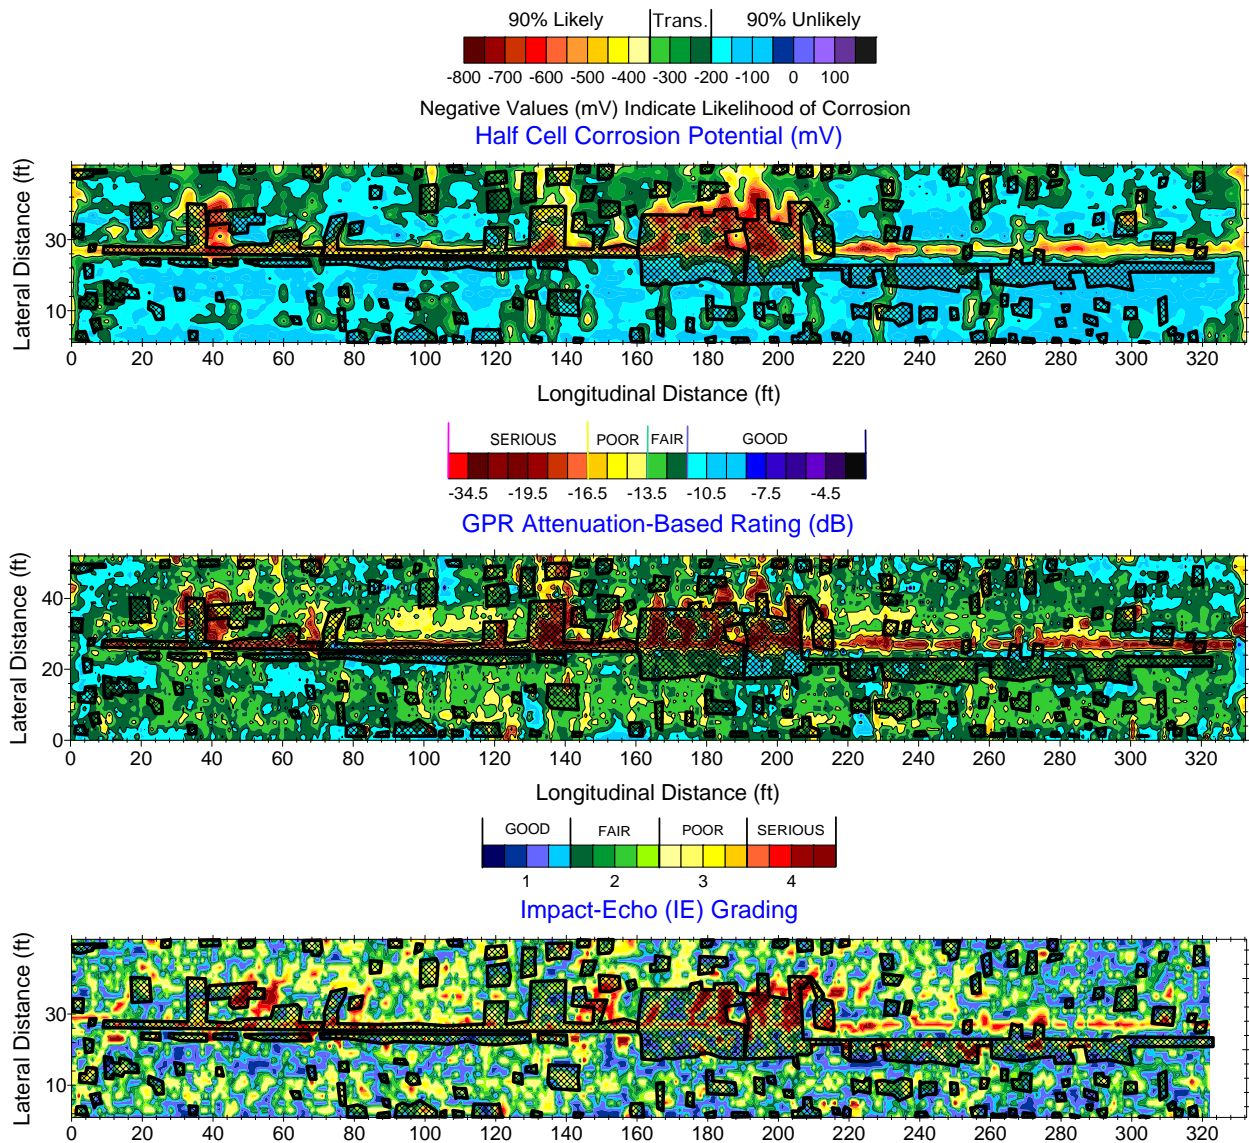
Figure 88. HCP, GPR and IE maps with overlaid repairs.

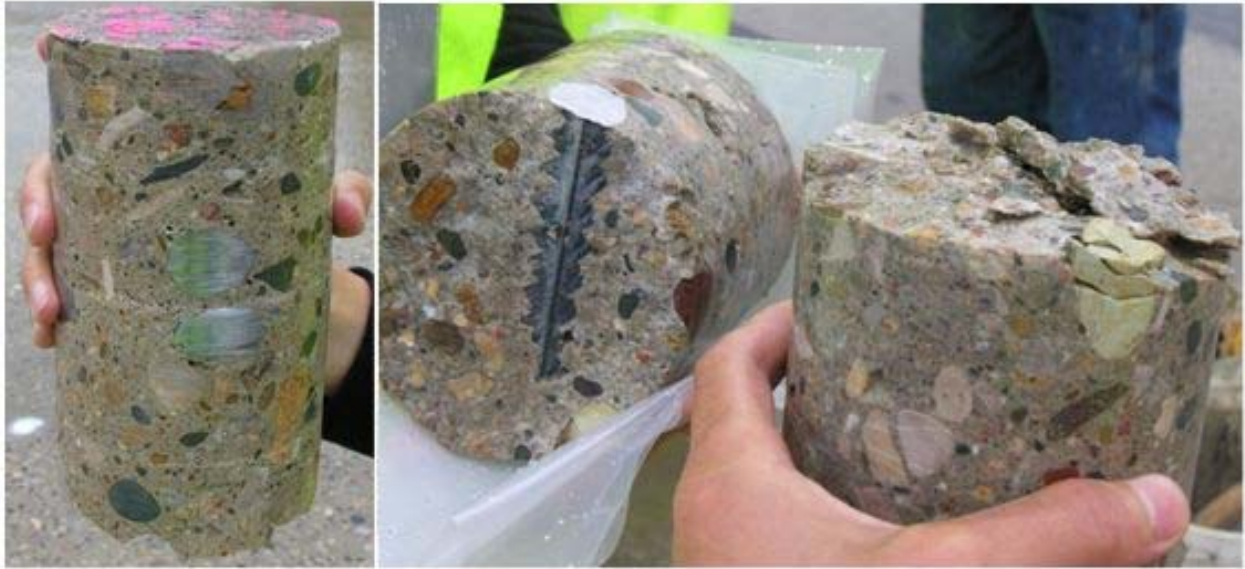
Figure 90. Core #2 (left) selected as control, retrieved intact; Core #1 (right) retrieved in two parts.

Cores essentially revealed deck conditions that were expected, based on using GPR field data for selecting locations. One control core was selected as "sound" and three others were targeted as "deteriorated". Figure 90 includes Core #2 (control), where GPR signal was uniform with high signal strength (no visible signal attenuation) and Core #1, where GPR showed visibly attenuated top rebar reflections – a strong indicator of deck deterioration. As seen in Figure 90, Core#2 was retrieved intact with no evidence on the core surface or within the core hole of vertical cracking, rust or delamination. On the other hand, Core #1 was retrieved in two parts, but only after prying at the core in an attempt to break it at the bottom after reaching the targeted depth of 6.5in. This certainly raises a question whether it may have failed during the prying because of the presence of an existing or incipient crack.

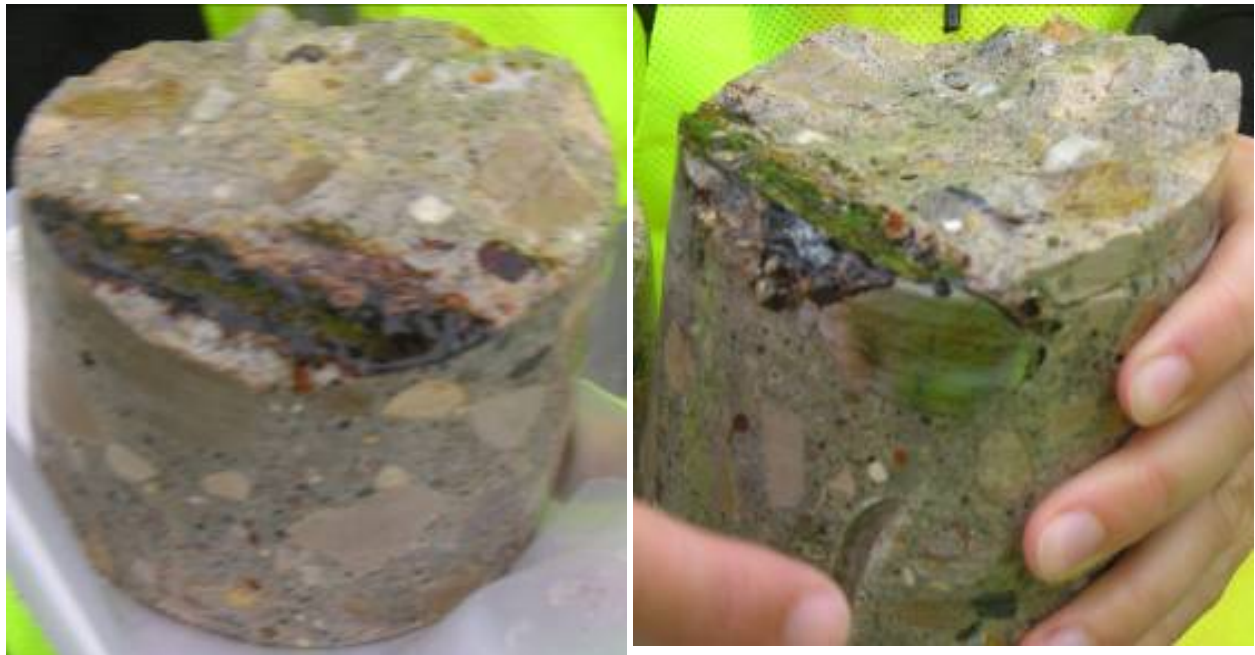
Figure 91. Top of Core #4 (inverted, left) reveals corrosion products above delamination; core bottom (right) with corrosion products on top and sides of rebar.

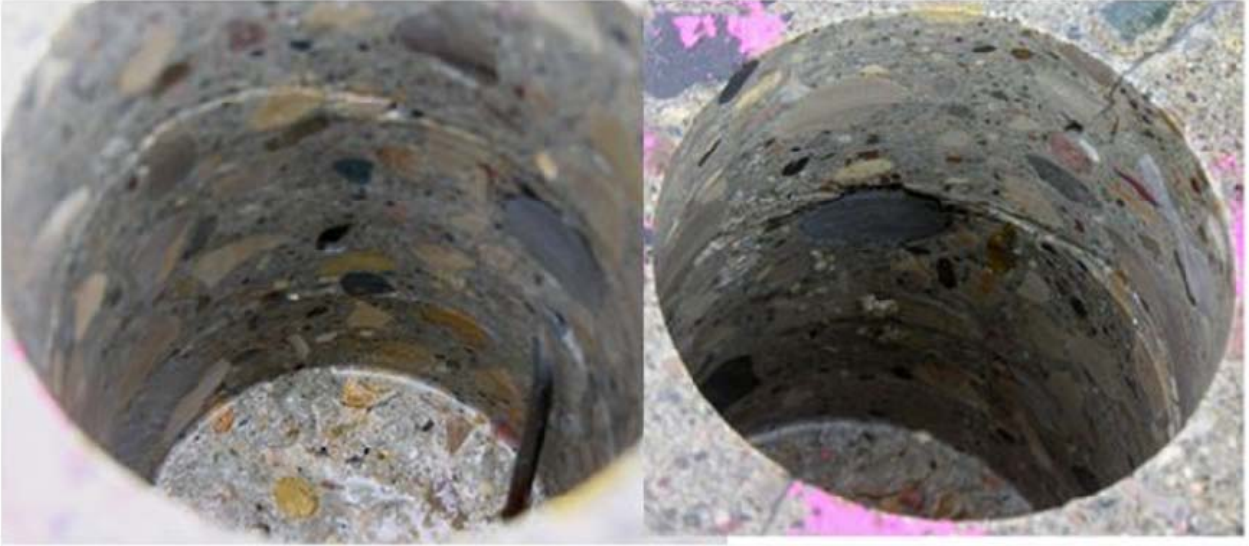
Figure 92. Hole from which Core #4 was retrieved, showing delamination in both photos, rebar chair beneath bar in left photo, and rebar with corrosion at top and sides in right photo.

Core #4 is shown in Figure 91, where the top part of the core is inverted to show a linear swath of corrosion products directly above a rebar, at the delamination (where the top portion broke just after reaching the upper rebar depth). The rust staining on the upper part of the core, which extends toward the middle of the core sample along the delaminated surface, provides clear evidence that the core was delaminated prior to retrieval. The bottom part of the core is also shown, upright, to reveal the rebar, which is corroded at top and on both sides (very obviously on top and left sides in photo). Core #4's hole also indicates that delamination had taken place prior to core retrieval (Figure 92). The rebar chair can also be observed (lower right of Figure 90, left photo), which was imaged, and interpreted as such, in the GPR data at the core retrieval location.

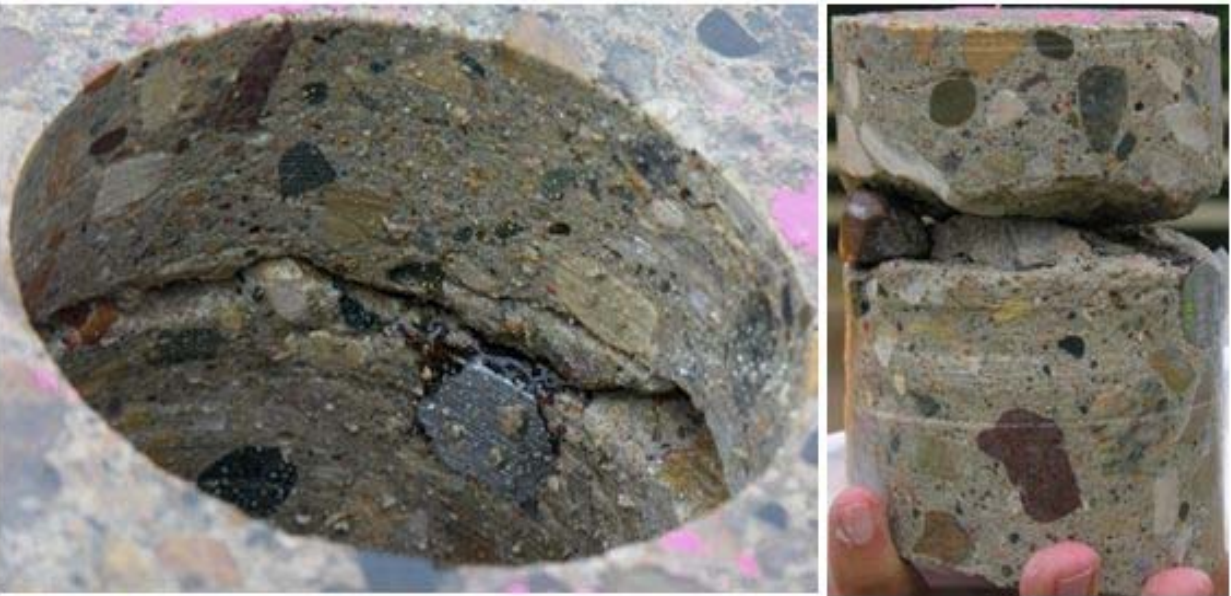
Figure 93. Hole and core sample (Core #3) with severe delamination and corrosion at top and sides of rebar.

Finally, GPR was used to target Core #3 as a deteriorated one. The results of coring are shown in Figure 93, where the core broke apart in many pieces. Both coarse and fine aggregate, as well as crumbled mortar, were accumulated at the bottom and along the sides of the core hole.

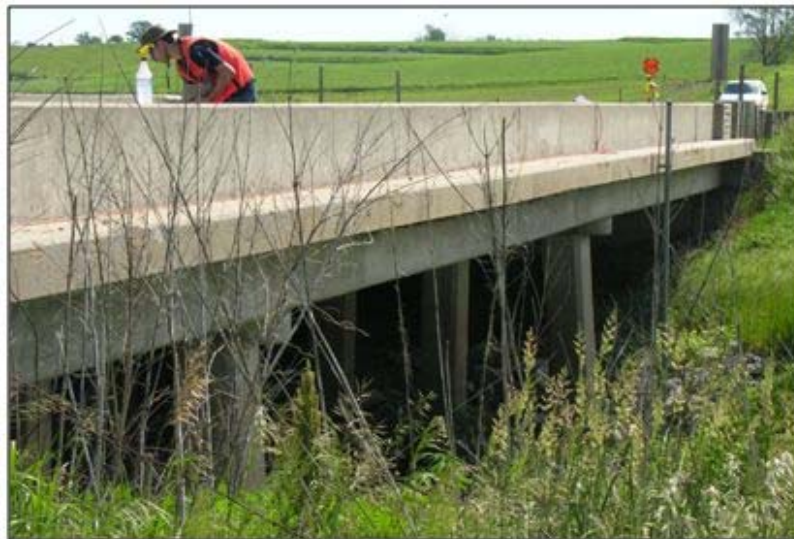
Figure 95. Side view of Bridge O5 showing full-depth (slab) deck construction between piers.

The deck on Bridge O5 (Bridge No. 6927.6S034, FHWA No. 037500) consists of a 127ft x 30ft concrete slab (Figure 94 and Figure 95) carrying US #34 over Indian Creek, located 1.1 miles east of US Highway 59. The bridge was designed in 1962 and constructed in 1964, according to the inspection report provided the NDE team by Iowa DOT. Cores extracted during the NDE/field work activities do not indicate that there is any overlay in place, as will be shown in subsequent figures. However, the deck surface has several concrete and asphalt patches, and there were also exposed spalls, as documented in Figure 96. This bridge is recommended for a complete PC concrete overlay, to be completed in 2009.
