Comprehensive Bridge Deck Deterioration Mapping of Nine Bridges by Nondestructive Evaluation Technologies

Final Report
January 2011

Iowa Highway Research Board (IHRB Project SPR-NDEB(90)--8H-00)
Iowa Department of Transportation
Federal Highway Administration

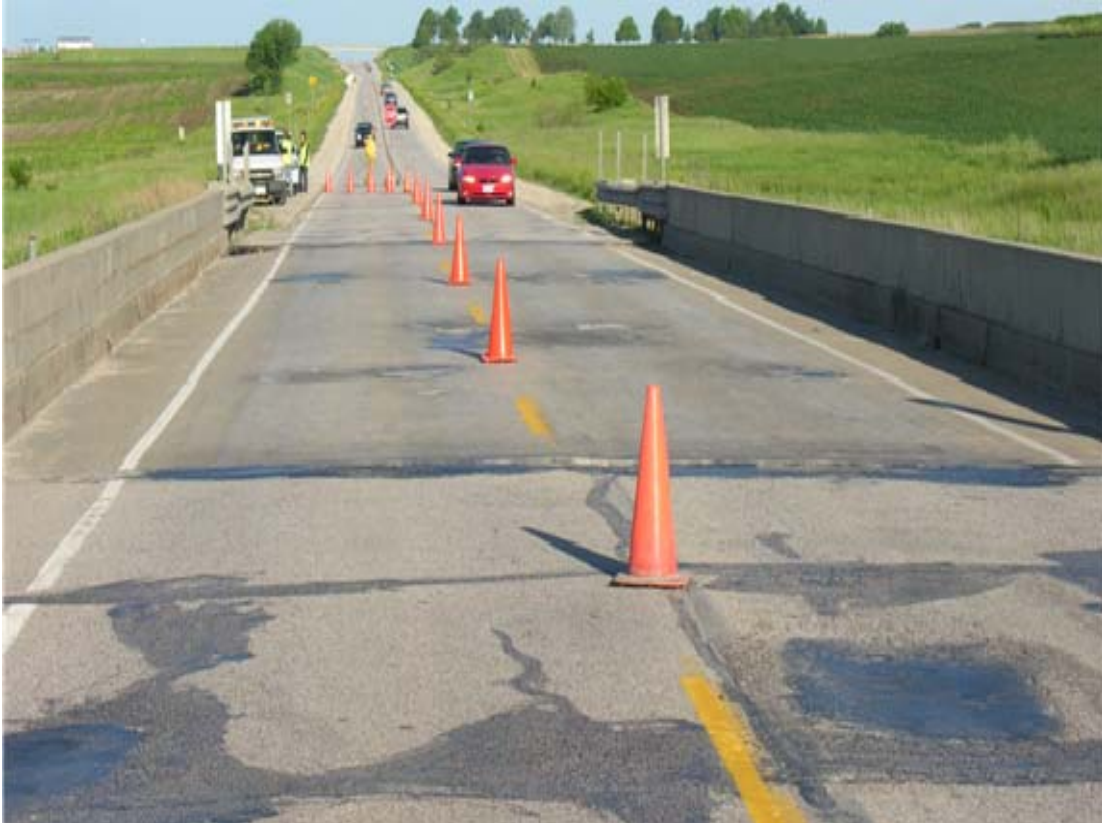
Figure 96. Perspective view of Deck O5, showing patches and spalls; also, repaired settlements in approach slab (foreground).

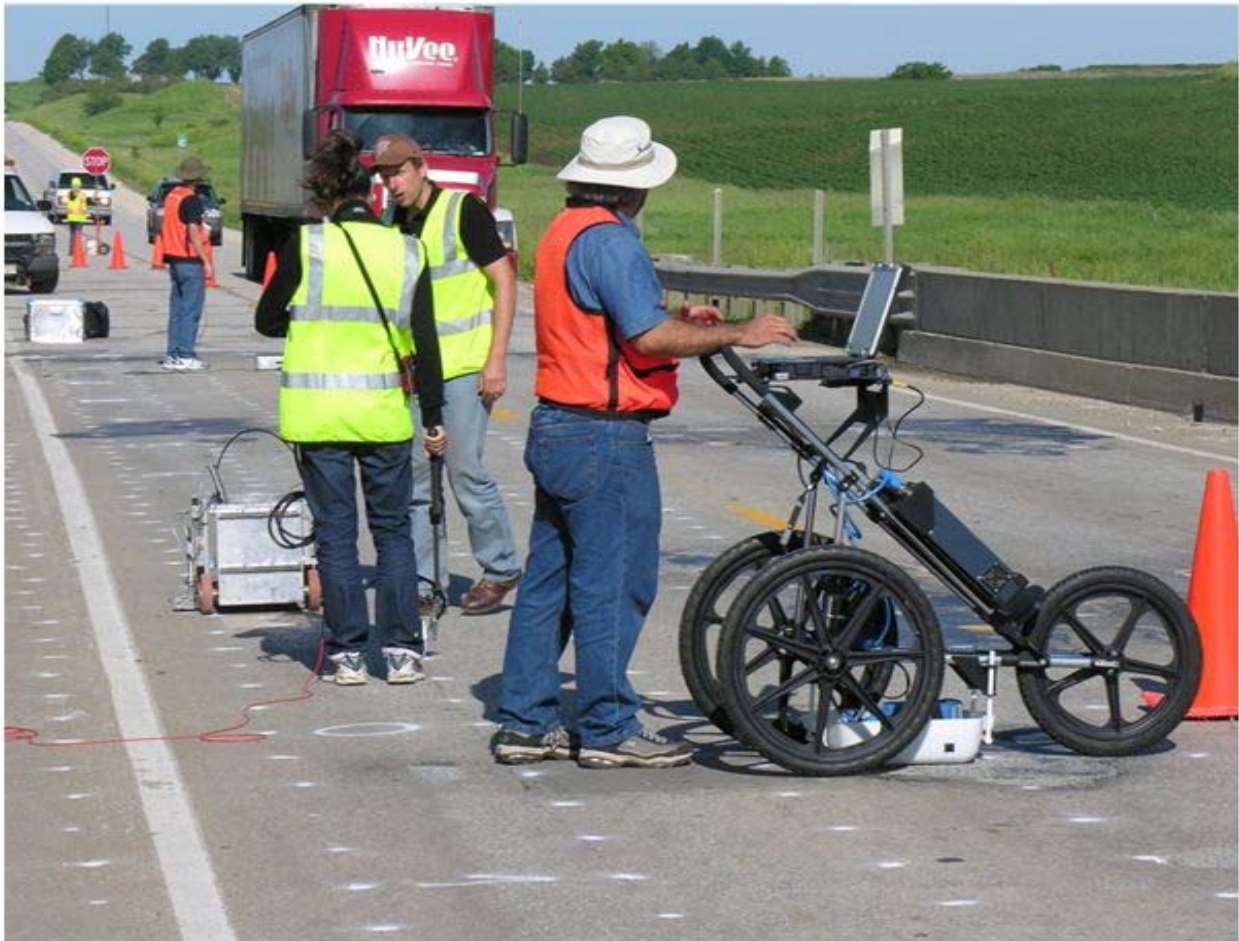
Figure 97. GPR data collection oriented perpendicular to traffic direction on slab decks, with other NDE methods unaffected by rebar orientation in upper mat.

GPR data collected on the deck confirmed that the shallowest steel in the upper mat of reinforcement was oriented in the longitudinal direction, parallel with the traffic flow, while transverse bars are tied to the bottom of the longitudinal steel. Once again, this rebar configuration required GPR data collection across the traffic lanes, in lines oriented perpendicular to the traffic flow (Figure 97). Data on one-half of the deck was collected up to the point where the antenna (in tub between rear and front wheels of the GPR cart) could just cross the centerline, when no traffic was approaching. This mode of data collection was to all the slab decks with the longitudinal steel tied on top of the transverse rebars in the upper mat (O3, O6, R1 and R3). Data collection was unaffected for other NDE methods (Figure 97, upper left), where

Stepper™ is moving along Line C (5ft from the curb), rolling half-cell (HC) data are being collected on Line D, and PSPA data collection is taking place near the west abutment (near the passing semi-truck).

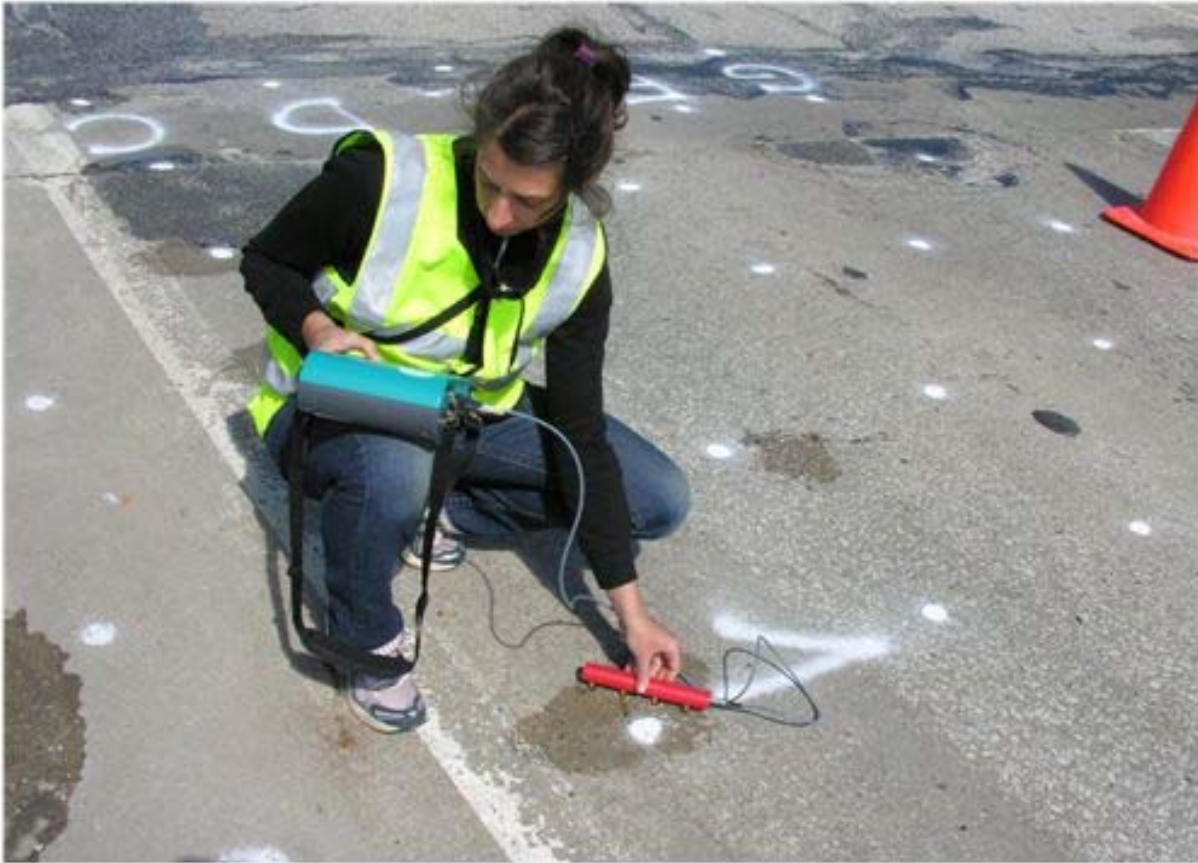
Figure 98. ER measurement on EB lane along Line C (5ft from curb), 10ft from west abutment, near origin.

Traffic control and gridding were performed in the same manner as on Deck O2. The region near the origin, also located at the SW corner of the gridded deck, is shown in Figure 98. Because of the positive deck skew (acute angle between curb and abutment at the origin) on Deck O5, an orthogonal grid the length and width of the deck surface was marked for the NDE data collection, but did not require using negative x-coordinates as did Deck O3.

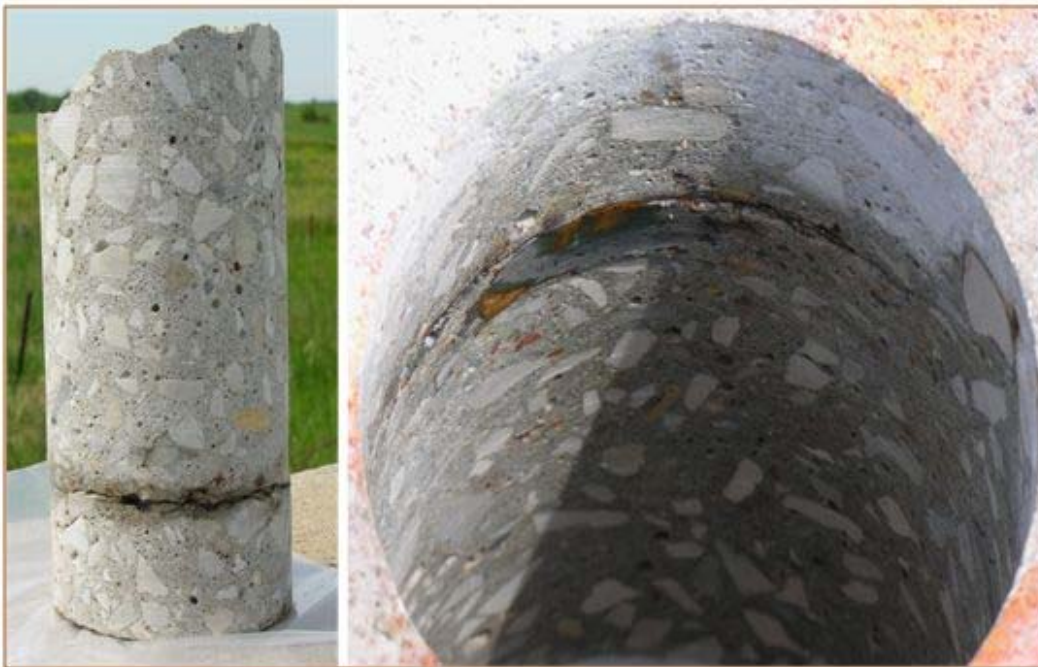
Figure 100. Core #1 – expected to be “fair to poor” – shows delamination, and core hole reveals “nicked” rebar, delamination and corrosion.

GPR was used in the selection of core locations. Cores ranged from “good” (control) to “fair-to-poor” and “serious”. The results are shown in Figures 100 and 101. A “fair to poor” rating using impact-echo indicates that there is some evidence of damage that was measured at the Core #1 location, since the signal included both a high-frequency response from a crack or initial (incipient) delamination and a portion of energy reflected back from the deck’s bottom. As can be seen in Figure 100, Core #1 (inverted) was also expected to be “fair to poor” based on its IE grading shown on the map within Figure 99 (IE was not used for field-selection of the core) and was extracted intact, with a delamination extending 2/3 of the way around the sample’s circumference. The core hole also showed a “nicked” rebar with corrosion products surrounding the steel and along a good part of the delamination. Some rust discoloration (corrosion products) embedded within the delamination, bonded to the crack’s interior surface. Since the IE signal response represents a response of a larger deck volume, in comparison to the core sample, the IE ranking may slightly differ from the condition observed on the core.

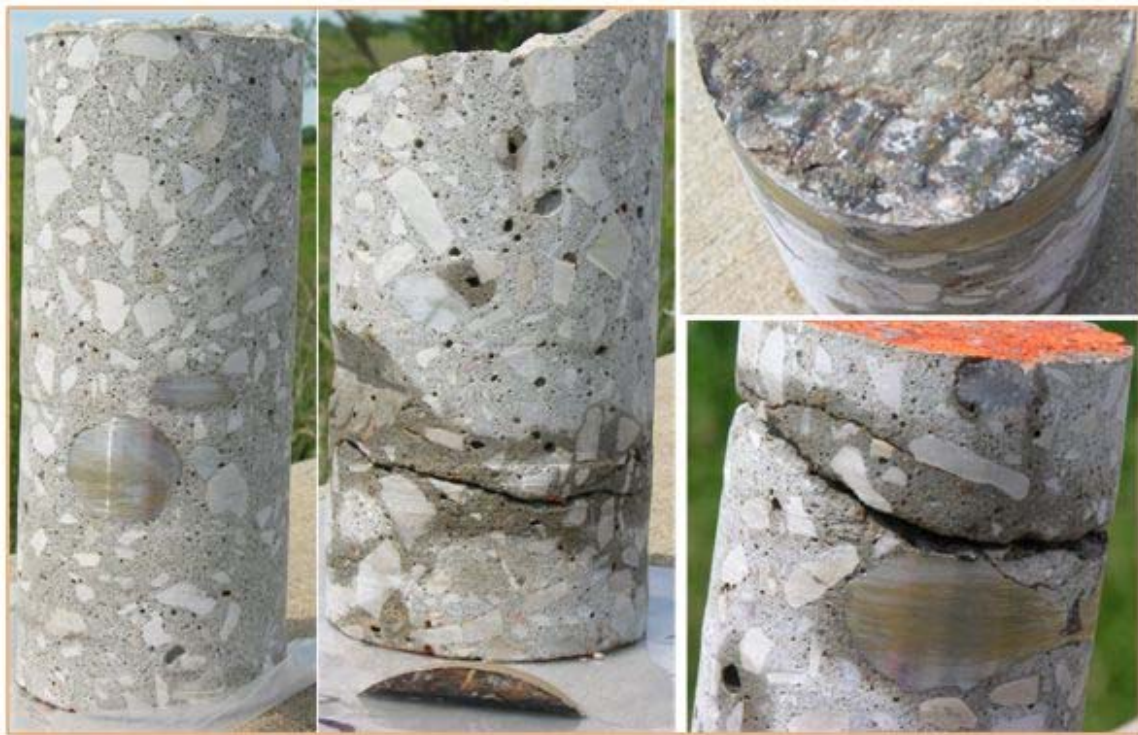
Figure 101. Cores 2, 3 and 4 are shown left to right, respectively, with control (good) core at left.

Cores #2, #3 and #4 are shown in Figure 101 (respectively, left to right), where Core #2 is the “control” specimen and Cores #3 and #4 were field-predicted by GPR to be in serious condition, with regard to what was visible in the raw data. Core #2 (control) is shown inverted at

left and was extracted fully intact, with no visible signs of deterioration within the concrete or corrosion surrounding the transverse and longitudinal bars exposed in the core sample. The core hole also showed no signs of deterioration. Core #3 was predicted to be in serious condition (reference circular dot with two red quadrants indicating same, Figure 99), and though it was removed intact there were a number of horizontal cracks that nearly cut through the entire specimen. This included one major delamination that was propagating toward the surface from the top of the cut rebar (cut piece of rebar shown in front of the inverted core specimen, at center of Figure 101), which fell off the left side of the core (see rebar imprint on the core at the center of the figure). The core hole also showed a delamination surrounding most of its circumference, just above the top rebar, with other intersecting horizontal cracks (delaminations) propagating elsewhere along the core hole. Finally, Core #4 was extracted in two pieces and is shown at right where the upper right photo shows the fully-delaminated (bottom portion) of the core sample with an embedded rebar that has corroded and generated corrosion products that have moved outward into the delamination. The photo at lower right shows the upper section of the core placed on top of the lower portion (core not inverted), including the embedded rebar that corroded and likely generated the delamination shown. The core hole for this sample also shows a fully delaminated deck at that location, with horizontal cracks matching those seen in the sample and rust-staining embedded within the open delaminations (not shown). Though many of the observations described for NDE and core results include discussions about the condition of cores and the holes where they were extracted, not all photos can be possibly included within the report. Project photos, however, are archived and used to support any reported observations that may not be fully evident within the cited figures.

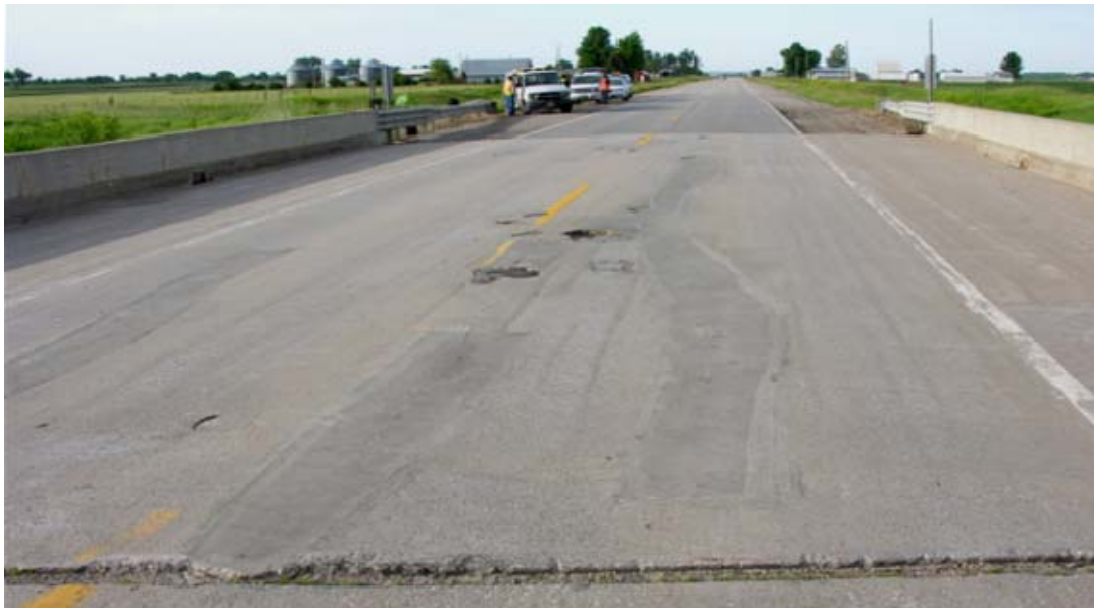
Figure 103. Perspective view of Deck O6, looking southbound, shows PC patches and spalls.

The deck on Bridge O6 consists of an 83ft x 44ft continuous concrete slab (Figures 102, 103, 104 and 105) carrying US #71 over a small stream, located 0.8 miles north of North Junction Secondary Road, J20. The provided plans and inspection report indicate that the deck was designed in 1971 and constructed in 1972. Inspection reports include an analysis that the deck was found adequate for two lane legal loads. Finally, the deck surface was reported to have been randomly sounded and had previously been repaired (about 5% of the deck area) using PC patches, based on an inspection report generated in November 2007. A number of visual underside inspections over the years, coupled with the reported repairs, surface spalling and deterioration, etc. included in the most recent inspection report; caused the deck to be recommended for a complete PC concrete overlay, scheduled to be completed in 2009.

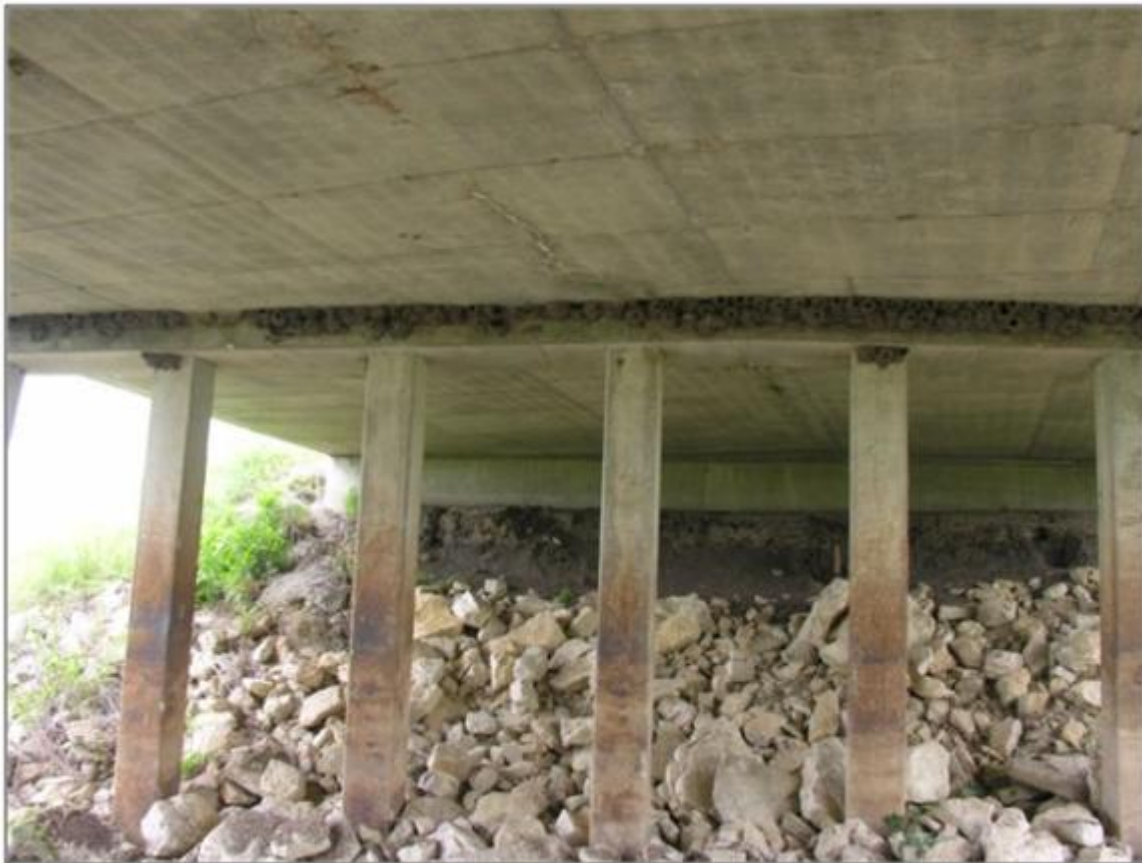
Figure 105. Bottom view of Deck O6 (continuous slab) shows rust staining, efflorescence and swallow nests along entire deck underside at pier.

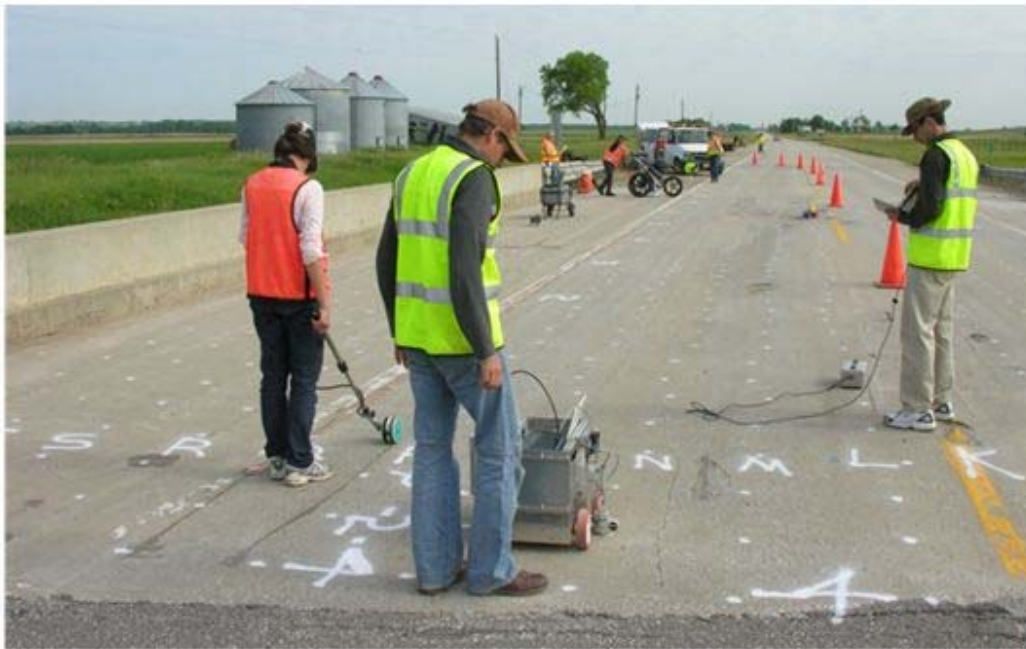
Figure 106. Multiple NDE methods collected in longitudinal direction on SB lanes, with GPR data collection across lanes.

Again, the rebar configuration required GPR data collection across traffic lanes, in lines oriented perpendicular to traffic flow (Figure 106, far distance), as previously described. Data collection was unaffected for other NDE methods (Figure 106), such as half-cell (HC), Stepper™ (IE and ultrasonic pulse echo), and PSPA (foreground, left to right). Though there were spalls, the deck was drilled with a small hole for a positive electrical connection during half-cell (HC) measurement preparation (not shown). Gridded areas outside the lane closure were collected the day prior (June 5, 2009), on the NB lanes. Though provided design maps show positive deck skew, negative skew was encountered in the field (see NDE maps at end of Deck O6 write up). This was also verified in field notes and using Google Map image, shown in Figure 107, though dimensions of bridge and plans matched.

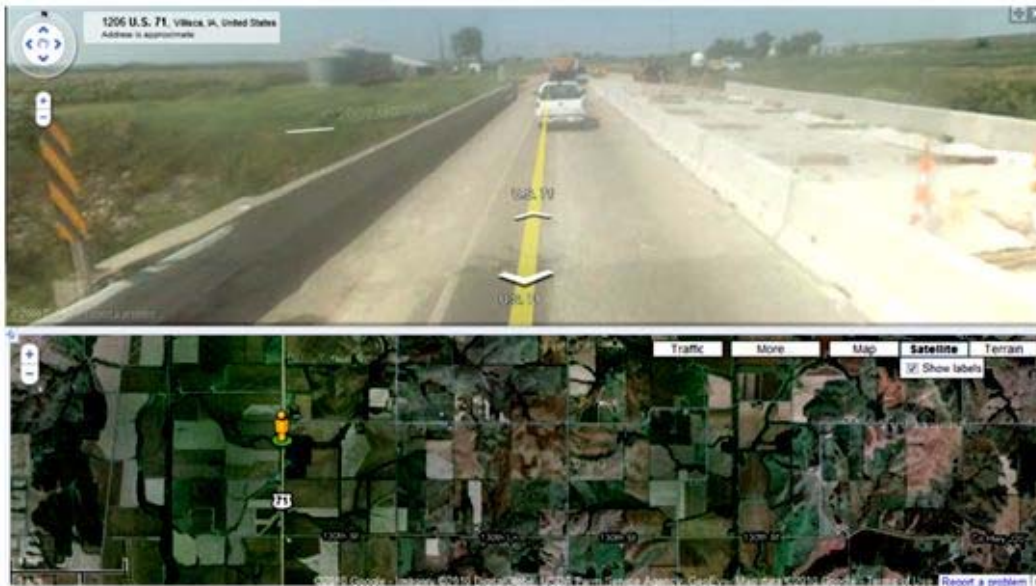
Figure 107. Google Map (photo taken in 2009) showing Deck O6 repairs underway on NB lanes, confirming negative deck skew.

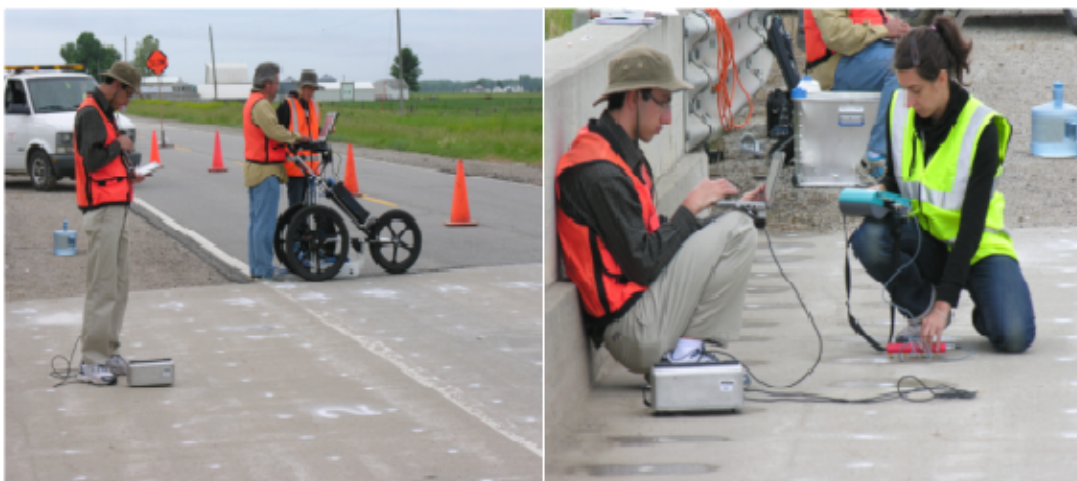
Figure 108. PSPA and GPR (left), PSPA and electrical resistivity (ER) data collection near south abutment in NB lanes.

Traffic control and gridding were performed in the same manner as on Deck O2, except that the region near the origin, also located at the SW corner of the gridded deck, is shown in Figure 108. Because of the negative deck skew (obtuse angle between curb and abutment at the origin), an orthogonal grid the length and width of the deck surface was marked for NDE data collection, and required using negative x-coordinates as did Deck O3.

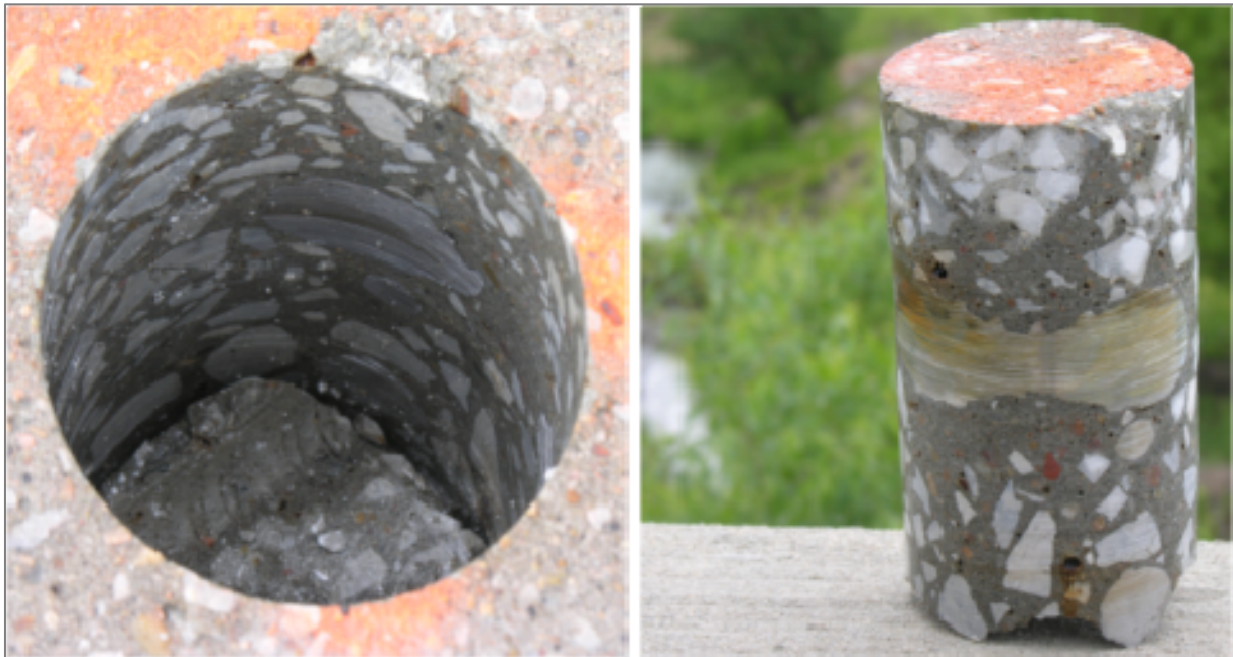
Figure 110. Core #1 – rated “good” – reveals no damage; core hole shows part of sliced upper rebar along with imprint of lower rebar.

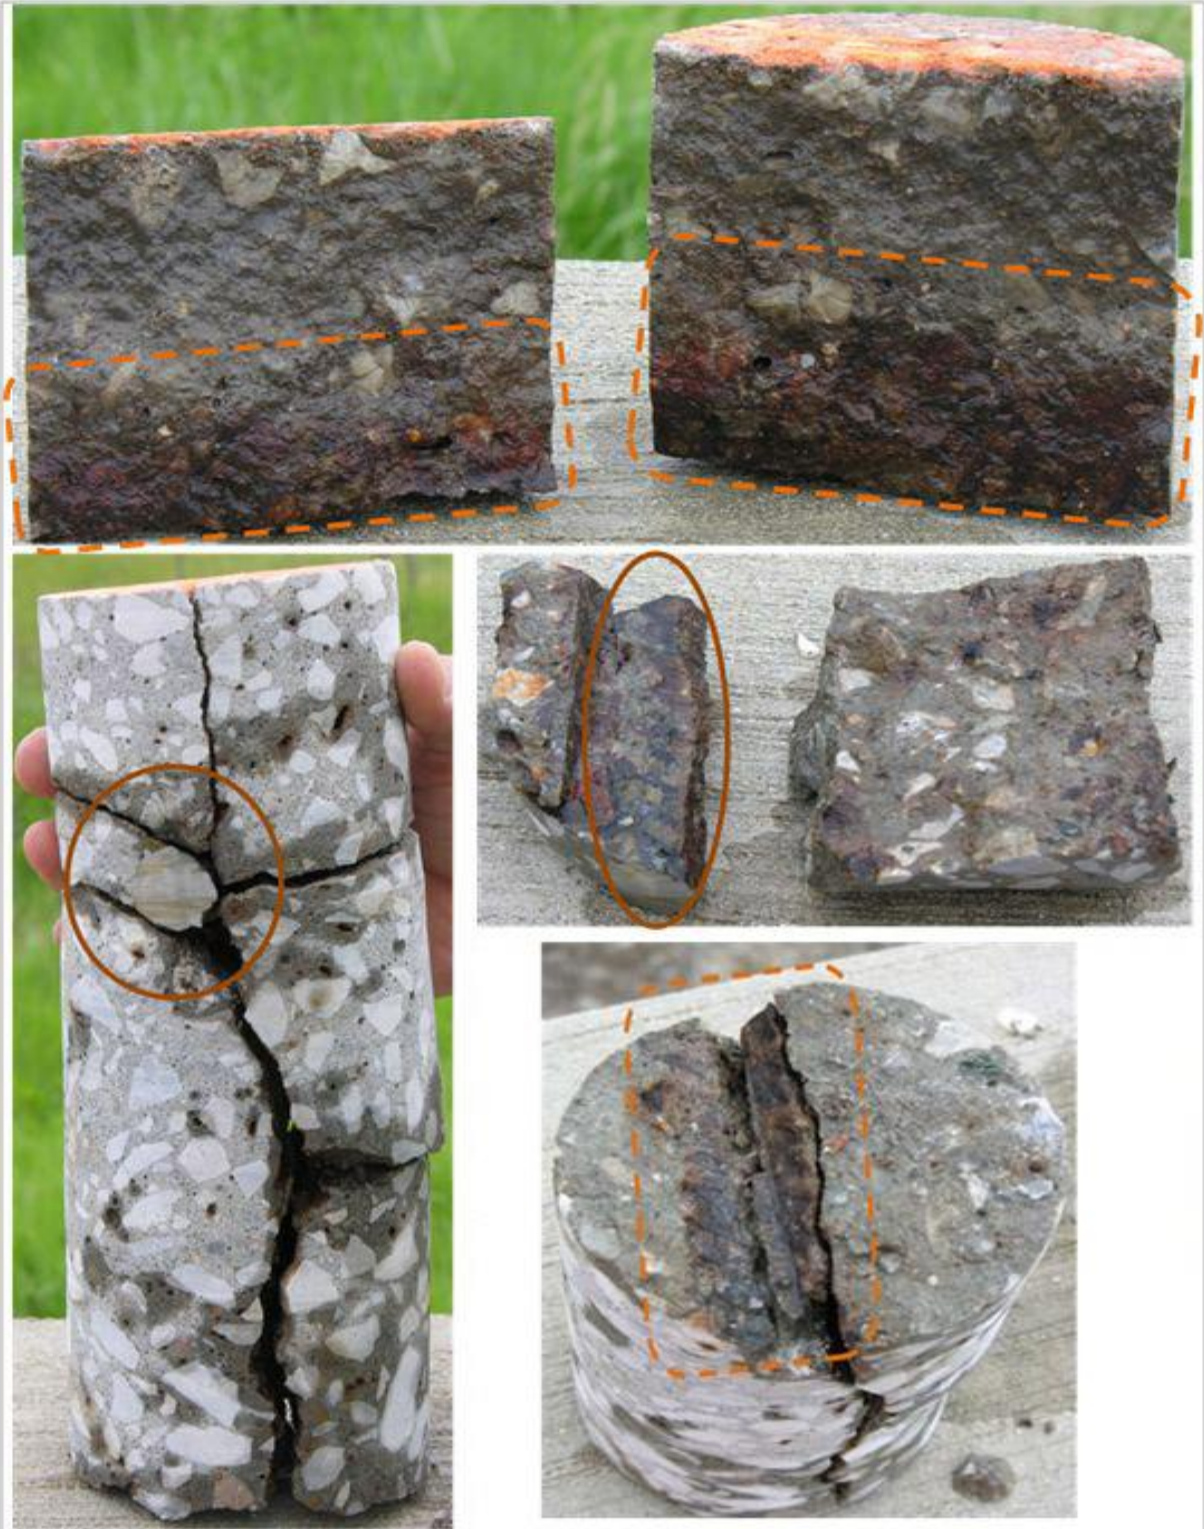
Figure 112. Core #3, retrieved in six pieces, extracted above longitudinal bar at surface crack.

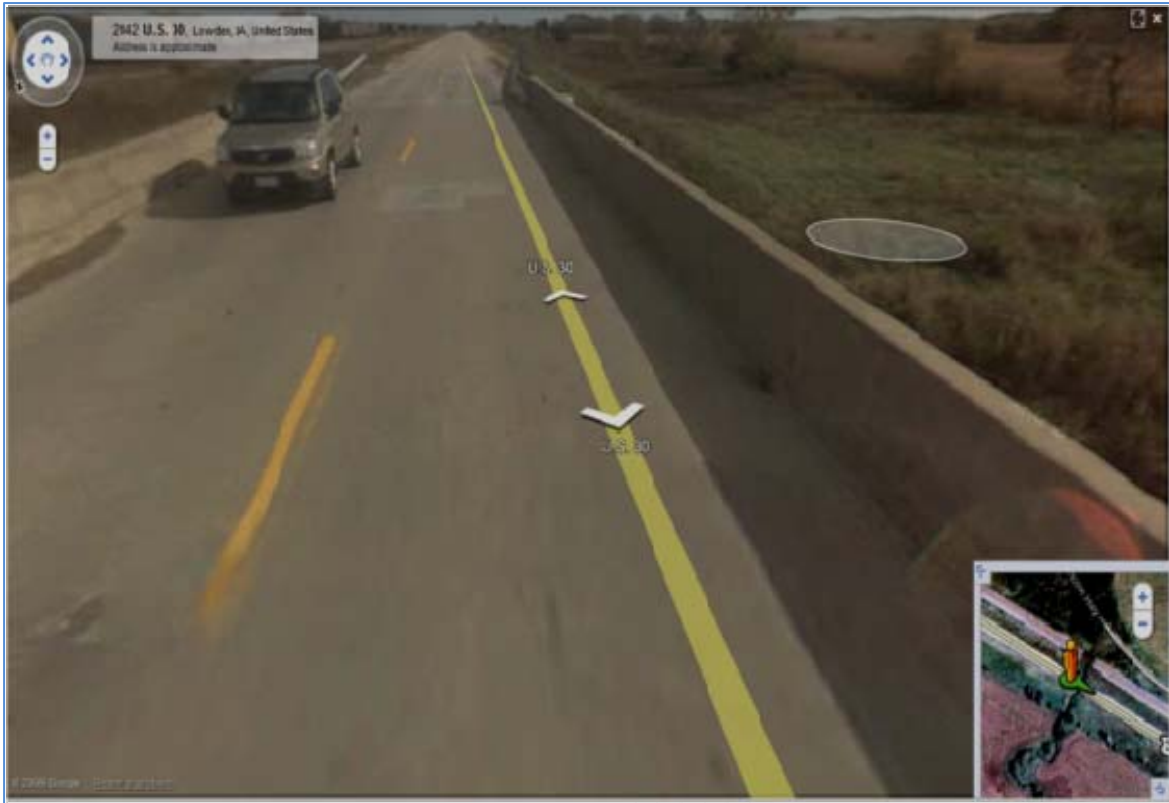
Figure 115. Perspective view of Deck R1, looking down eastbound lane of US Highway 30.

The deck on Bridge R1 consists of a 113ft x 28ft, three-span continuous concrete slab structure (Figures 114, 115 and 116) carrying US #30 over Yankee Creek, located 1.9 miles west of Lowden, Iowa. Deck R1 half-sections near the abutments and piers; and partial plan views near centerline (C/L) of piers, C/L of abutments and C/L of deck areas between; are shown in Figure 114 for this concrete slab deck. The provided plans and inspection report indicate that the deck was designed in 1953 and constructed in 1955. The deck is PC concrete overlaid with dense, low-slump PC concrete in 1979. A December, 2005, inspection report includes an analysis that the deck was found adequate for two lane legal loads. Also, the deck surface was reported to have been randomly sounded, with hollow areas reported, a number of them which had begun to crack and breakup. A number of visual underside inspections over the years, coupled with the condition of the deck after previously reported repairs, surface spalling and deterioration, etc. were included in the most recent inspection report. The combined analyses, along with recognition of other deficiencies at or near deck boundaries, and with the presence of deck spalling and deterioration, triggered a corrective recommendation to declare the deck as a candidate for a complete re-overlay. Figure 117 shows typical underside deterioration.

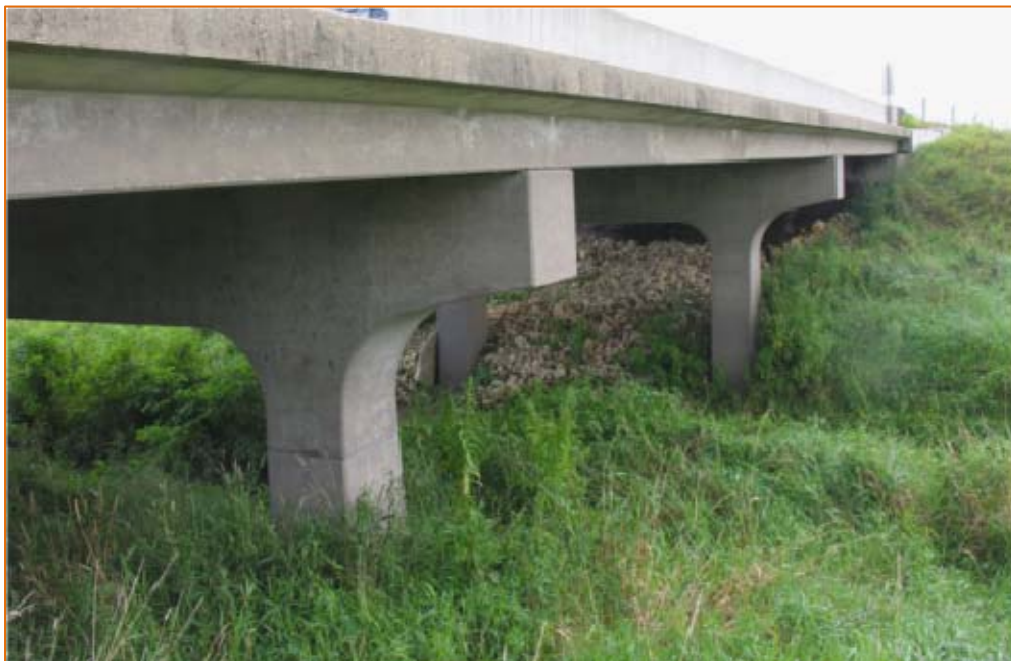
Figure 116. Side view of Deck R1 showing continuous slab construction on east face.

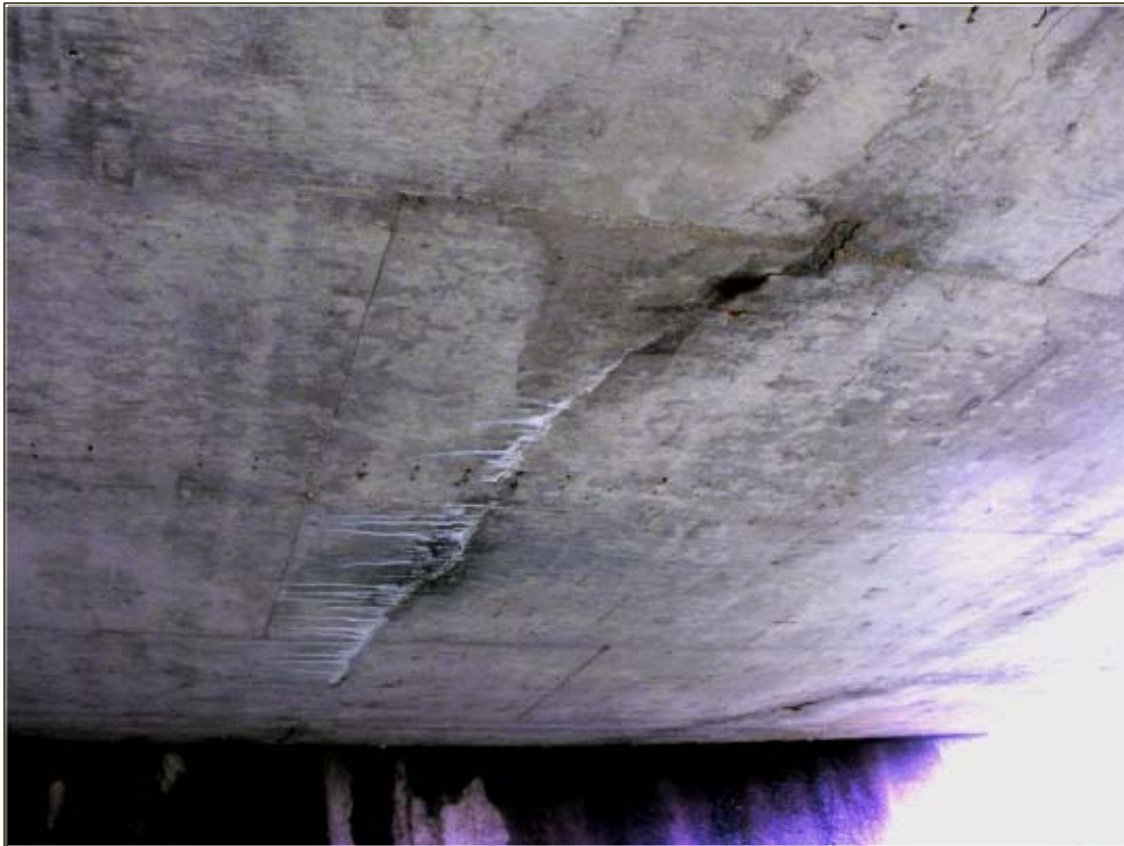
Figure 117. Bottom view of Deck R1 (continuous slab) with rust staining, efflorescence and crack running between pier and abutment.

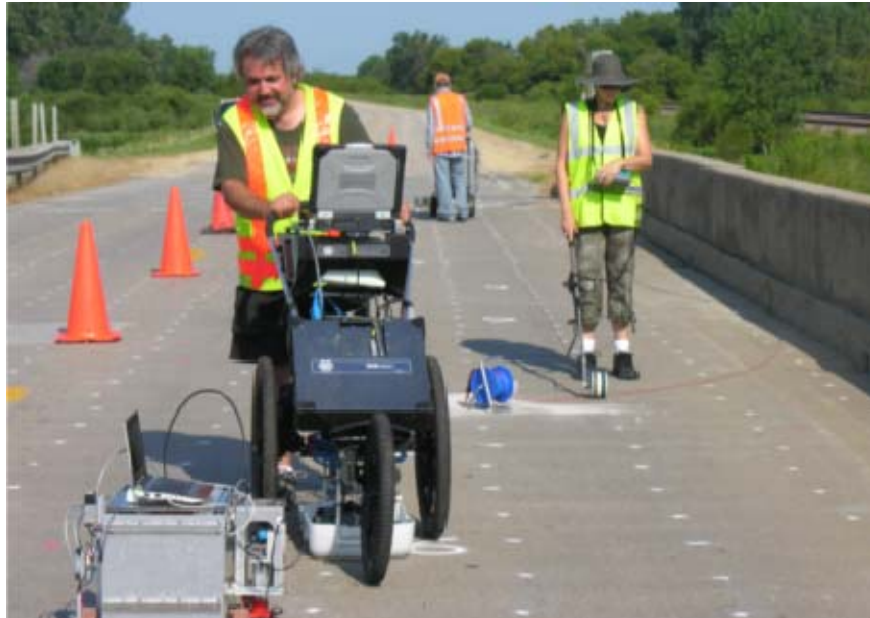
Once more, the rebar configuration required GPR data collection across traffic lanes, in lines oriented perpendicular to traffic flow, as previously described. Data collection was unaffected for other NDE methods (Figure 118), such as Stepper™ (IE and ultrasonic pulse echo) and half-cell (HC) in the foreground, and PSPA at the west end of the deck. Here, GPR is used to determine rebar orientation, since the first sixteen feet near either abutment had no rebars in an upper mat. This was verified by Iowa DOT personnel who compared these field observations with additional deck plans. Once bars were confirmed to be oriented in the longitudinal direction, for the middle section of the deck, all GPR lines had to be collected across lanes at 2ft intervals. A small hole was prepared for a positive electrical connection during the

half-cell (HC) measurement, where the blue roll of insulated wire rests on the concrete powder drilled from the deck.

Figure 118. Multiple NDE methods collected on WB lane.

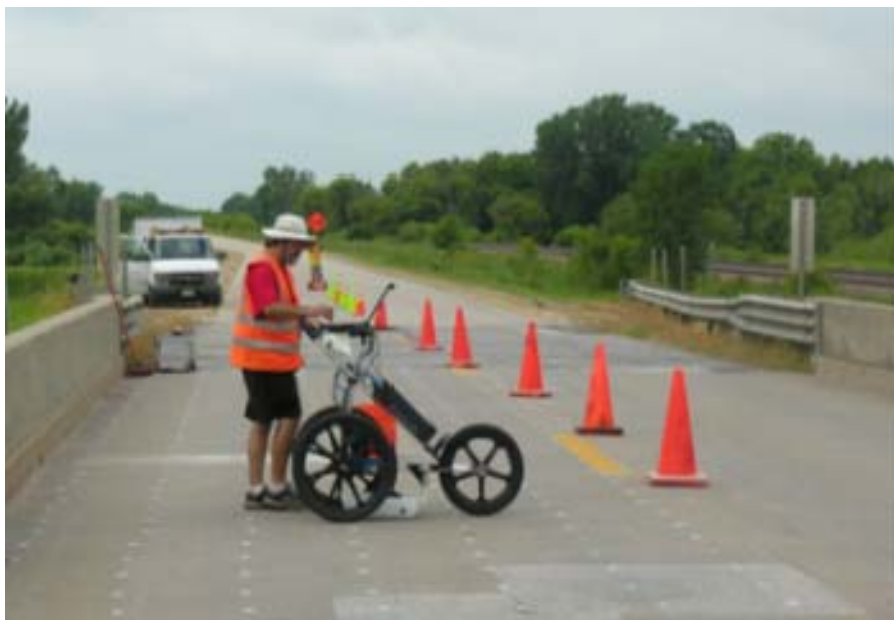
Traffic control and gridding were performed in the same manner as previously with the origin at the SW corner of the deck (Figure 119, upper left). The deck is not skewed.

Figure 119. Stepper at far left (curb) near west abutment; GPR near patches on EBL.

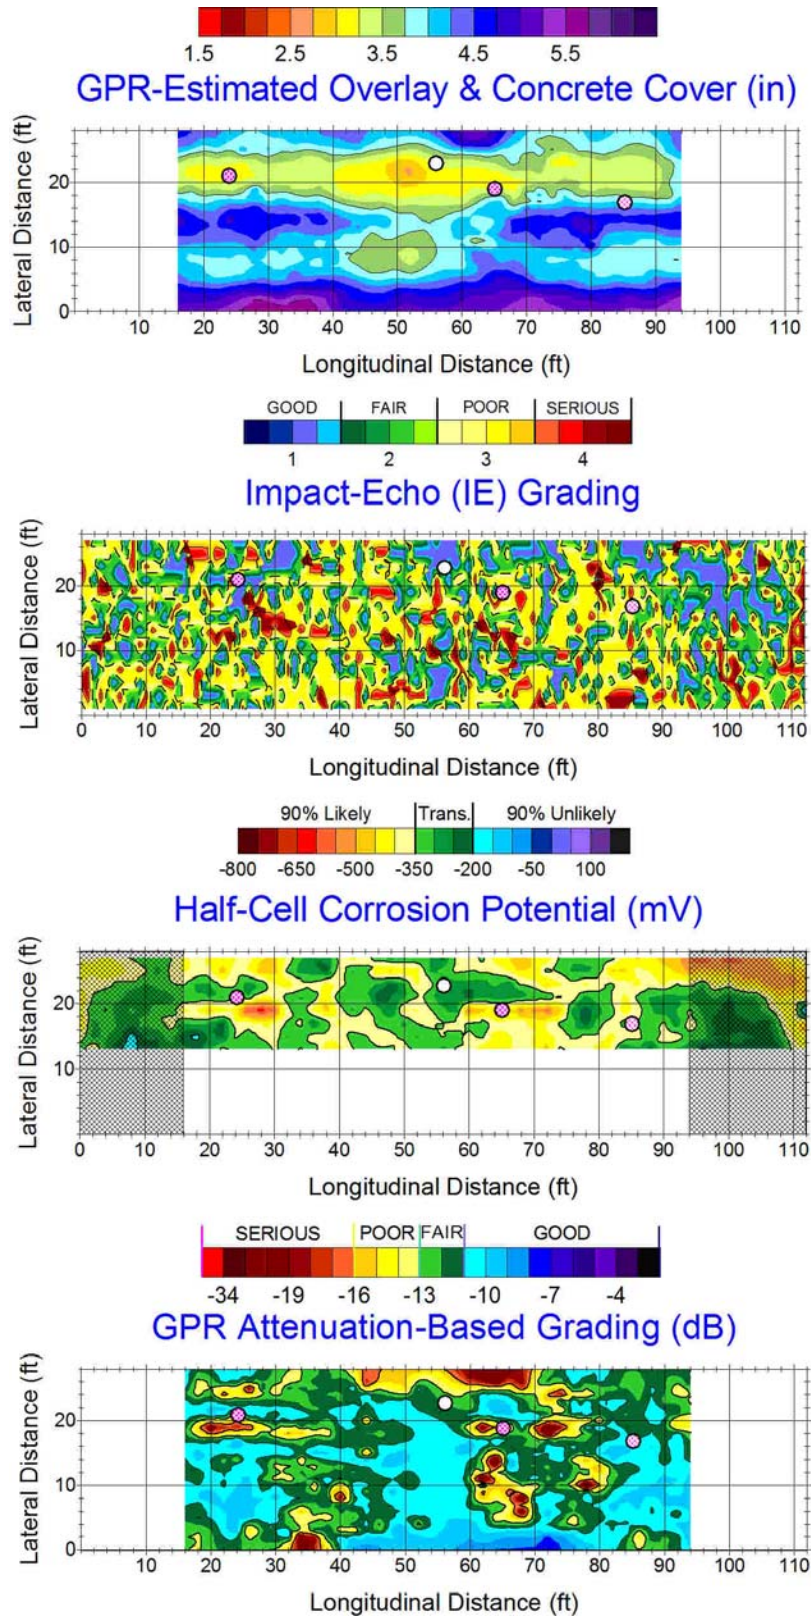
Figure 120. Concrete Cover, IE, HC, and GPR Maps, with core locations marked (Cores #1 through #4, left to right, respectively).

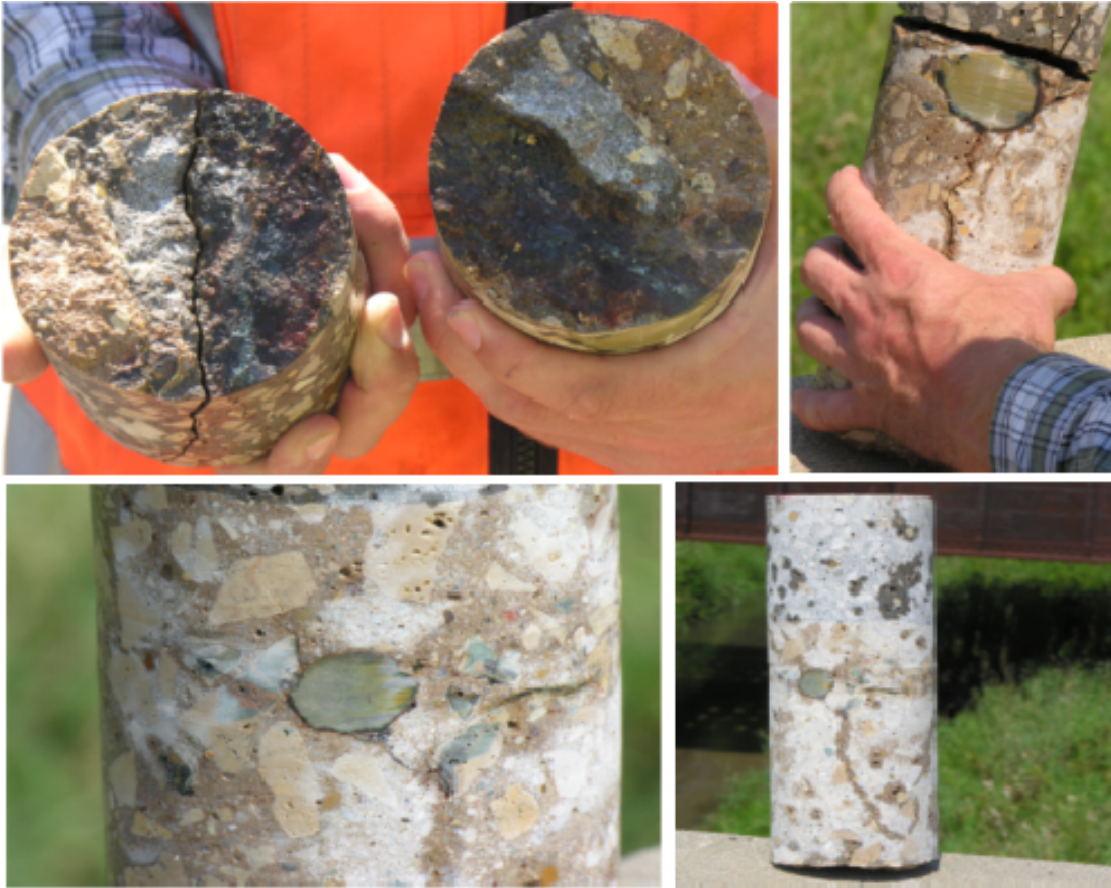
Core locations for Bridge R1 selected on the basis of Impact-Echo (IE) Data			
Drilled August 11, 2009			
Sample	Location	IE Grading	Core Observation
Core1	K24	Serious	delaminated
Core2	L56	Good	good condition
Core3	J65	Serious	delaminated
Core4	I85	Fair to Poor	Incipient crack and corroded steel

Core results (photos) can be seen in Figure 121 and Figure 122 where Cores #1 and #2 are shown in Figure 121, and Cores #3 and #4 are seen in Figure 122. Core #1 is fully delaminated below the overlay; Core #2 is fully intact and visibly sound. Core #3 is seriously split and delaminated with a great deal of corrosion products surrounding the top rebar, and was retrieved in 5 pieces (three split at top, three split at bottom with the upper rebar as the boundary between upper and lower portions).

Figure 122. Cores 3 (upper) and 4 (lower), graded “serious” and “fair to poor” with IE.

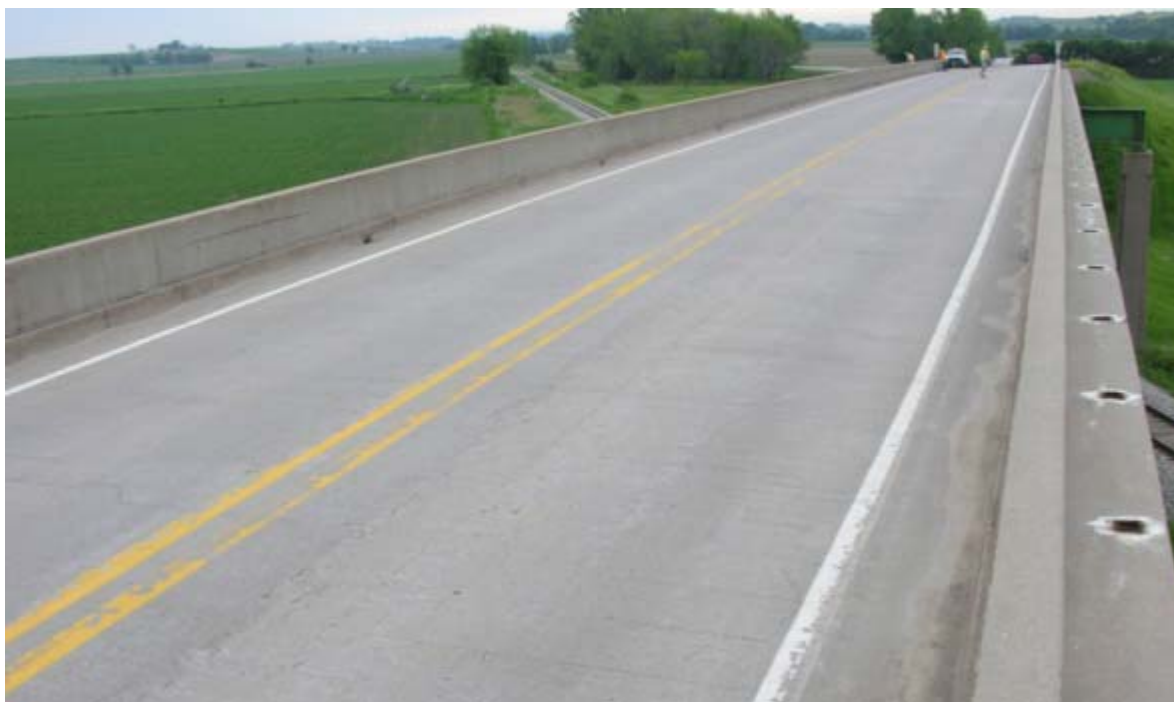
Figure 125. Perspective view of Deck R2, looking eastward along US Highway 6.

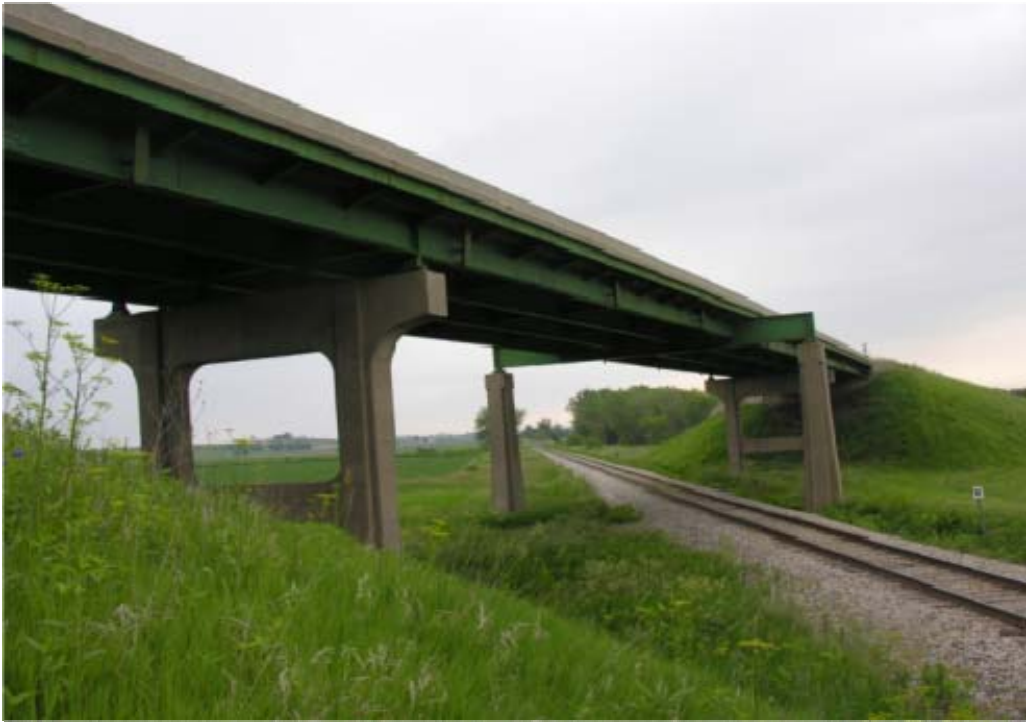
Figure 126. Side view of Bridge R2 showing steel girder construction on south face.

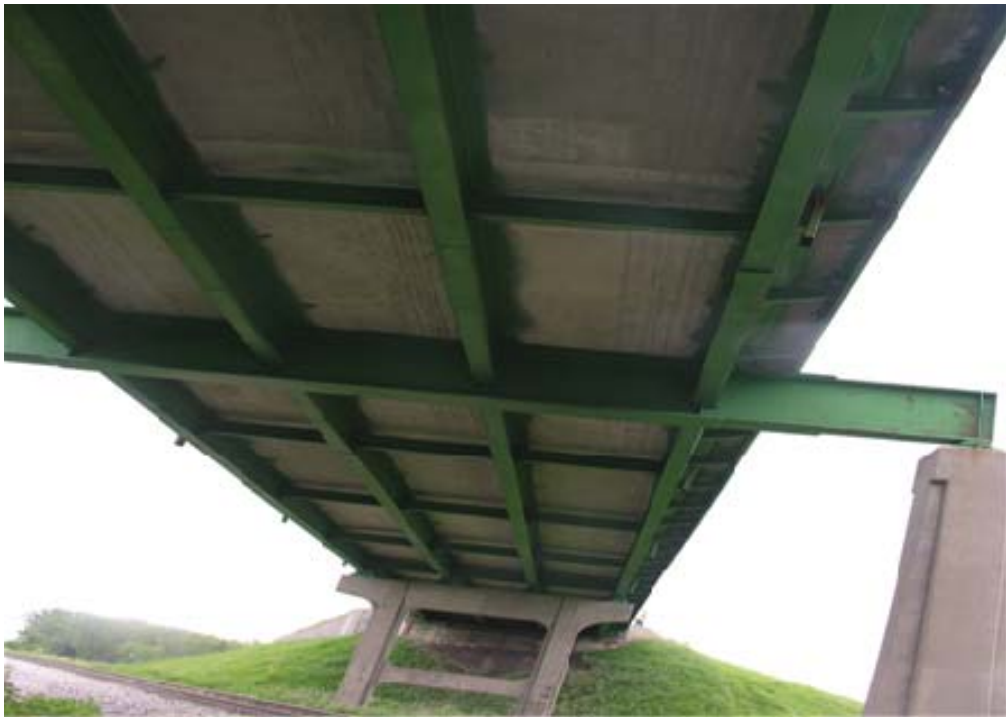
Figure 127. Bridge R2 superstructure as seen from deck underside.
