Comprehensive Bridge Deck Deterioration Mapping of Nine Bridges by Nondestructive Evaluation Technologies

Final Report
January 2011

Iowa Highway Research Board (IHRB Project SPR-NDEB(90)--8H-00)
Iowa Department of Transportation
Federal Highway Administration

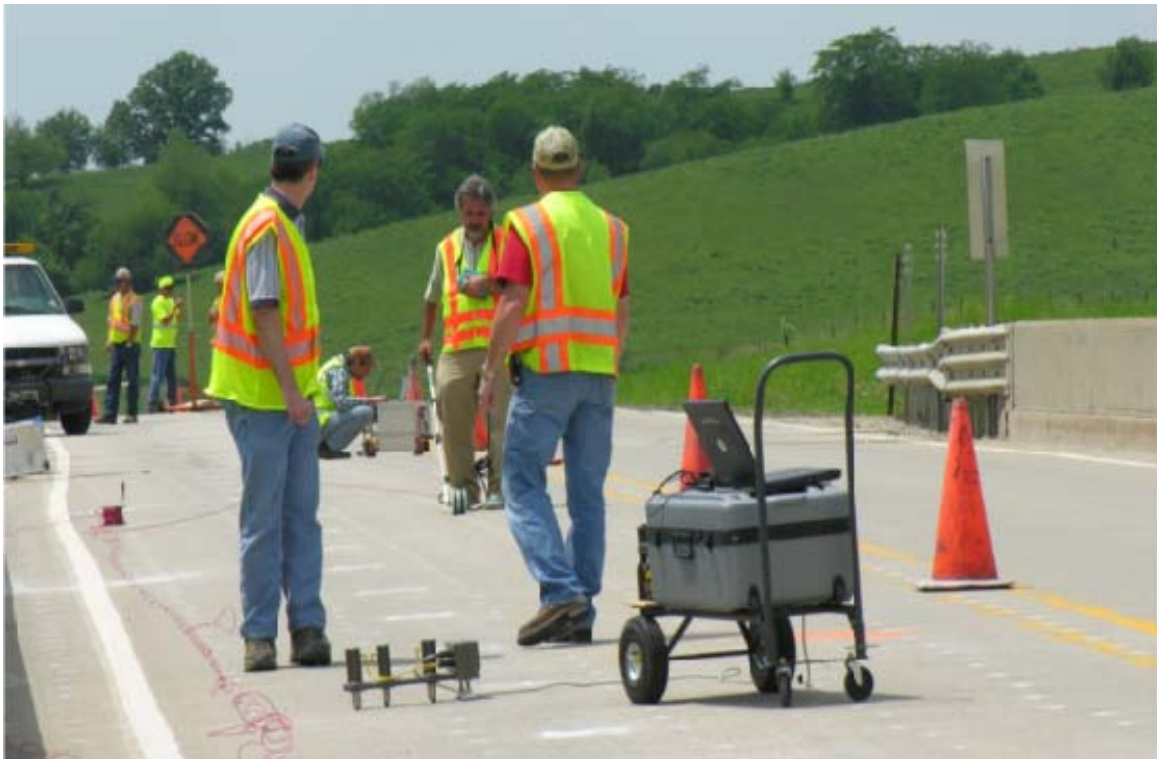
Figure 128. PSPA, HC and Stepper (IE and US) collection on EB lane.

NDE methods used for collecting condition data on Deck R2 included (a) both GC and AC (ground- and air-coupled) GPR deployments; (b) the impact-echo (IE) and ultrasonic (US) devices on the robotic Stepper; (c) the rolling half-cell (HC); and (d) ultrasonic surface wave (USW) measurements of in-situ concrete modulus using a PSPA. Simultaneous data collection using various methods took place on Deck R2 on June 11 and 12, 2009 (EB and WB lanes, respectively), as described previously and shown in Figure 128. On this steel girder deck, the rebar configuration allowed GPR data collection along lines oriented with traffic.

Traffic control and gridding were performed in the same manner as previously with the origin at the SW corner of the deck (Figure 128, upper left). The deck is not skewed. The remainder of the EB lane is seen in Figure 129, from approximately $X = 50\text{ft}$ to the far end where the coring crew is preparing to extract samples.

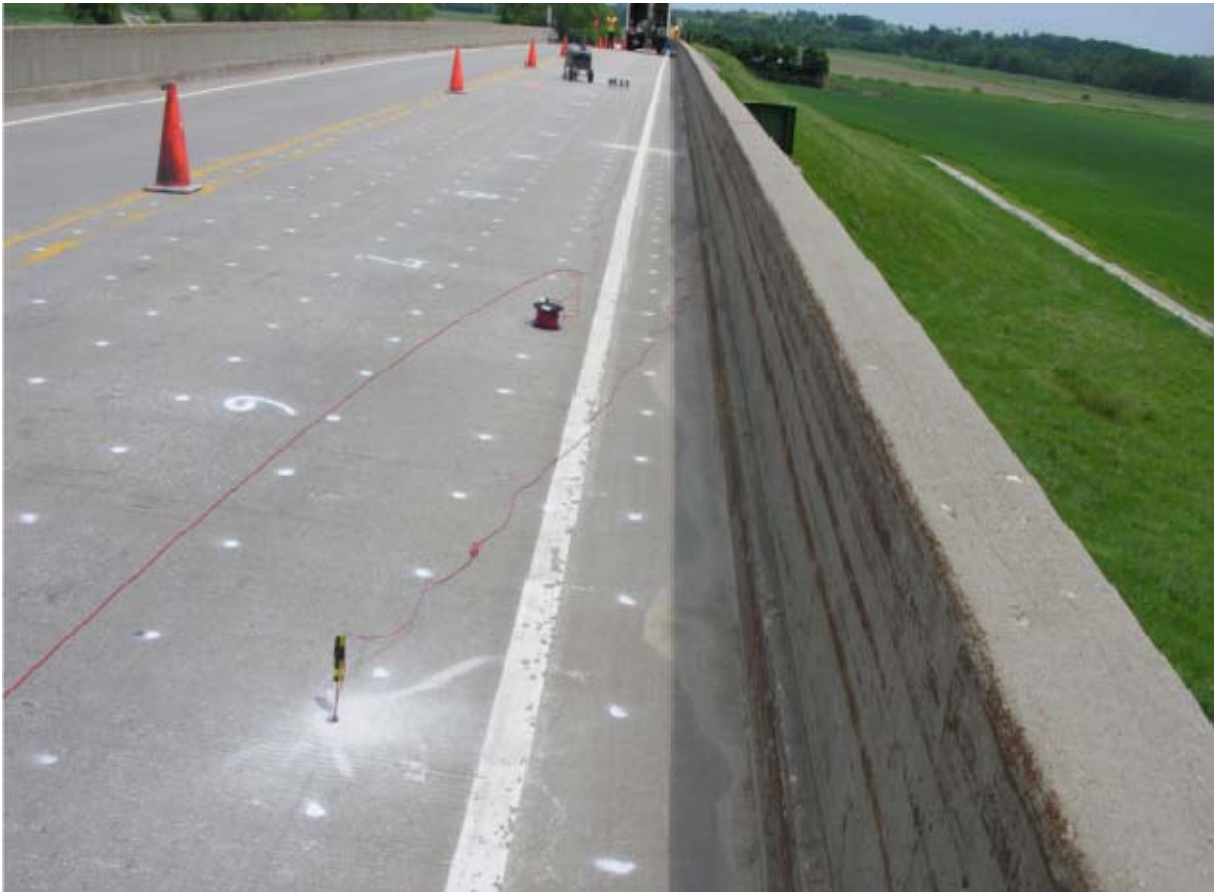
Figure 129. Grid on EBL, showing HC lead connected to rebar through small hole (foreground).

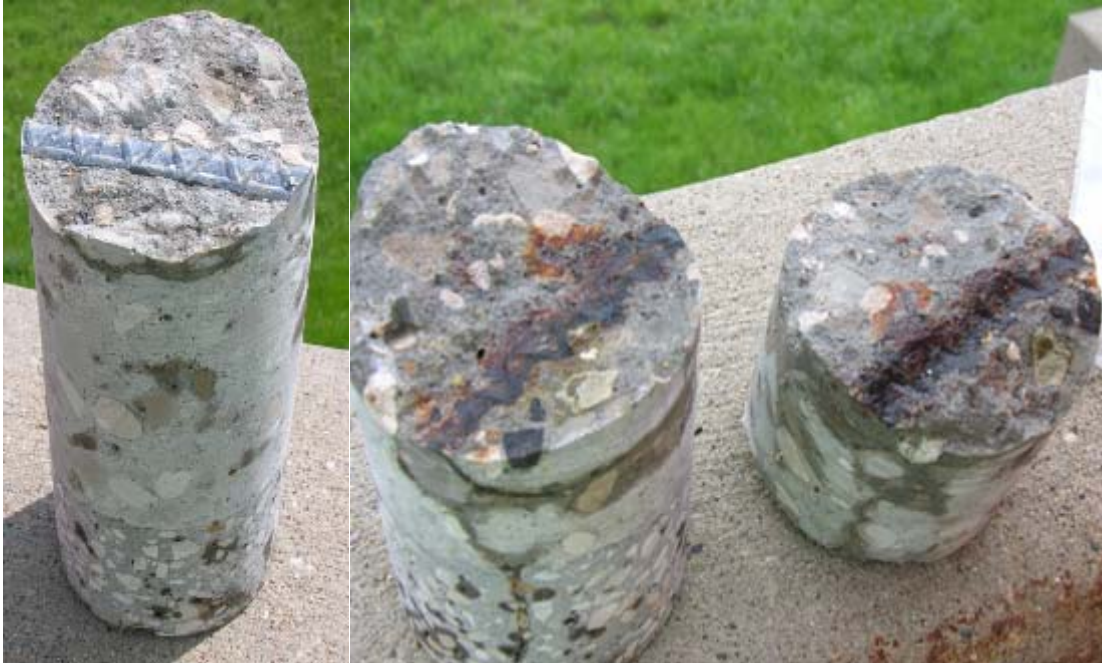
Core #1 (Figure 131, left) showed no evidence of damage at the upper steel, where GPR showed moderate signal attenuation. It should be noted that the selected GPR location for Core #1 was centered diagonally between two isolated deteriorated spots on lines spaced a few feet apart, in an attempt to show that the two locations could potentially be connected. The GPR map does show two yellow areas with orange/red spots in them on either end of the Core #1 location, but the core location itself is mapped on a green color (fair condition grade) while the raw data itself was reviewed along the two lines on either side of where the core was extracted. Impact-echo (IE) at that location indicated that the core would be sound, rated “good”, and HC showed similar results to the GPR map. Ultimately, Core #1 was marked within the transition zone, located between two small dots on the map that were barely above the 90% likely threshold for corrosion activity.

Figure 131. Cores 1 & 2 (left, right), were graded “serious” in the field. Core #1 is inverted, showing bottom of core, broken purposely to retrieve it.

Core #2, selected within a long segment of attenuated GPR signal, was marked close enough to the desired location that the measurement discrepancy did not matter. This can be seen on the map, where the Core #2 “dot” is marked right on a yellow zone with orange/red in the middle. The IE map shows the location of Core #2 to be directly on an area graded as “poor”, which means it is delaminated, but likely not detectable by chain drag. This is reasonable, because the core, though highly deteriorated, delaminated and split (there was also a longitudinal crack at the surface where the core was drilled), had the overlay and some parent concrete above. This would be considered a “deep” delamination. The core hole did not show a large gap, though there was a crack where the core had separated into two pieces during removal. The HC map shows Core #2 to be located just above the 90% deterioration threshold, indicating likelihood of active corrosion. Thus, all three NDE maps were in agreement regarding the predicted/observed condition of this core. The core itself is shown in Figure 129, at right.

A lesson learned on this deck was not to mark the deck for core extraction at any location where NDE sampling did not occur, as was the case between test lines (Core #1 location), since there is no real basis for determining whether the core is expected to be sound, or deteriorated, at an interpolated location between test lines.

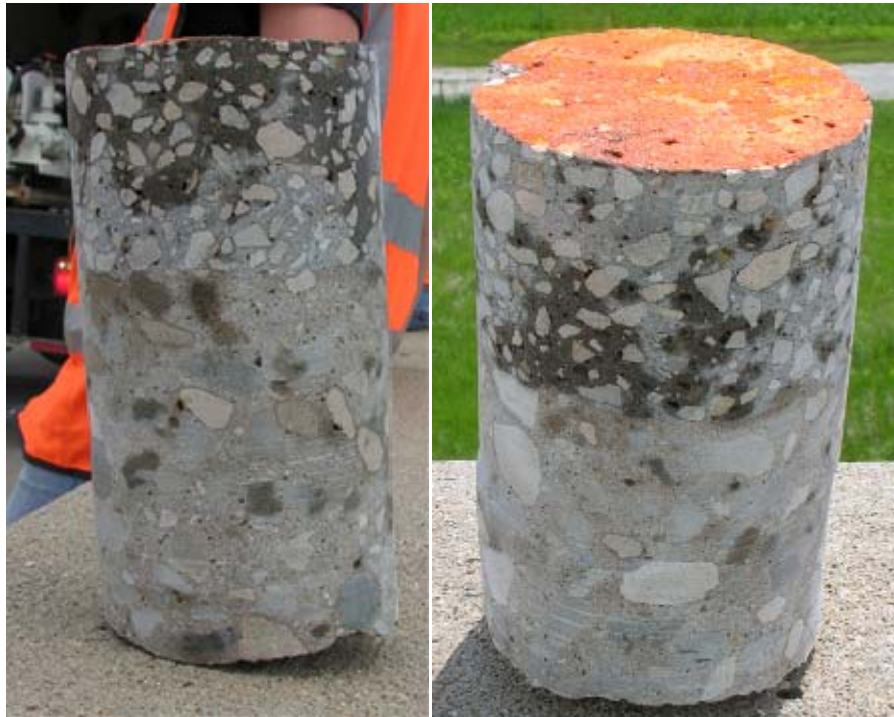
Despite using the GPR to select this core location, field-viewing the raw data apparently supported this selection but the distance-corrected GPR map does not. Thus, it is not unexpected that the extracted core, in general, appears to be good (Figure 132) since the mapped NDE data all indicate a “fair to good” (IE), “transitional” (HC) or “fair” condition (GPR) – and all the maps have been corrected for cumulative distance error. Unfortunately, the marked grid on the deck was used to directly locate the spot where the core was to be retrieved, and no distance-

Figure 132. Cores 3 (left) and 4 (right), graded “deteriorated” and “good” with GPR.

Core #4 (control) fell on locations where all maps were in agreement (transition for HC, “fair” for IE, and “good” for GPR), and the field-reviewed GPR data at the selected location in the data confirmed the same. The core was also extracted intact (Figure 132), with no visible signs of corrosion or damage/cracking. Fortunately, at this location, the mapped GPR data appears “good to fair” for a fairly long distance (6ft or so) along the line over which the field GPR data was reviewed to look for “sound concrete”. This meant that the applied distance correction did not seem to impact whether the field extraction was slightly misplaced on the deck, with regard to the desired sample location. Thus, in this particular case a sound core would have been removed from the deck even if a 2 to 3ft measurement discrepancy in the x-coordinate for the core, along the measured GPR line, would have resulted.

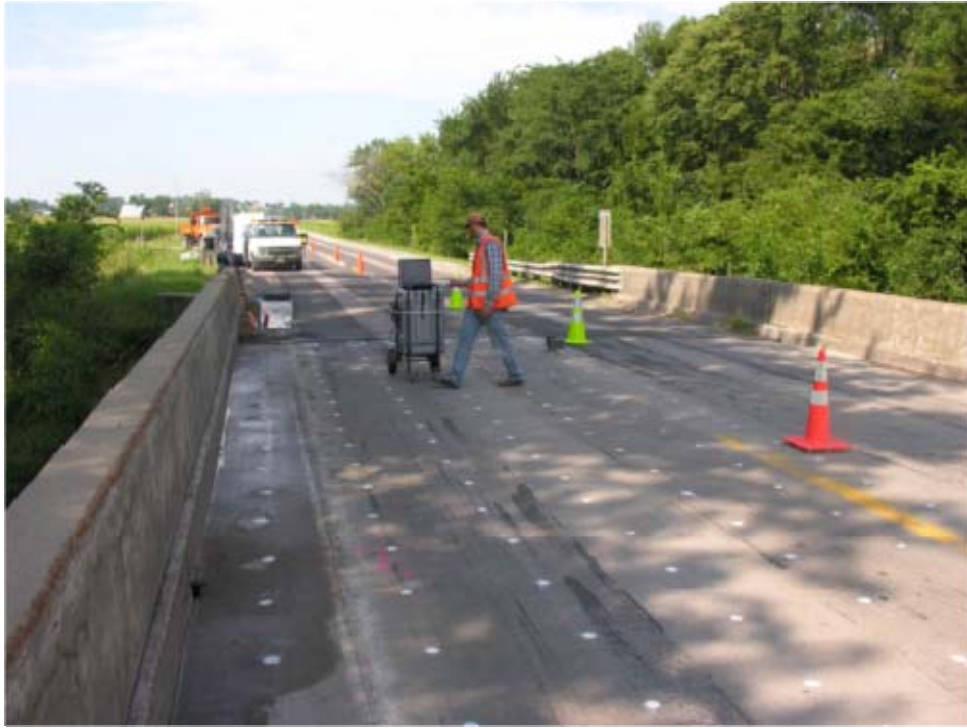
Figure 134. Perspective view of Deck R3, looking SW down northbound lane of Iowa #1.

Simultaneous data collection using various methods took place on Deck R3 on August 13 and 14, 2009 (EB and WB lanes, respectively), as described previously and shown in Figure 134. On this steel girder deck, the rebar configuration allowed GPR data collection along lines oriented with traffic.

Traffic control and gridding were performed in the same manner as previously with the origin at the SW corner of the deck (Figure 134, upper left). The deck is not skewed, and though the roadway runs north/south, the northbound traffic is actually oriented almost directly east at this bridge's location.

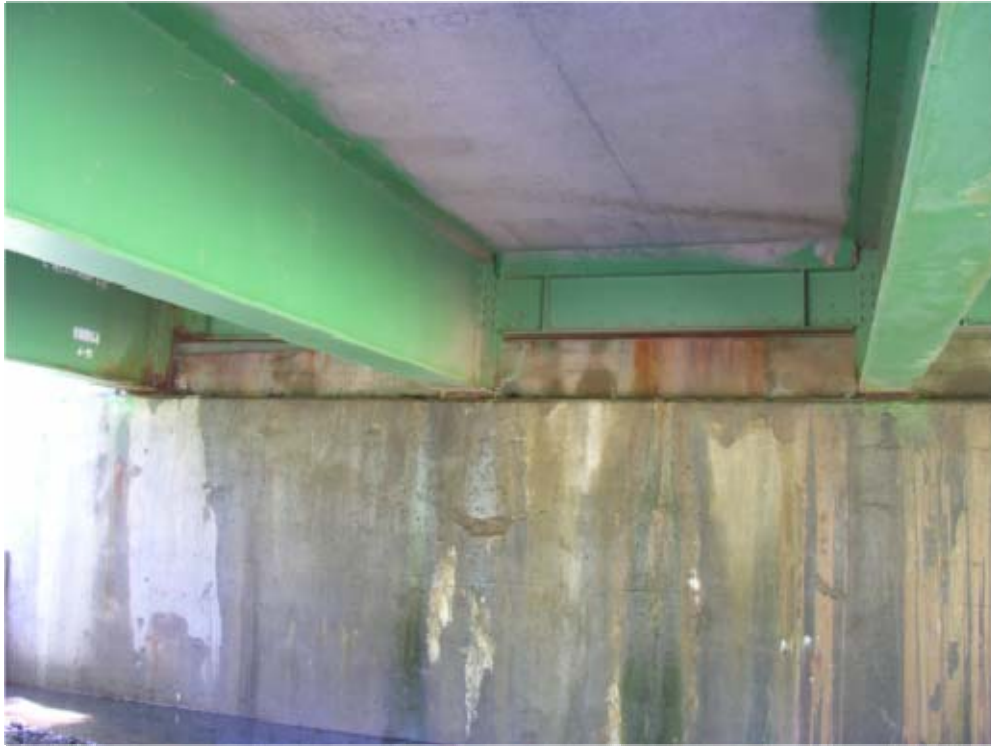
Figure 136. Bottom view of Deck R3 with rust staining, cracking and efflorescence at abutment.

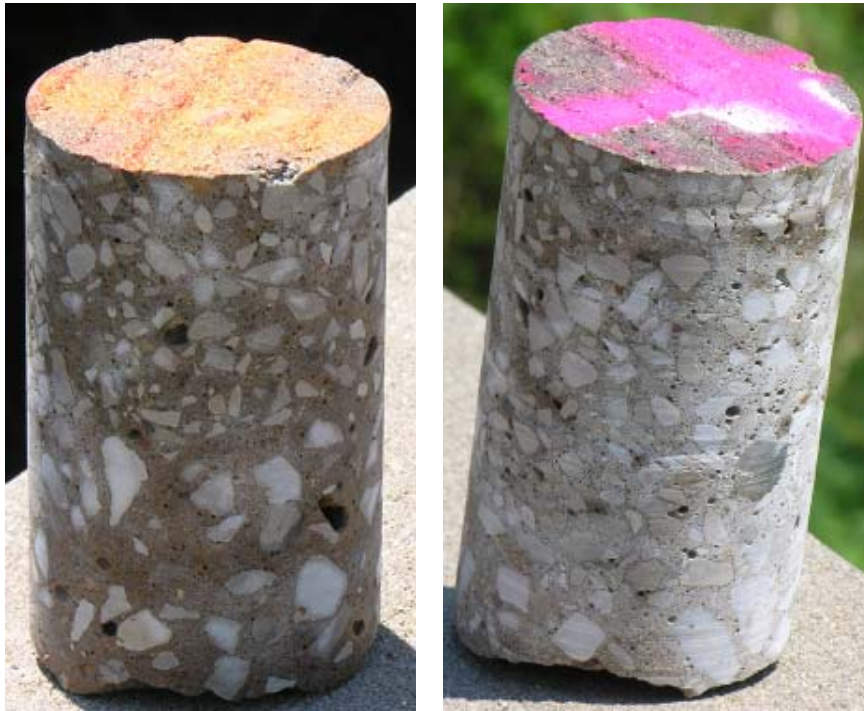
The IE was used to identify core positions based on the review of the data while being collected in the field. Core #1 was selected to be in the sound zone of the deck, Cores #2 and 4 to be in transition zones (fair to poor), while Core #3 to be in a clearly delaminated zone. Positions of the four cores were marked in Figure 138. Once the IE condition map was completed, it became obvious that all four locations were actually in the zones of transition from one condition level to another. In summary, Cores #1 and #3, predicted correctly good condition and delamination, respectively, while Cores #2 and #4 did not show clear damage, in terms of visible delamination or cracking.

Core results (photos) can be seen in Figures 139 and 140, where cores 1 and 2 are shown in Figure 139 (left and right, respectively), and cores 3 and 4 (left and right, respectively) are seen in Figure 140.

Figure 139. Cores 1 & 2 (left, right) graded “good” (intact) and “fair” by IE.

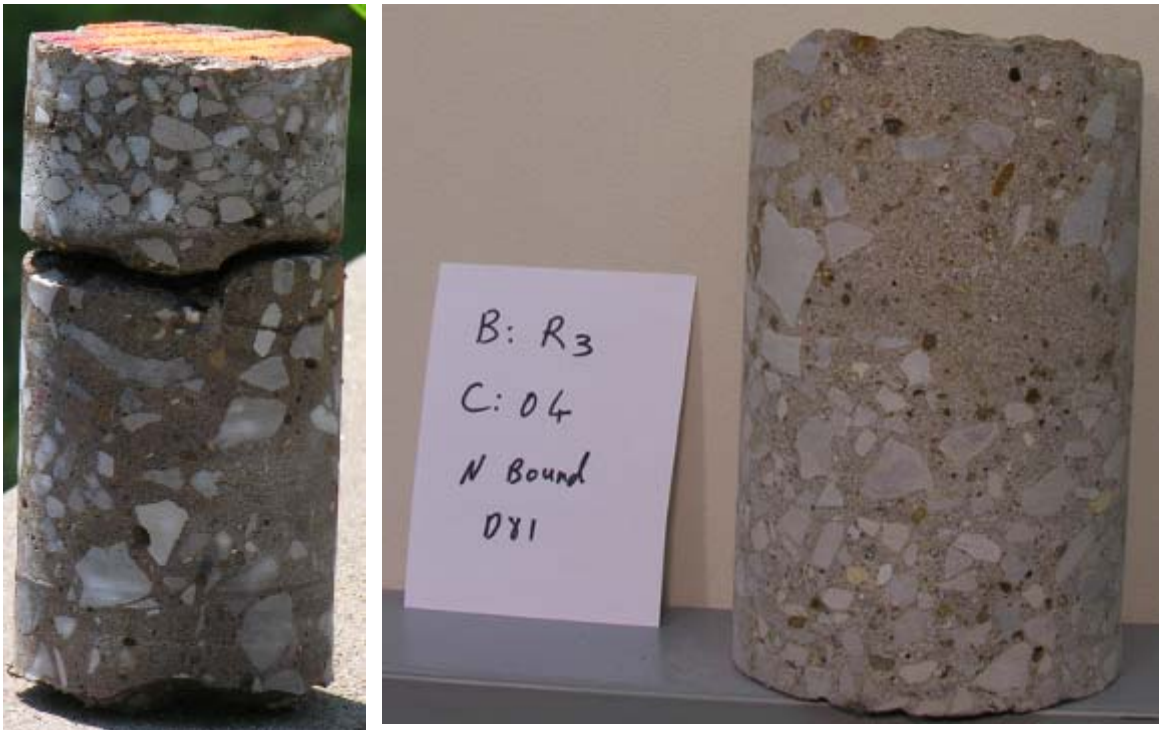
Figure 140. Cores 3 (left) and 4 (right), graded “serious” and “fair to poor” with IE.
