Test and Evaluation Report

Testing and Evaluation of the I-235 Pedestrian Bridges

January 6, 2006

Bridge Engineering Center

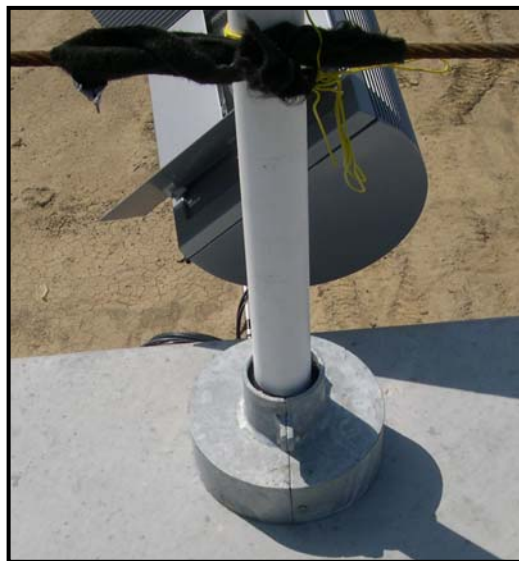
Figure 5. Galvanized trumpet pipe cover provides UV protection for FBG sensors leads

The functioning fiber optic sensors on both bridges were left in place (see Figure 4) and are protected from weather and UV degradation by a galvanized steel trumpet pipe cover (see Figure 5).

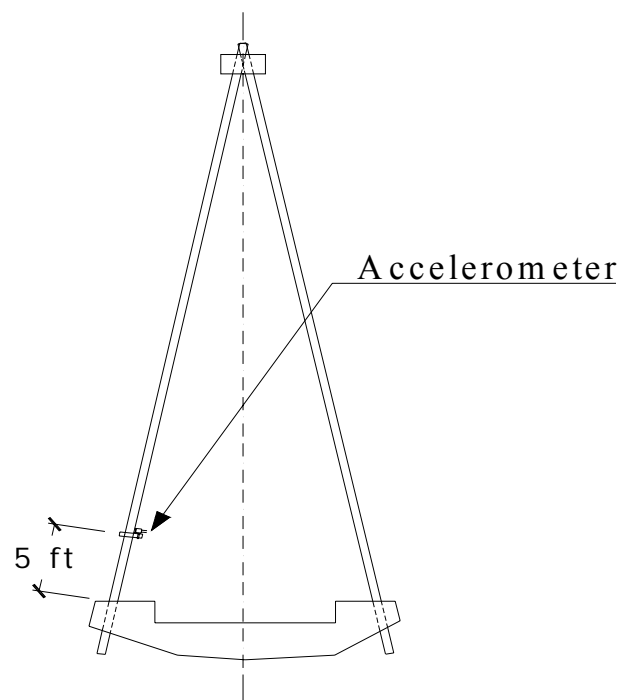
Figure 6. Typical section of bridge showing position of accelerometer mounted on hanger rod

In order to supplement the data collected using the fiber optic strain sensors, the research team elected to collect free vibration data for each hanger rod used on the 40th Street Bridge. The researchers used a PCB model 393 U353B33 accelerometer attached to the hanger rod approximately 5 feet above the deck level as shown in Figure 6. The accelerometer was oriented with its primary axis perpendicular to the centerline of the bridge.

The acceleration record for each hanger was collected by manually exciting the hanger using a suddenly applied, horizontal force or displacement approximately 4 feet above deck level. The force or displacement was applied perpendicular to the bridge centerline. Natural frequencies from the free vibration record were obtained and used to calculate the hanger force. This method is referred to as the Free Vibration Method (FVM) in this report. Each time a deck panel was installed, the research team collected vibration data from each active hanger rod.

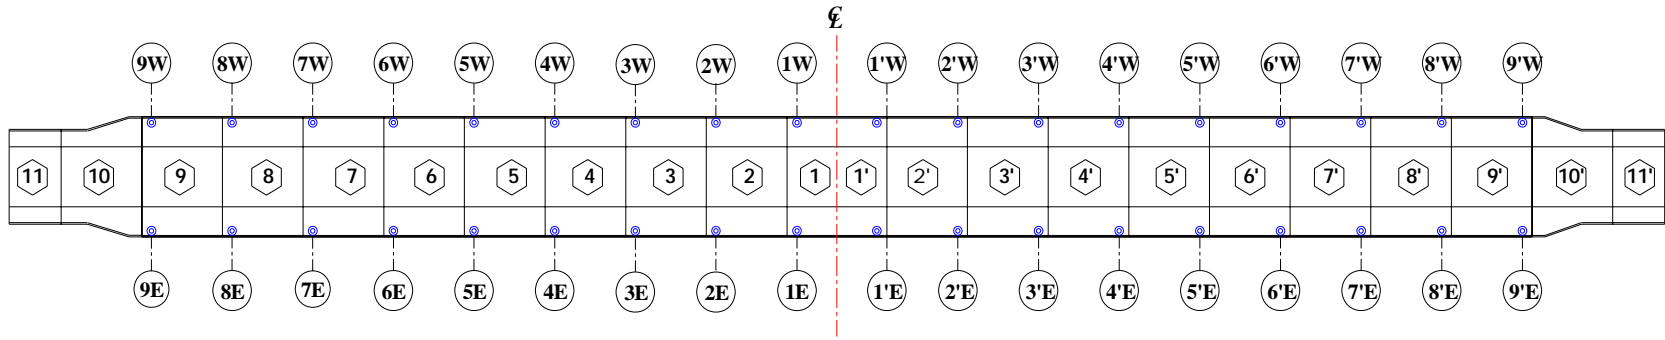
Figure 7. Precast panel layout – 40th Street Bridge

The 40th Street Bridge contains a total of 22 precast concrete panels, while the 44th Street Bridge contains a total of 20 precast concrete panels. The precast panel layout and numbering system for the two bridges are presented in Figures 7 and 8 respectively.

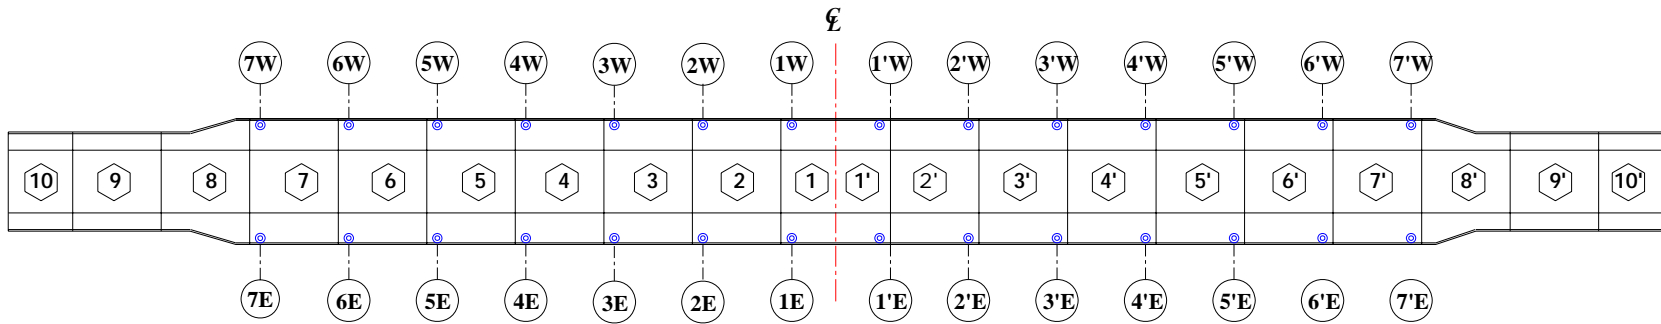
Figure 8. Precast panel layout – 44th Street Bridge

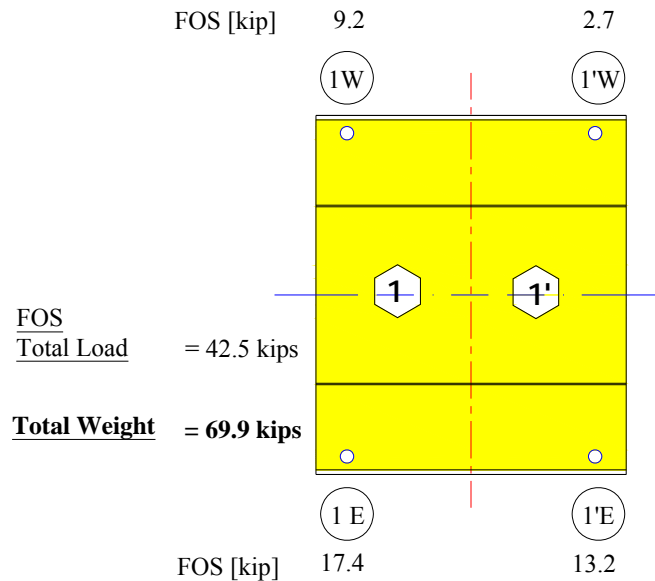
Figure 11. Stage 1 hanger forces from fiber optic sensors

Stage 1. The estimated dead load of the Stage 1 deck panel (with the added ballast) is 69.9 kips. Based upon the FOS strain data, the sum of the four hanger forces was calculated as 42.5 kips, which is only approximately 60% of the total dead load. Only at hanger 1E is the force obtained reasonably close to the theoretical dead load expected to be carried per hanger (17.5 kip). The calculated force at hanger 1'W is significantly lower than expected and the calculated hanger 1W force is also smaller than expected (Figure 11).

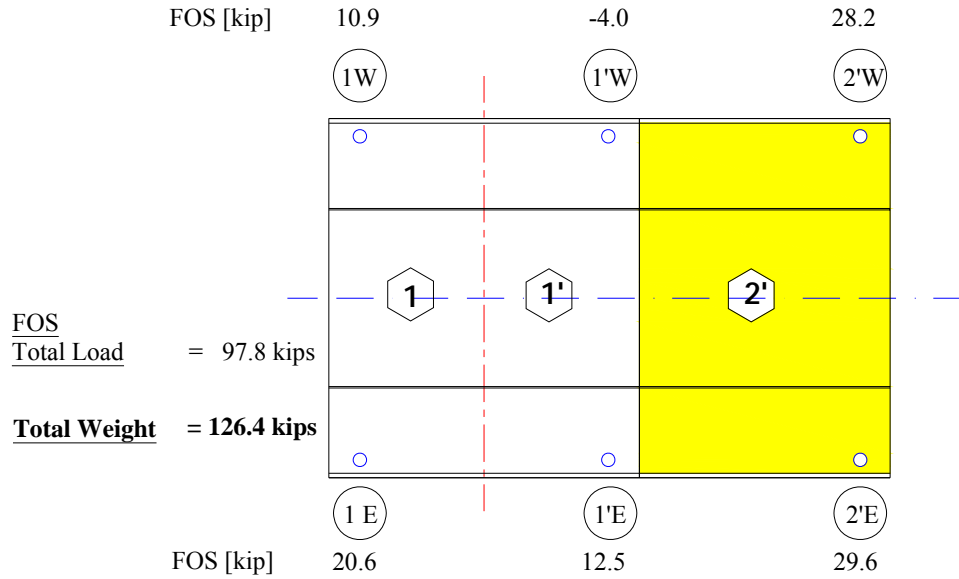
Figure12. Stage 2 hanger forces from fiber optic sensors

Stage 2. After placement of the Stage 2 deck panel, the estimated dead load was 126.4 kips. As shown in the figure, the summation of the six hanger forces was 97.8 kips (approximately 77% of the total dead load). Regarding hanger 1E, again the force computed is close to the expected load carried per hanger (21.1 kips). The hanger forces calculated in the two new hangers (2'W and 2'E) associated with the newly placed deck panel seemed very reasonable (28.2 kips and 29.6 kips, respectively) (Figure12).

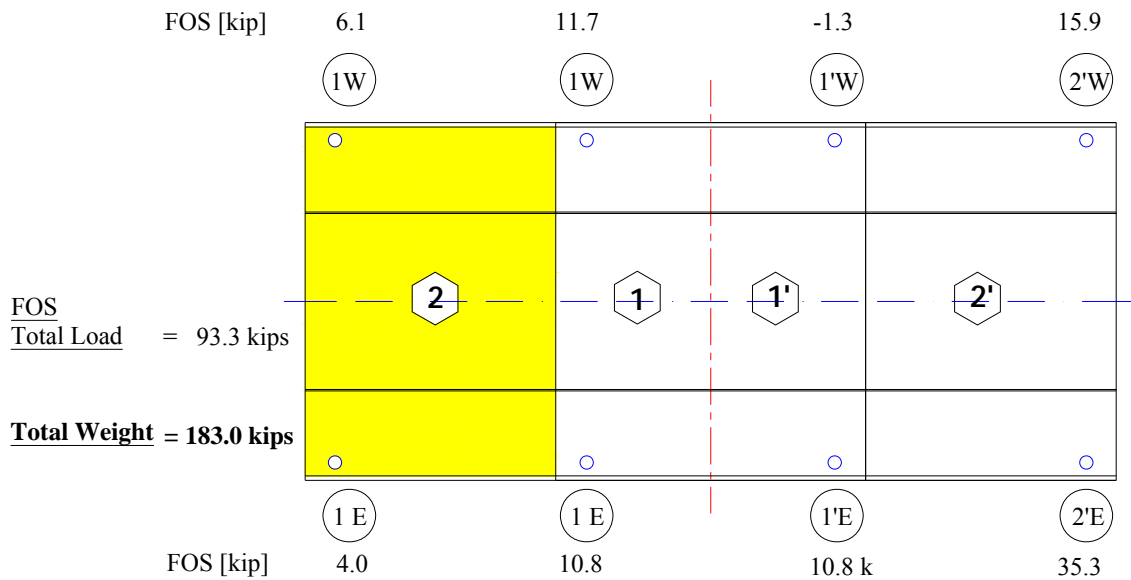
Figure 13. Stage 3 hanger forces from fiber optic sensors

Stage 3. The summation of the eight hanger forces for Stage 3 construction was 93.3 kips, compared to an estimated dead load of 183.0 kips. This represented only 51% of the estimated dead load. Several of the FOS away from the added deck panel appeared to give reasonable results (e.g. at hangers 2'W and 2'E), but in general there was concern about the lack of consistency of the results using the FOS (Figure 13).

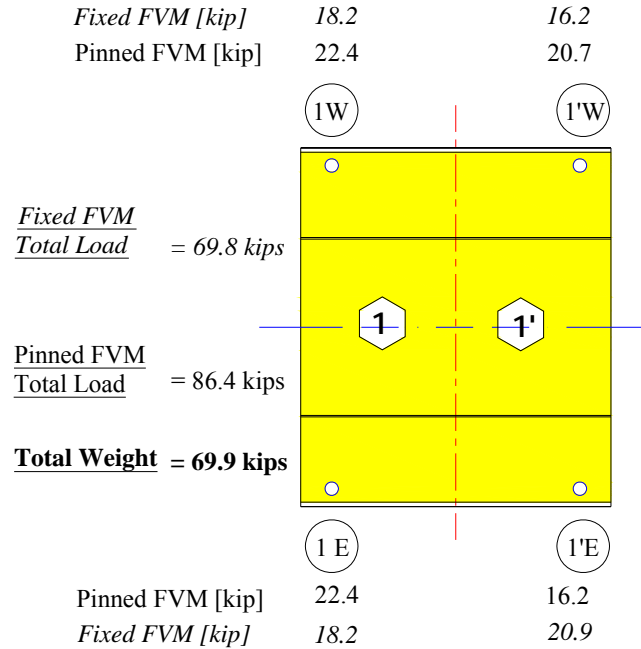
Figure 14. Stage 1 hanger forces from free vibration method

Stage 1. The estimated dead load of the panel (including ballast) was approximately 69.9 kips. The calculated forces for the four hangers was 69.8 kips and 86.4 kips, respectively, for the fixed and the pinned conditions. The four hanger forces were relatively similar and correlation with the estimated theoretical hanger forces (based on equal distribution of dead load to all hangers) of 17.5 kips was relatively good.

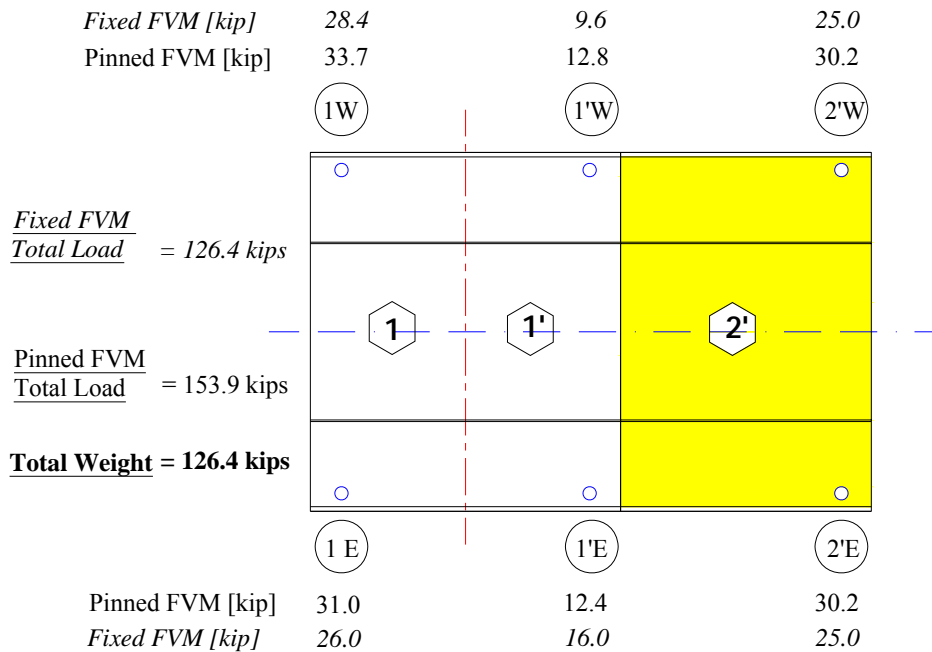
Figure 15. Stage 2 hanger forces from free vibration method

Stage 2. The summation of the six hanger forces at the completion of Stage 2 was 126.4 kips and 153.9 kips, respectively, for the fixed and pinned conditions. This compares with the total estimated dead load of the panels of 126.4 kips. Note that the hanger forces in 1'W and 1W were reduced after the second panel was placed, while the other four hanger forces increased in magnitude.

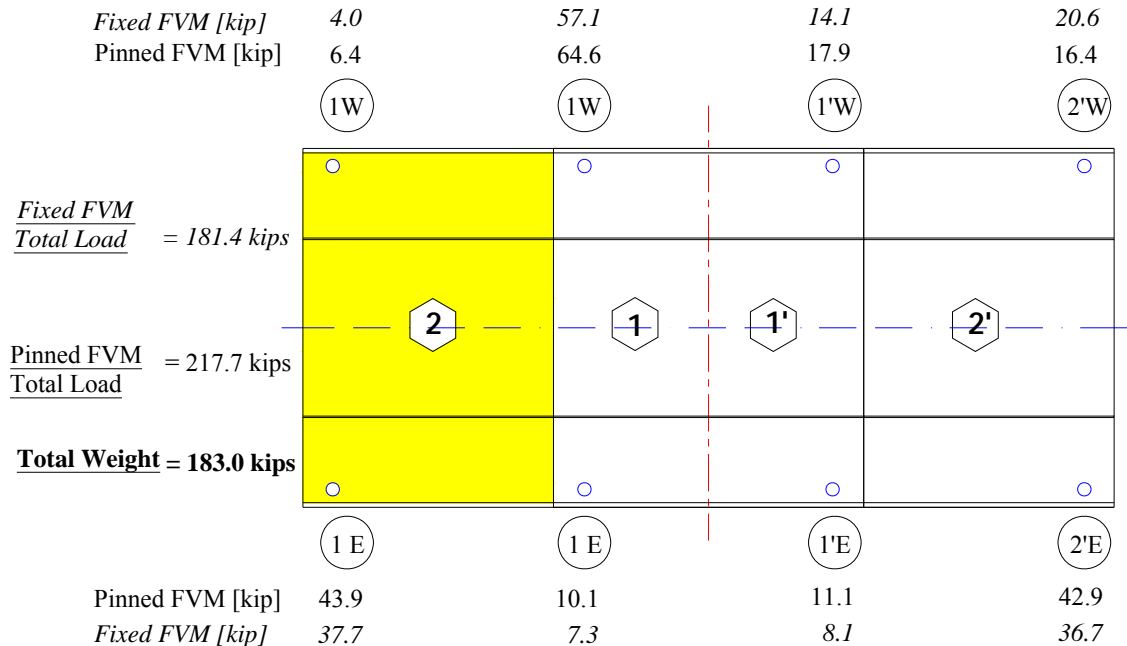
Figure 16. Stage 3 hanger forces from free vibration method

Stage 3. After placement of the Stage 3 deck panel, the estimated dead load was approximately 183.0 kips. In comparison, the calculated forces for the six hangers was 181.4 kips and 217.7 kips, respectively, for the fixed and pinned conditions. It is interesting to note that hanger 1W (one of the newly placed hangers) was very lightly loaded compared to expectations (4.0 kips for the fixed condition). In contrast, hanger 1E carried 36.7 kips for the fixed condition. There was a considerable non-uniform redistribution of hanger forces throughout the three panels at the end of the Stage 3 construction, with significant hanger force unbalances noted at several panel point pairs (e.g. 1W and 1E, and 2'W and 2'E).

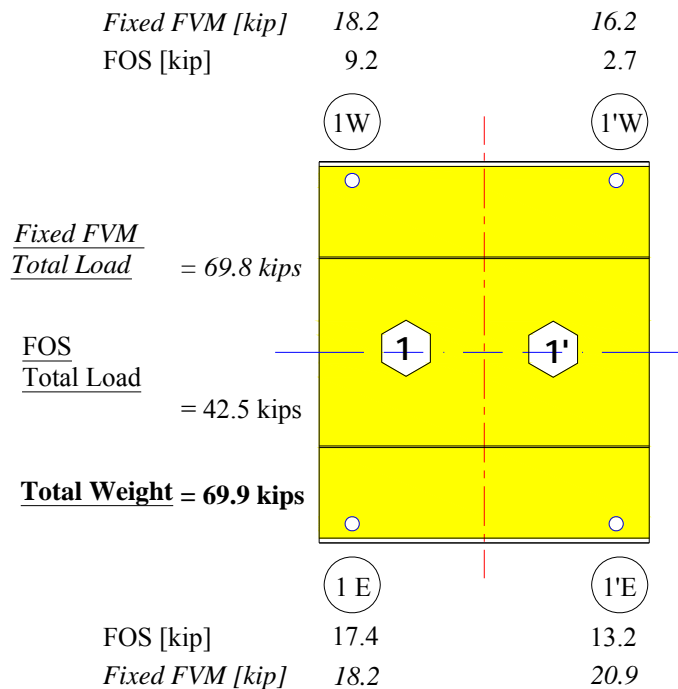
Figure 17. Correlation of Stage 1 hanger forces from free vibration and FOS data

Stage 1. The following observation is provided for Figure 17:

- The correlation between the FOS and vibration hanger force data is significant at hanger 1'W. The correlation is also relatively poor at hanger 1W. The other two hangers (1E and 1'E) show relatively good force correlation.

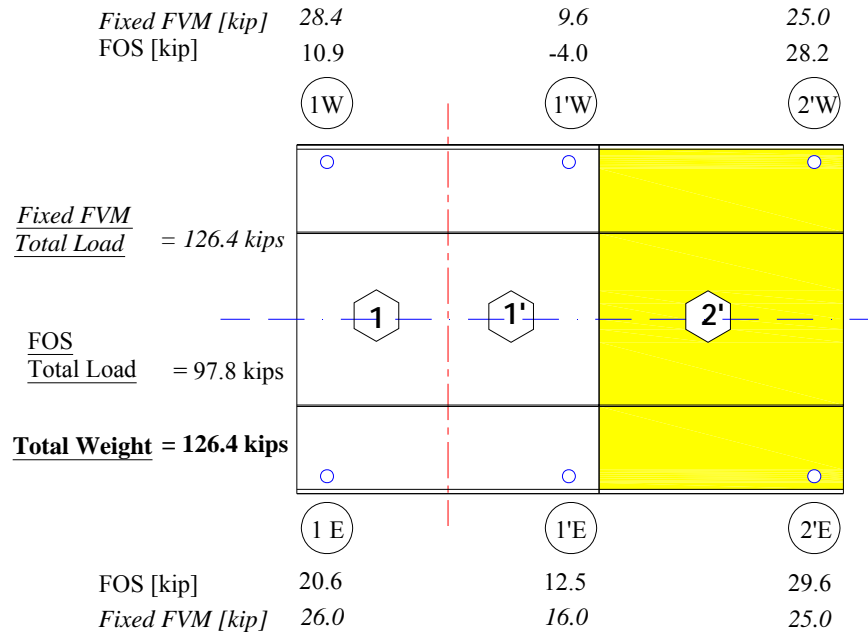
Figure 18. Correlation of Stage 2 hanger forces from free vibration and FOS data

Stage 2. The following observations are provided for Figure 18:

- Note for Stage 2 that the hanger forces in 2'W and 2'E (newly added hangers) were very similar.
- It's interesting to note that while the Stage 1 correlation of forces in Hanger 1'W was very poor, the change in force in the hanger (reduction of approximately 6 kips) was very similar during Stage 2 construction.

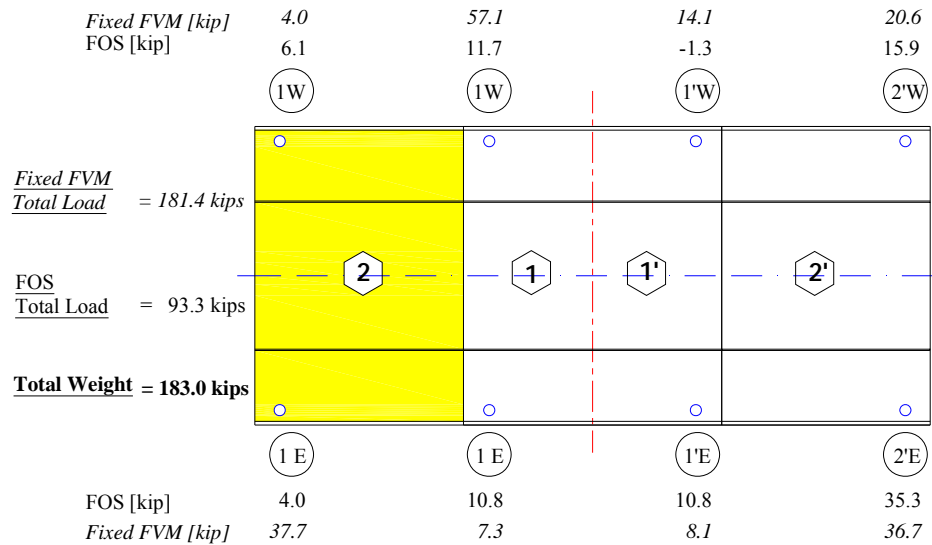
Figure 19. Correlation of Stage 3 hanger forces from free vibration and FOS data

Stage 3. The following observations are provided for Figure 19:

- Note that for Stage 3 construction the correlation in hanger force for 2W was relatively good.
- Note that the hanger force correlation at 2'W and 2'E was still quite good as noted above for Stage 2 construction.
- Also note how the change in hanger force at 1'W from Stage 2 and 3 were similar (i.e., increased approx. 3 to 5 kips). This was similar to observation at the same hanger noted above for Stage 2 construction

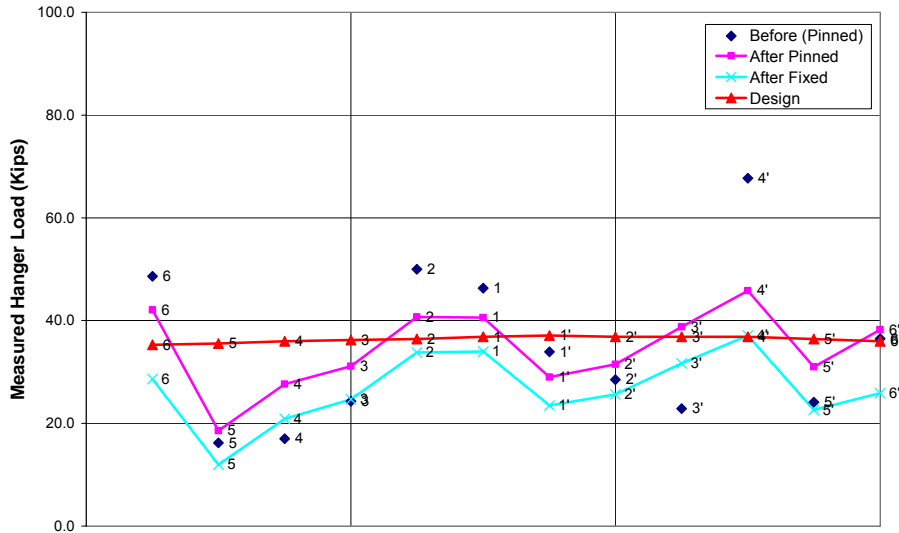
Figure 20. Hanger forces for east arch of the 44th Street Bridge after adjustment

Figure 20 shows a plot of the hanger forces for the East Hangers based on the vibration data to illustrate the redistribution of the hanger forces after adjustment. The target design forces for each hanger are also shown for comparison. As noted the adjustments eliminated the outliers relative to the design values and improved the overall distribution of the forces.
