# Monitoring and Evaluation of a Plate Girder Bridge

Many of Iowa's multiple steel girder bridges are experiencing fatigue cracking of the girder webs at diaphragm connections. The state, along with Iowa State University, has been investigating a retrofit method involving bolt loosening in the diaphragm/girder connection. Testing of this retrofit has included continuous monitoring of a demonstration bridge to assess the impact of the retrofit over an extended period of time.

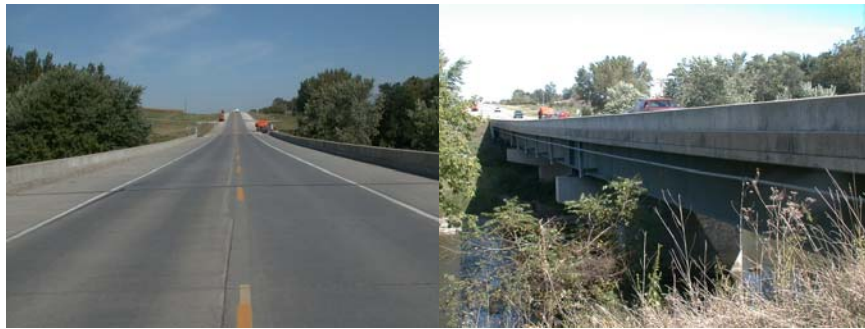
**FIGURE 1. Photographs of Bridge Deck and Profile**

Bridge 4048.2S017, shown in Fig. 1, is a three span bridge crossing the Boone River on Highway 17 in central Iowa. As shown in Fig. 2, the end spans are 29.7 m and the interior span is 38.1 m. The girders are labeled as G1 to G5 and the diaphragms in each span are labeled as D0 to D5. The bridge has five main plate girders with an integral concrete deck as shown in Fig. 3. The 1.5 m deep girders are connected by X-type diaphragms every 6.1 m. A visual inspection revealed no fatigue cracking in the girder webs near the connections to the diaphragms. However, many multiple steel girder bridges with this diaphragm connection detail in Iowa have experienced cracking in that region.

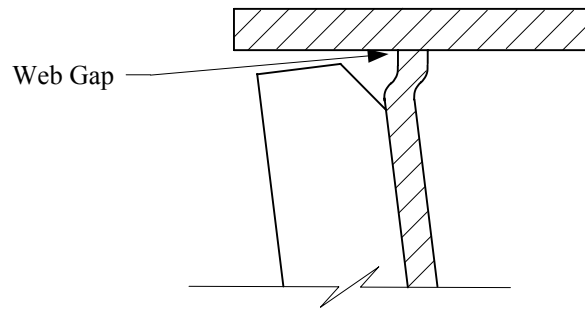
**FIGURE 4. Out-of-plane Distortion in Web Gap**

Fatigue cracking in the web gap is a result of differential deflection of the adjacent girders due to asymmetric traffic loading on the bridge deck. As vehicles cross a bridge, the adjacent girders deflect differently at the same cross section and the diaphragms between the girders are distorted. This is especially true on bridges with skewed piers. Forces created in the diaphragms cause a rotation at the connection between the girder and the diaphragms. The force is transferred to the girder by the web stiffener, which causes the web gap to displace out-of-plane. The stiffener pulls at the web, but the top flange, being integral with the deck, resists movement and the result is out-of-plane displacement as illustrated in Fig. 4. Continued cycles of this out-of-plane displacement result in fatigue cracking in the web gap. Exterior girders are especially prone to fatigue cracking because, unlike interior girders, they do not have a diaphragm on both sides of the girder to oppose the out-of-plane forces.

Many existing steel girder bridges in Iowa had the same connection design between the diaphragms and webs. Fatigue cracking has occurred in the web gaps of this design, especially in the negative moment region, because the stiffener is not attached to the girder top flange which allows out-of-plane distortion. The web gap is defined as the region of the web between the top flange fillet weld and the stiffener weld and is typically only an inch in length in the vertical direction. Typically the cracks found in this region are horizontal, parallel to the top flange, and extend up to a few inches away on either side of the web gap.

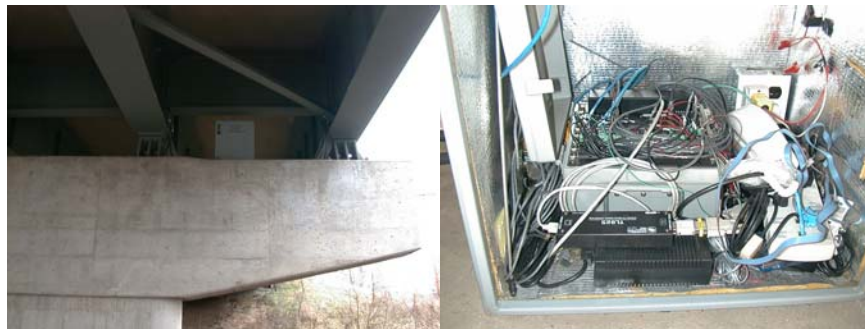
**FIGURE 5. Photographs of Environmental Enclosure and CR 9000**

A Campbell Scientific CR 9000 was selected as the base for the remote continuous monitoring data collection system. The system was set up in an environmental enclosure on Pier 2, which provided the system protection from the weather and vandalism as shown in Fig. 5. The system has an input capacity of 24 channels with further expansion possible. Thermocouples, strain gages, and displacement transducers were used in this study, but the system is capable of supporting many different sensor types. Instrumentation was focused at a diaphragm in the negative moment region near Pier 2 as illustrated in Fig. 6.

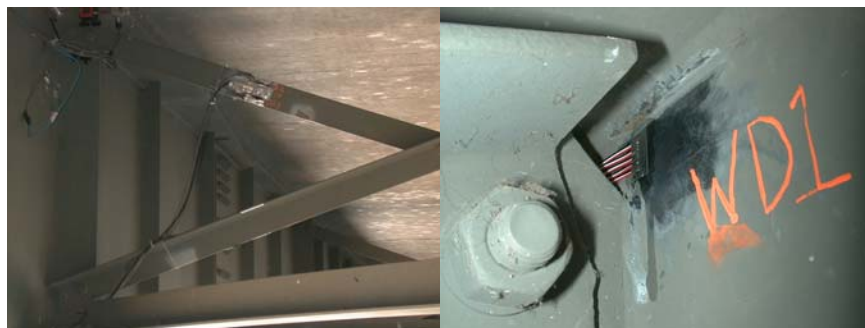
**FIGURE 7. Photographs of Diaphragm and Web Gap Strain Gages**

Two gradient strain gages were installed in the G1 and G2 web gaps as shown in Fig. 7. These gradient gages consist of five small, foil backed strain gages placed within the web gap to collect a detailed strain profile. For this study the strain in the web gap was the most important indicator of the effectiveness of the retrofit.

Three weldable strain gages were mounted on the diaphragm members between G1 and G2 as pictured in Fig. 7. The gages were encased in plastic to provide protection from the environment.

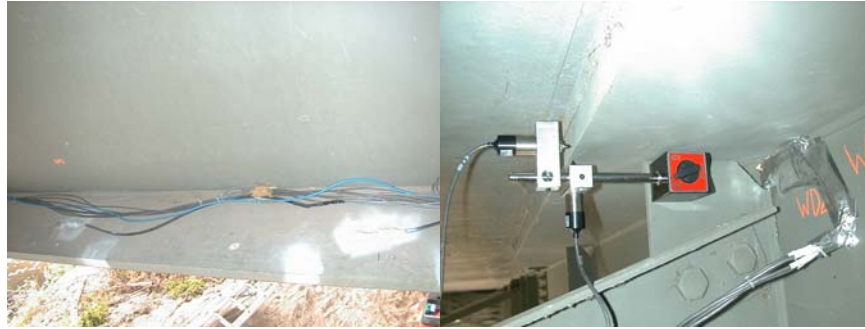
**FIGURE 8. Photographs of Longitudinal Strain Gages and Out-Of-Plane Transducers**

Four Direct Current Displacement Transducers (DCDT) were installed at the stiffener connection of D5. Two were placed on G1 and two were placed on G2 as shown in Fig. 8. One transducer measured out-of-plane displacement of the web gap and the other measured vertical movement of the flange relative to the stiffener. Out-of-plane displacement of the web was indicated by the change in horizontal position of the stiffener with respect to the top flange, which was integral with the deck. The out-of-plane displacement of the web is an indicator similar to the strain in the web gap of the effectiveness of the retrofit.

Two weldable strain gages were also used to measure the strain in the bottom flange of G1 and G2 at 0.9 m from the bearing at Pier 2 as pictured in Fig. 8. The strain in the girders reflects the global effect the retrofit has on the bridge and was also used as a trigger for the DAS as described below.

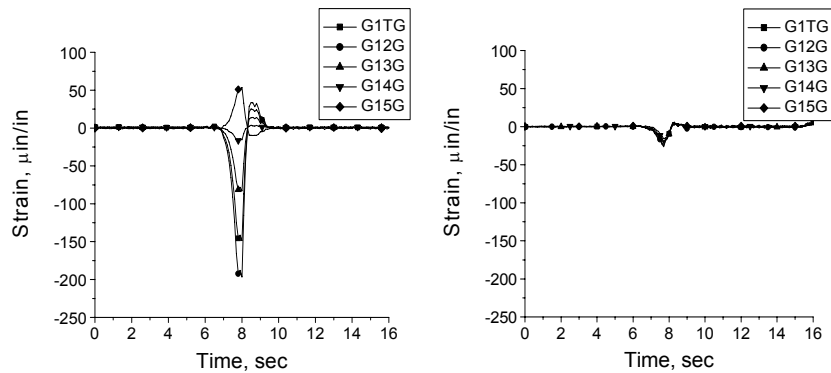
**FIGURE 9. Web gap Strain Vs. Time Plots before and after the Retrofit**

Typical plots of the 16 seconds of data for the DOT trucks are shown in Fig. 9 before and after implementation of the retrofit. The DOT load trucks showed a substantial (nearly 90 percent) reduction in strain in the G1 web gap following implementation of the retrofit. Other sensors in the web gap region also showed similar reductions with the exception of the bottom flange strain

in the girders. The girder strain showed very little change due to implementation of the retrofit, and because of this the bottom flange strain was useful as a trigger.

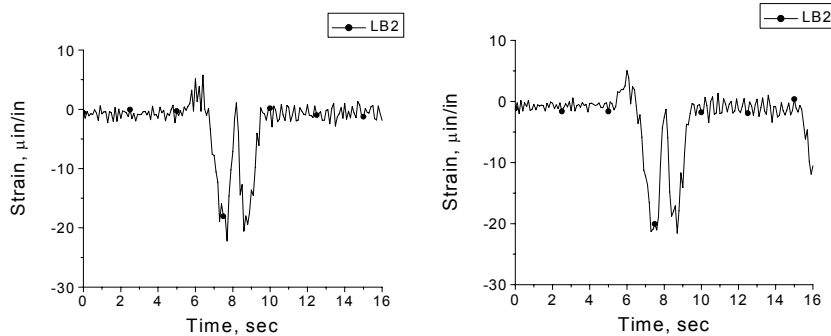
**FIGURE 10. Longitudinal strain vs. time plots before and after the retrofit**

The girder strain showed very little change after implementation of the retrofit so that the bottom flange strain was useful as a trigger. The strain in the girders during the DOT truck loading was similar with and without the retrofit, about 20 microstrain as shown in Fig. 10, even though the trucks were of slightly different weights. To correct for the difference in weight the plots from before the retrofit were normalized to represent equal loads of approximately 22680 kg in both tests. The longitudinal strain was used to identify load size of ambient trucks before and after the retrofit was installed.

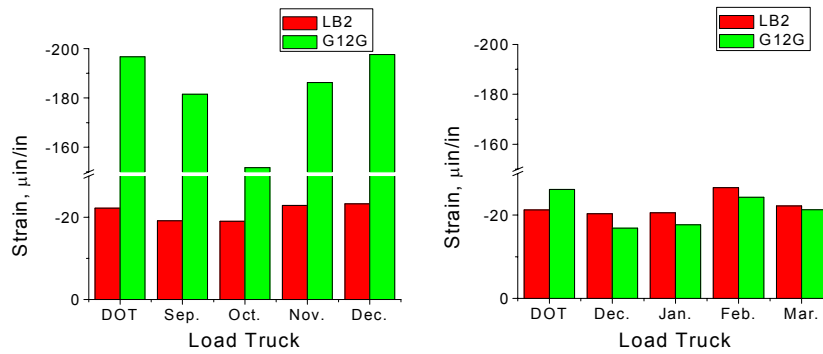
**FIGURE 11. Long Term Web Gap and Longitudinal Strain before and after the Retrofit**

A sample ambient truck similar to the DOT load trucks as far as causing similar longitudinal strain patterns and peak strains was selected for each of the four months before and after the retrofit was implemented. The longitudinal strain and web gap strain for each of these trucks is plotted in Fig. 11. Web gap strains for each of these trucks and the DOT trucks are similar both before and after the retrofit was implemented suggesting that the reduction in web gap strain does not change over time.

The long term testing program revealed that the overall results (the peak strain and displacement associated with a loading) did not change over time when the retrofit was implemented. This suggests that the retrofit will be effective in reducing or eliminating fatigue cracking in the web gap and the effectiveness will not deteriorate over time.
