Bolt Loosening Retrofit to Inhibit Fatigue Cracking in Steel Girder Bridges

A paper submitted to the Transportation Research Board for presentation and publication.
November 15, 2002

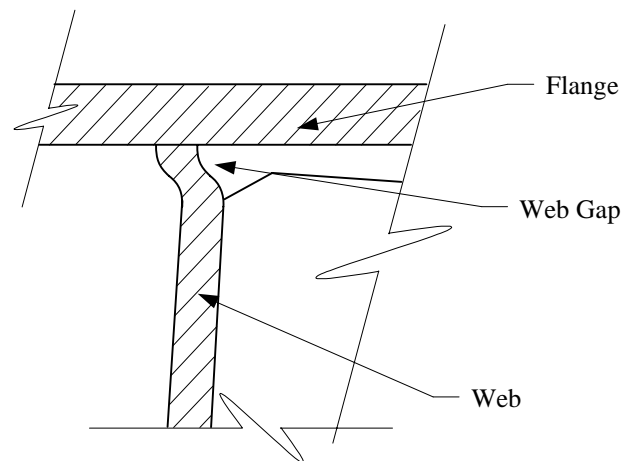
a. Web gap double bending.

Theoretically fatigue cracking due to this rotational force can occur in the girder web, web stiffener, or the diaphragm itself. Bridges in Iowa have typically exhibited cracking in the web resulting from a lack of connection between the girder top flanges and the web stiffeners. The problem area, commonly referred to as the "web gap", is between the top of the web stiffener fillet welds and the top flanges in the negative moment regions. The web stiffeners carry lateral load effectively, but can place significant out-of-plane loading on the webs. The web gaps displace out-of-plane as illustrated in Fig. 1a which shows double bending of a web gap resulting from out-of-plane loading on the web. A typical fatigue crack, along with a drilled hole retrofit resulting from the phenomena is shown in Fig. 1b.

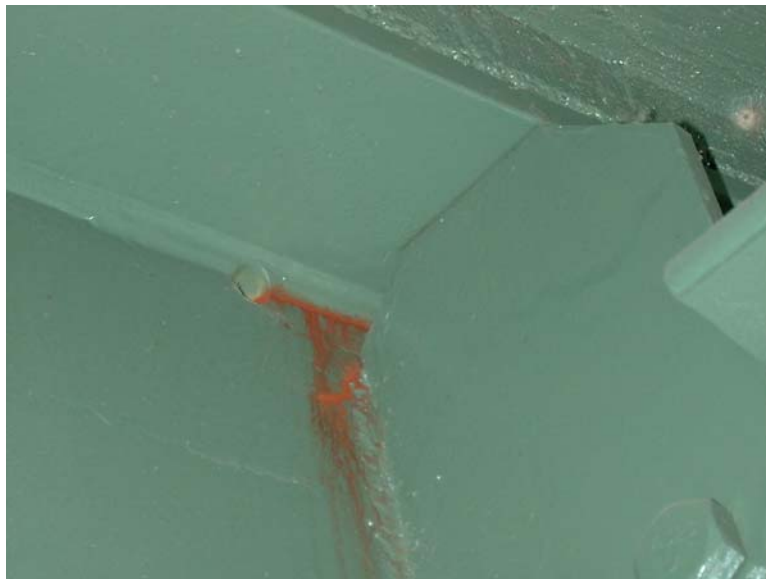
Figure 1: Typical web gap condition.

b. Typical drilled hole retrofit in a web.

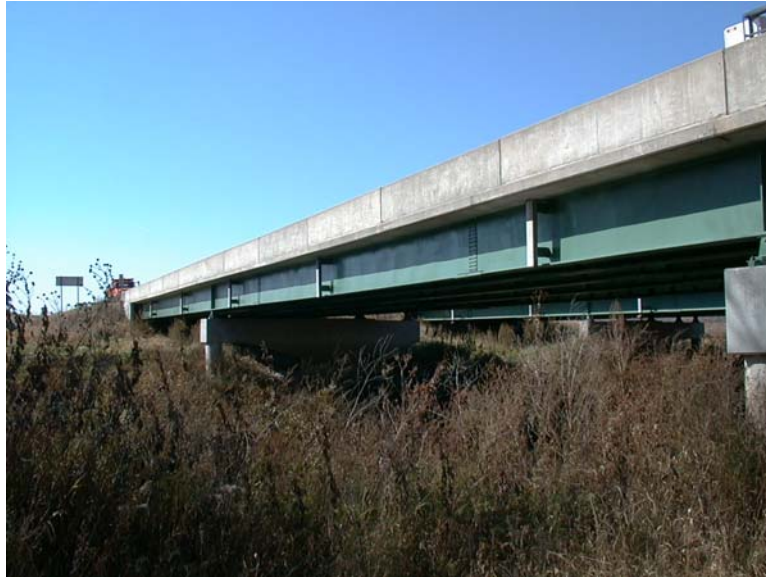
a. Bridge 5075.5R080 looking northwest.

The I-beam Diaphragm Bridge, shown in Fig. 2a, is a two lane, three span, multiple steel girder bridge on Interstate 80. The bridge cross section, with diaphragms, is shown in Fig. 2b. I-shaped diaphragms, spaced at approximately 20 ft, provide lateral support to the girders. Figure 2d shows a plan view of the superstructure, which is skewed at 10 degrees. The five 48 in. deep welded plate girders support an 8-in. concrete deck that is integral with the top flange. The bridge has multiple examples of web gap fatigue cracking near diaphragm connections in the negative moment region. The webs with visible cracks have had holes drilled in the web following crack identification. The high occurrence of fatigue cracking in this bridge makes it a critical bridge for fatigue and a prime specimen for retrofit testing. The diaphragms are bolted to vertical stiffeners as illustrated in Fig. 2c. The vertical stiffeners are welded to the web and the compression flange of the girder. In the negative moment region above the piers, the top flange is in tension and is not welded to the stiffeners. A web gap of about 1 in. in the vertical direction exists between the top of the stiffener weld and the bottom of the girder top flange where the stiffener is clipped. As noted previously, fatigue cracks have occurred in this region.

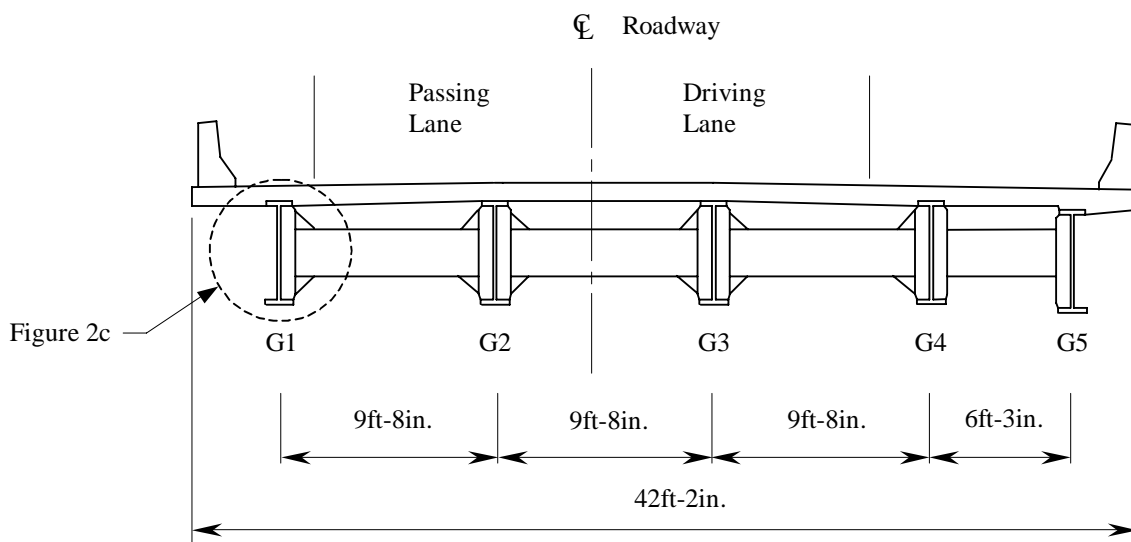
Figure 2: Bridge 5075.5R080 layout (cont.).

b. Bridge 5075.5R080 cross section looking toward direction of traffic.

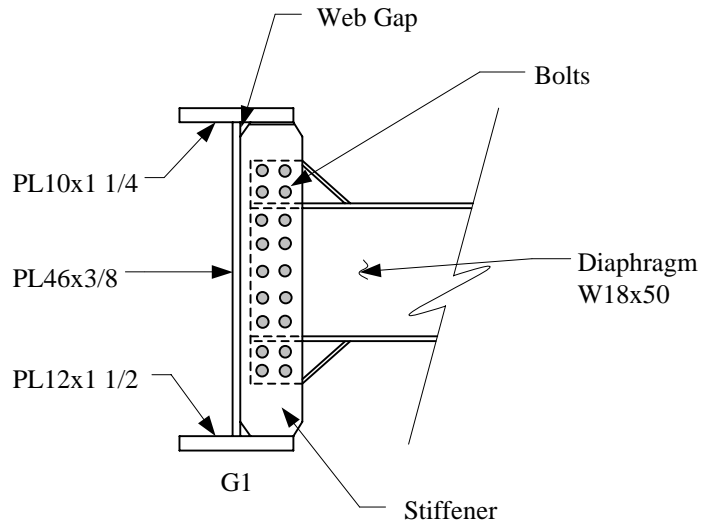
c. Diagram of a typical diaphragm/girder connection in the negative moment region of bridge 5075.5R080.

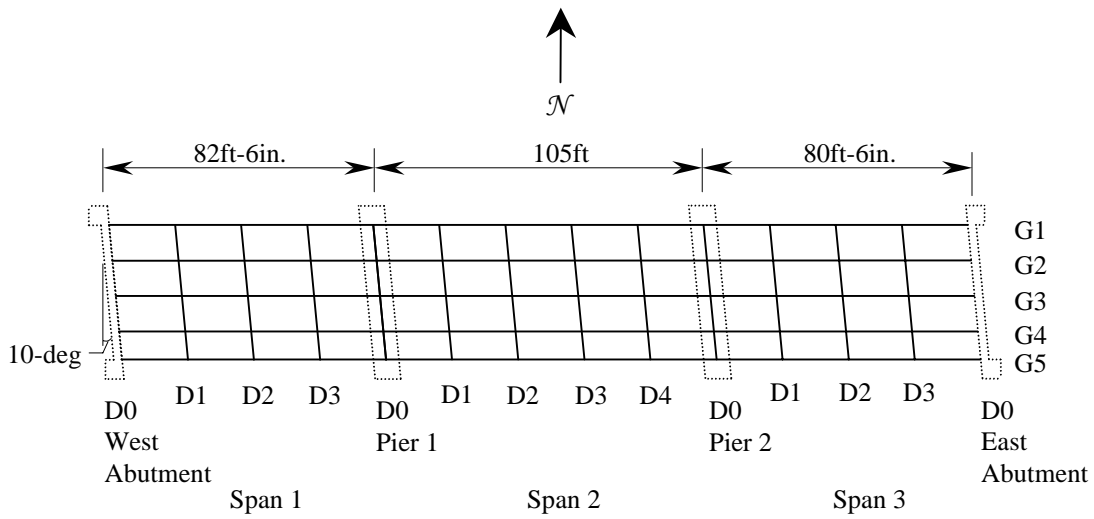
Figure 2: Bridge 5075.5R080 layout.

d. Plan view of bridge 5075.5R080 superstructure.

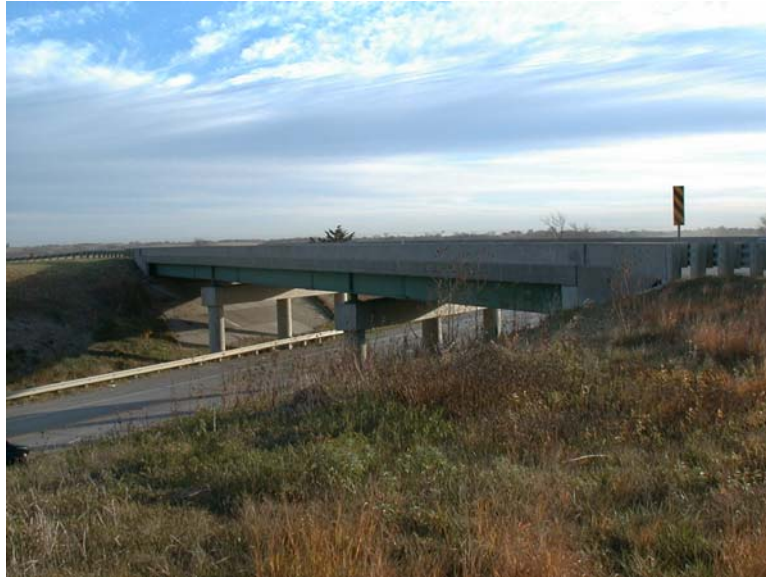
a. Bridge 2700.0R035 looking northeast.

The Channel Diaphragm Bridge on Interstate 80 is a multiple steel girder bridge similar to the I-beam Diaphragm Bridge except it has channel diaphragms connecting the five girders. It is a three span structure with five 38 in. steel girders supporting an 8-in. concrete deck shown in Fig. 3a. The bridge is skewed 40-degrees as shown in Fig. 3c. The girders are spaced at 9 ft-6 in. as illustrated in Fig. 3b. The channel diaphragms are rolled 18C42.7 sections. The X-type Diaphragm Bridge on Iowa Highway 17 is a five-girder bridge, shown in Fig. 4a, with X-type diaphragms, similar to the I-beam Diaphragm Bridge with the exception of the diaphragms and the 62 in. girder depth. Figure 4d shows a plan view of the bridge. The diaphragms in this bridge are an X-type diaphragm made up of angles and a horizontal T section as illustrated in Fig. 4b. The angles are L4x3x5/16 and the T is an ST5WF10.5 and are bolted to web stiffeners on the main girders as shown in Fig 4c.

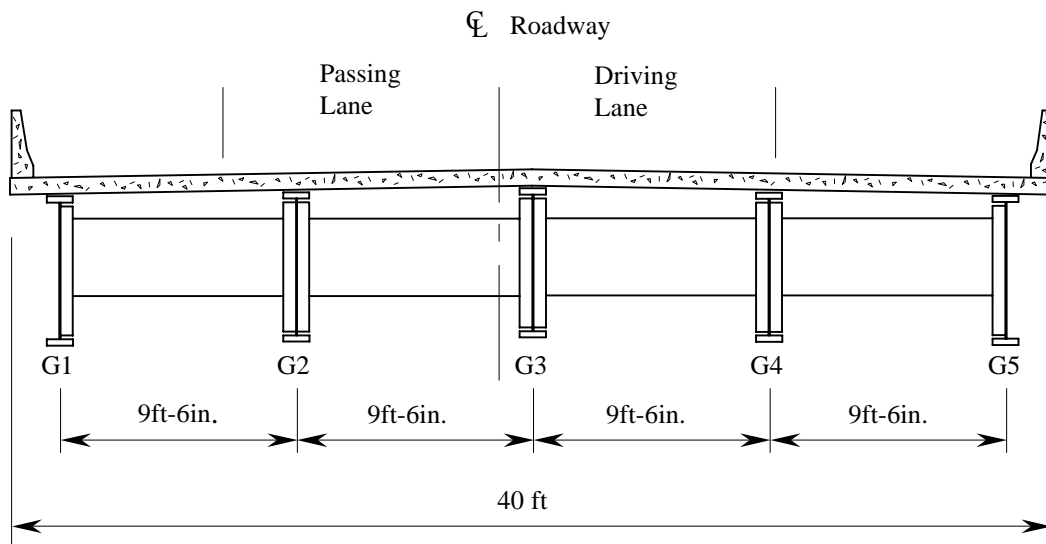
Figure 3: Bridge 2700.0R035 layout (cont.).

b. Cross section of bridge 2700.0R035 looking in direction of traffic.

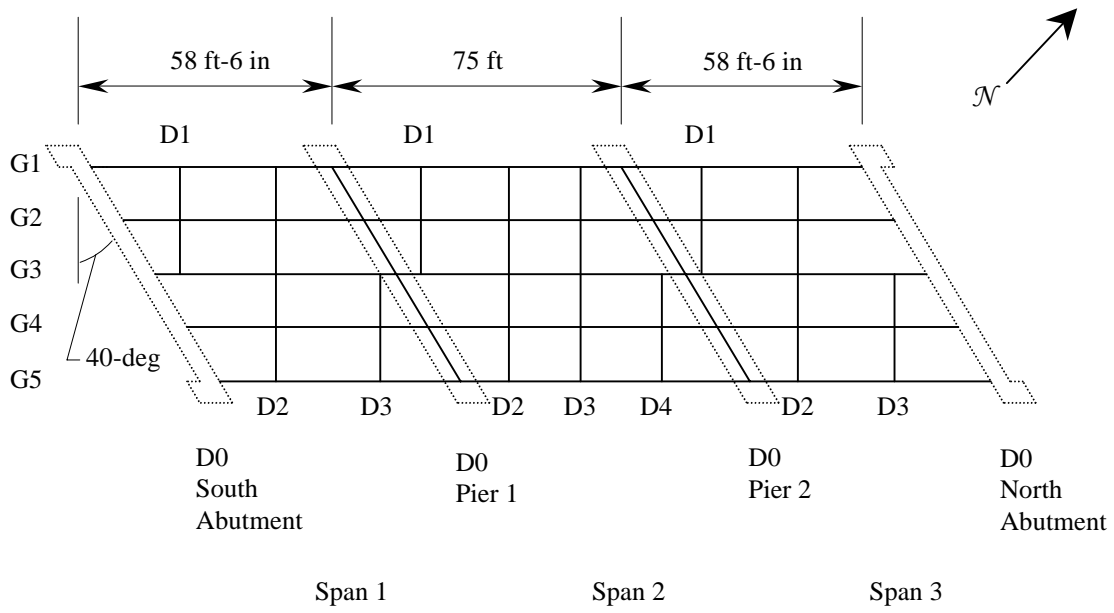
Figure 3: Bridge 2700.0R035 layout.

c. Plan view of bridge 2700.0R035 superstructure.

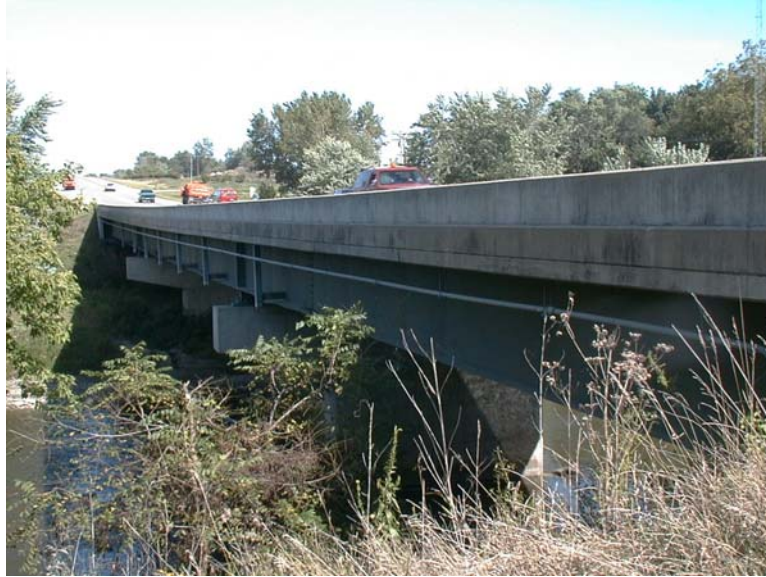
a. Bridge 4048.2S017 looking northeast

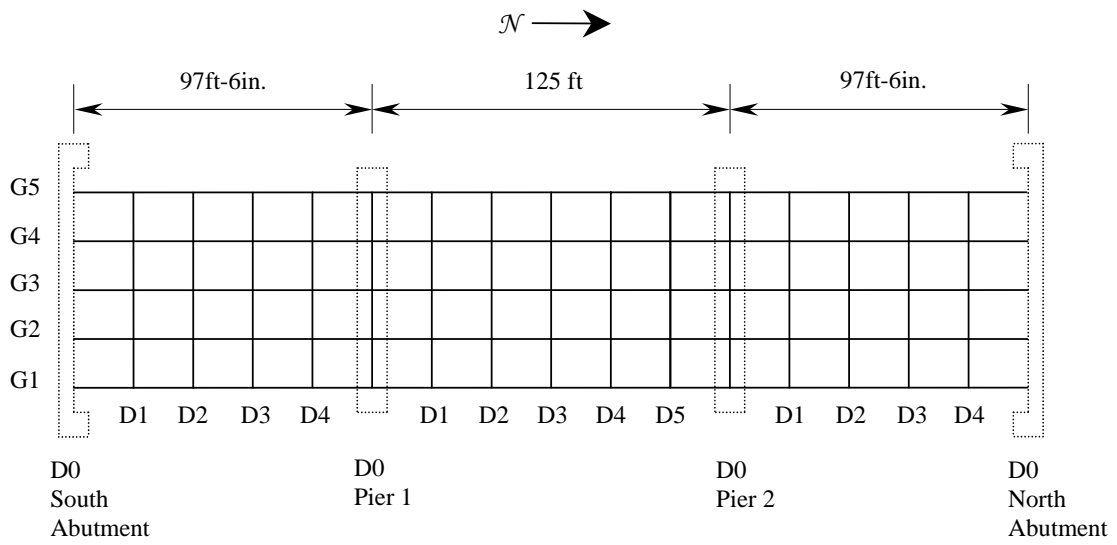
Figure 4: Bridge 2700.0R035 layout (cont.).

b. Plan view illustration of bridge 4048.2S017 superstructure.

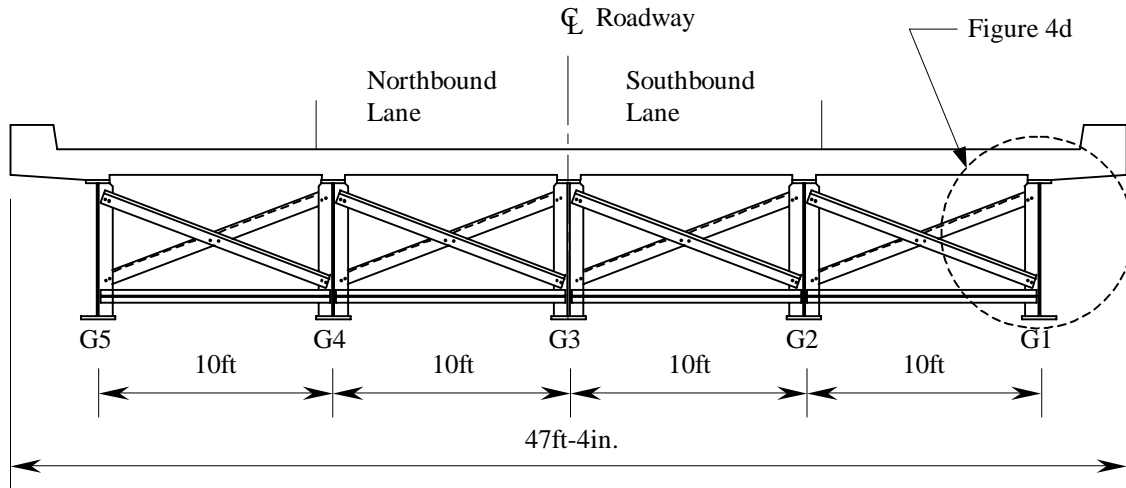
c. Cross section of bridge 4048.2S017.

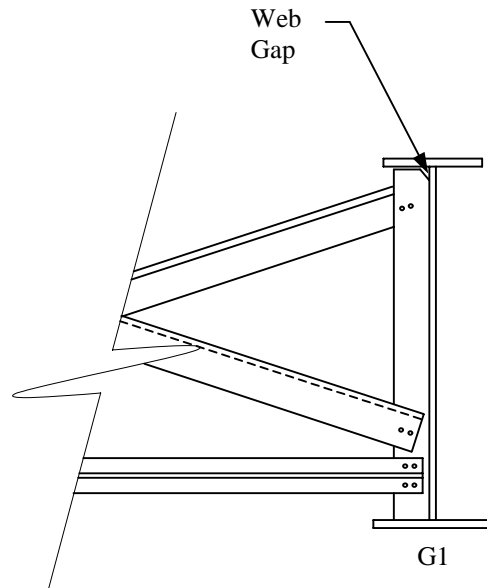
Figure 4: Bridge 4048.2S017 layout.

d. Diaphragm connection with web gap at stiffener clip on bridge 4048.2S017.

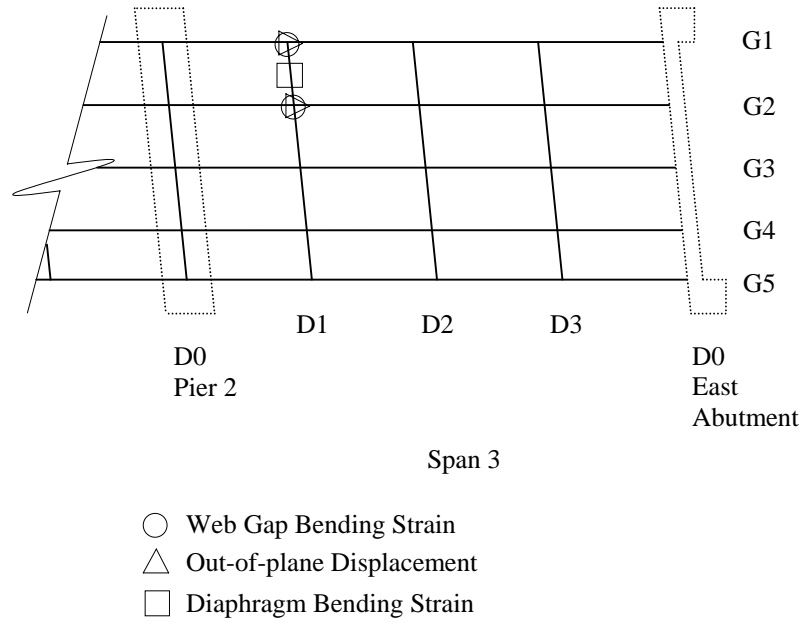
Figure 5: Typical plan view of gage placement (bridge 5075.5R080 shown).

Instrumentation locations on the I-beam Diaphragm Bridge are shown in Fig. 5. Bondable 120-Ohm gradient strain gages were used to measure strain distribution in the web gap, which were important in determining the effectiveness of the diaphragm connection retrofit. The gradient gages consisted of three to five small foil backed strain gages factory assembled in a very small unit. They were mounted in, or as close to, the web gap as possible as seen in Fig. 6a.

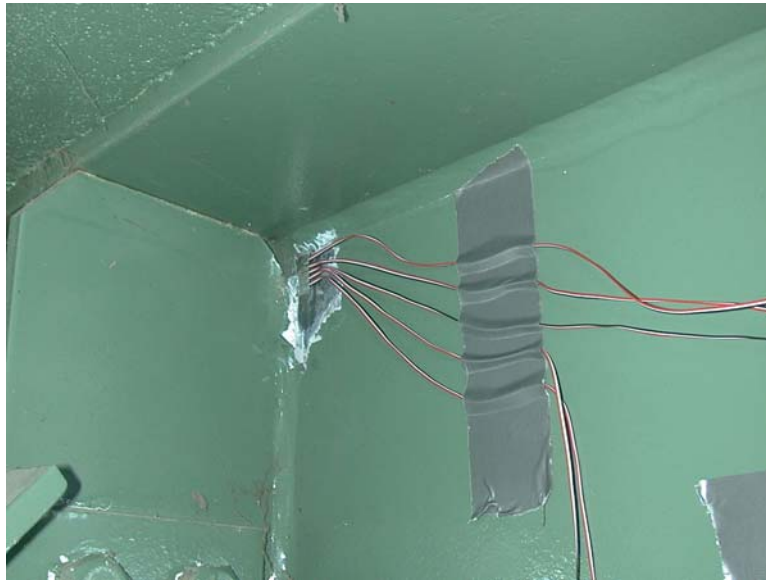
a. Typical web gap gradient instrumentation (bridge 5075.5R080 shown).

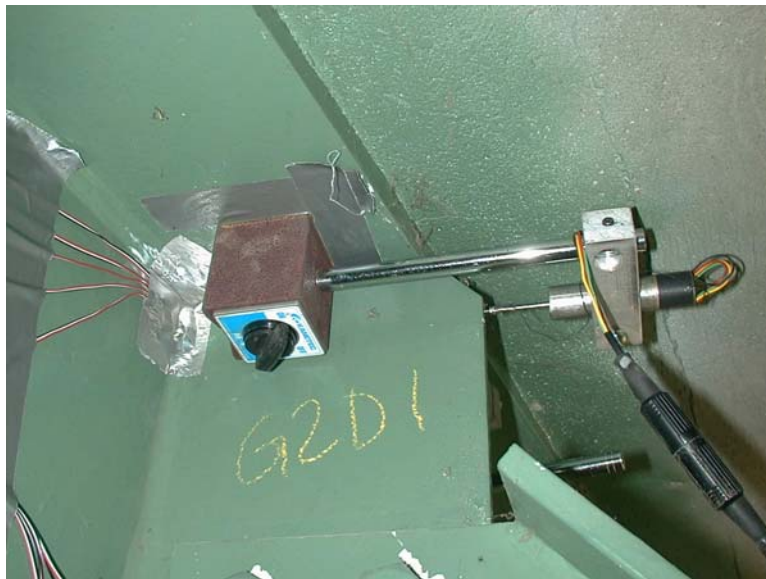
Figure 6: Typical instrumentation (cont.).

b. Typical out-of-plane displacement instrumentation (bridge 5075.5R080 shown).

Direct Current Displacement Transducers (DCDT's) were used to measure displacement of the web gaps. They were attached by magnetic stands to the girder webs and flanges at the connections with the diaphragm as shown in Fig. 6b. The interior and exterior girders each had a DCDT for out-of-plane displacement measurement. The gage measured out-of-plane displacement of the web by measuring the horizontal displacement of the web stiffener relative to the top flange.

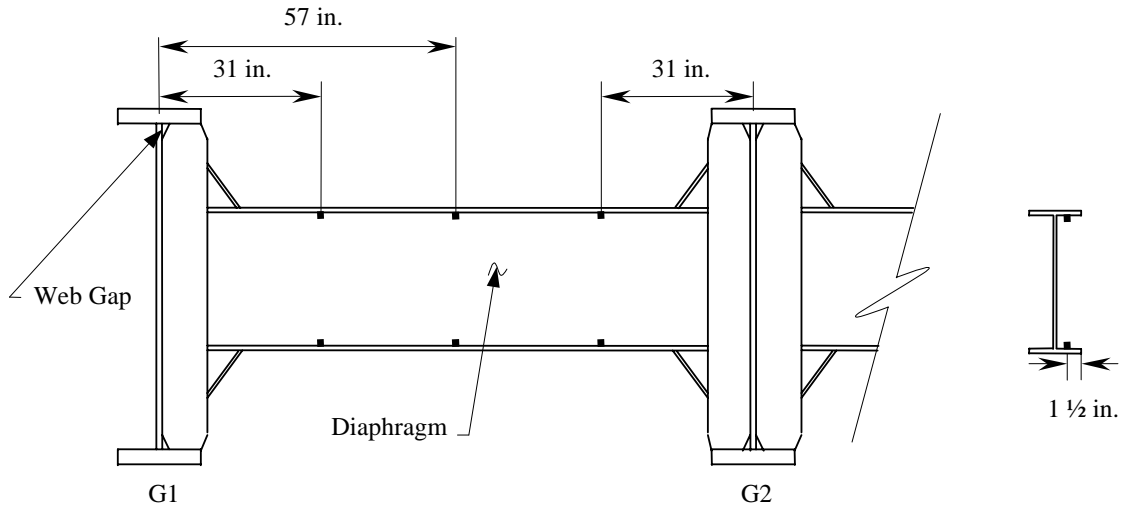
Figure 6: Typical instrumentation.

c. Typical diaphragm strain instrumentation looking east and south (bridge 5075.5R080 shown).

Gages were placed at the mid and quarter points of the diaphragm between the exterior and interior girder on the top and bottom flanges as shown in Fig. 6c to measure the change in force due to the retrofit for the X-type Diaphragm Bridge, which had X-type diaphragms. A gage was placed at the quarter point of each of the three diaphragm members.

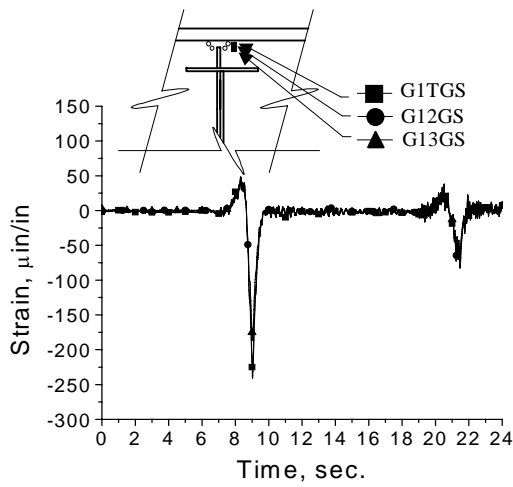
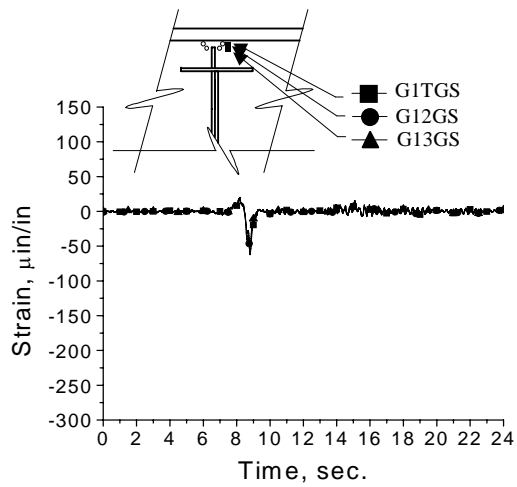
All bolts tight.

All bolts loose.

a. Exterior girder gradient strain plots (bridge 5075.5R080).

Typical web gap strains in the I-beam Diaphragm Bridge for both the tight and loose bolt conditions are shown in Fig. 7a. A strain reduction of approximately 80 percent occurred due to bolt loosening. It should be pointed out that the strain of the web gap on this bridge could not be measured directly in the web gap due to the presence of fatigue cracks and two drilled hole retrofits. The gages were positioned to the side of the gap away from the holes. As a result, the strains measured are smaller than they would be otherwise. Figure 7b depicts the out-of-plane displacement of the web gap on the I-beam Diaphragm Bridge with the bolts tight and loose. A similar reduction of approximately 75 percent occurs when loading is in the lane above the diaphragm. The bending strain in the diaphragm is shown in Fig. 7c. The strain in the diaphragm reduces almost completely when the bolts are loose. This suggests that the forces created in the diaphragm due to differential deflection are released by the retrofit. Figure 8a shows the web gap strains for the Channel Diaphragm Bridge. Web gap strain reduction with the bolts loose is over 80 percent. The out-of-plane displacement of the web gap with the bolts tight and loose is shown in Fig. 8b and was reduced by nearly 80 percent with the bolts loose. The web gap strain and the out-of-plane displacement appear closely linked, as expected. Strain reductions in the channel diaphragm are plotted in Fig. 8c. The strain in this diaphragm is nearly eliminated, as was the case with the I-beam, again suggesting the forces in the diaphragm are removed.

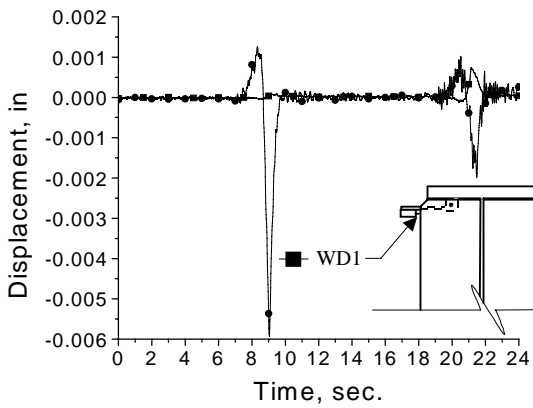
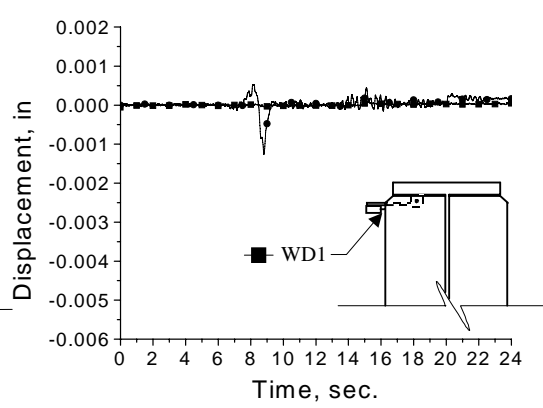
Figure 7: Bridge 5075.5R080 test results (cont.).

All bolts tight.

All bolts loose.

b. Out-of-plane displacement plots (bridge 5075.5R080).

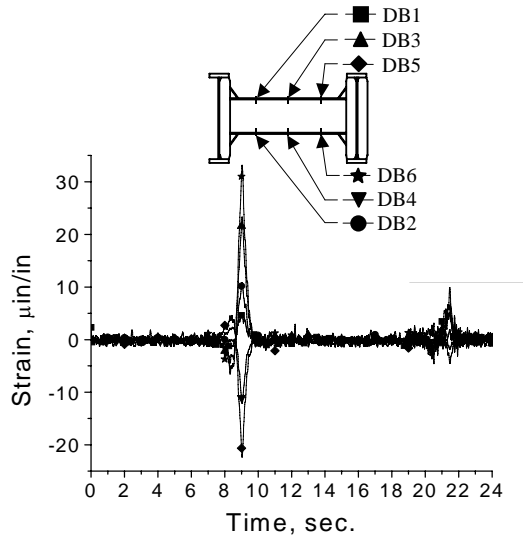
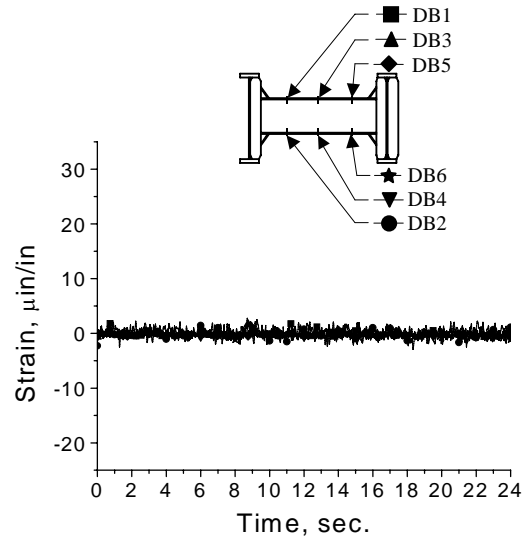
Figure 7: Bridge 5075.5R080 test results.

All bolts tight.

All bolts loose.

c. Diaphragm bending strain plots (bridge 5075.5R080).

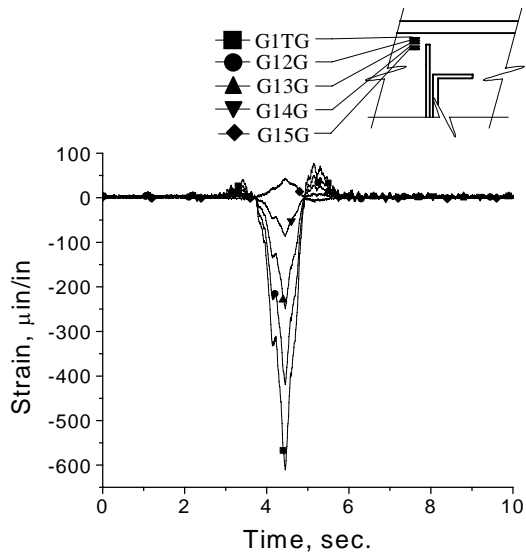
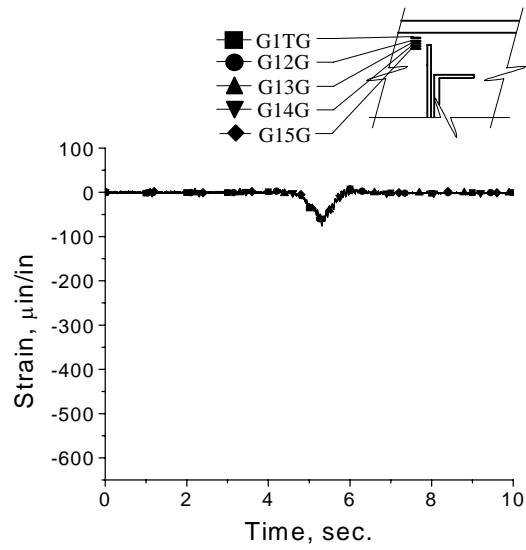
All bolts tight.

All bolts loose.

a. Exterior girder gradient strain plots (bridge 2700.0R035).

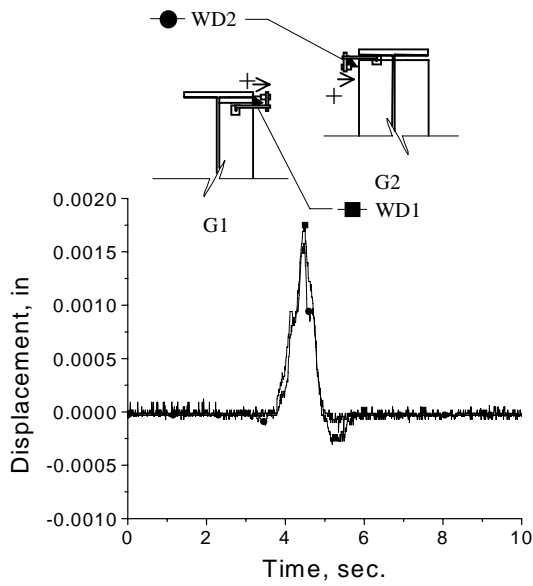
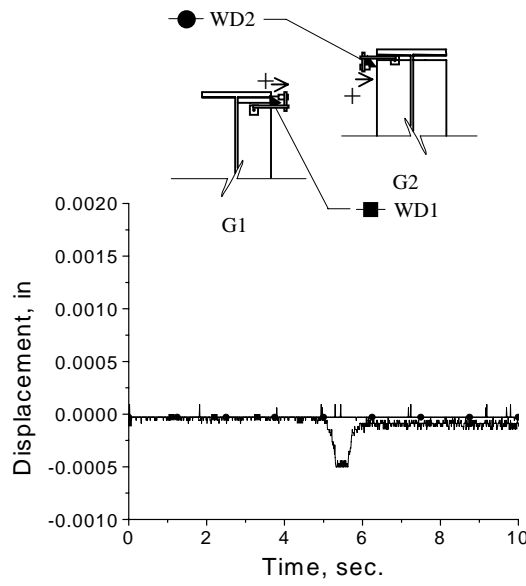
Figure 8: Bridge 2700.0R035 test results (cont.).

All bolts tight.

All bolts loose.

b. Out-of-plane displacement plots (bridge 2700.0R035).

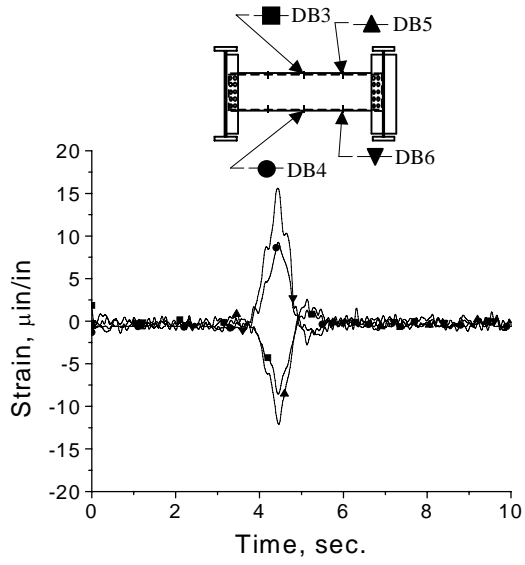
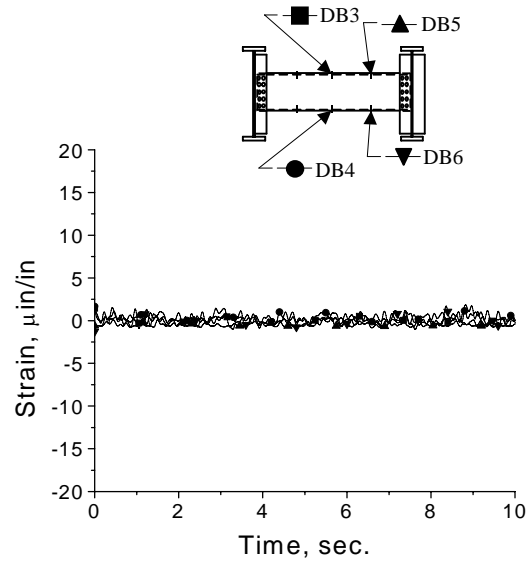
Figure 8: Bridge 2700.0R035 test results.

All bolts tight.

All bolts loose.

c. Diaphragm bending strain plots (bridge 2700.0R035).

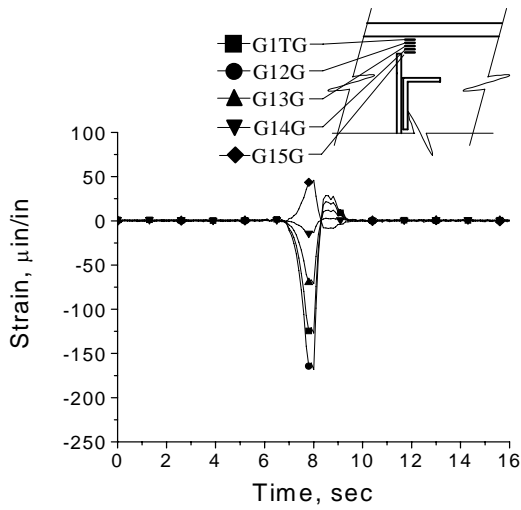
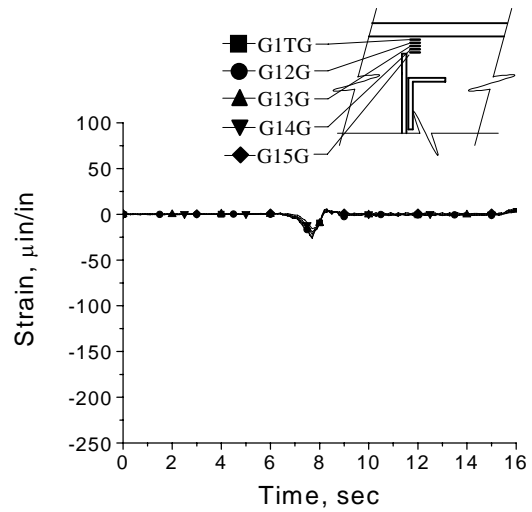
All bolts tight.

All bolts loose.

a. Exterior girder gradient strain plots (bridge 4048.2S017).

Web gap strains of the X-type Diaphragm Bridge are plotted in Fig. 9a. The strain reduction due to the retrofit in this bridge is approximately 80 percent. As before, Fig. 9b shows the out-of-plane displacements in the web gap with the bolts in both conditions. The displacement reduced nearly 70 percent with the bolts loose. It should be noted that, due to inaccessibility, the bolts in the exterior side of the horizontal member were not loosened and the results may be somewhat effected, as suggested by Fig. 9c. The strain in the diaphragm members were not completely eliminated when the bolts are loose, possibly due to the bolted horizontal member; however, the reduction is nearly 100 percent and still shows the effectiveness of the bolt loosening.

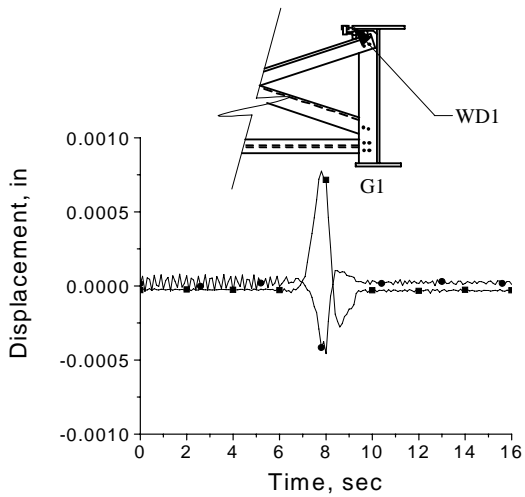
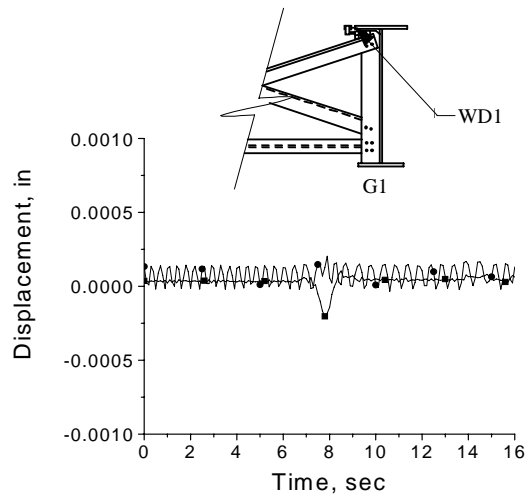
Figure 9: Bridge 4048.2S017 test results (cont.).

All bolts tight.

All bolts loose.

b. Out-of-plane displacement plots (bridge 4048.2S017).

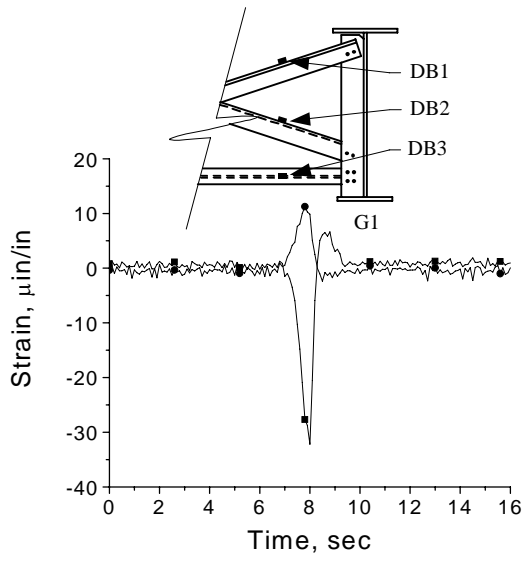
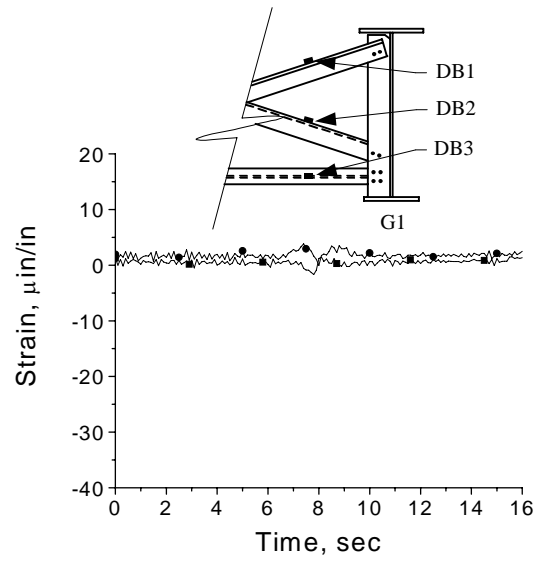
All bolts tight.

All bolts loose.

c. Diaphragm bending strain plots (bridge 4048.2S017).

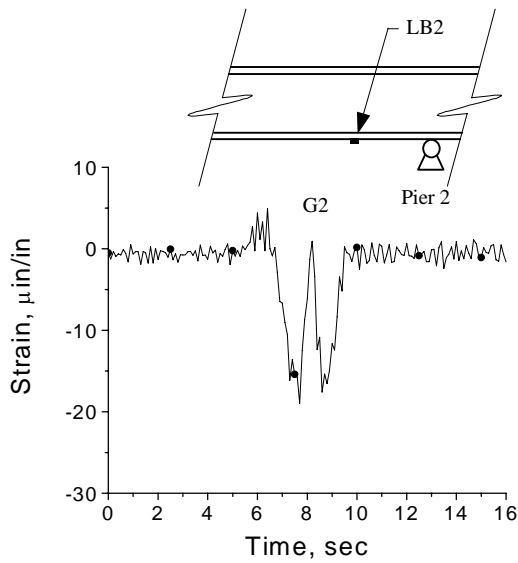
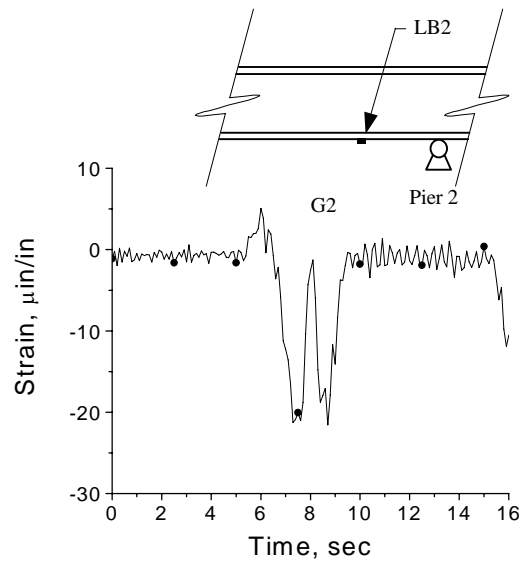
Figure 9: Bridge 4048.2S017 test results.

All bolts tight.

All bolts loose.

d. Longitudinal girder strain plots (bridge 4048.2S017).

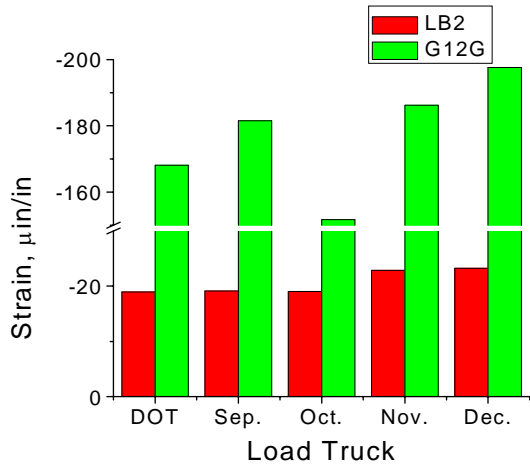
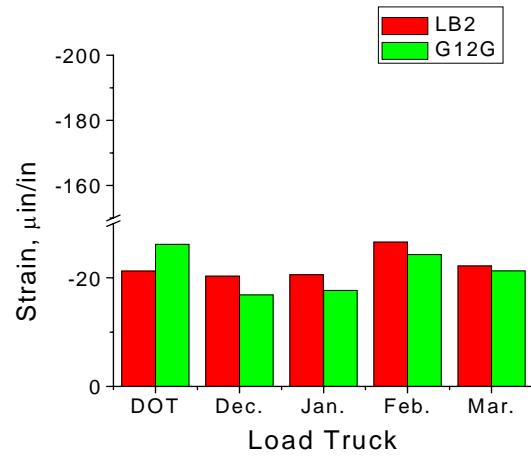
All bolts tight.

All bolts loose.

Figure 10: Maximum exterior web gap (G12G) strains and longitudinal girder strains for individual truck loadings on bridge 4048.2S017.

A sample of trucks similar in loading to the DOT trucks versus maximum web gap strain is shown in Fig. 10, one typical truck from each month of testing. The maximum web gap strains with the bolts in each position are similar enough to develop a trend in strain that appears unaffected by time.
