Construction, Monitoring and Evaluation of a Pedestrian Arch Bridge with a Precast Deck System

ABSTRACT

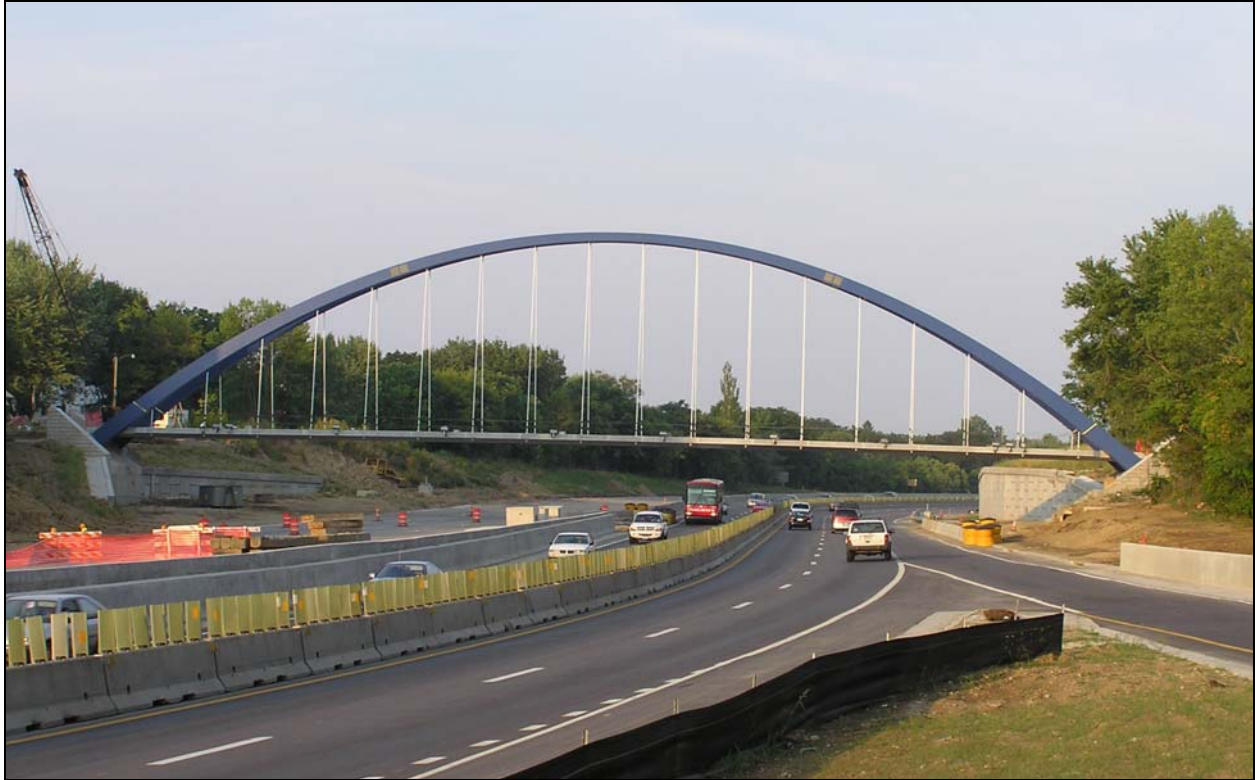
FIGURE 1 40th Street Pedestrian Bridge over I-235 – Des Moines, IA.

a) Overall view of bridge looking east

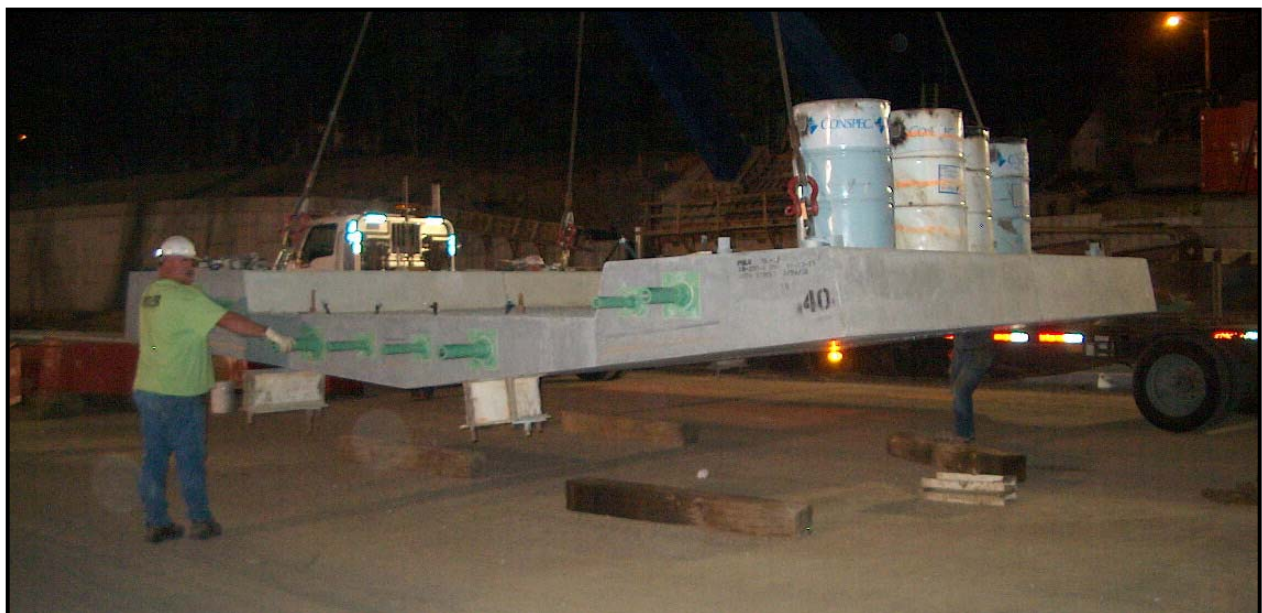
b) Sand-filled barrels were used as ballast during the erection of 40th Street Bridge panels

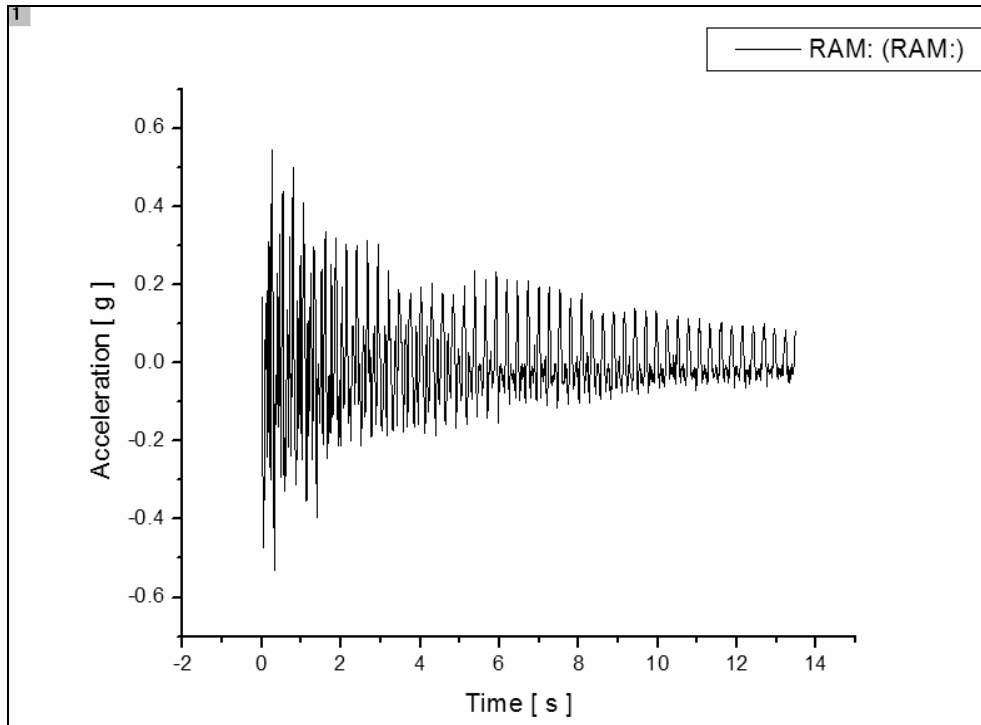
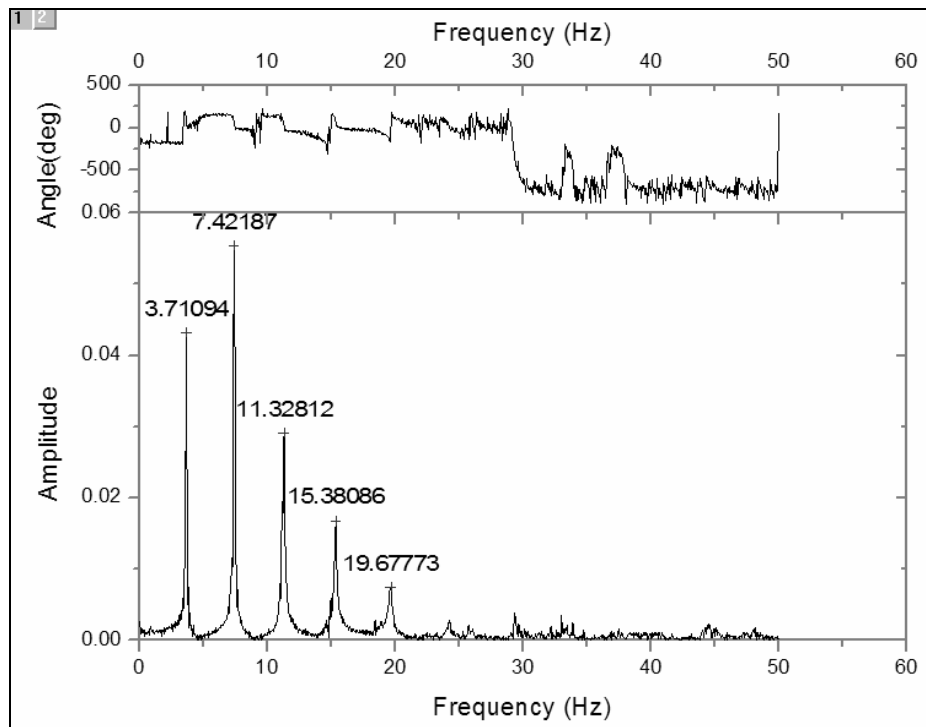
FIGURE 3 Measured and processed vibration data for Hanger 2'W of the 40th Street Bridge.

a) Real time vibration record

b) FFT Results

After placing an accelerometer, the initial values were balanced to allow for stabilization of the sensor. The acceleration record for each hanger was collected by manually exciting the hanger using a suddenly applied, horizontal force approximately 4 ft above deck level. The external force was applied perpendicular to the bridge centerline. Data were collected for a period of approximately 10 sec. from which free vibration records were utilized for data processing. The test was repeated at least two times per hanger to verify the reproducibility of the data. Commercial software was used for processing the free vibration data and to obtain the natural frequencies as illustrated typically in Figure 3.

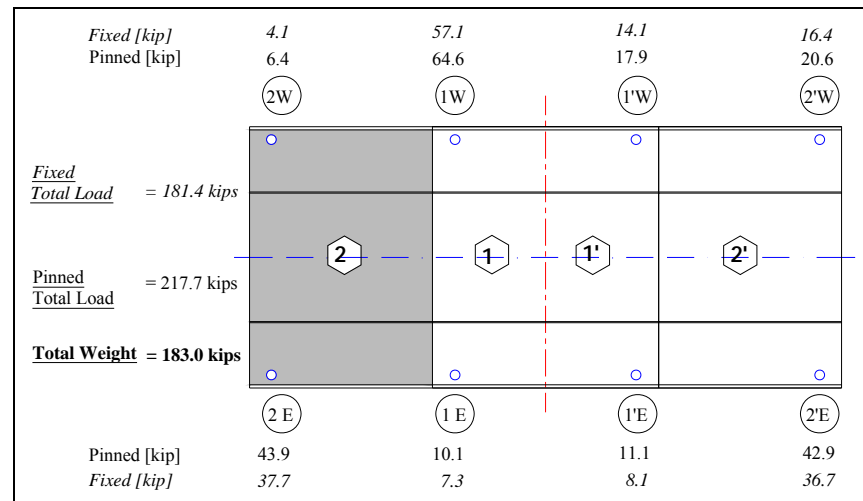
FIGURE 4 Schematic view of hanger forces calculated using free vibration method

c) Stage 3

Figure 4 presents calculated hanger forces for Construction Stages 1, 2 and 3. The data include force calculation for two member end boundary condition assumptions: 1) complete rotational fixity at both ends (fixed) and 2) no rotational fixity at both ends (pinned). A brief discussion of the data for each stage is described below.

Stage 3 After placement of the Stage 3 deck panel, the estimated dead load was approximately 183.0 kips. In comparison, the calculated forces for the six hangers was 181.4 kips and 217.7 kips, respectively, for the fixed and pinned conditions. It is interesting to note that hanger 2W (one of the newly placed hangers) was very lightly loaded compared to expectations (4.0 kips for the fixed condition). In contrast, hanger 2'E carried 36.7 kips for the fixed condition. There was a considerable non-uniform redistribution of hanger forces throughout the three panels at the end of the Stage 3 construction, with significant hanger force unbalances noted at several panel point pairs (e.g. 1W and 1E, and 2'W and 2'E) (Figure 4c).

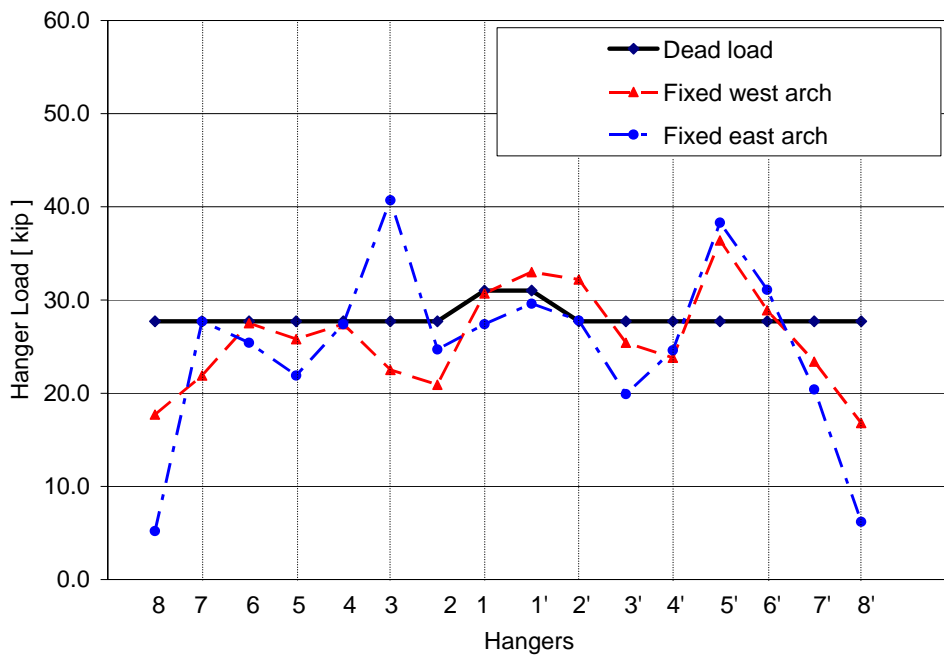
FIGURE 5 Hanger forces for both arches of the 40th Street Bridge after adjustment.

Figure 5 shows a plot of the hanger forces for both of the arches to illustrate the redistribution of the hanger forces after adjustment. The calculated approximate panel dead load values are also shown for comparison. As noted the adjustments eliminated the outliers relative to the design values and improved the overall distribution of the forces.

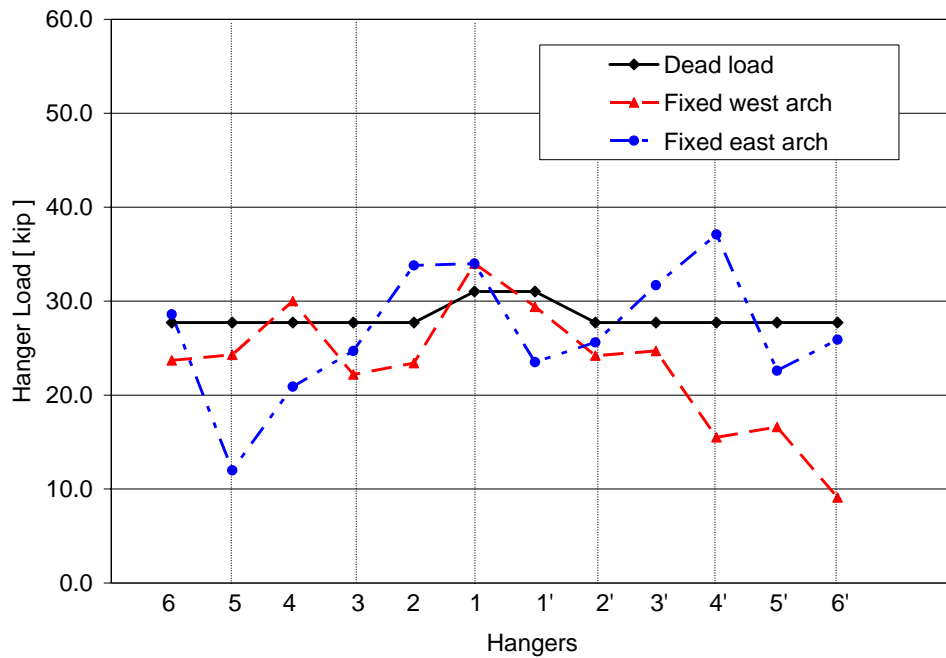
FIGURE 6 Hanger forces for both arches of the 44th Street Bridge after adjustment.

Figure 8 shows a plot of the hanger forces for both of the arches to illustrate the redistribution of the hanger forces after adjustment. The calculated approximate panel dead load values for each hanger are also shown for comparison. As noted the adjustments eliminated the outliers relative to the design values and improved the overall distribution of the forces.

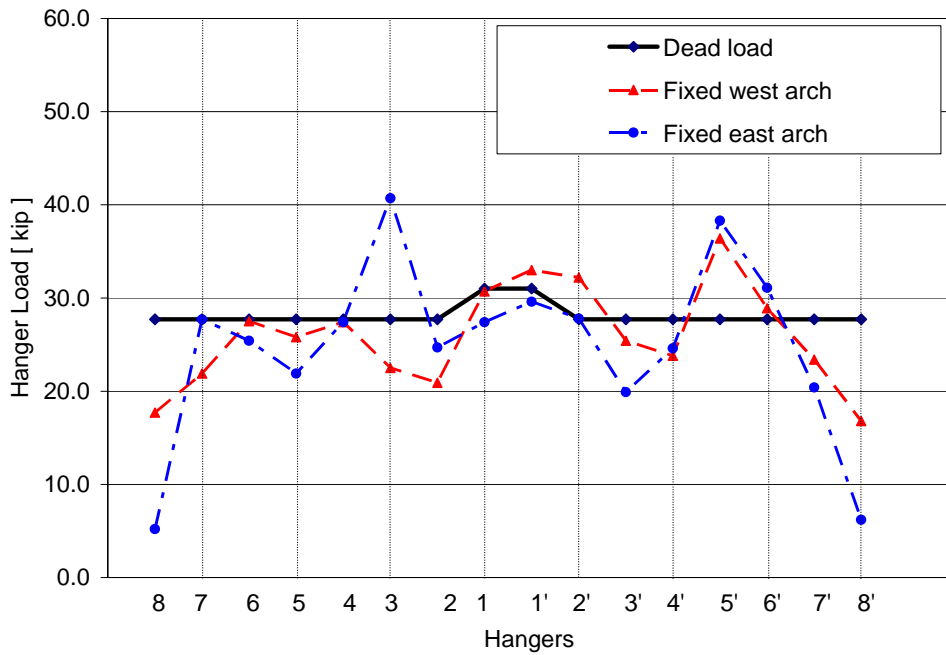
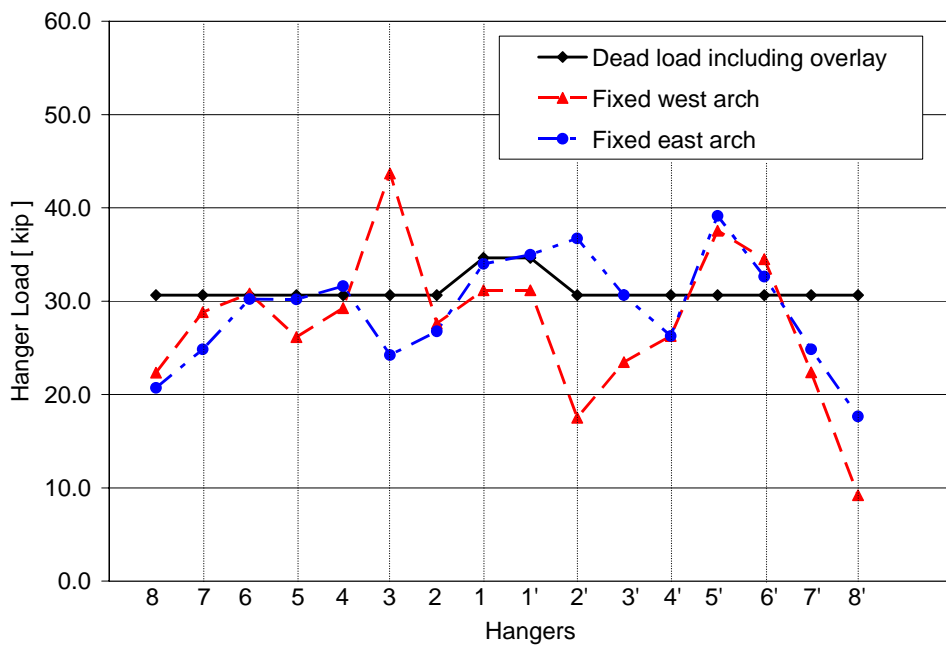
FIGURE 7 Hanger forces for both arches of 40th Street Bridge.

a) 2005 monitoring

b) 2006 monitoring

Figure 7 shows the hanger forces for the 2005 and 2006 monitoring on the 40th St. Bridge (2005 data have already been discussed in the paper). The calculated dead load forces for each hanger for both years are also shown. Observations noted from comparison of the 2006 data with the 2005 data include the following:

- The total dead load incremented at least 10% from 2005 to 2006 due to the deck overlay and security fence.
- For the 2006 data only a few hanger forces have exceeded the predicted dead load forces.
- The West Arch forces are more unevenly distributed than are the East Arch forces. Hangers 3W and 2'W changed significantly from 2005.

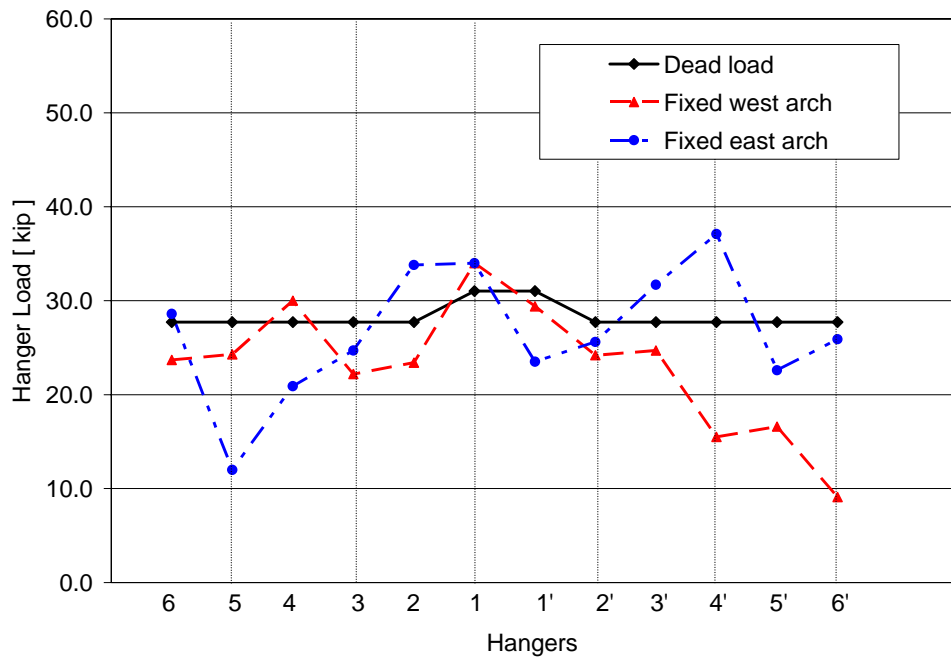
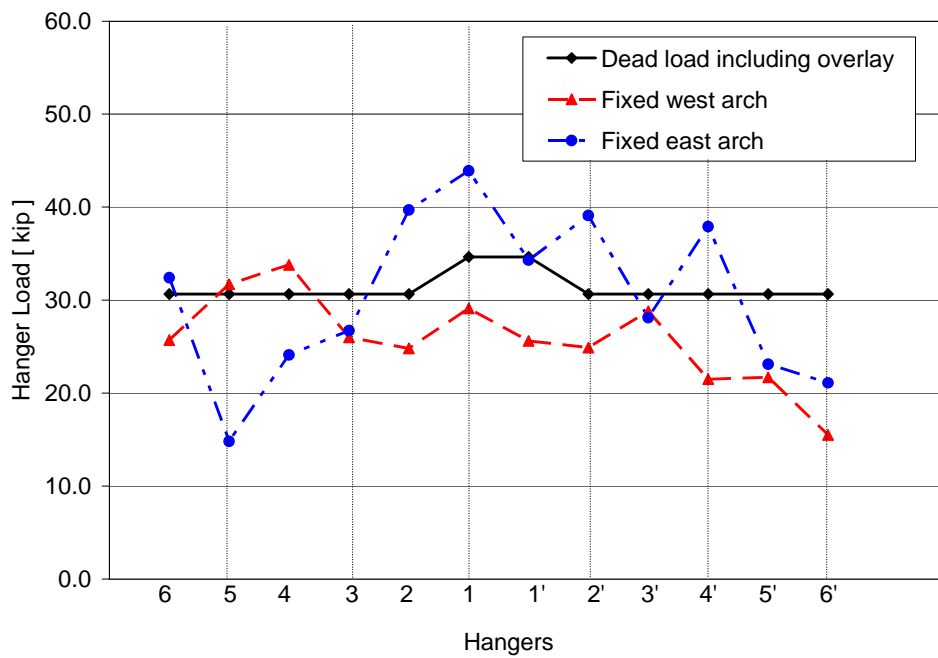
FIGURE 8 Hanger forces for both arches of 44th Street Bridge.

a) 2005 monitoring

b) 2006 monitoring

Figure 8 shows the hanger forces for the 2005 and 2006 monitoring on the 44th St. Bridge (2005 data have already been discussed in the paper). The calculated dead load forces for each hanger for both years are also shown. Observations noted from comparison of the 2006 data with the 2005 data include the following:

- The overall distribution of the hanger forces was much more uniform than for the 40th St. Bridge
- There were very moderate changes in the hanger forces during the one year of service.
