Monitoring of I-235 Pedestrian Bridges

**Presentation to
University
of Iowa
Civil
Engineering
Students**

September 29, 2005

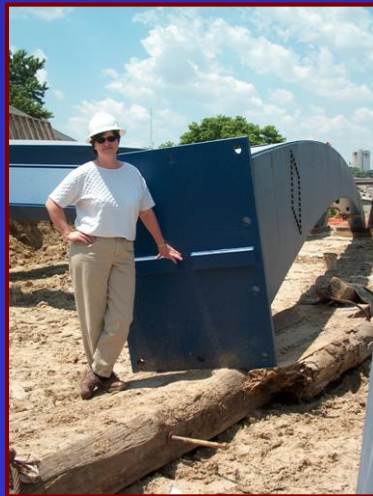
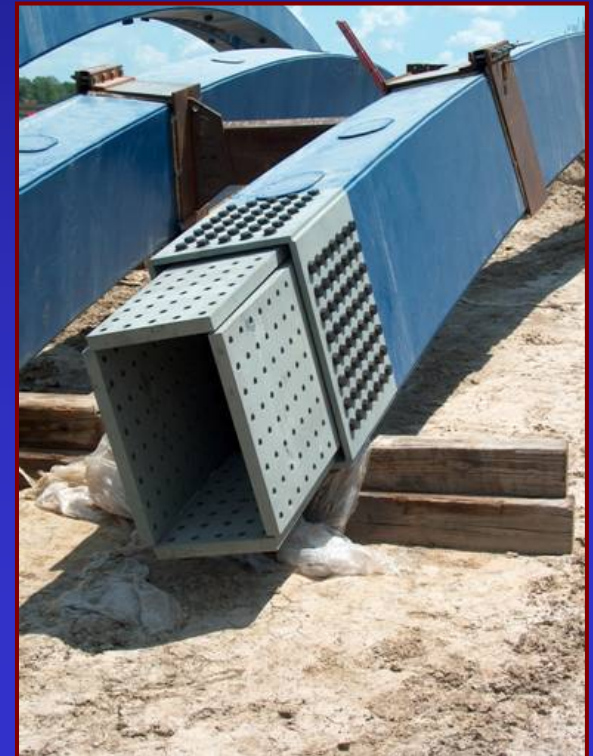
- Gateway to the City
- Spans ranging from 74 m to 80 m
- Drilled shafts and pile foundations
- Steel box arch ribs
 - ◆ 500 mm x 700 mm at crown
 - ◆ 750 mm x 1250 mm at base

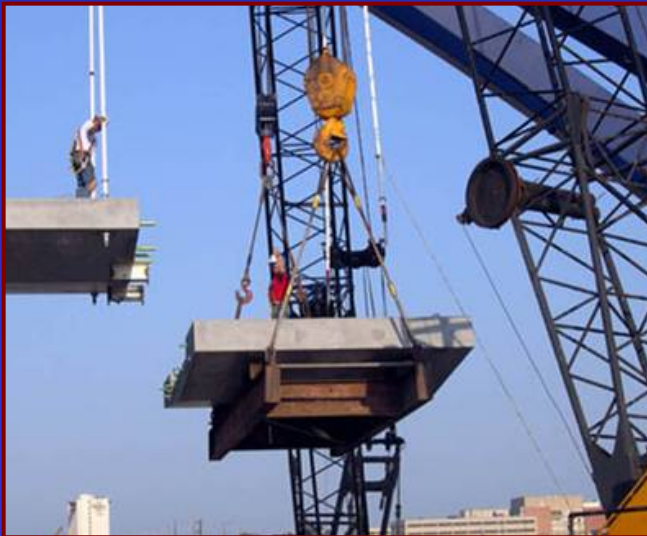
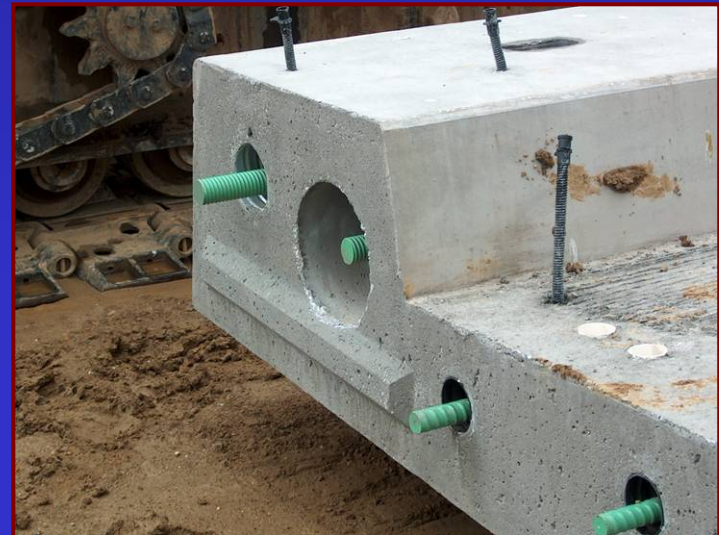
- Gateway to the City
- Spans ranging from 74 m to 80 m
- Drilled shafts and pile foundations
- Steel box arch ribs
- Precast/post-tensioned deck segments

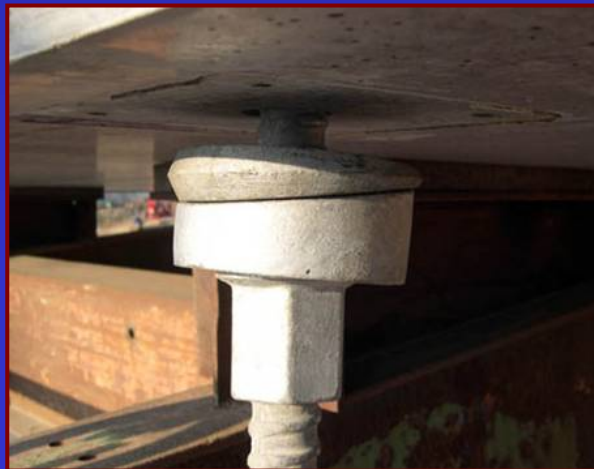
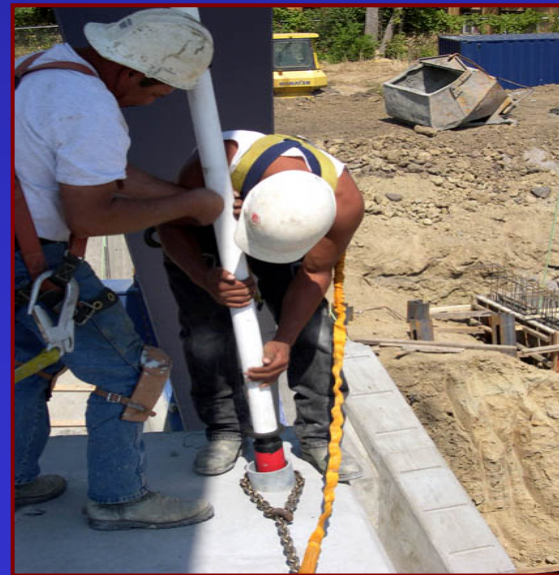
- Gateway to the City
- Spans ranging from 74 m to 80 m
- Drilled shafts and pile foundations
- Steel box arch ribs
- Precast/post-tensioned deck segments
- Dywidag hangers

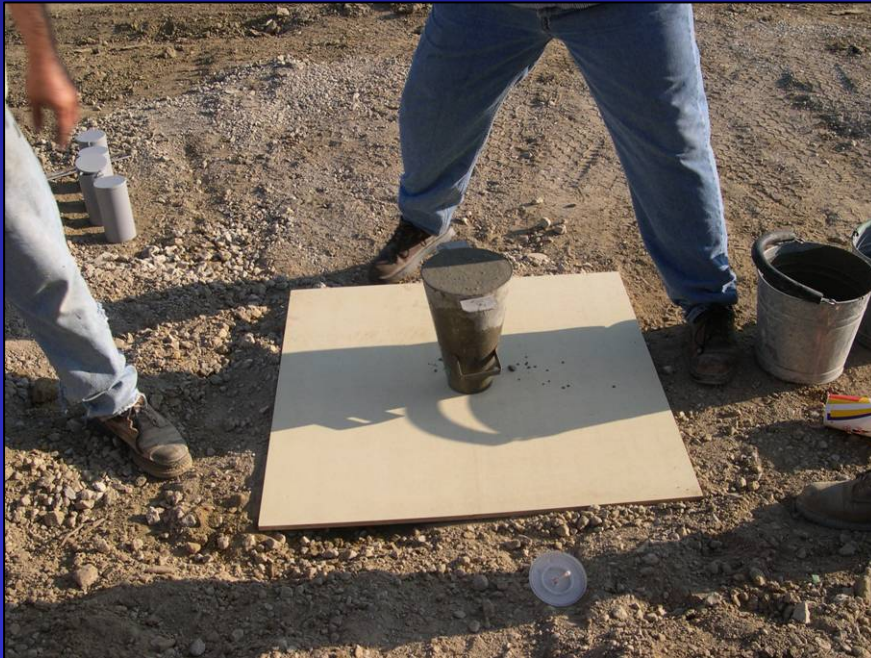
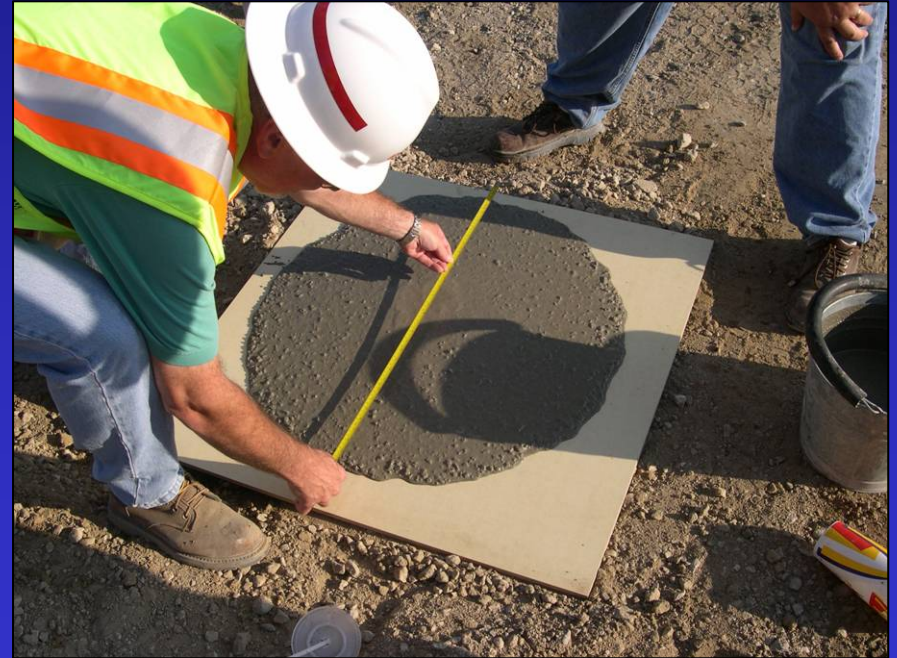
Self-Consolidating Concrete

- Admixtures provide temporary flowability
- Measure “spread” rather than “slump”

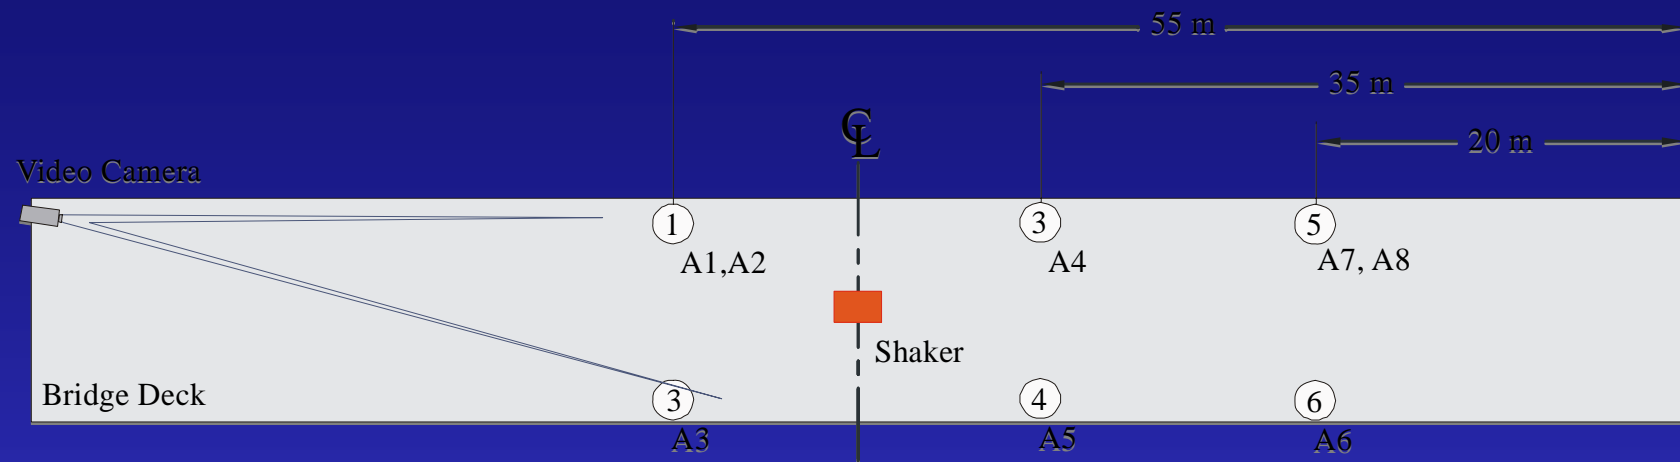
Field Testing of I-235 Pedestrian Bridge

A1, 3, 4, 5, 6, 7 - Vertical Accelerometers
A2&8 - Lateral Accelerometers

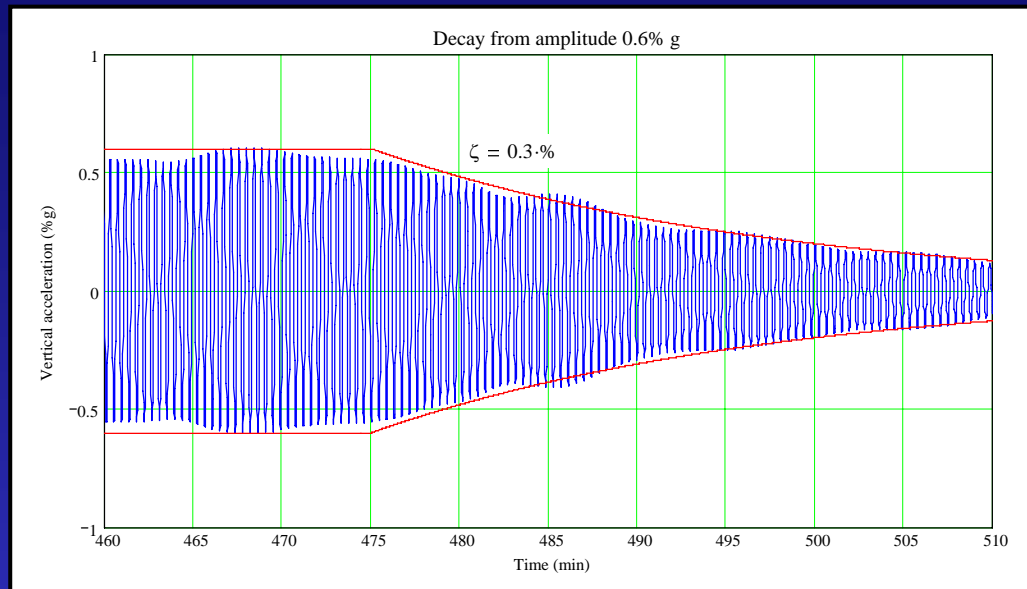
Identification of Structural Damping

Test 8
forced excitation at 2.344 Hz

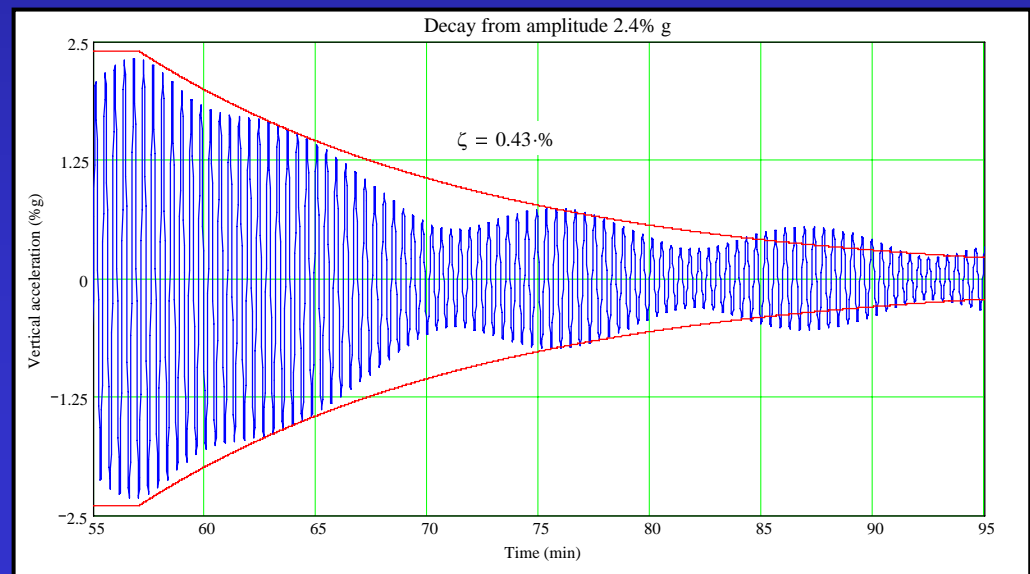
Test 26
forced excitation at 2.344 Hz
plus 5 jumping individuals

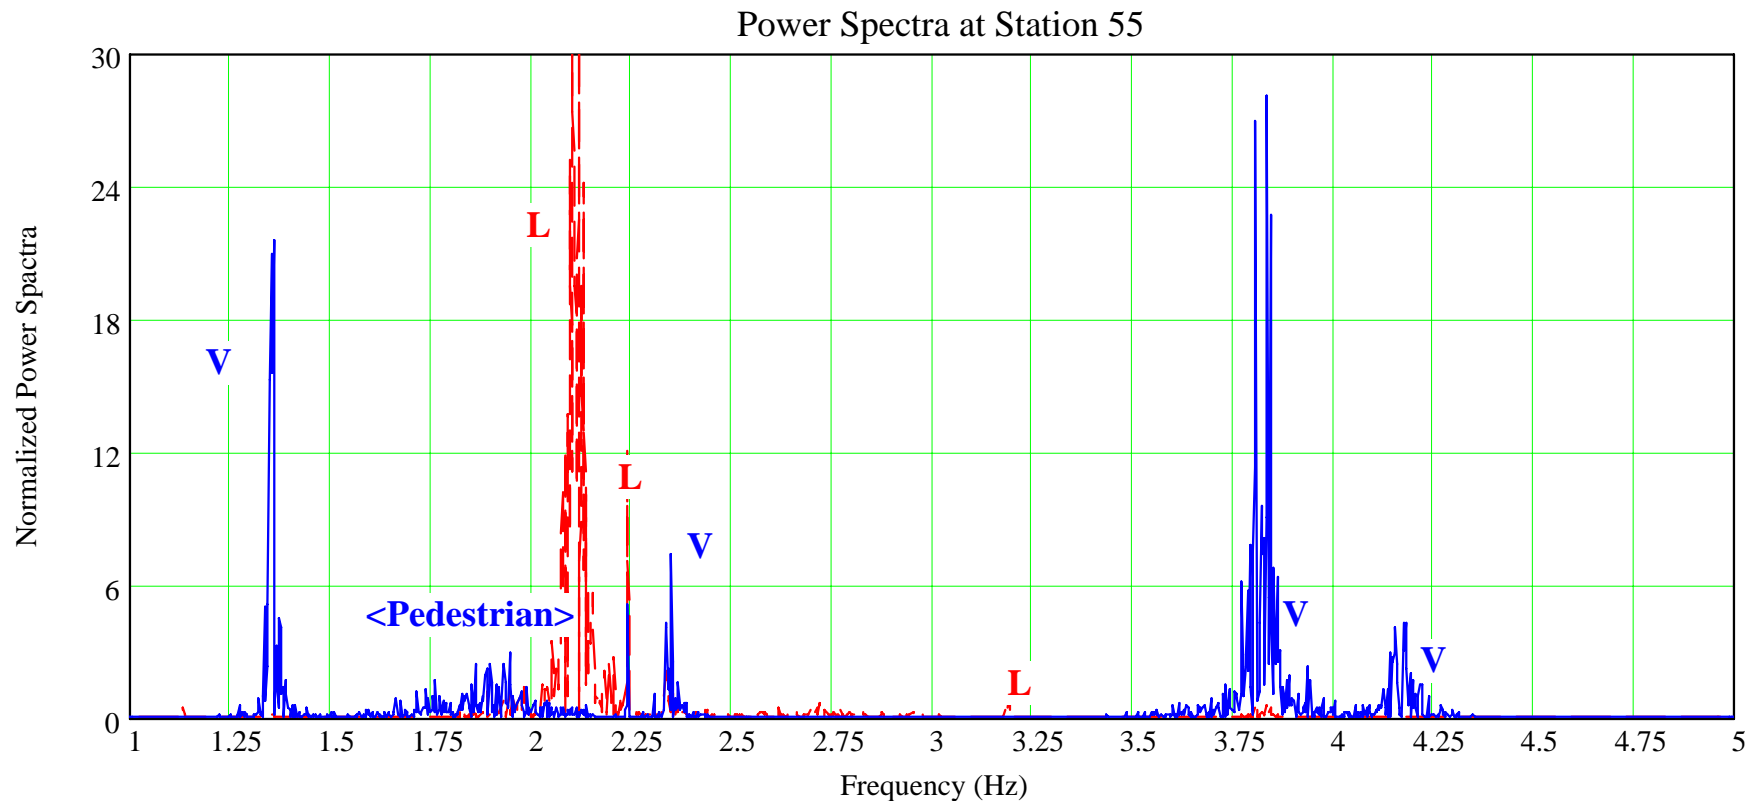
Identification of Modes

Power spectra from walking of 33 individuals
Test 35 - low pass filtered at 20 Hz

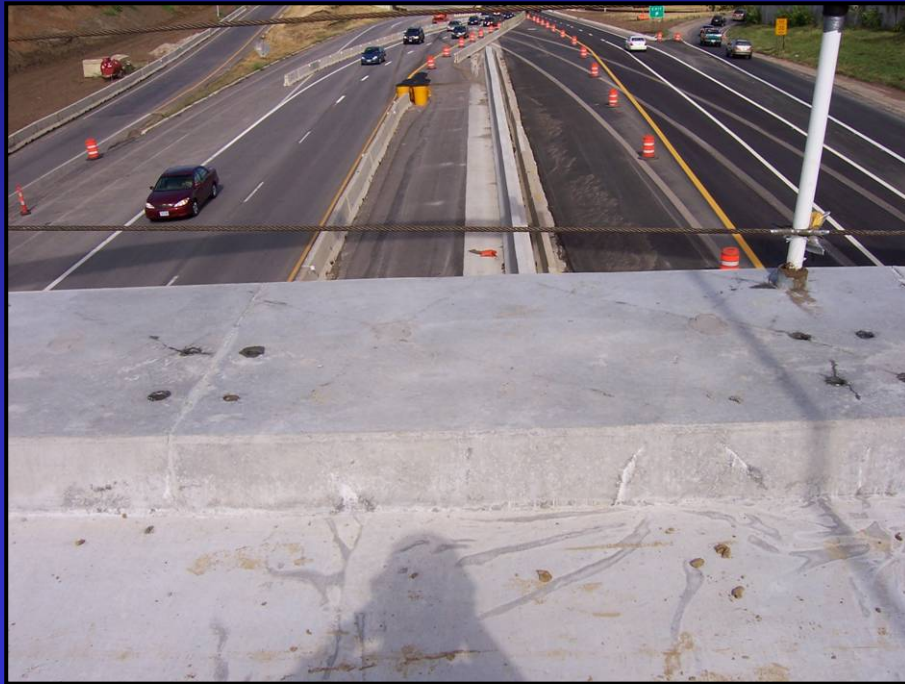
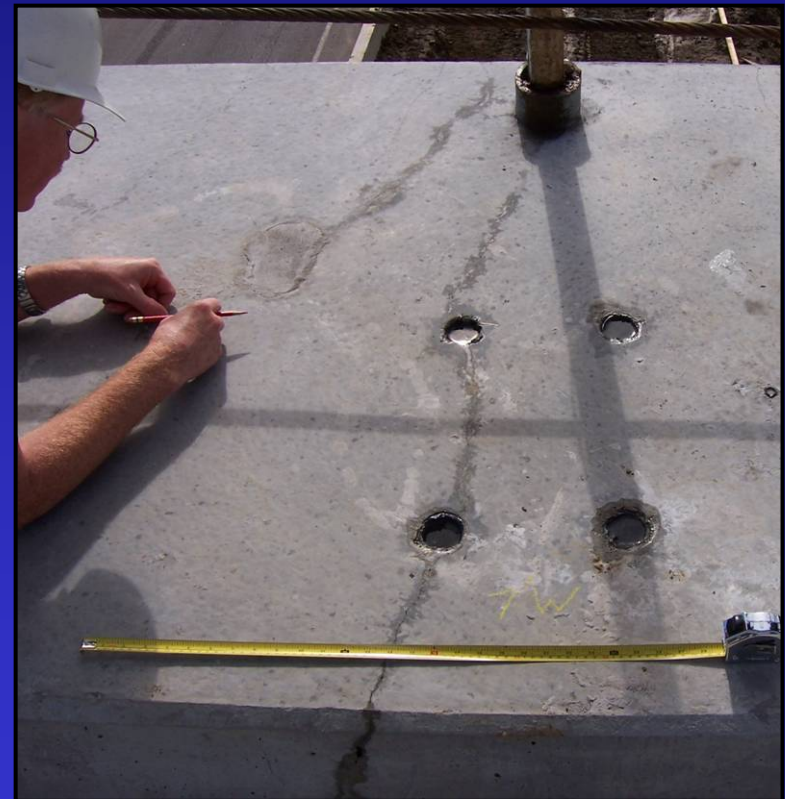
Concrete Panel Cracking

Minor cracking of panels occurred during 2003 construction

Unequal loading of hanger rods considered most likely cause of panel cracking

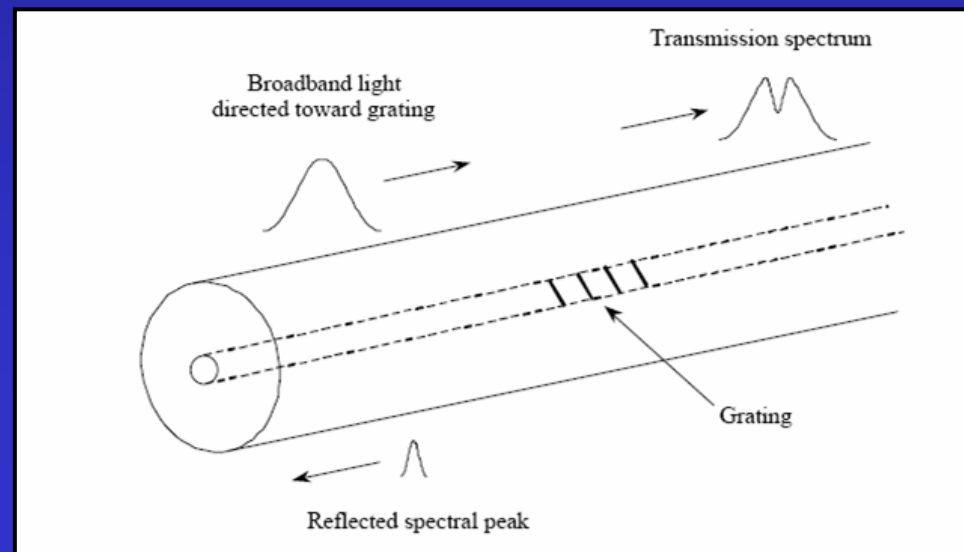
Fiber Bragg Gratings (FBG)

- Introduced 1995
- FBG reflects very narrow band of wavelengths – all others pass through
- Any change in strain/temperature causes proportional shift in reflected spectrum

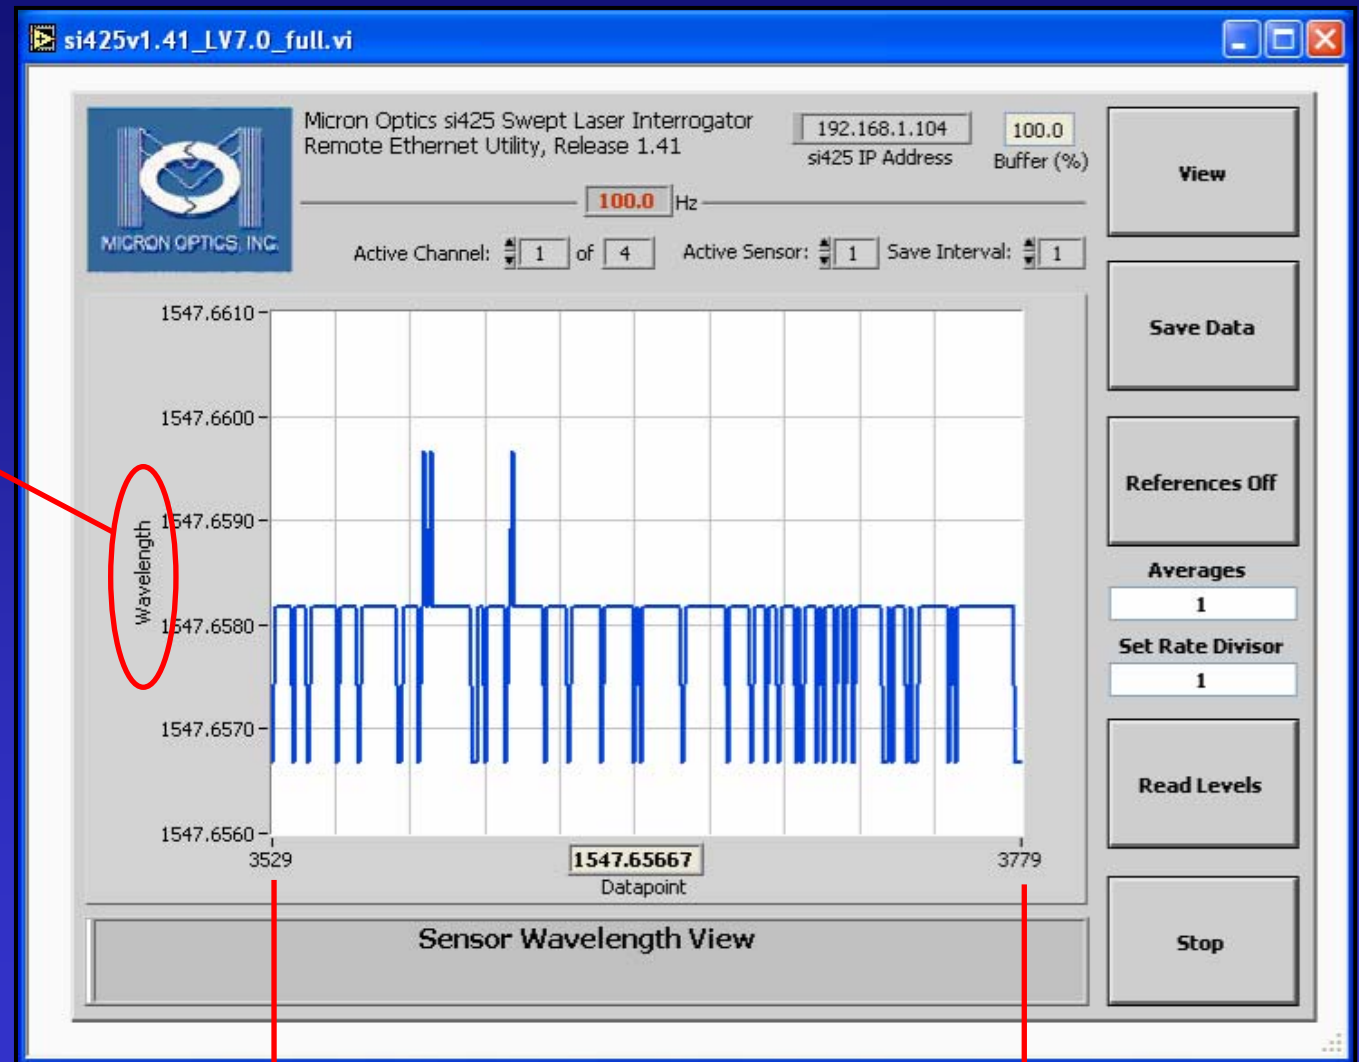
Fiber Optic Strain Sensor – data collected

Reflected
Wavelength

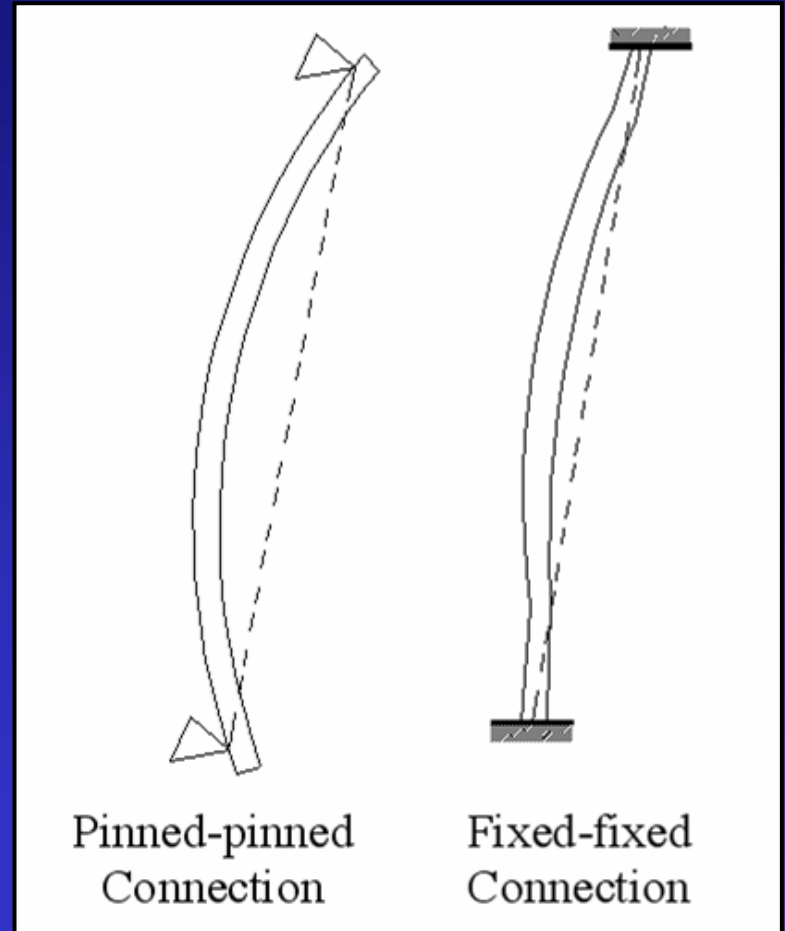
Natural frequencies for simple span beams, $\beta_1 L$:

- Pinned-pinned = 3.141
- Fixed-fixed = 4.730

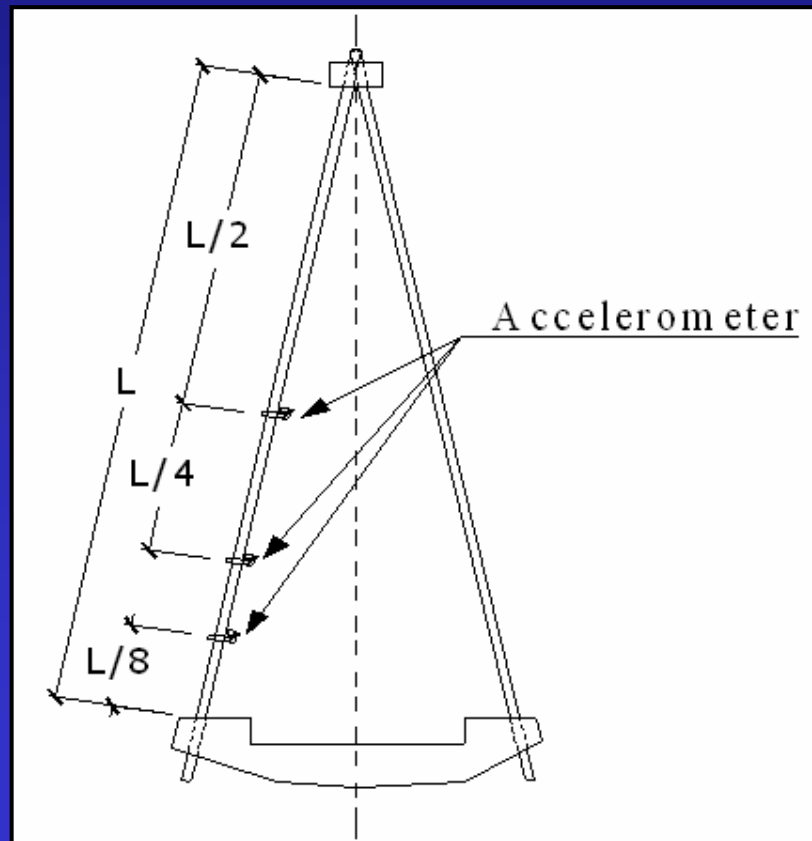
Vibration Testing of Hanger Rods

Initial testing included varying the position of the accelerometer to ensure identical ω_n measured

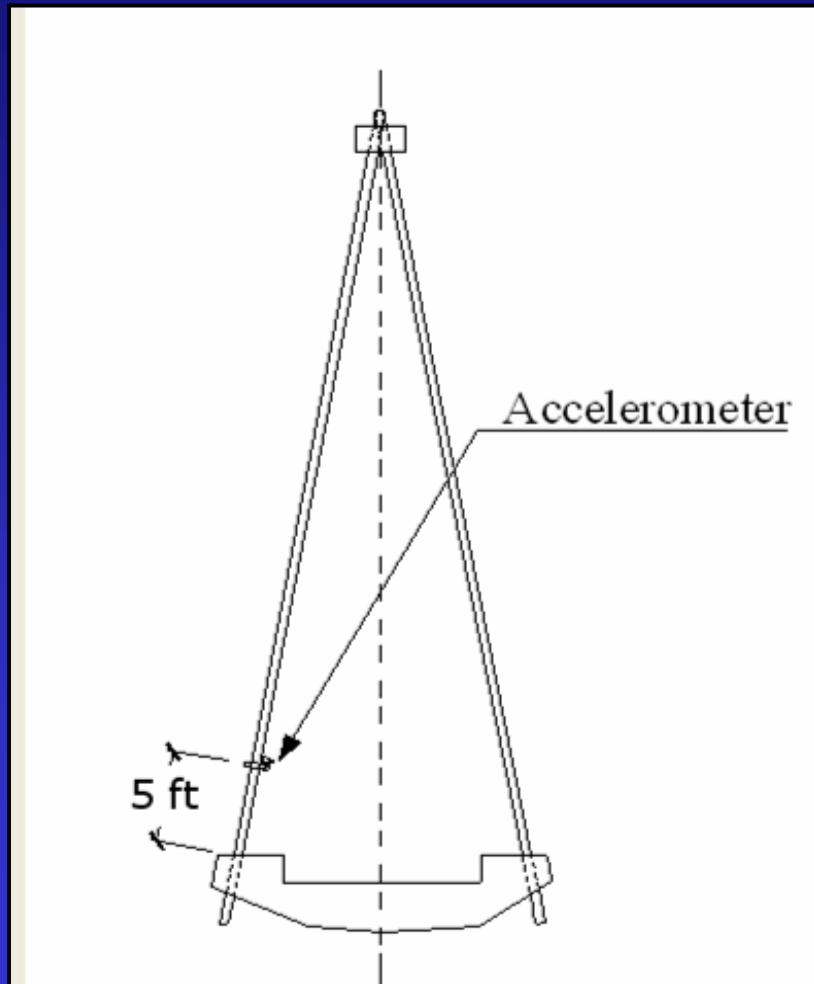
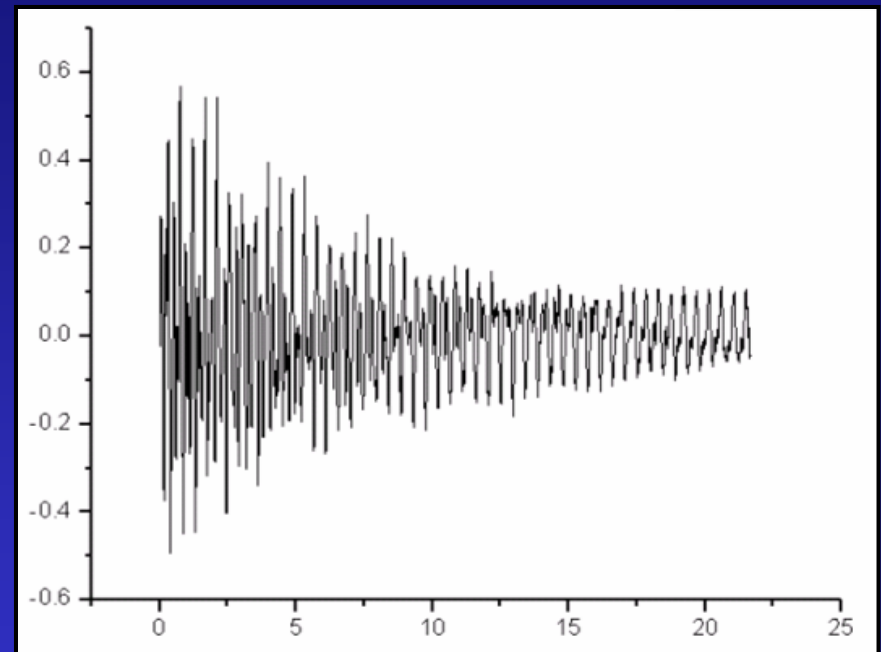
Free vibration of hanger rods

Each hanger excited
and allowed to vibrate
for 10-15 seconds

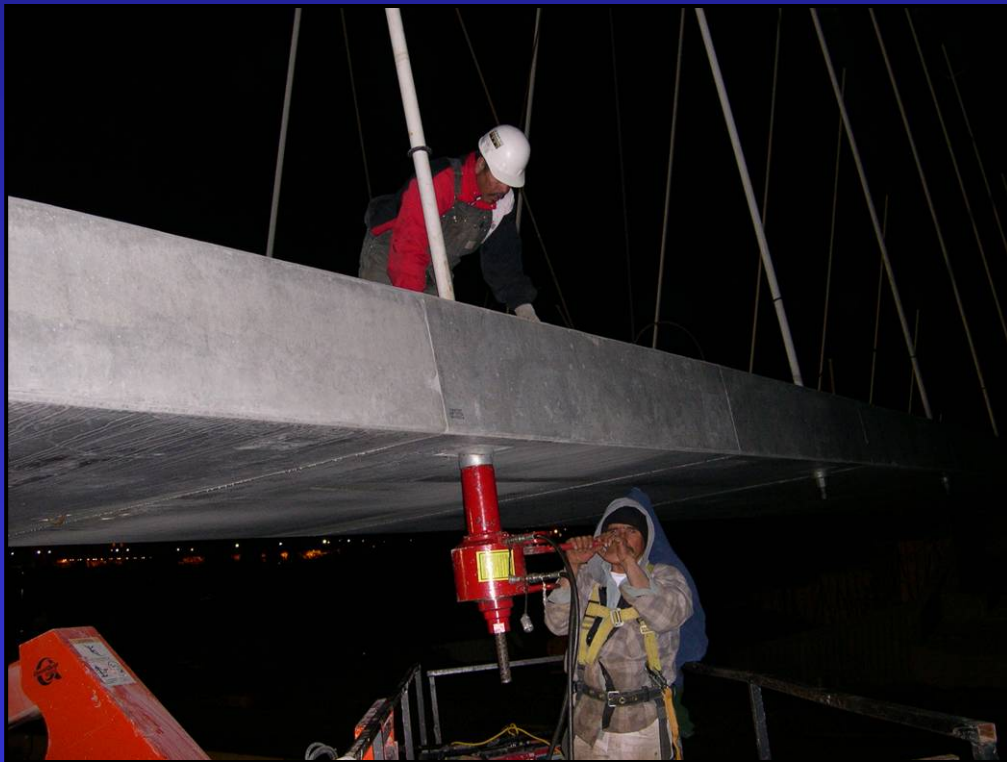
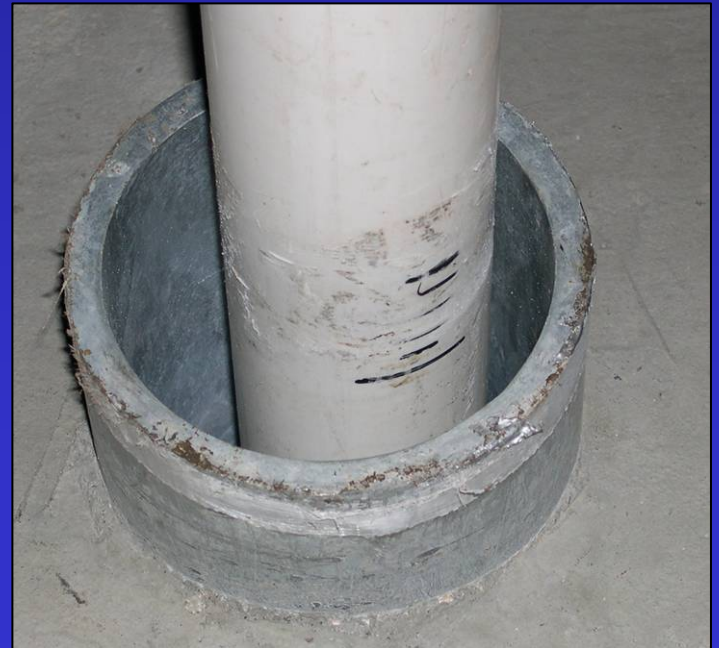
Adjustment of Hanger Loads

Recall that deck must be constructed to match the profile grade as precast

On the shortest hanger rods, a change in length of 1/8" changes force by approx. 40 kips
