# IMPACT OF DECK CRACKING ON DURABILITY

Sponsored by the Project Development Division  
of the Iowa Department of Transportation  
and the Iowa Highway Research Board  
Iowa DOT Project TR-405  
CTRE Management Project 97-5

MARCH 2000

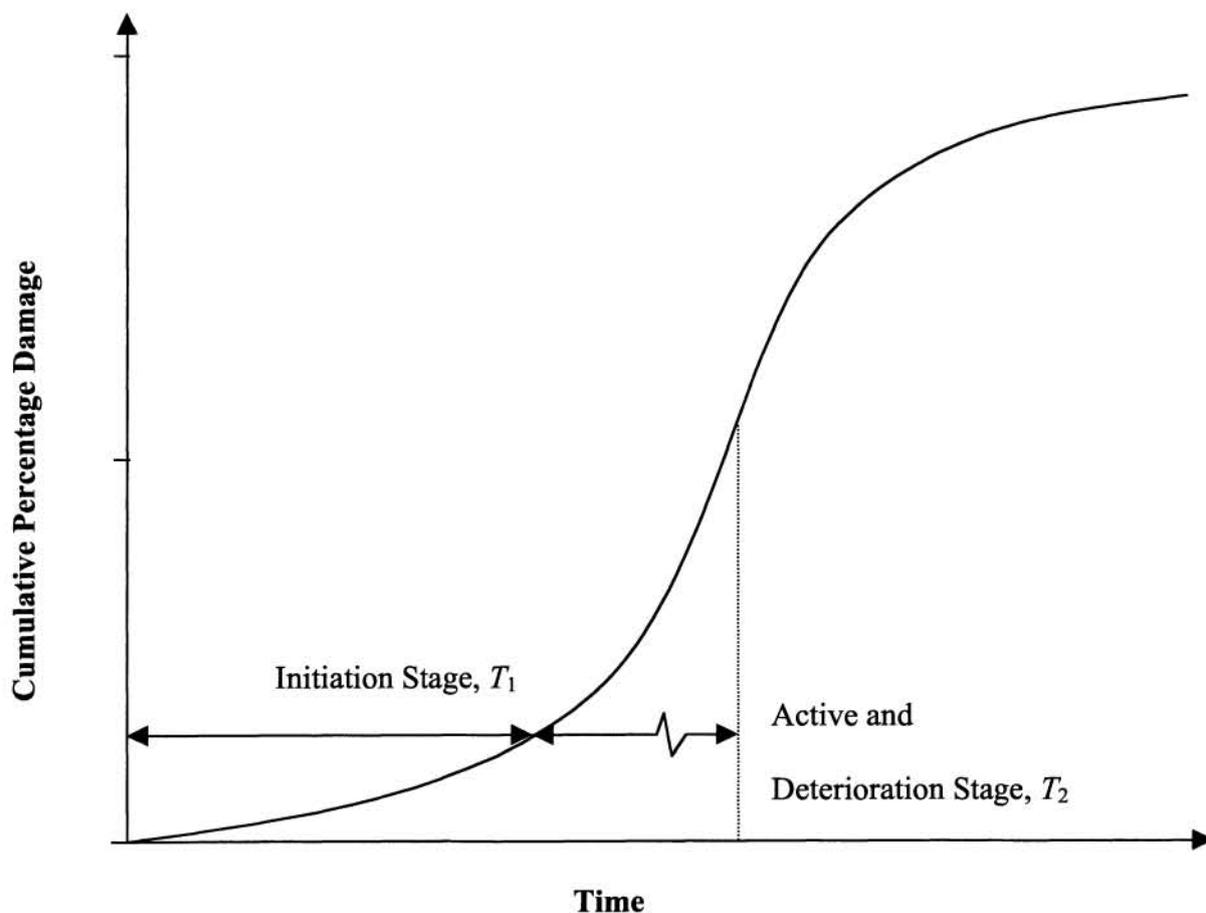
**FIGURE 2.1 General Deterioration Curve versus Time**

Corrosion of reinforcing steel in concrete can be modeled as a two-stage process. The first stage is known as the initiation or incubation period, in which chloride ions transport to the rebar level. In this stage the reinforcing steel experiences negligible corrosion. The time,  $T_1$ , required for the chloride concentration to reach the threshold value at the rebar level can be determined by the diffusion process of the chloride ion through concrete following Fick's Second Law (see section 2.6; 14). In the second stage, known as the active and deterioration stage, corrosion of reinforcing steel occurs and propagates, resulting in a noticeable change in reinforcing rebar volume that could induce cracking and spalling of the surrounding concrete. The length of the second stage,  $T_2$ , depends on how fast the corroded reinforcing rebars deteriorate resulting in an observable distress. Figure 2.1 illustrates an arithmetic plot of cumulative percent deterioration versus time based on the above model generated an S-shaped (ogive) curve (15). Although it is not an easy task to predict, once again, the length of the second stage, eventually a deck will reach a condition at which some types of maintenance activities must be taken.

The corrosion model discussed above was often used to assess corrosion of uncoated rebars (14). This concept was assumed herein to be applicable to estimate the service life of a bridge deck constructed using ECR. However, the corrosive threshold initiating corrosion of ECR and the length of the active and deterioration stage should be higher than those of uncoated steel bars. The determination of the length of these two stages is outlined in sections 4, 5, and 6 of this report.

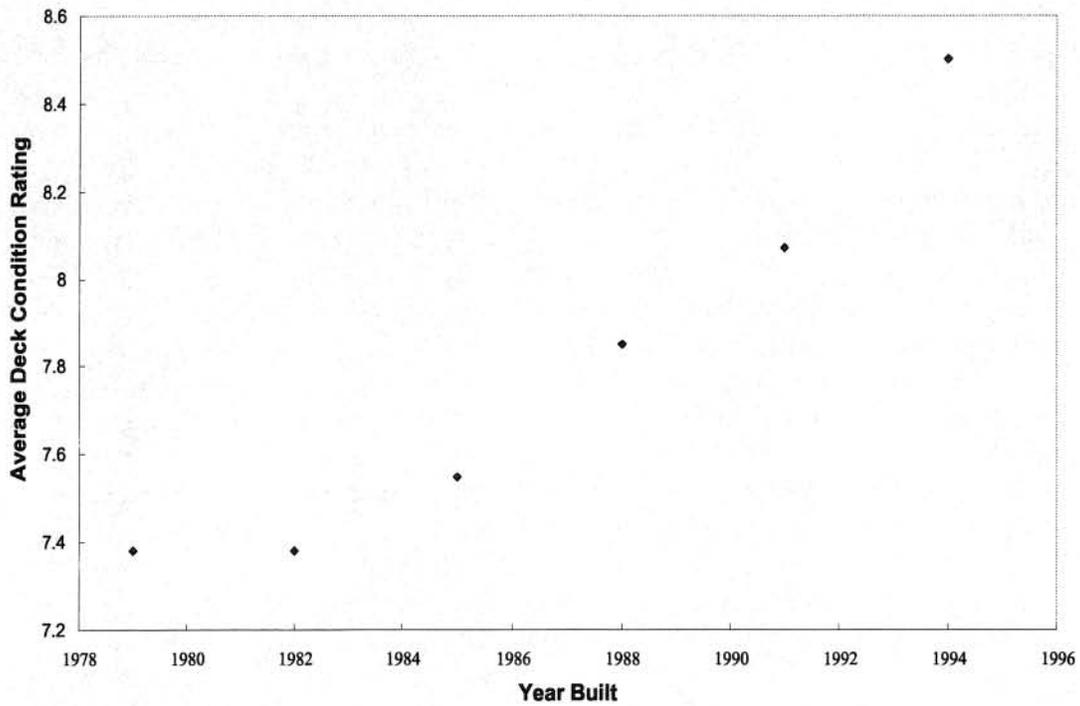
**FIGURE 3.1 Average Deck Condition Rating versus Year Built**

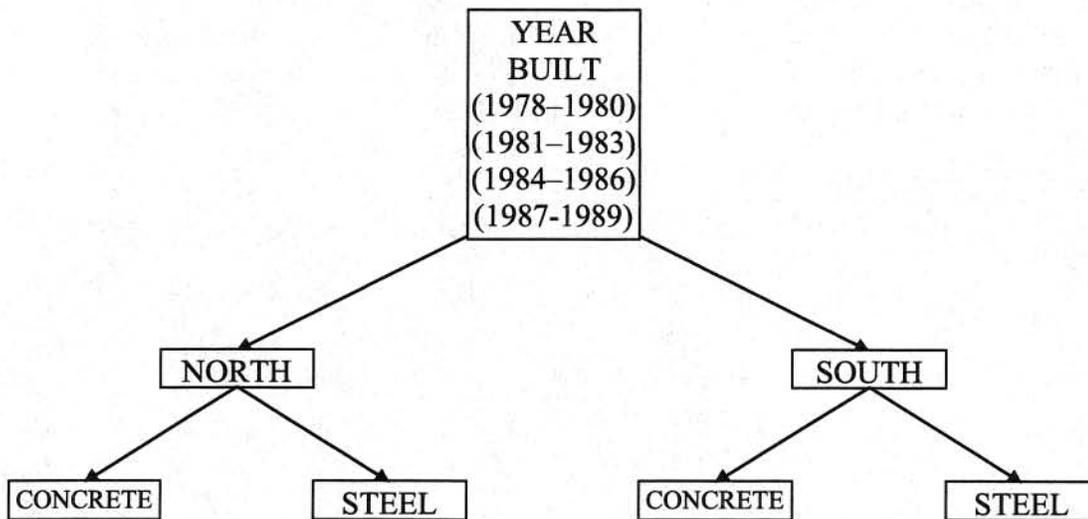
**FIGURE 3.2 Bridge Grouping Used in Phase I**

examined. The bridges with the most deck cracking were chosen from each group. This allowed the selection of bridges based on cracking severity without having to compare inspection records for all 711 bridges.

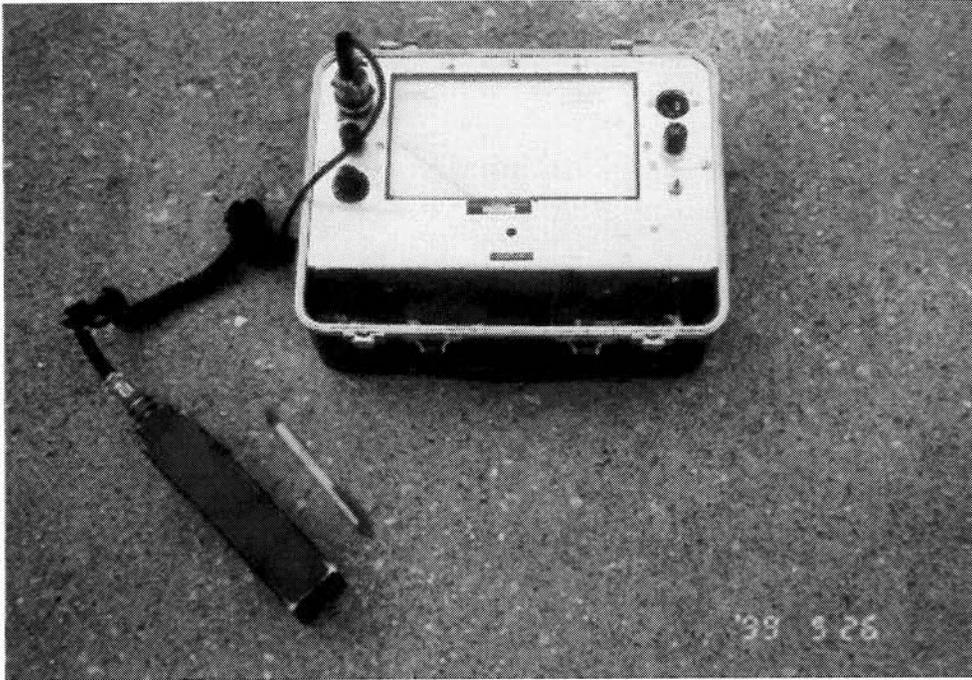
**FIGURE 4.1 Pachometer Used to Locate Reinforcing Steel in a Bridge Deck**

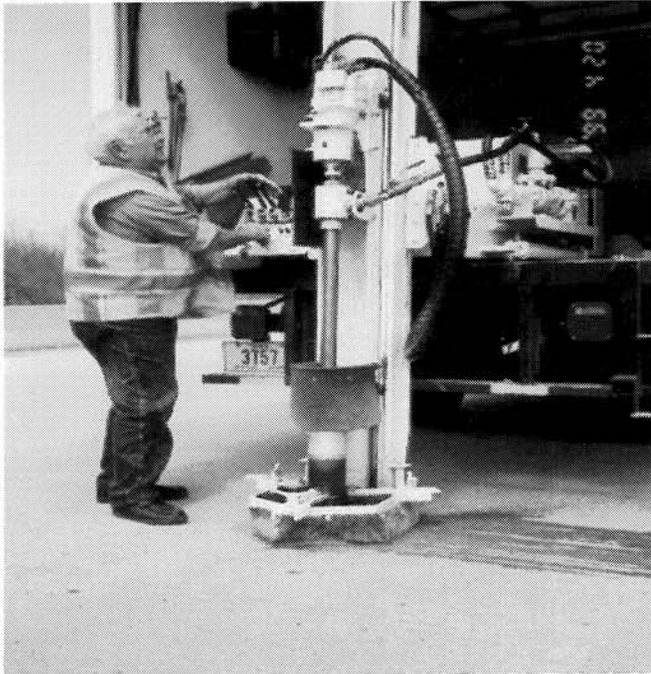
**FIGURE 4.2 The Setup of the Coring Process**

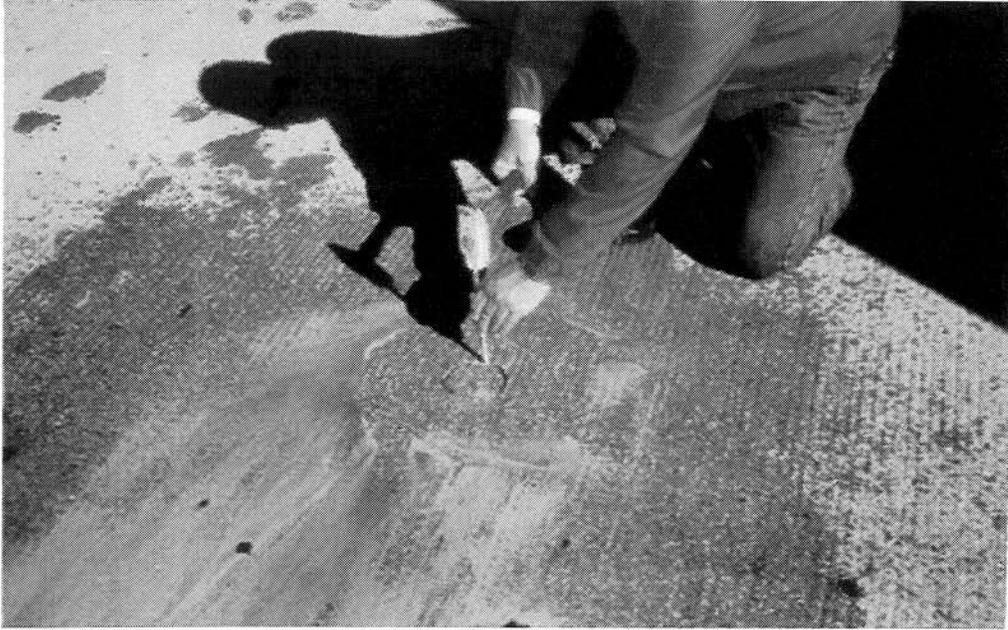
**FIGURE 4.3** Breaking the Core

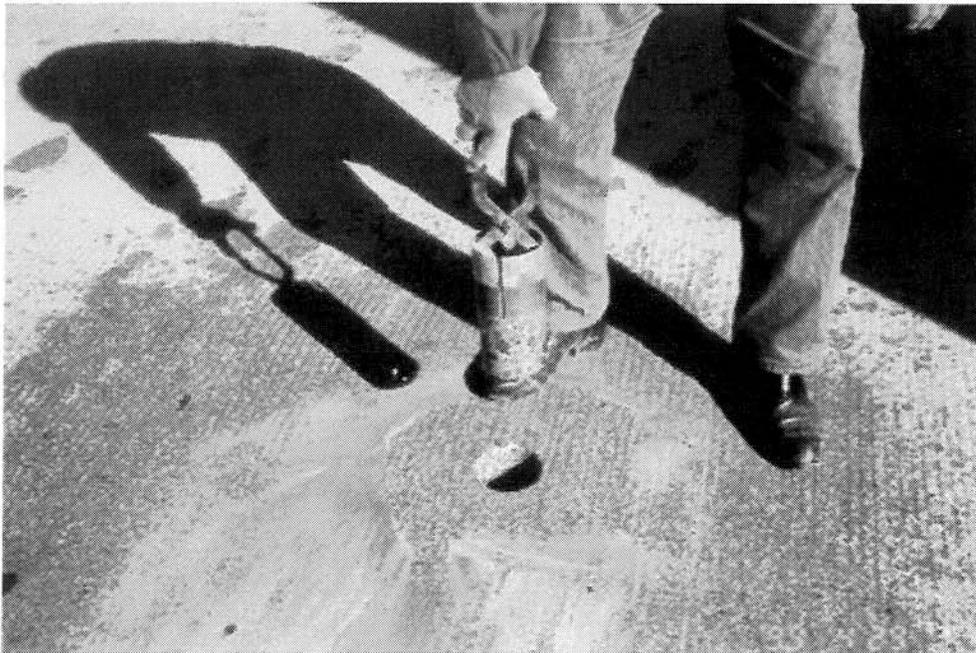
**FIGURE 4.4** Extracting the Core

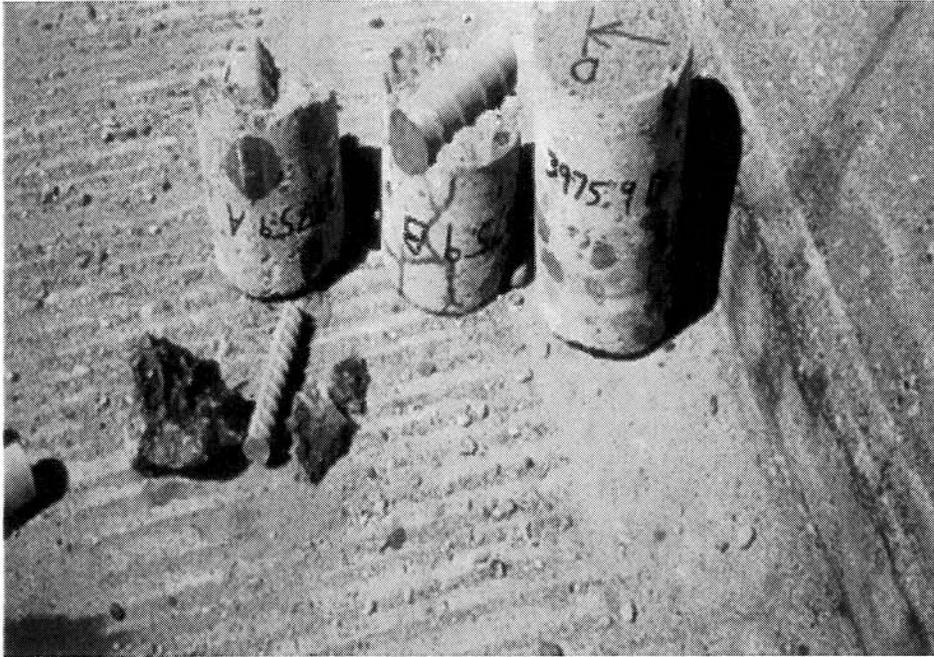
**FIGURE 4.5** Extracted Cores

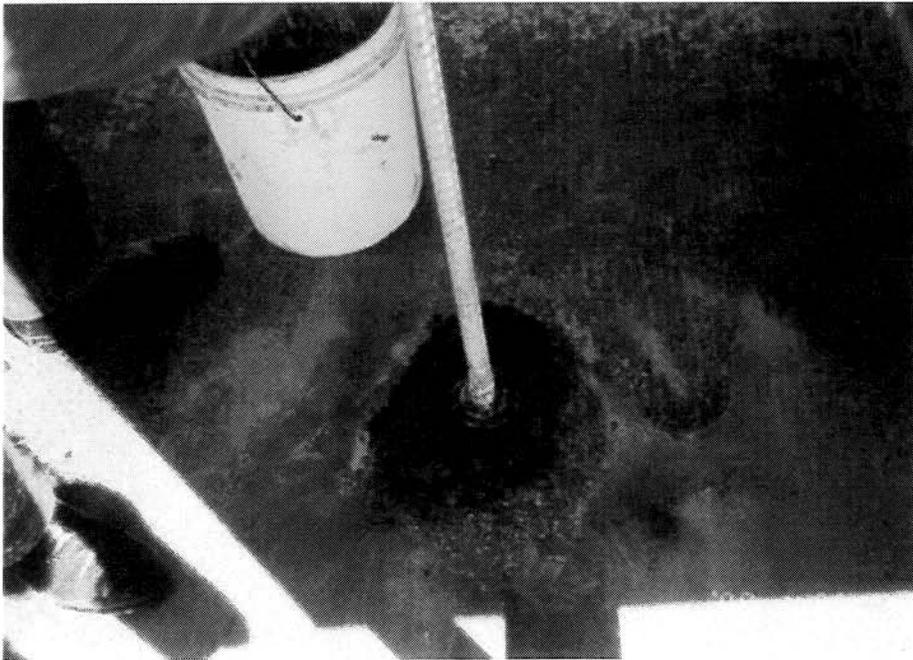
**FIGURE 4.6** Patching the Cored Hole after a Core Being Extracted

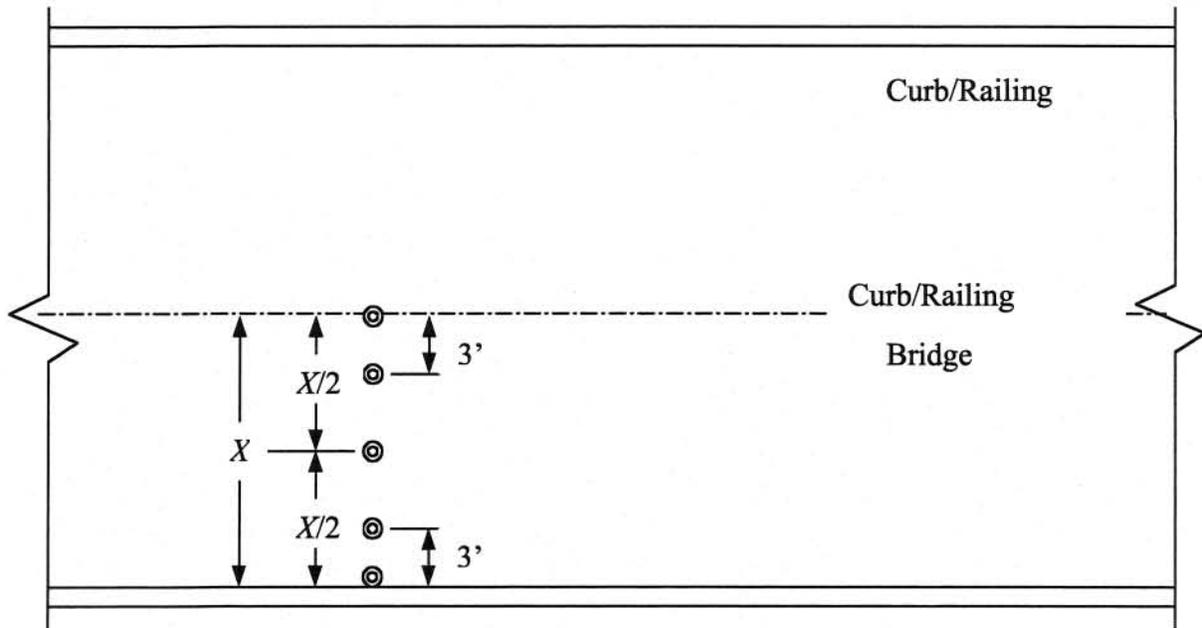
**FIGURE 4.7 Field Concrete Powder Sample Locations**

In phase I, while the cores were being drilled, concrete powder samples at five locations across each bridge deck were collected. Two samples were drilled with a three-eighths-inch drill bit at each location. One sample at each location contained concrete powder drilled from a depth of 0.5 to 1.5 inches. The other sample contained concrete powder drilled from a depth of 2.5 to 3.5 inches. The five locations where powder samples were drilled are shown in Figure 4.7.

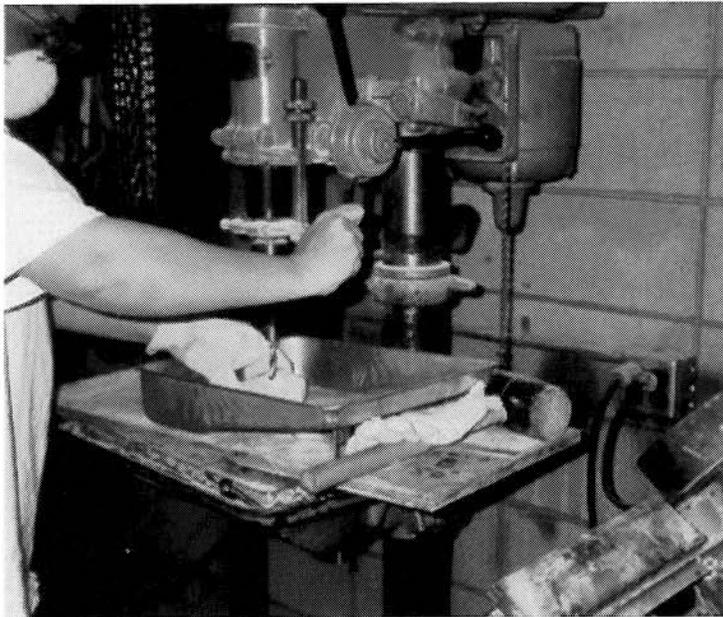
**Figure 4.8 Collection of Powder Samples**

Collection of powder samples is shown in Figure 4.8. At least 20 grams of powder were collected for chloride content analysis. Four powder samples were collected from each core using three-eighths—inch drill bit. The location of these samples were at 0.5 inches below the surface, midway between the first sample and rebar level, rebar level, and one inch below the rebar level.

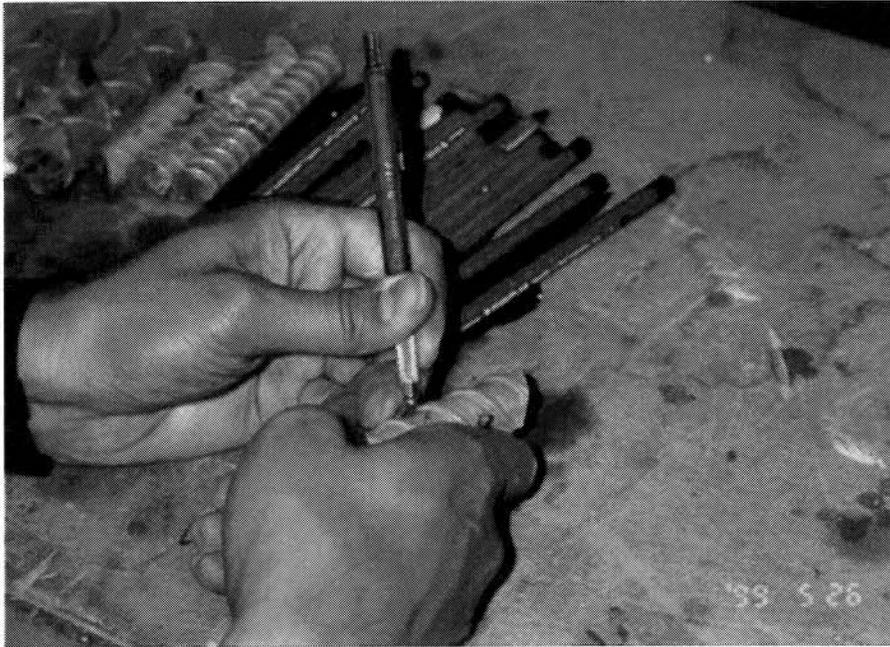
**FIGURE 4.9 Coating Hardness Test**

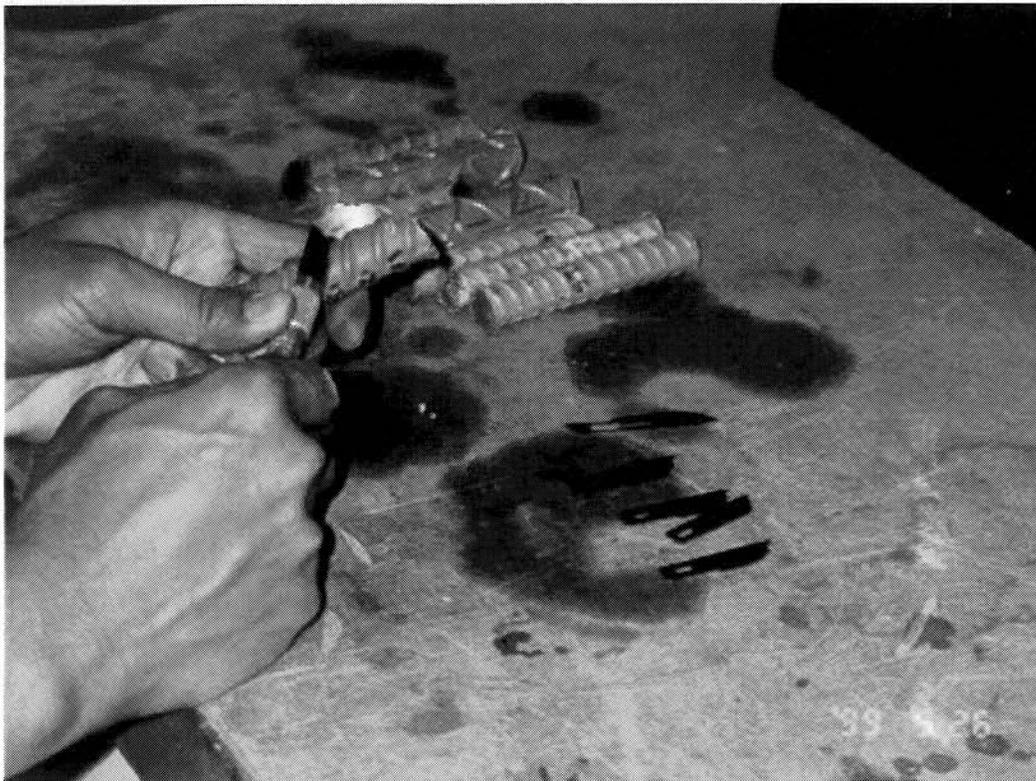
**FIGURE 4.10 Epoxy Coating Bond Test**

To determine the coating bond in between steel and coating film, the dry knife adhesion test was performed for each rebar as shown in Figure 4.10. The recommended standard procedure is described in NACE TM-0185, section 5.3.2.1, as follows:

The recommended method for determining adhesion is to cut the coating to the base metal using a Number 22 hobby knife blade. The point of the blade shall be drawn across the film (using multiple cuts if necessary to cut a single V-shaped groove. Using the sharp side of the blade as a wedge, the coating film should be pried up within the groove. The exposed base should be observed under a 10 to 15X microscope to determine adhesion performance. An average of three attempts shall be used to rate the sample.

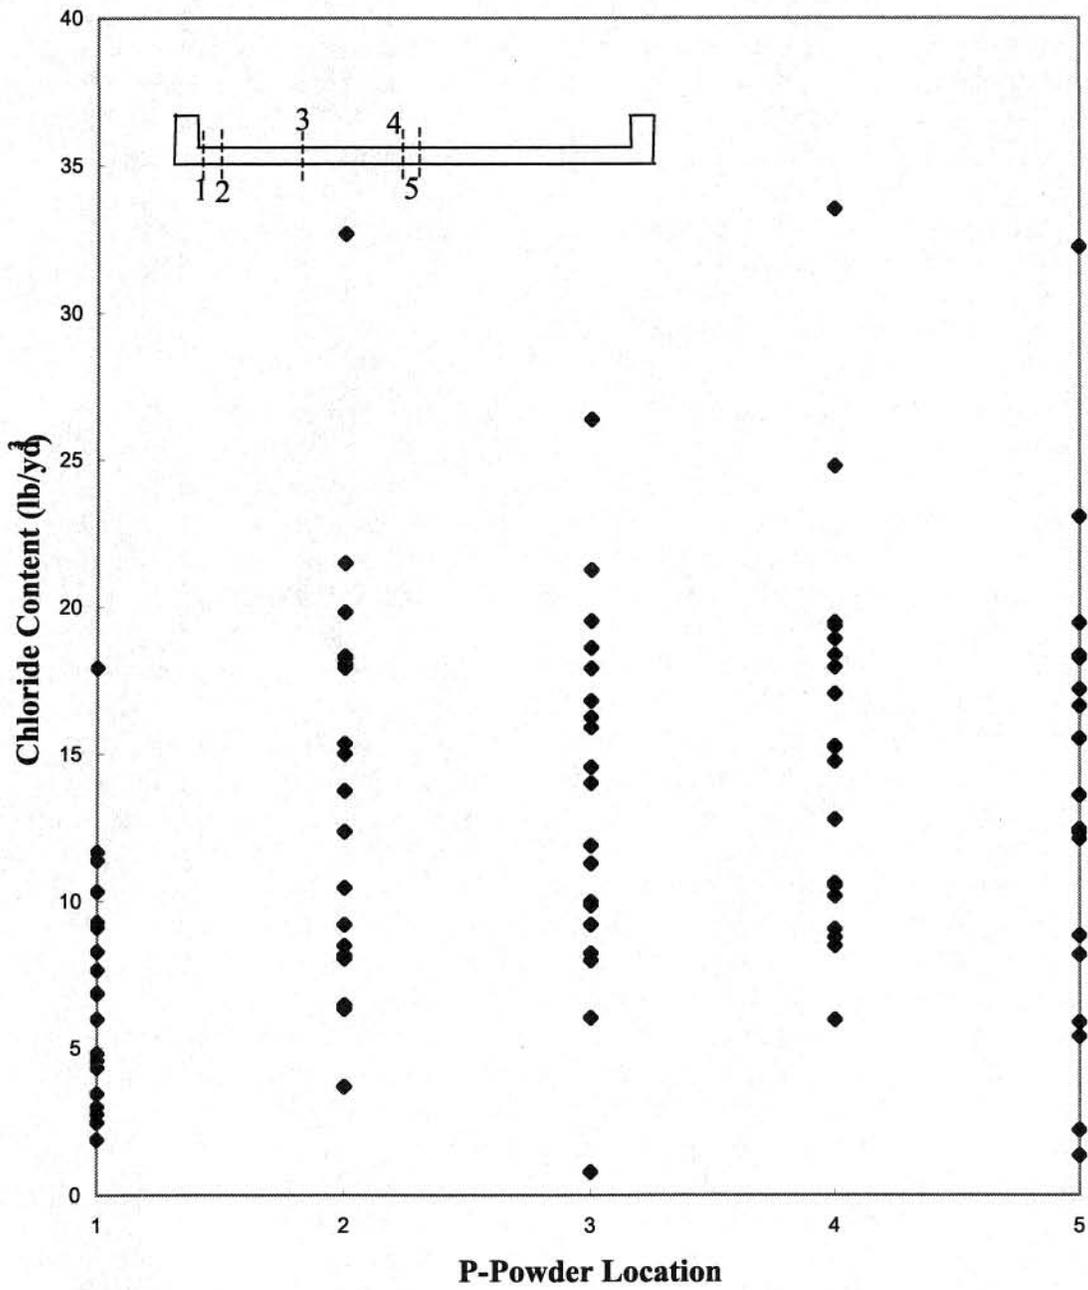
Figure 5.1 Chloride Content vs. Location (0.5 in. to 1.5 in. Depth)

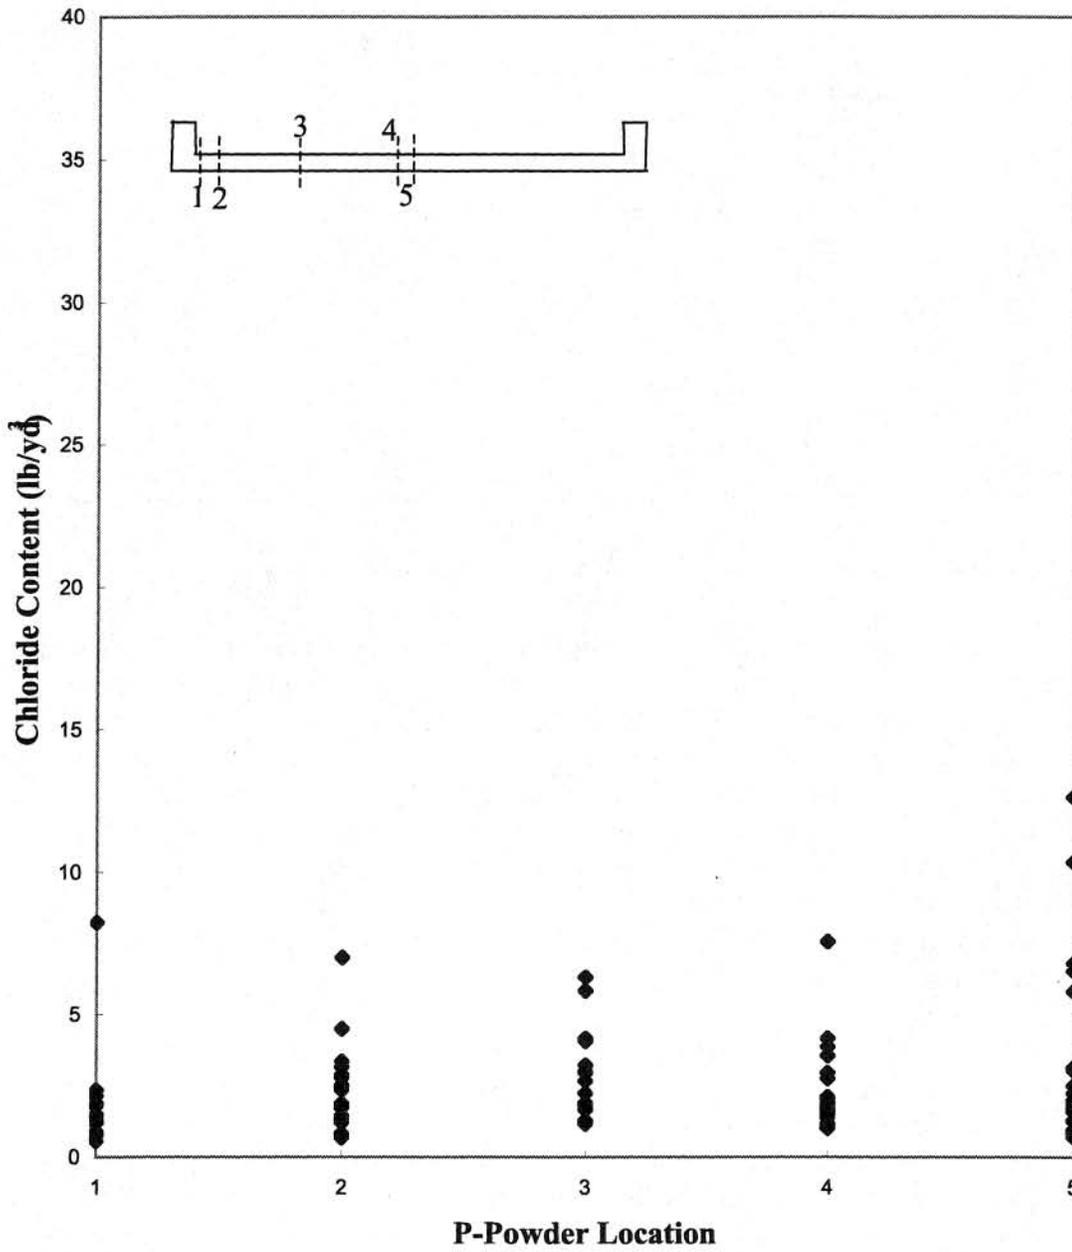
**Figure 5.2 Chloride Content vs. Location  
( 2.5 in. to 3.5 in. Depth)**

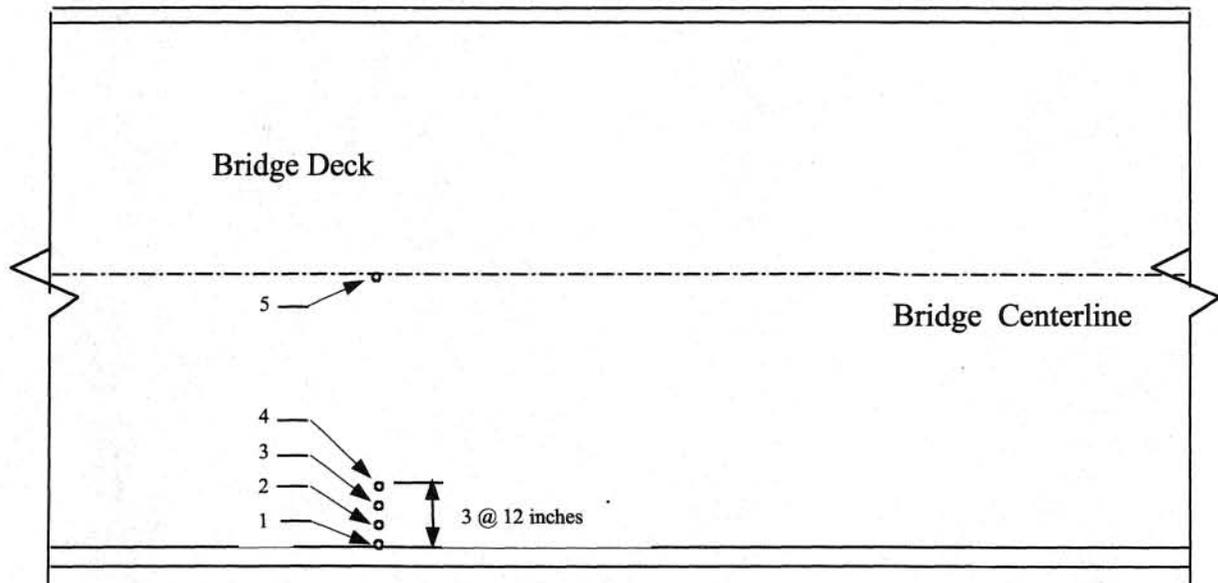
**FIGURE 5.3 Field Concrete Powder Sample Locations (X-powders)**

In order to verify the above results, a different sampling scheme was used in collecting samples from the bridges that remained to be sampled in phase I. For these bridges, powder samples were taken from the locations shown in Figure 5.3. These are referred to as *X*-powder samples hereafter. Although the depths of the powder samples remained the same as the first set of bridges, the five locations were different. Location 1 remained adjacent to the bridge gutter. Locations 2, 3, and 4 were 1, 2, and 3 feet away from the bridge gutter, respectively, and location 5 remained at the center line of the bridge deck.

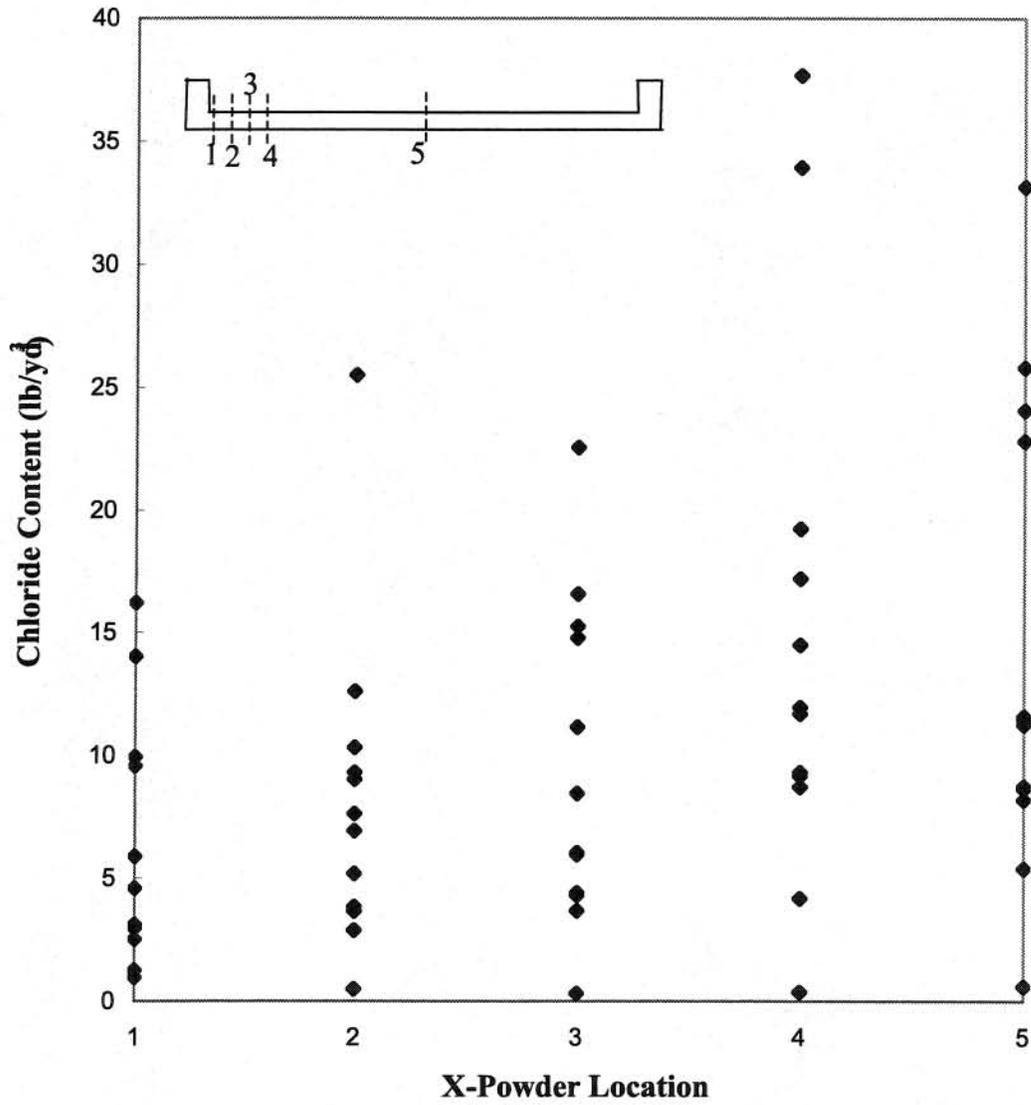
**Figure 5.4 Chloride Content vs. Location ( 0.5 in. to 1.5 in. Depth)**

The chloride concentration results from these *X*-powder samples are displayed in Figures 5.4 and 5.5. These plots also show that the chloride content in the concrete near the gutter is less than in other areas of the deck. The samples taken at the gutter from a depth of 0.5 to 1.5 inches still lower chloride content than those taken at 3 feet from the gutter and at the center line of the bridges at the same depth. Figures 5.4 and 5.5 also show a general increase in the chloride content from the curb/railing to 3 feet from the gutter, with the largest increase between 2 and 3 feet from the gutter.

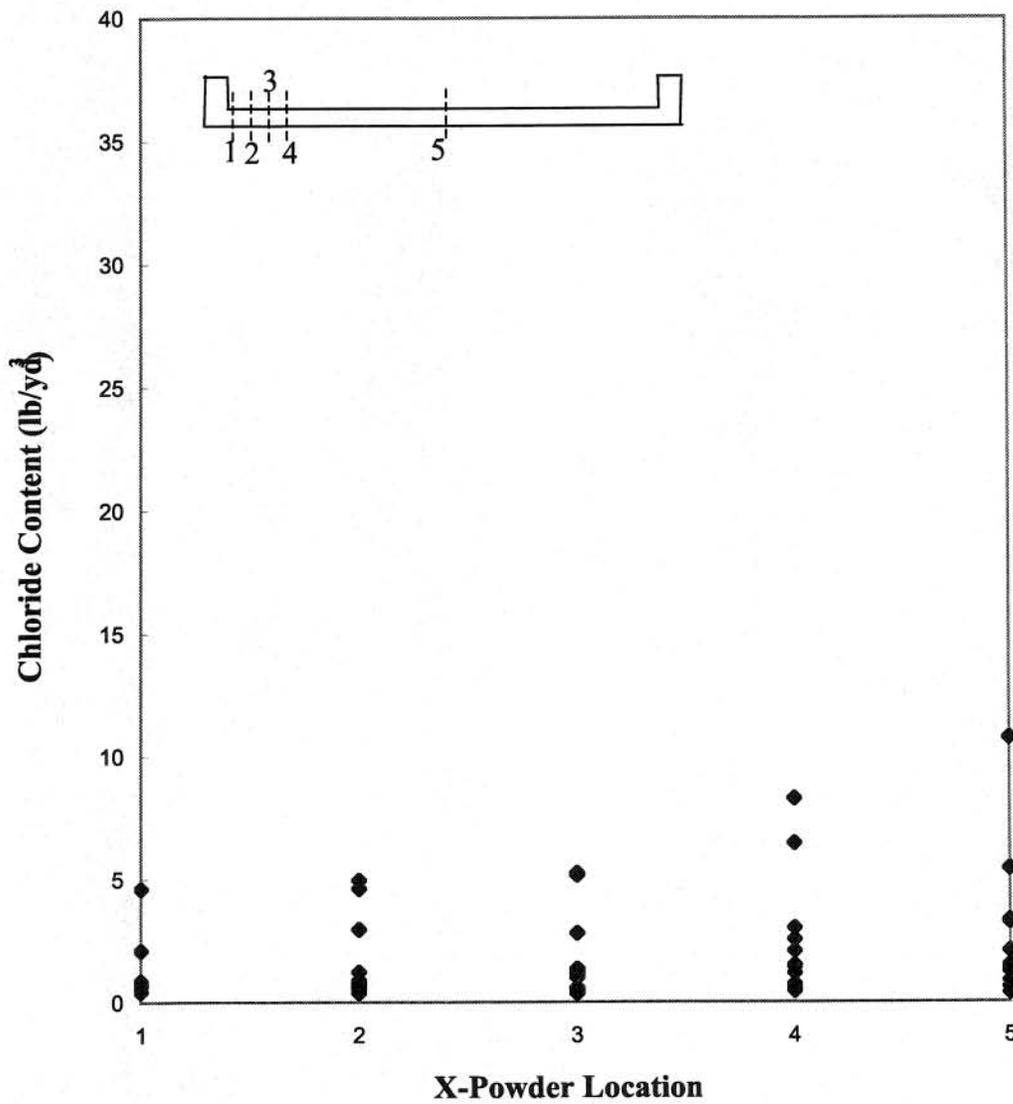
**Figure 5.5 Chloride Content vs. Location  
(2.5 in. to 3.5 in. Depth)**

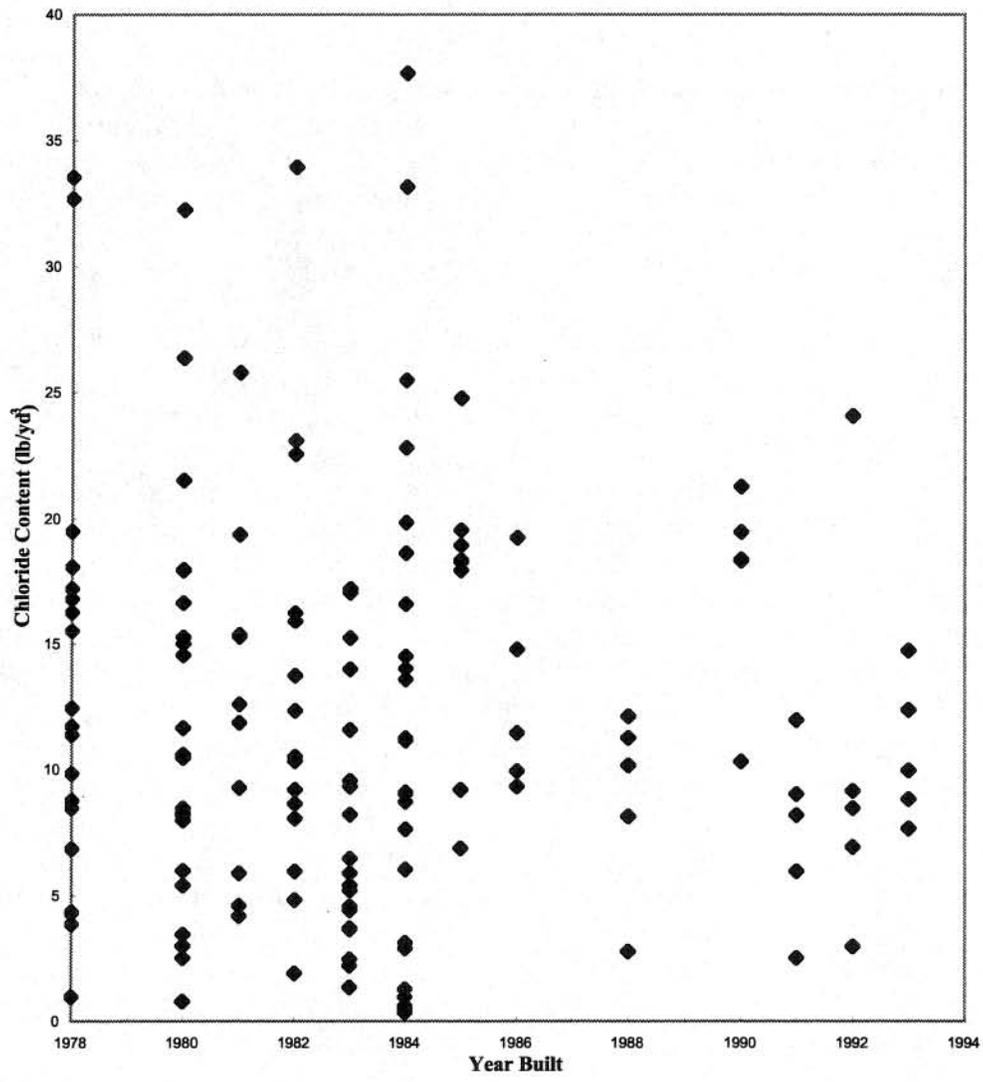
**Figure 5.6 Chloride Content vs. Year Built  
(0.5 in. to 1.5 in. Depth)**

The chloride content results from the *P*-powder and *X*-powder samples were also used to investigate the relationship between chloride content and bridge age. The graph of chloride content versus bridge age is shown in Figure 5.6 for 0.5 to 1.5 inch depths and in Figure 5.7 for 2.5 to 3.5 inch depths. Figure 5.6 shows that chloride content in most of the 0.5- to 1.5-inch-deep samples is significantly higher than the corrosion threshold for bare steel, i.e., greater than 1.2 lb/yd<sup>3</sup> (0.81 kg/m<sup>3</sup>). The data recorded in Figure 5.7 illustrate that a large number of samples have a chloride concentration greater than the corrosion threshold in the samples taken from depths between 2.5 to 3.5 inches. Figures 5.6 and 5.7 also show that relatively high chloride contents were noticed in some of the

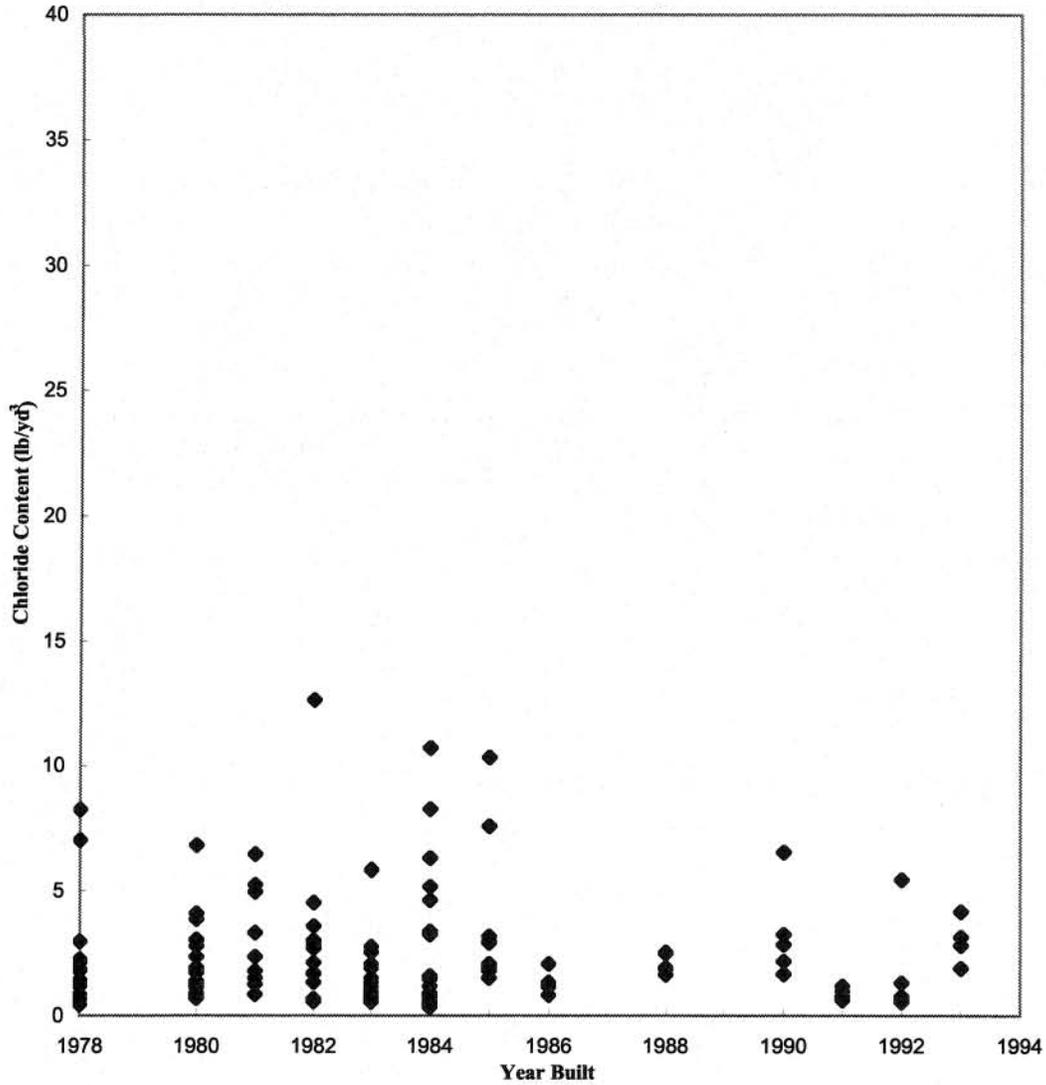
**Figure 5.7 Chloride Content vs. Year Built  
(2.5 in. to 3.5 in. Depth)**

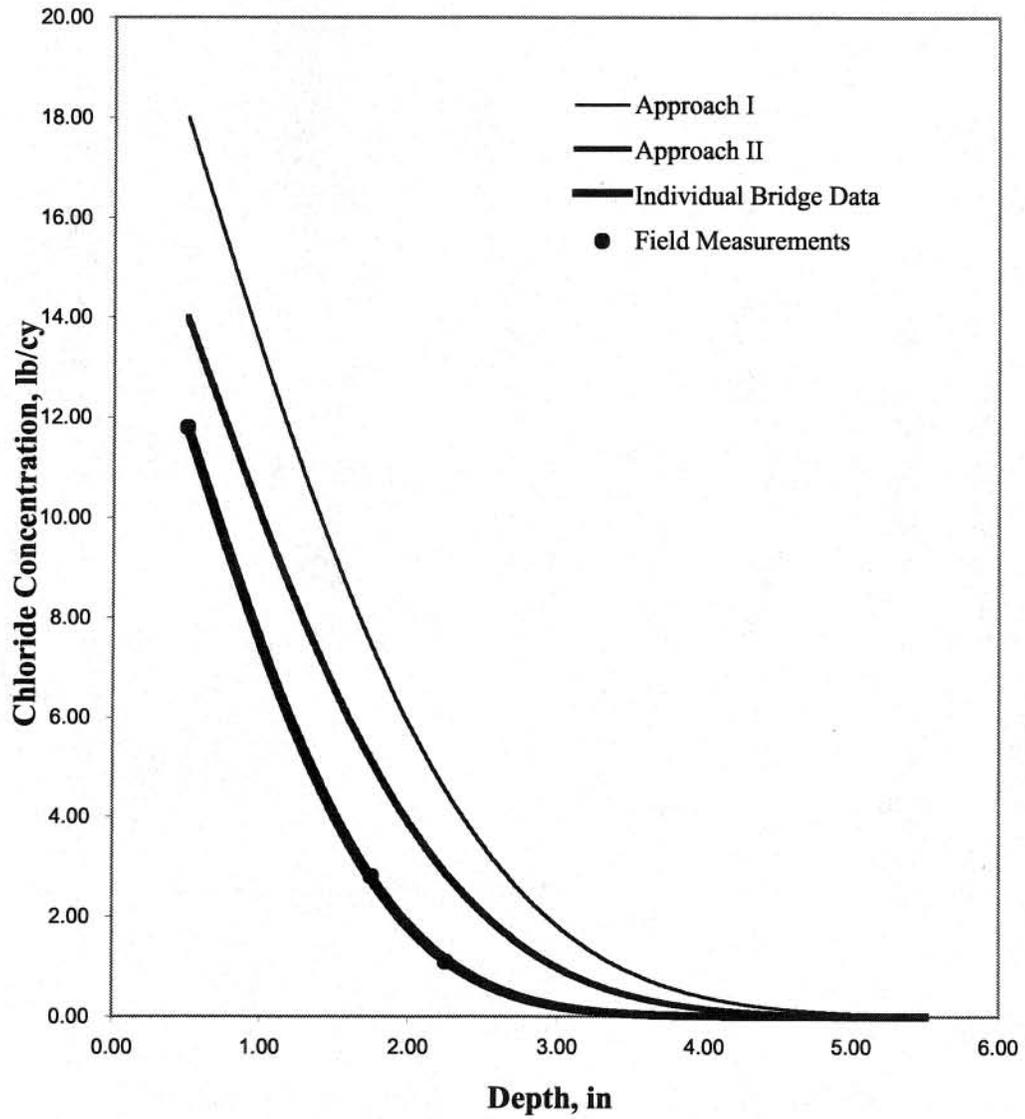
**Figure 5.8 Chloride Concentration vs. Depth, 0668.7S021A**

For illustrative purpose, based on equation 2.2, the results of chloride diffusion in three bridge decks are shown in Figures 5.8, 5.9, and 5.10 for bridges with ID numbers 0668.7S021A, 8609.2S030B, and 0781.5L218A, respectively. Shown in each figure are three relationships that were obtained using  $C_o$  and  $D_c$  from approaches I, using  $C_o$  and  $D_c$  from approach II, and using  $C_o$  and  $D_c$  for each individual bridge. Also included in these figures is the chloride concentration measured in each bridge.

As can be seen, the chloride concentration decreases to almost zero sharply at about depth of 4 inches regardless of what approach is used in developing the chloride concentration and depth relationship. In addition, although the three relations showed significant difference at surface chloride content between the measured and predicted chloride contents, these differences were insignificant at the rebar level. The figures reveal that approach II yields closer results to the measured values than those of approach I.

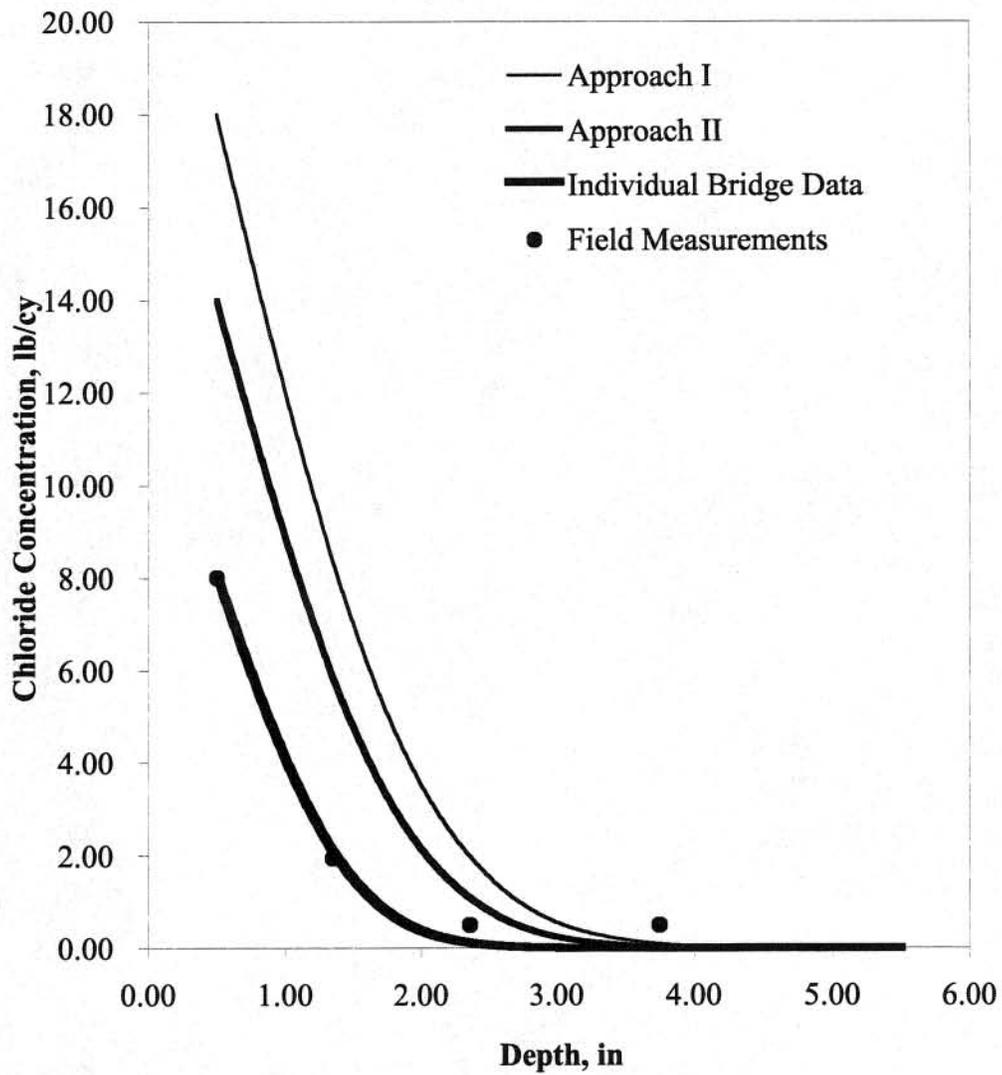
**Figure 5.9 Chloride Concentration vs. Depth , 8609.2S030 B**

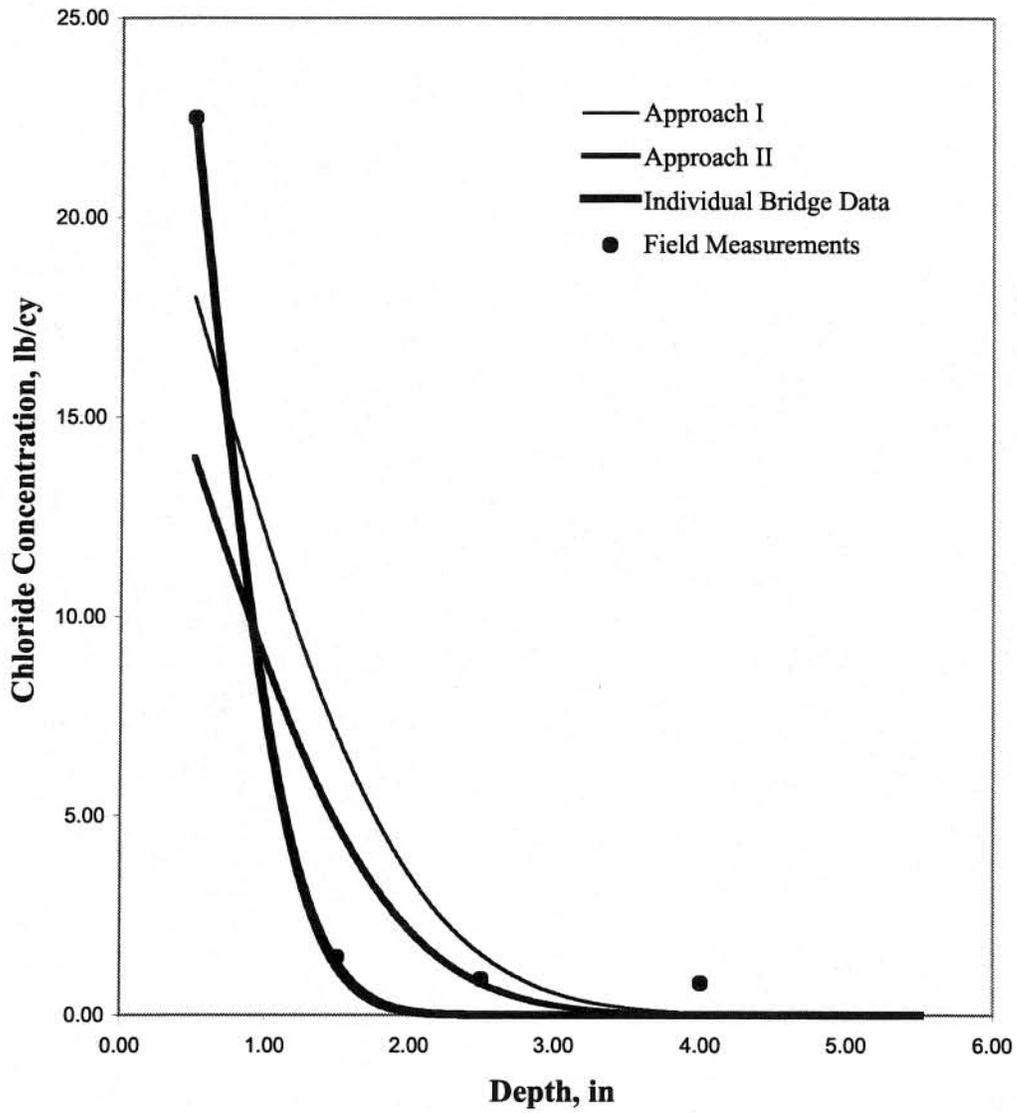
**Figure 5.10 Chloride Concentration vs. Depth, 0781.5L218 A**

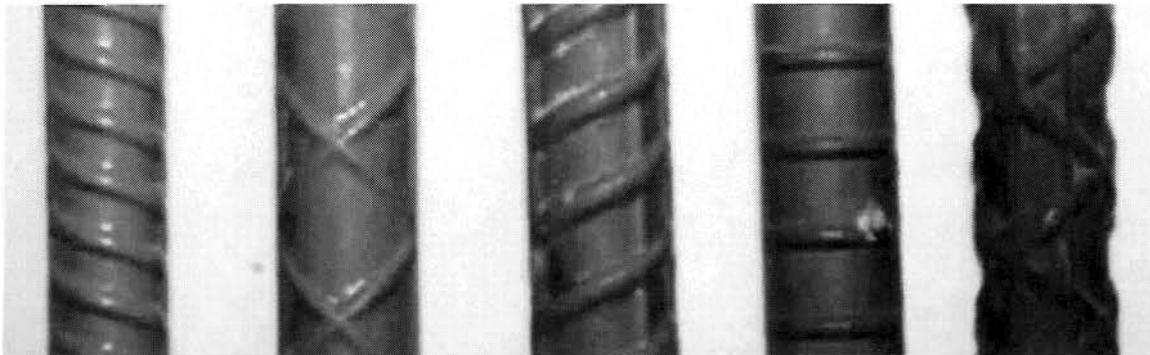
**FIGURE 6.1 Rebar Samples Showing Some Discoloration**

Most if not all of the collected rebar samples exhibited some level of epoxy discoloration. In most of the samples, the epoxy coating was discolored more on the top region of the rebars than on the bottom and side regions. There were a few exceptions to this trend though. Most discolored rebar samples came from the older bridges in this study, although some of the rebar samples from the newer bridges showed significant levels of discoloration as well. Figure 6.1 shows five rebar with some discoloration.
