# IMPACT OF DECK CRACKING ON DURABILITY

Sponsored by the Project Development Division  
of the Iowa Department of Transportation  
and the Iowa Highway Research Board  
Iowa DOT Project TR-405  
CTRE Management Project 97-5

MARCH 2000

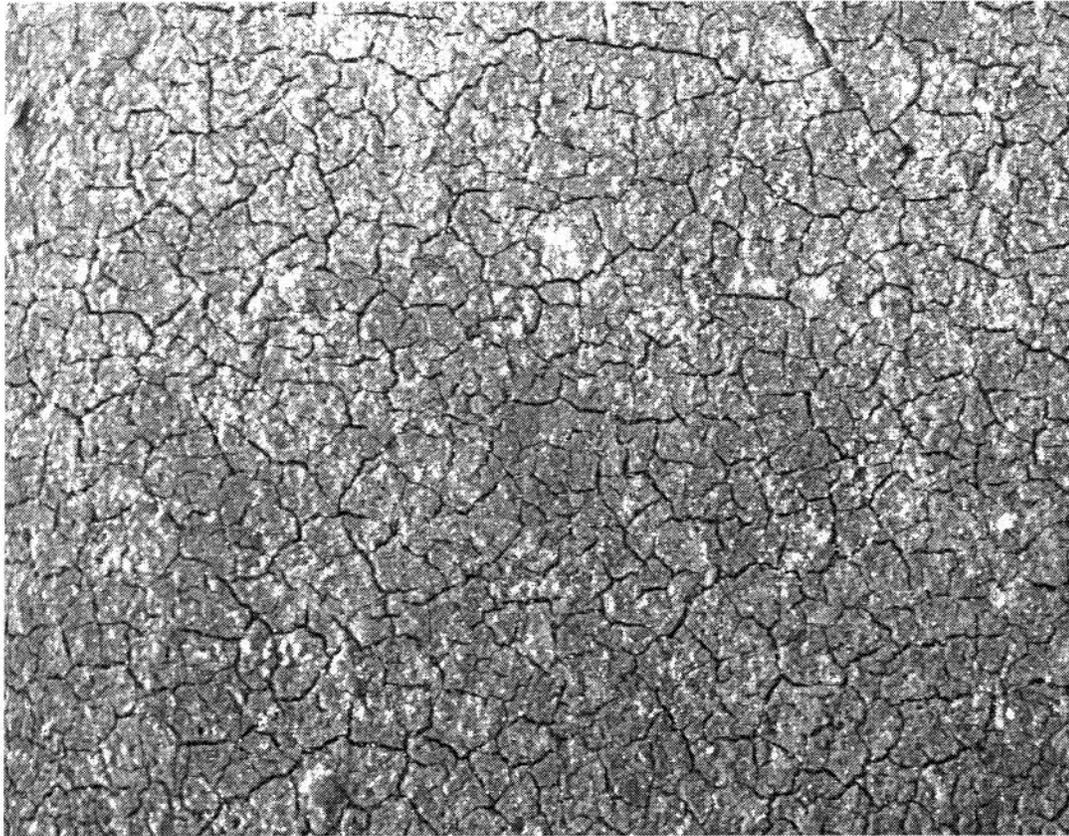
**FIGURE 6.2 Microcracking in Discolored Epoxy Surface**

From analyzing some of the rebar samples on the scanning electron microscope, it was observed that the severely discolored epoxy coating areas have small micro-cracks on the surface of the epoxy as shown in Figure 6.2. The exact cause of these microcracks is not known. Exposure to weather prior to construction or from aging and exposure to chloride could have caused these microcracks and discoloration. The impact that these microcracks have on the epoxy coating's ability to protect against reinforcement corrosion is not known. Because these cracks appear to be only on the surface of the epoxy coating, their significance may be minimal.

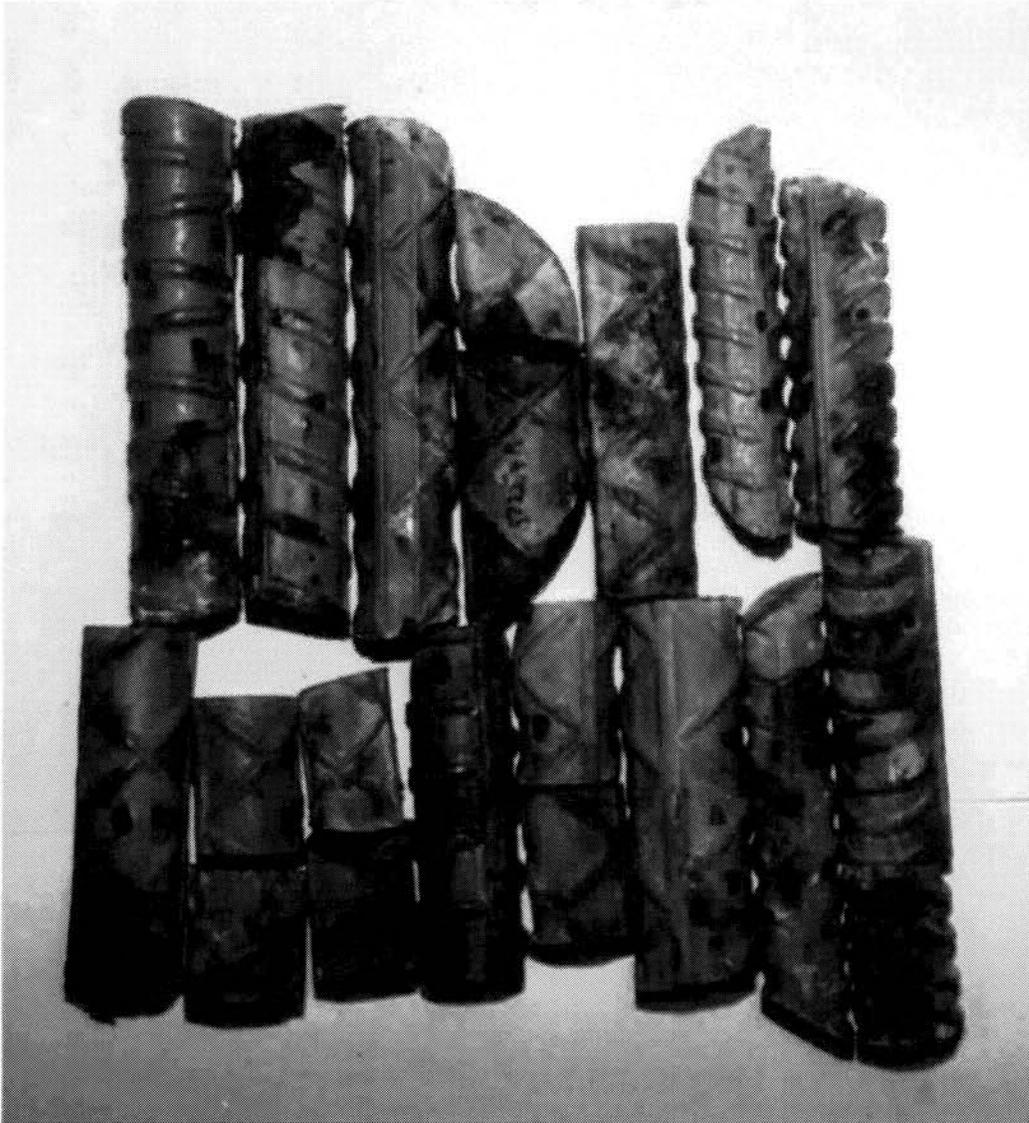
**FIGURE 6.3 Rebars Samples with Significant Corrosion**

Evaluation of the rebar samples collected from the bridge decks that were included in this study indicated a range of deterioration. The most corroded rebar samples were those collected from cracked locations. Although most of this corrosion was only on the surface of the steel, a couple samples were observed to have spots where corrosion product had built up slightly underneath the epoxy coating. The largest area of these spots observed was about two centimeters squared and bulged out to a depth of about one to two millimeters. One of the most significant findings from this study was that all of the rebar samples that were evaluated as having a rebar rating of one, two, or three came from cores that were taken from cracked locations. On all of the rebar samples rated one, two, or three, it appeared that surface corrosion was undercutting the epoxy coating. Figure 6.3 shows some of the rebar samples evaluated in this study that were given a rebar rating of one, two, or three.

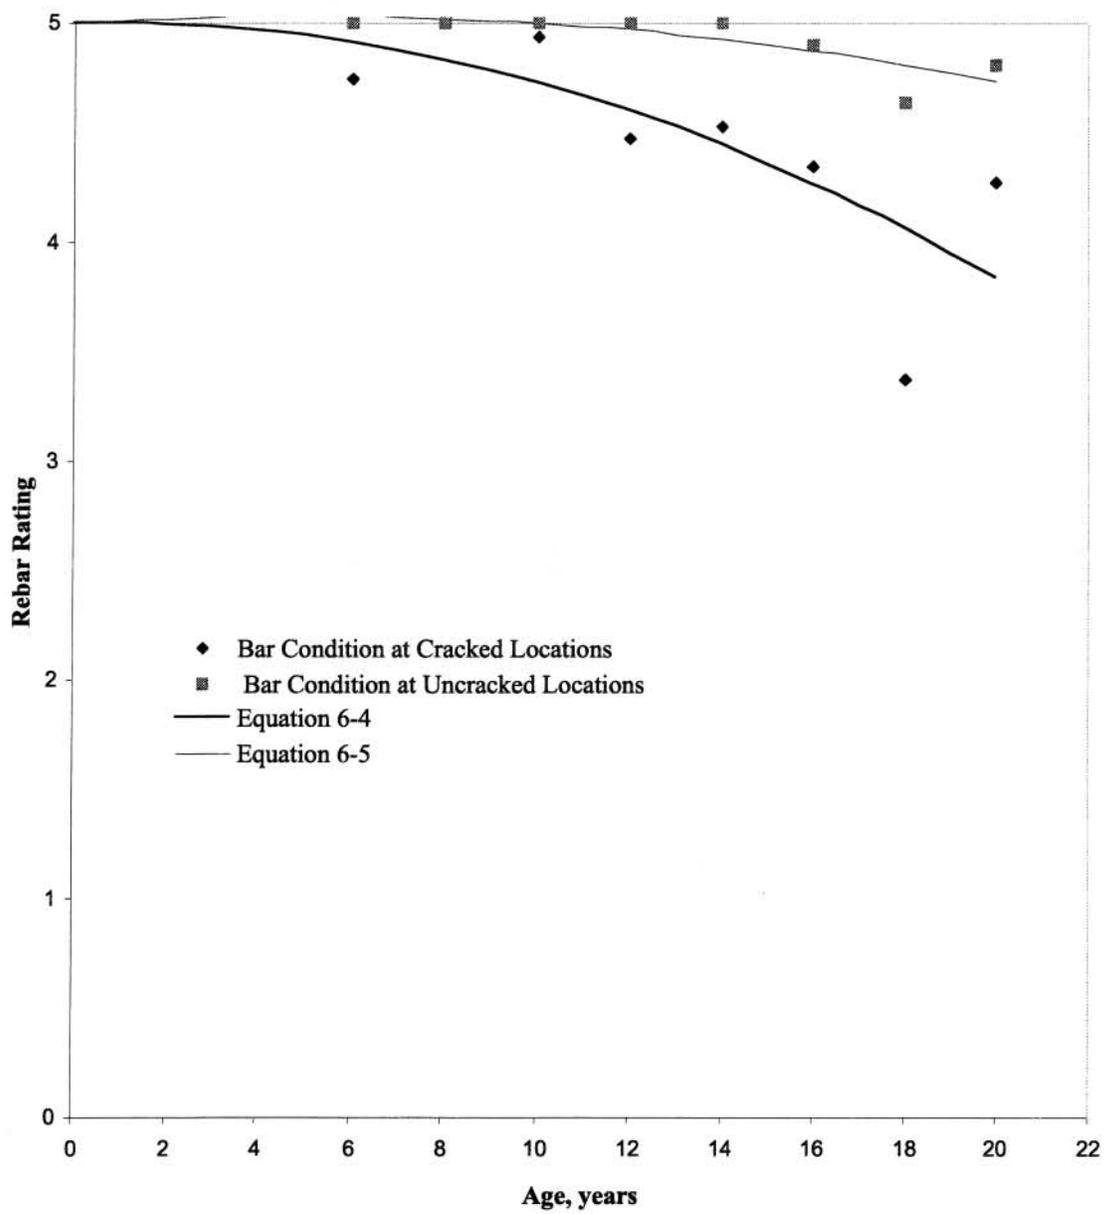
**Figure 6.4 Rebar Rating vs. Age (Equations 6-4 and 6-5)**

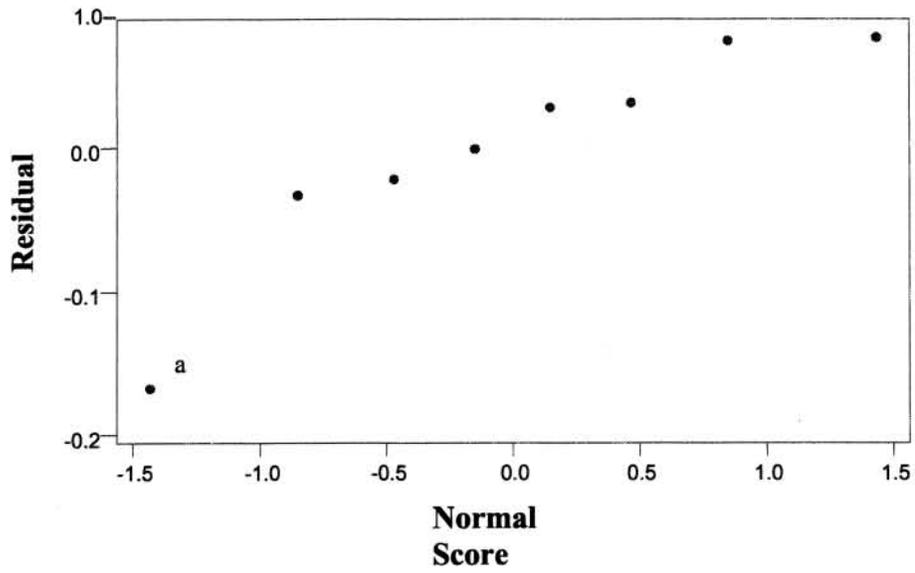
**FIGURE 6.5 Normal Probability Plot of the Residuals for Equation 6.4**

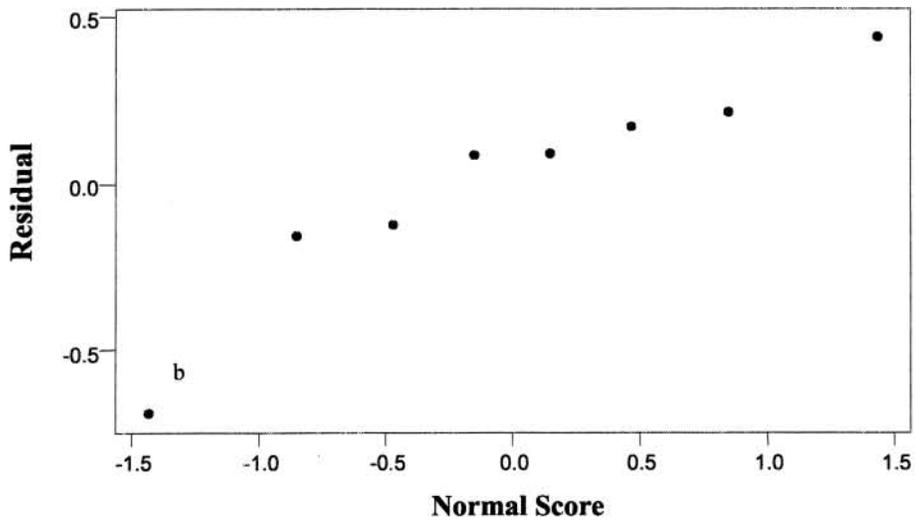
**FIGURE 6.6 Normal Probability Plot of the Residuals for Equation 6.5**

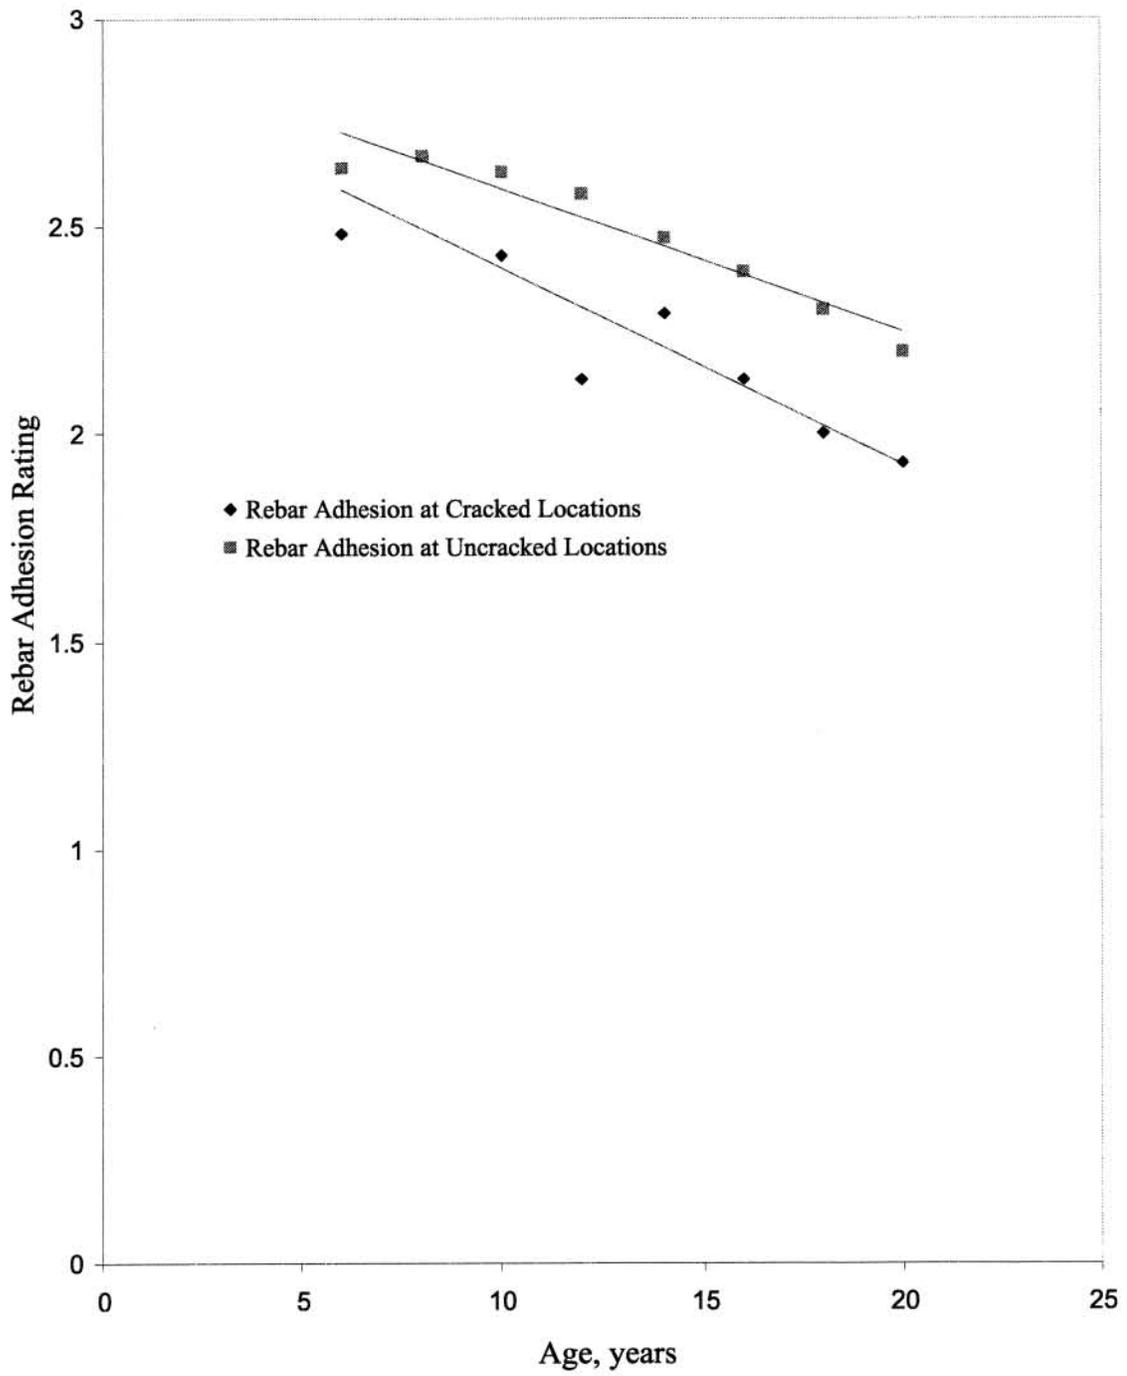
**Figure 6.7 Rebar Adhesion Rating vs. Age**

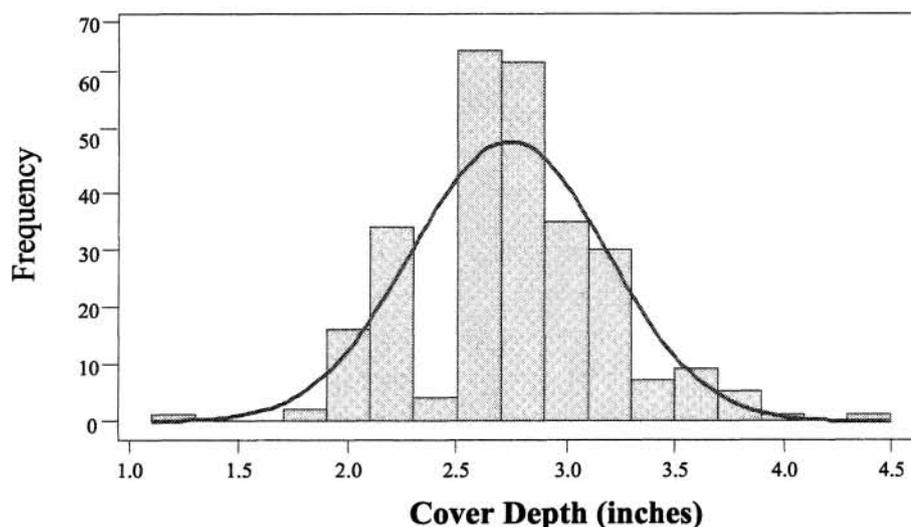
**FIGURE 6.8 Histogram of Cover Depth with Normal Distribution Curve for Iowa Bridge Decks**

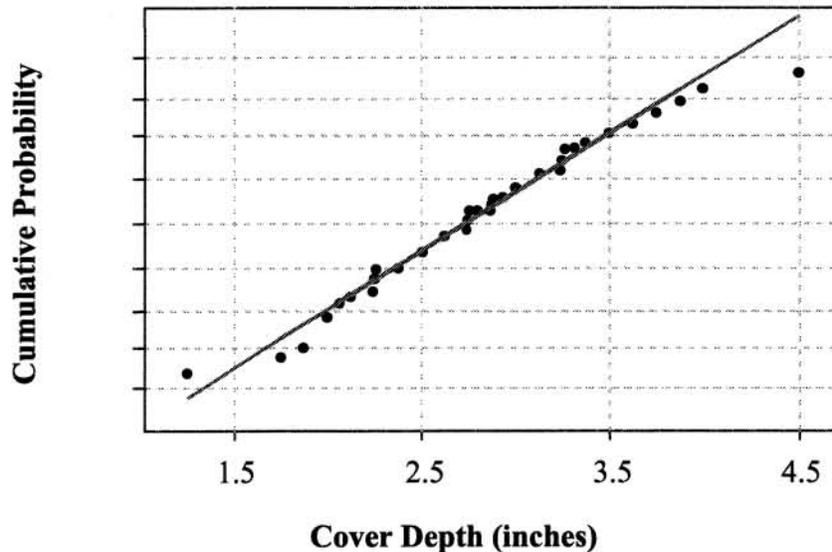
**FIGURE 6.9 Normal Probability Plot**

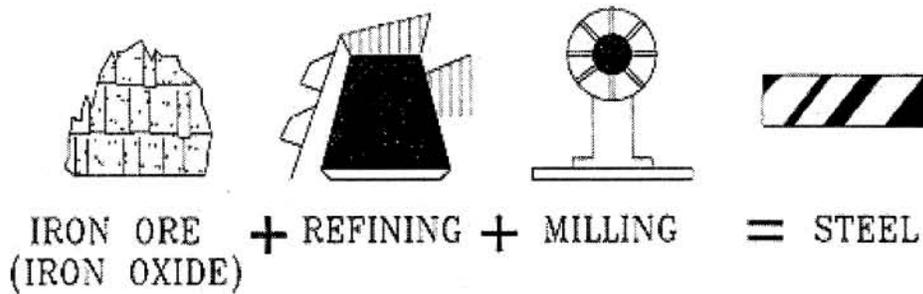
**FIGURE A.1 Conversion of Iron Ore to Steel (5)**

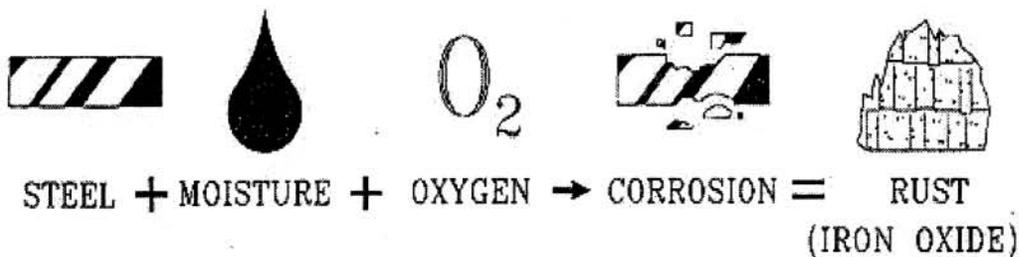
**FIGURE A.2 Conversion of Steel to Rust (5)**
