# Investigation of Steel-Stringer Bridges: Superstructures and Substructures, Volume I

**Final Report**  
**October 2007**

**Sponsored by**  
the Iowa Highway Research Board (Project TR-522)  
and the Iowa Department of Transportation (CTRE Project 04-184).

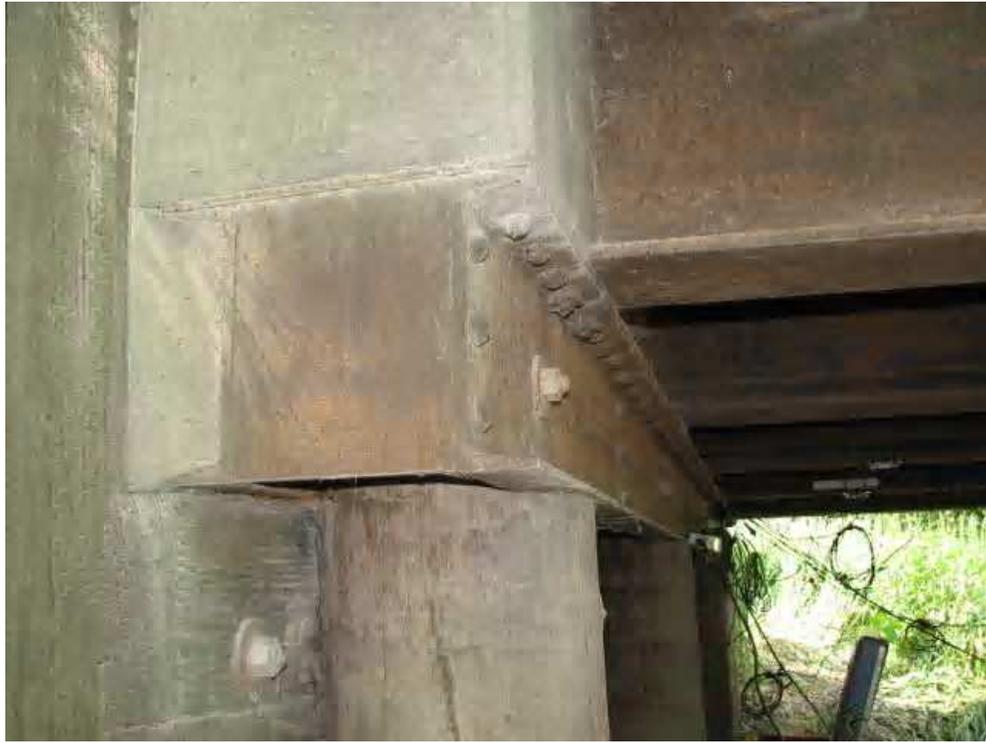
**Figure 3.2. Typical Pile Cap Configuration.**

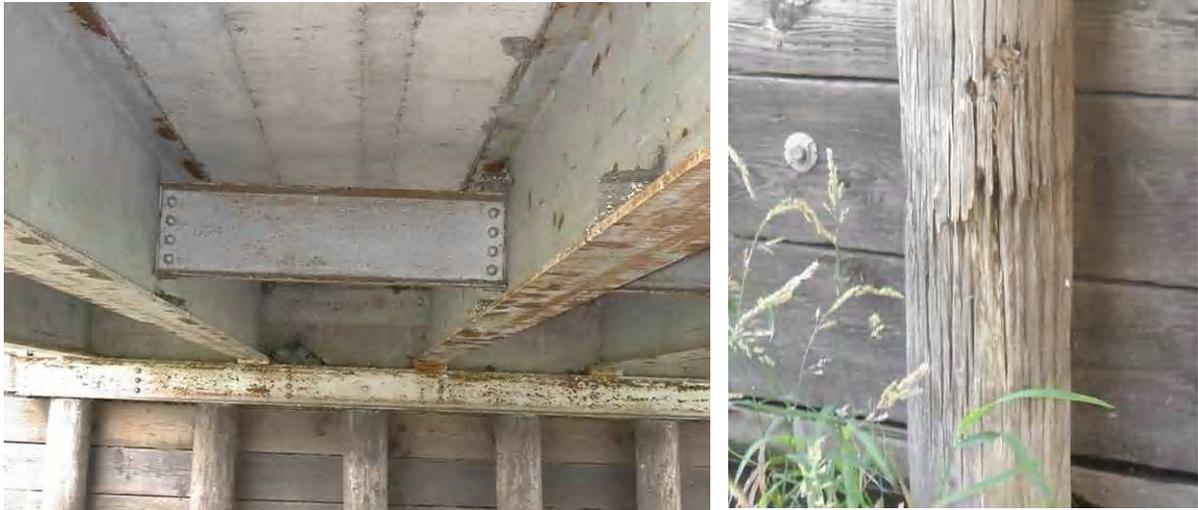
**Figure 3.4. BCB Deterioration.**

The superstructure appears to be in good condition with some minor rust in areas as shown in Figure 3.4(a). Typical decay that was found in some of the piles is shown in Figure 3.4(b). There were minor repairs made to the bridge in 1993 when the south bridge approach was washed away; the repairs consisted of the installation of a sheet pile wall behind the existing timber back wall and then filling the void with concrete. Shown in Figure 3.5(a) is the sheet pile wall while the concrete behind the top of the timber backwall is shown in Figure 3.5(b).

**(a) Minor rust on girders**

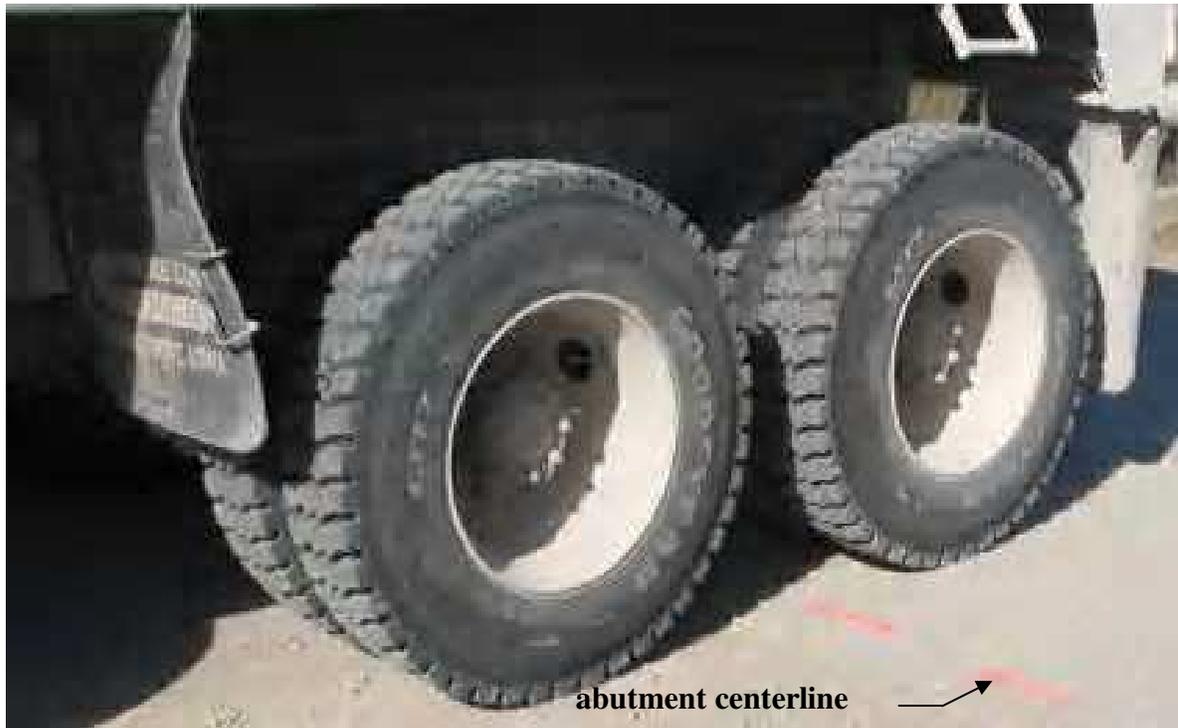
**Figure 3.11. BCB Truck Tandem Centroid Centered Over Abutment.**

There were three paths or lanes, shown in Figure 3.9, selected for the truck to follow as it crossed the bridge. Each lane was tested twice for each load increment to check repeatability of the test results. Measurements (strains and deflections) were taken when the centroid of the tandem was at the centerline of each abutment and at each quarter point (see Figure 3.9). The location of the centerline of the abutments and each quarter point were painted on the bridge as shown in Figure 3.10; the location of the tandem axle centroid in relation to one of the transverse lines painted on the bridge is shown in Figure 3.11.

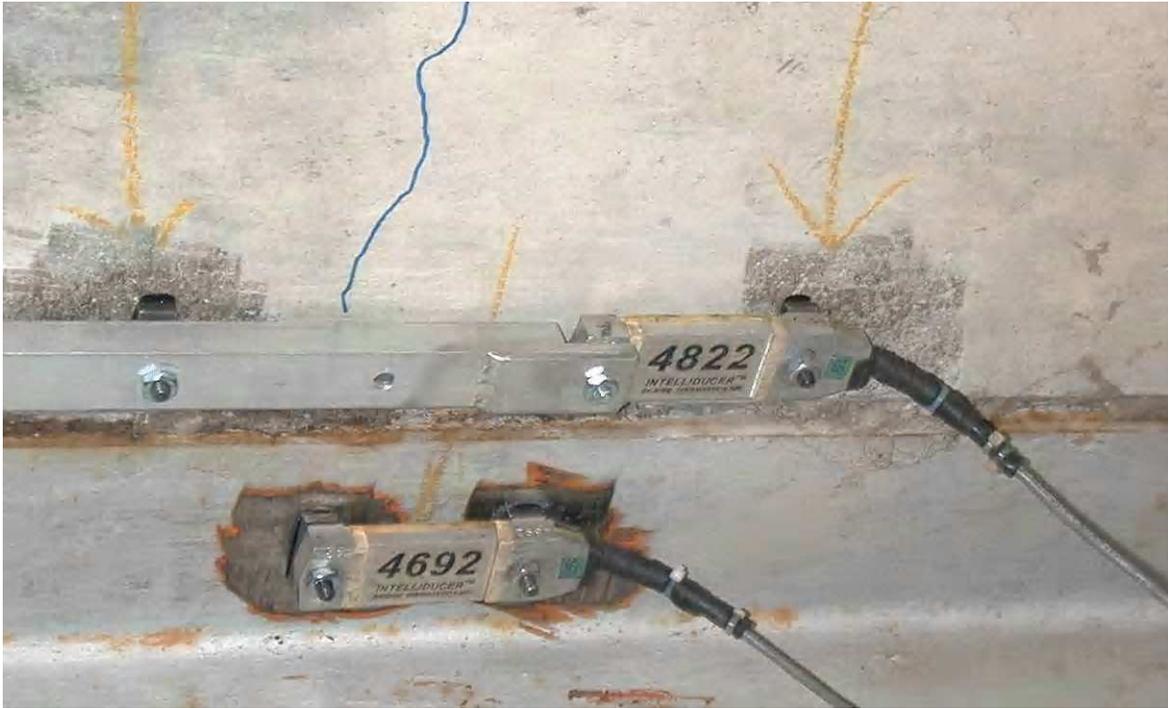
**Figure 3.15. Concrete and Steel Mounted Transducers at Midspan of BCB.**

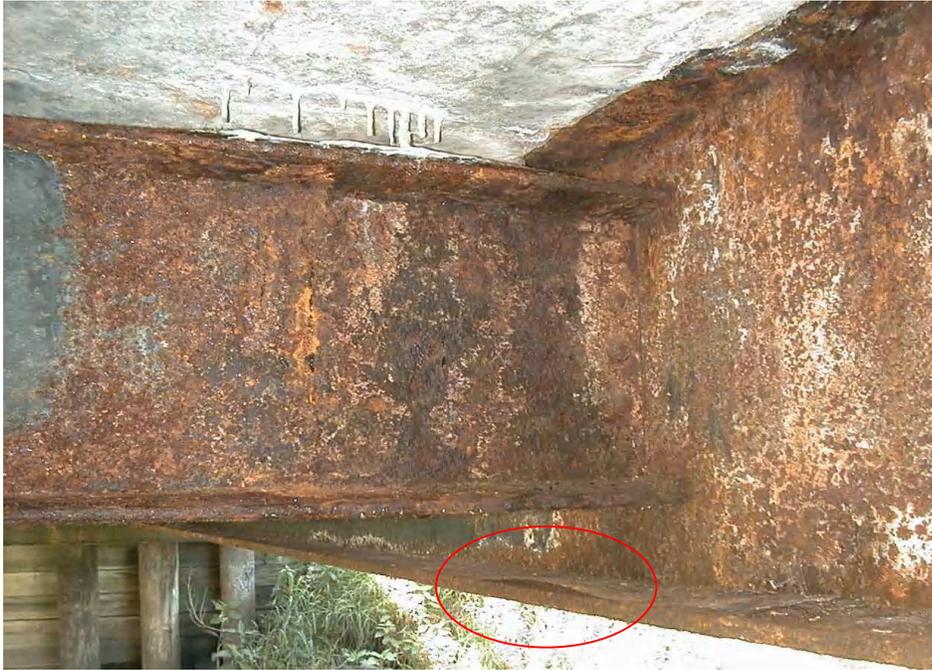
The asphalt overlay, which was heavily cracked and trapped water between the concrete deck and the overlay, also caused some major deterioration in the concrete deck. On this bridge, with the average daily traffic around 940 (2001), the repeated loading and the trapped water caused about two inches of the concrete deck to completely deteriorate. During the bridge inspection, three coring holes shown in Figure 4.3, were noticed; only one of the cores continued all the way through the concrete deck.

**Figure 4.2. MCB Girder 2 Deterioration and Delamination.**

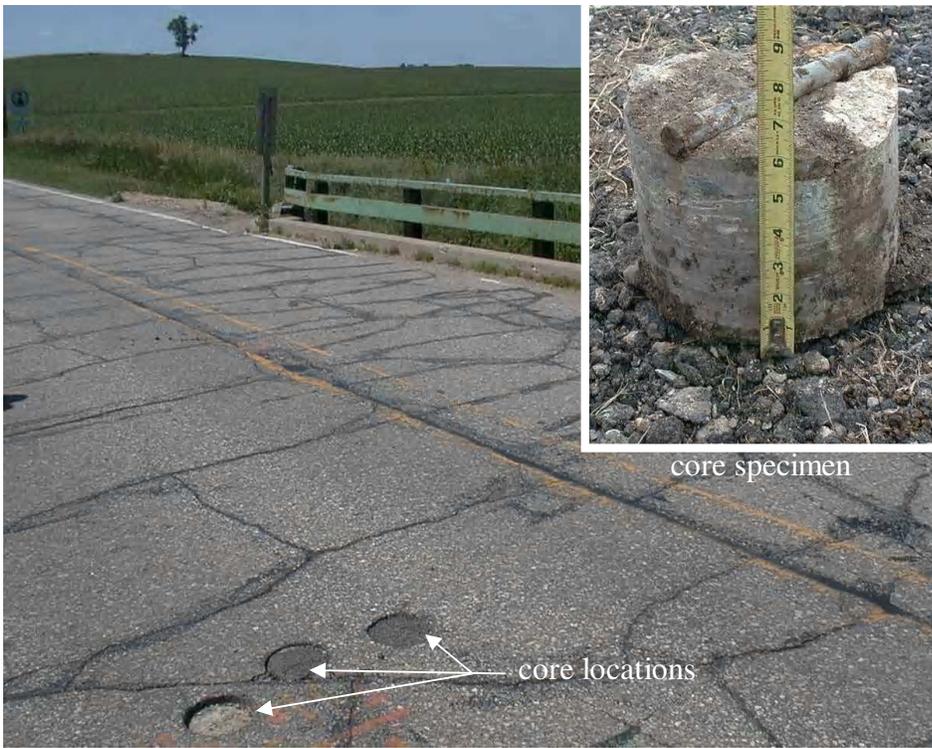
**Figure 4.3. MCB Core Locations and Retrieved Core Specimen.**

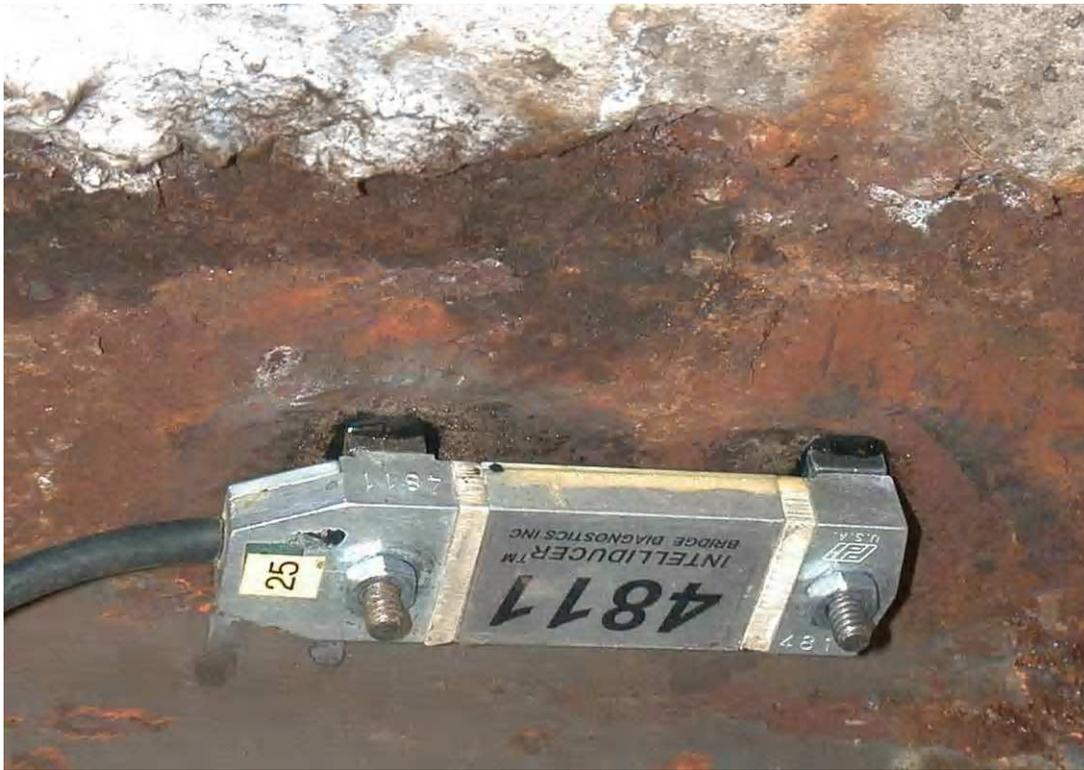
**Figure 4.11. MCB Removal of Excess Corrosion for Transducer Application**

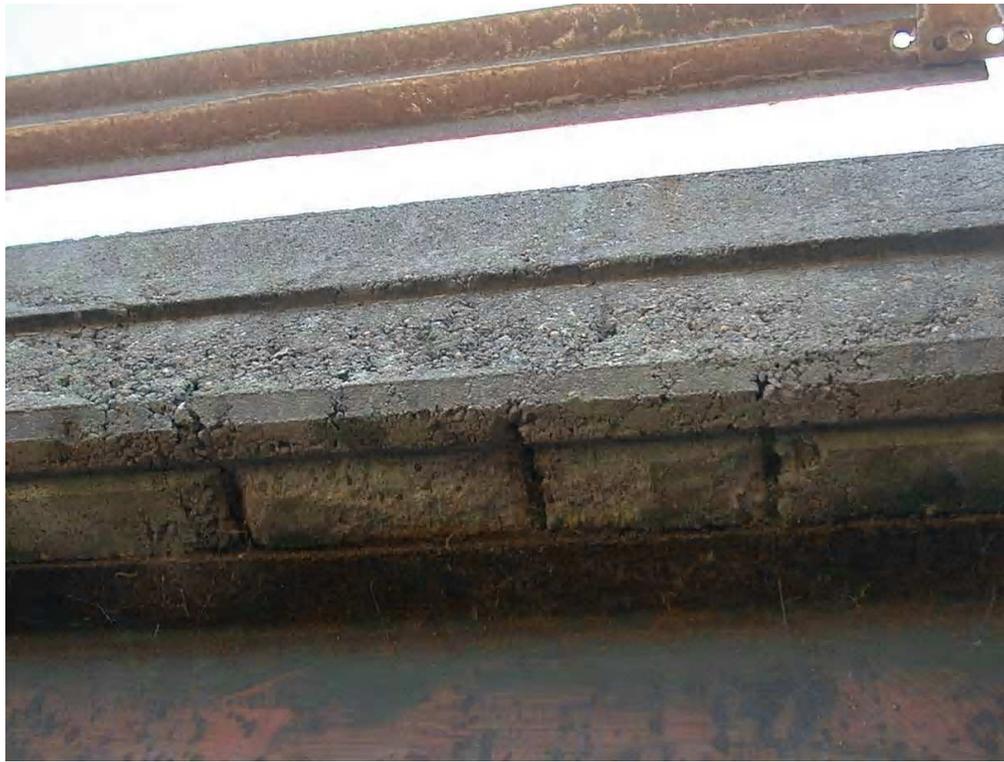
The superstructure was in relatively good condition with only minor rust on the girders. Signs of poor concrete consolidation during the construction of the deck were observed on the underside of the deck where there were large voids near the midspan. The poor consolidation caused some of the reinforcing steel to be exposed as shown in Figure 5.2. There was also a large crack in the concrete deck located at the midspan of the bridge, a photograph of which is provided in Figure 5.3.

**Figure 5.2. KCB1 Poor Concrete Consolidation.**

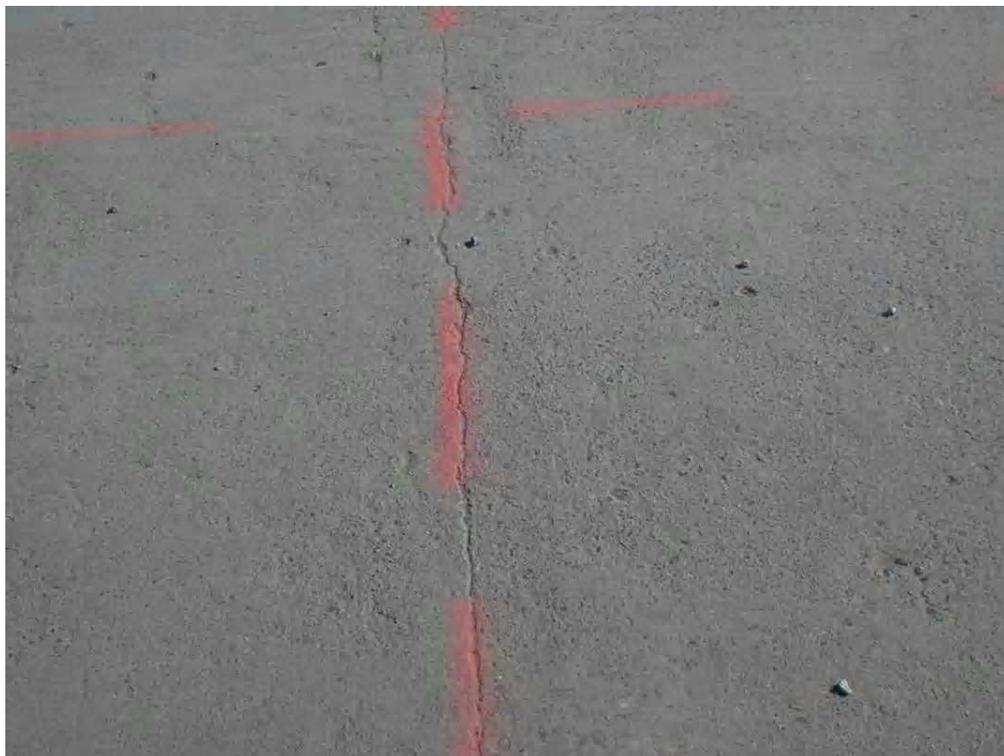
**Figure 5.3. KCB1 Deck Crack.**

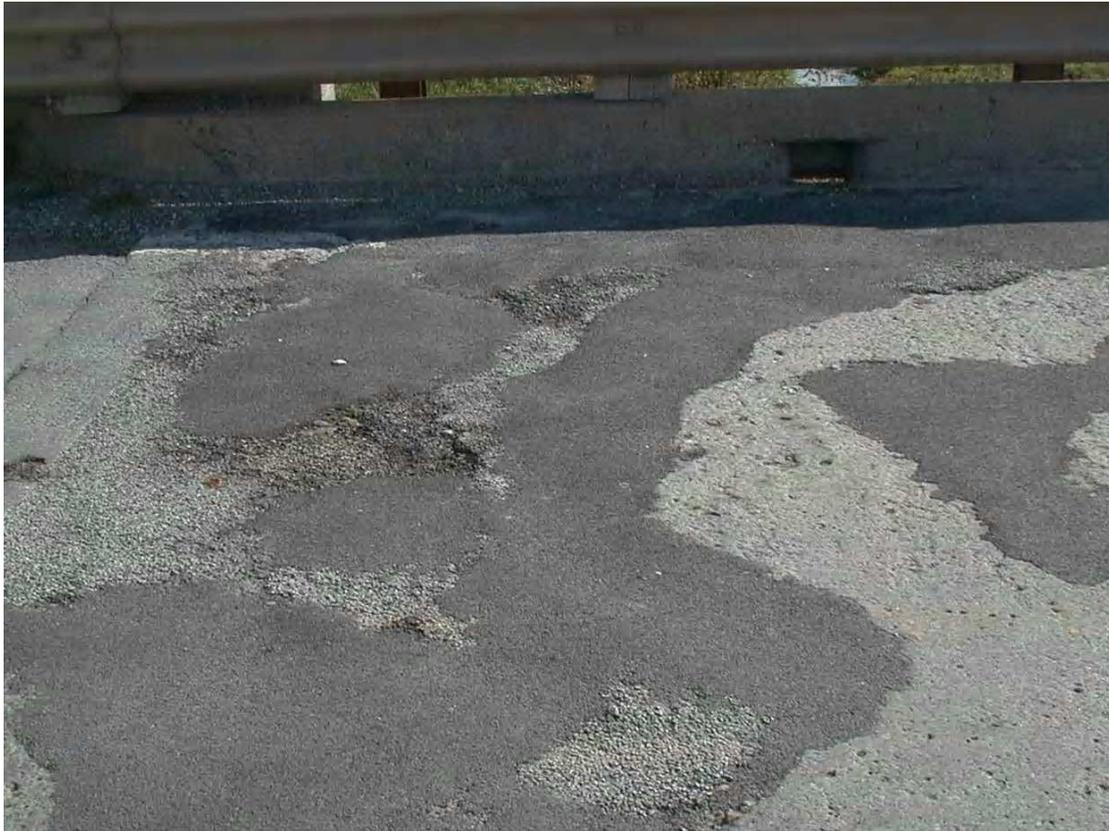
The superstructure was in relatively good condition with only minor rust on the girders. The concrete deck however was in poor condition; there were areas of severe spalling on the wearing surface of the deck that had been patched with asphalt to create a smoother ride over the bridge. A photograph of the asphalt patches is shown in Figure 6.2.

**Figure 6.2. Asphalt Patches in CCB Concrete Deck.**

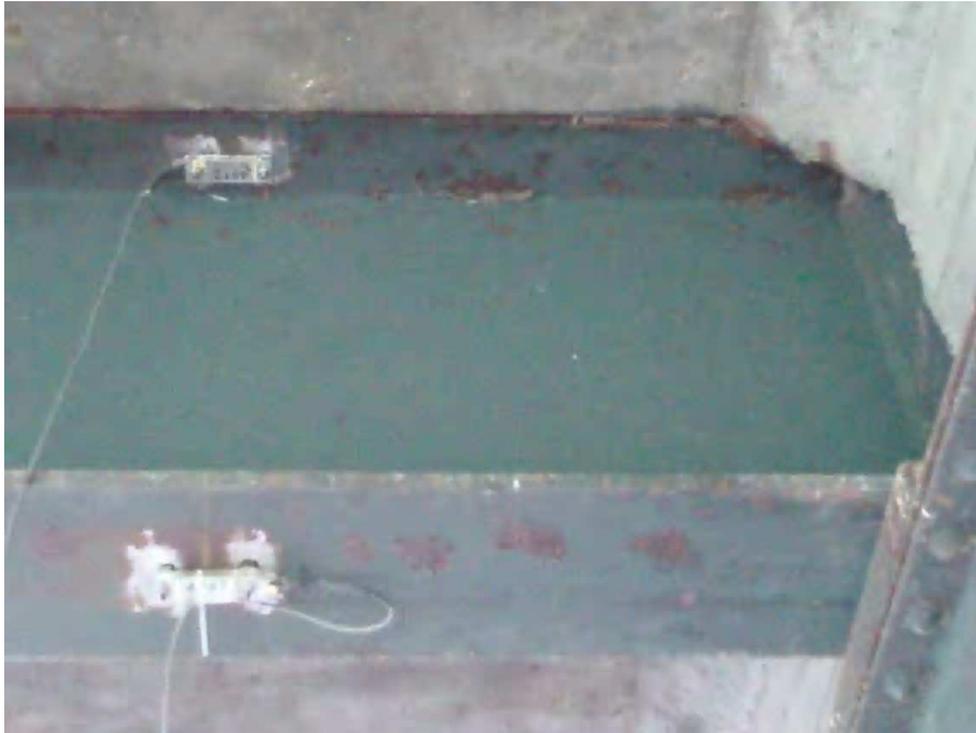
The bridge was instrumented 24 inches from the edge of the bearing at each abutment, at the north quarter point, and at the midspan. Figure 6.6 is a photograph showing the location of the strain transducers 24 inches from the edge of the bearing. In this test, the strain transducers near the abutment were moved from six inches away from the edge of the abutment cap to 24 inches from the abutment cap in an attempt to reduce the chance of

**Figure 6.6. CCB Bearing Transducer Locations.**

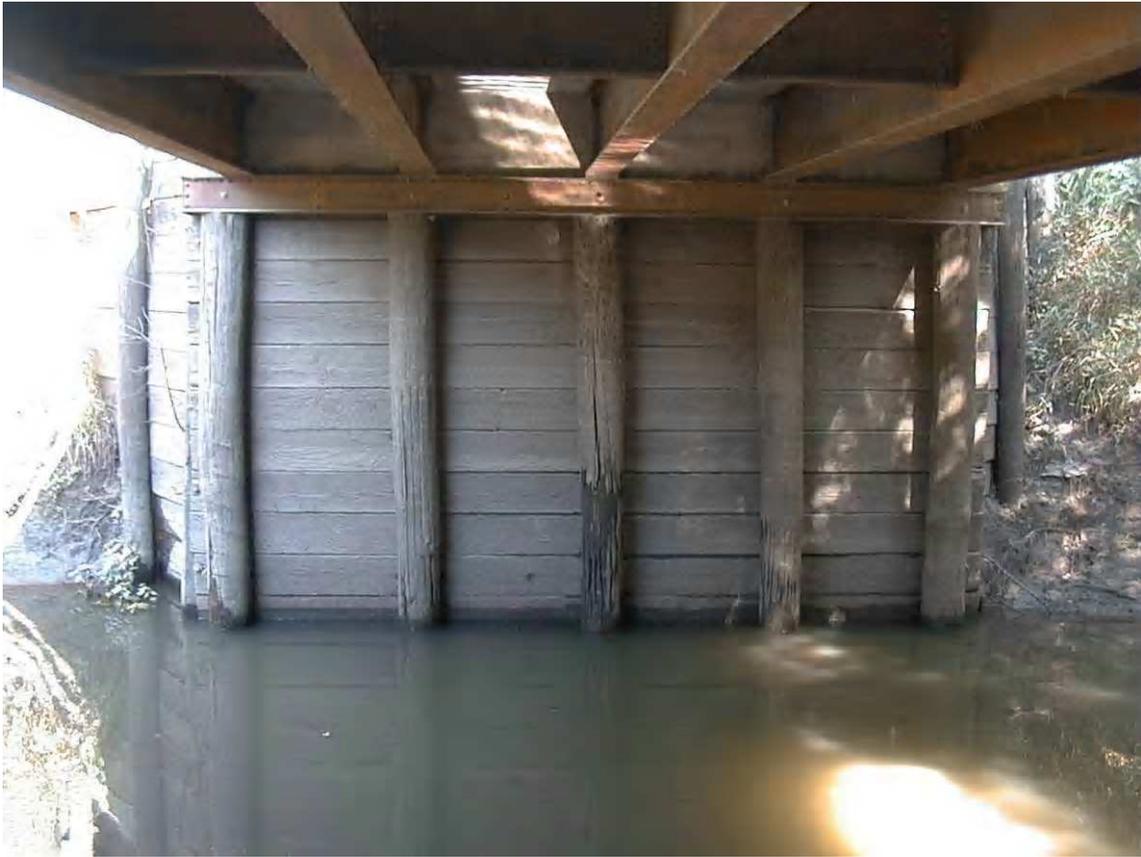
**Figure 7.2. KCB2 Pile Deterioration.**

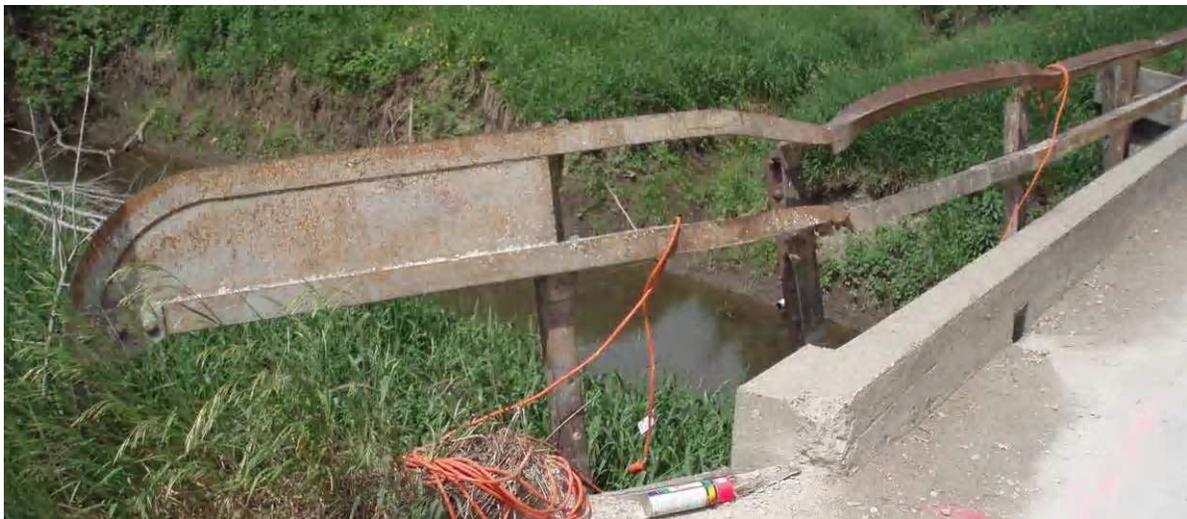
**Figure 7.3. KCB2 Railing Damage.**

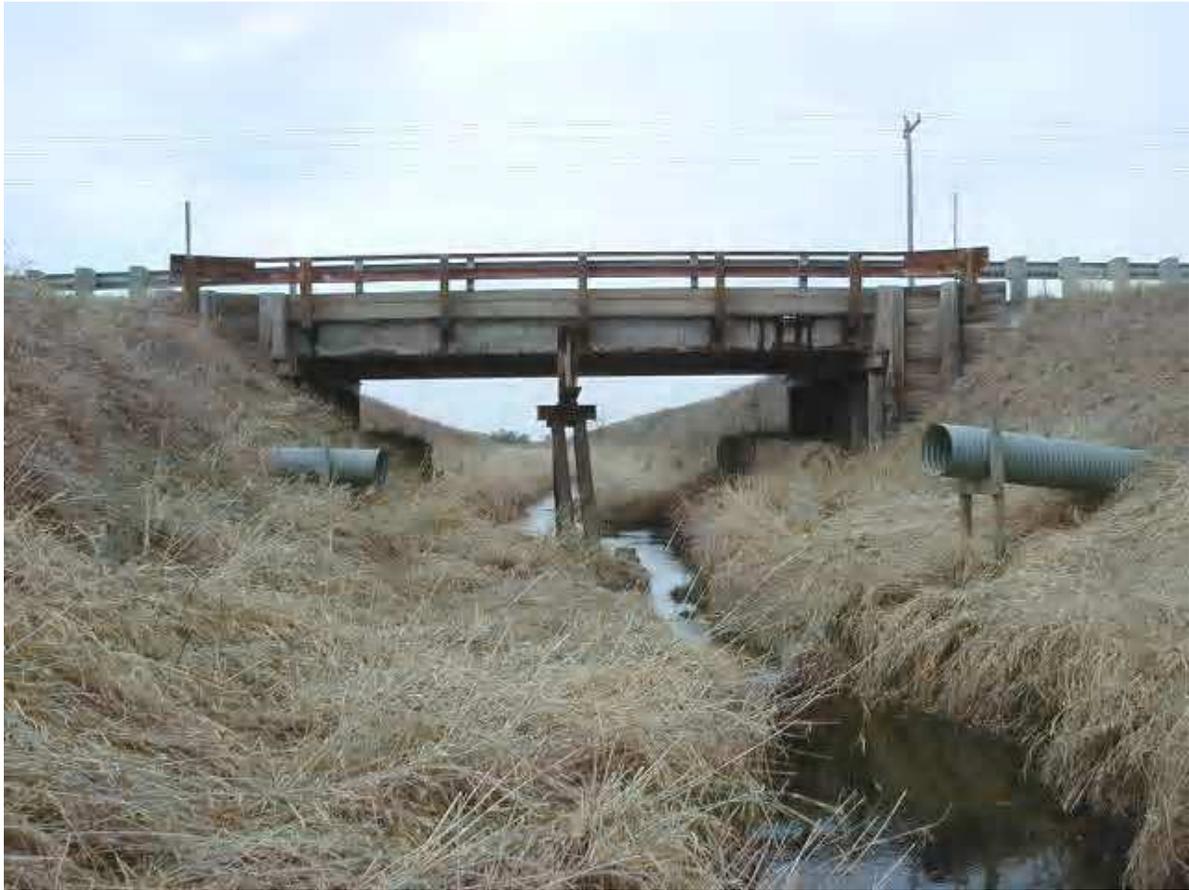
**Figure 8.2. HCB Elevation View of Bridge Looking North.**

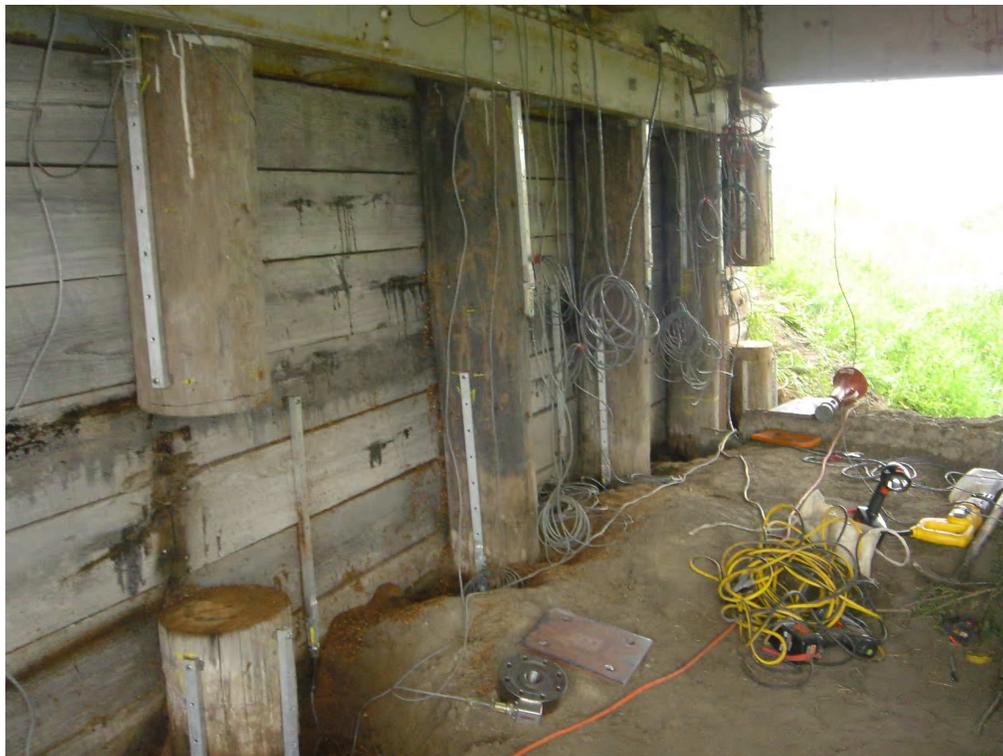
**Figure 8.22. Photograph Showing Sections of Piles 3 and 7 Removed from HCB.**
