Field Testing of Railroad Flatcar Bridges Volume II: Multiple Spans

**Final Report
August 2007**

the Iowa Department of Transportation
and
the Iowa Highway Research Board (Project TR-498)

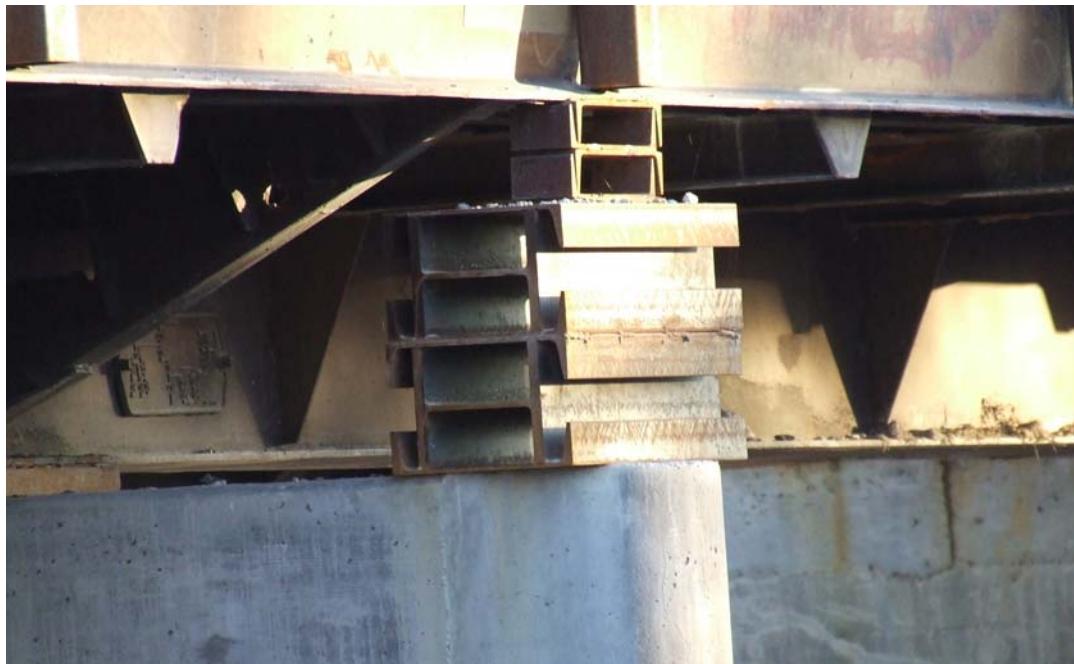
Figure 2.3. Miscellaneous I-shapes used as exterior girder support

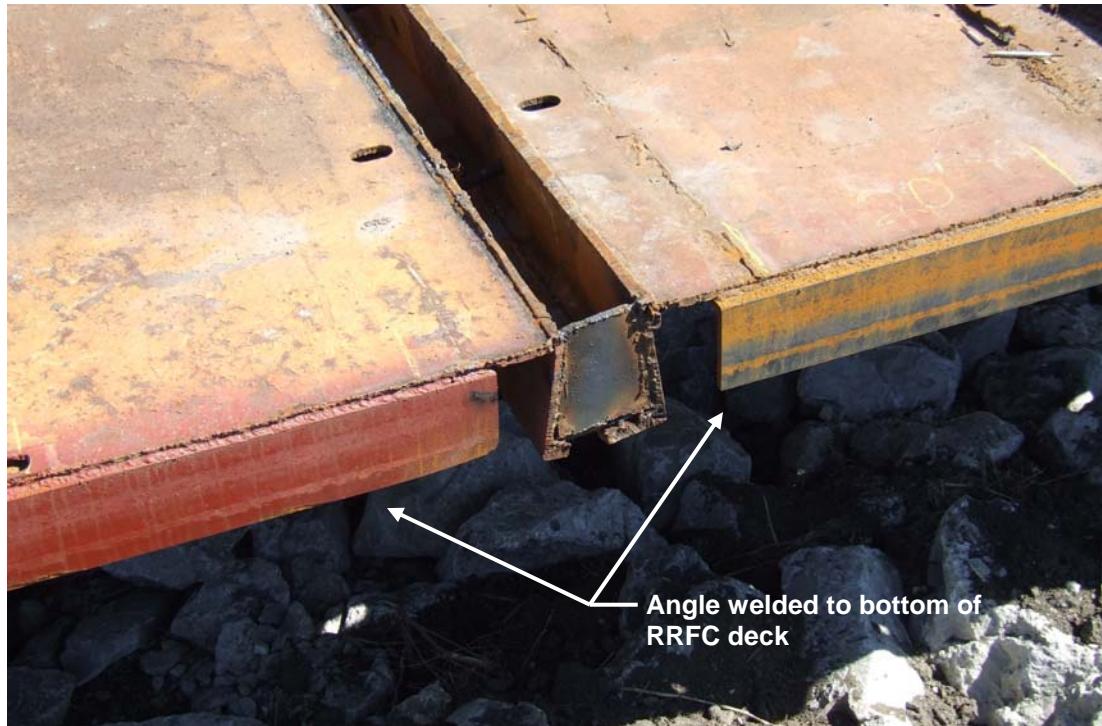
Figure B.7. Angle welded to bottom of RRFC deck

Due to a misunderstanding between the parties involved, a 5 inch x 3 inch x 1/2 inch angle was welded to the bottom of the deck of the RRFCs (Figure B.7) before the placement of the flatcars. This angle was proposed to represent the connection between the bridge superstructure and the abutments. However, after review by Iowa State University, additional stiffened angles 4 inch x 4 inch x 1/2 inch were added below the main bearing points (girders and longitudinal connections) as shown in Figure B.8. These angles were smaller than the angles discussed in Section B.1.4 because the top angle took a portion of the load. No connection was made between the additional angles and the bridge superstructure.

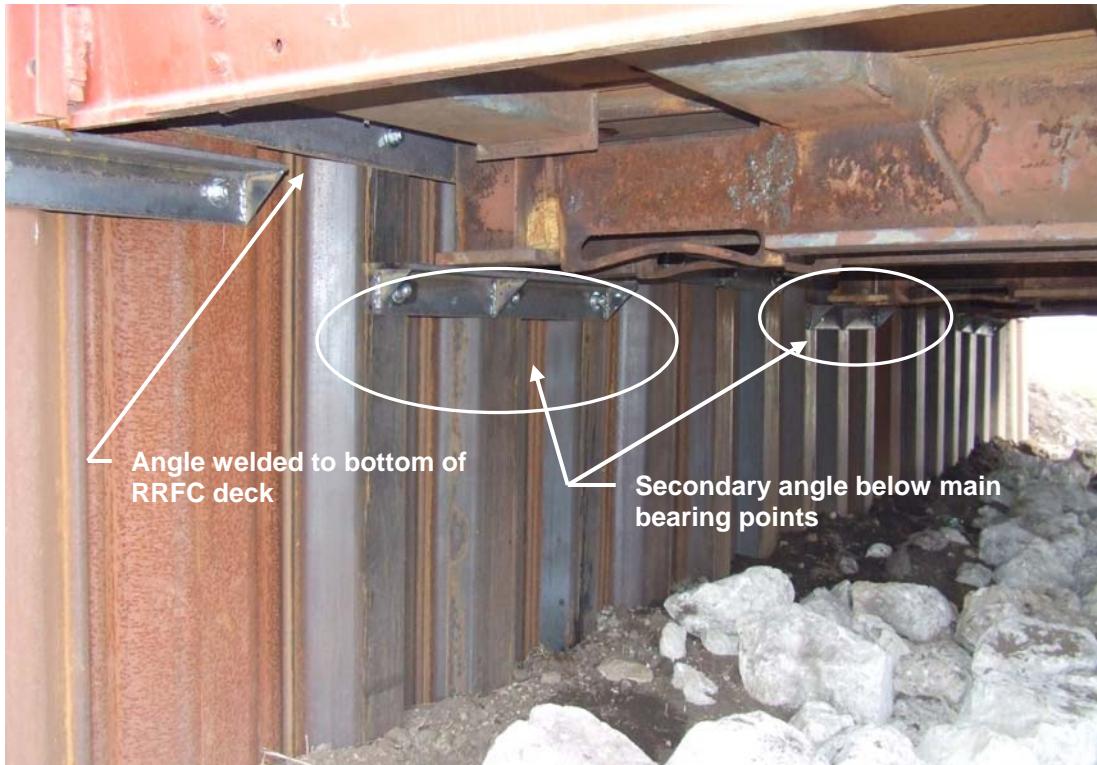
Figure B.8. Secondary angle attached below main bearing points

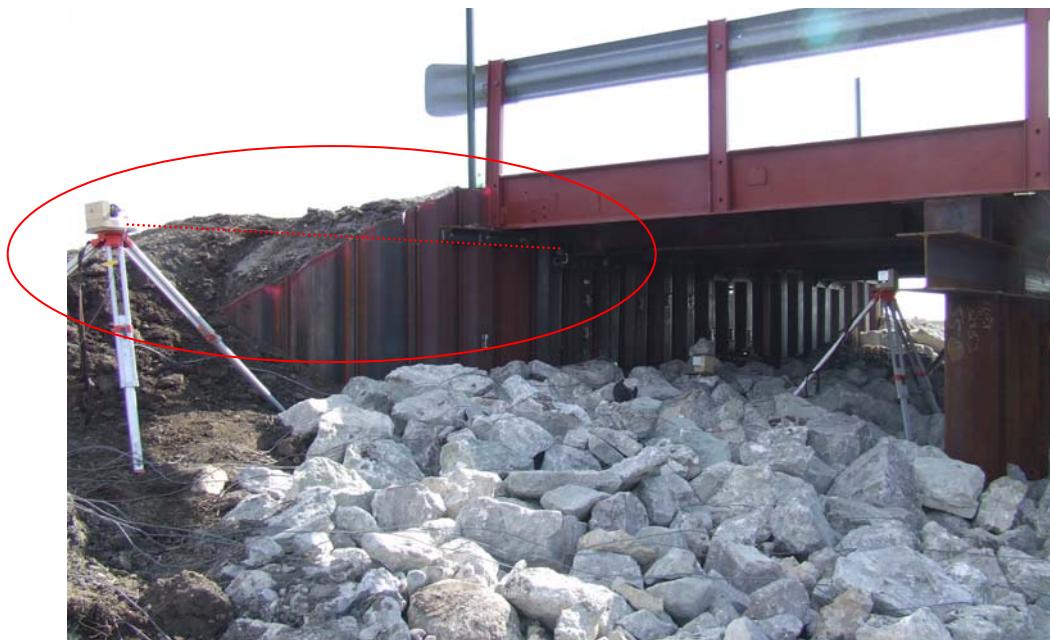
Figure B.11. Instrumentation measuring displacement perpendicular to traffic

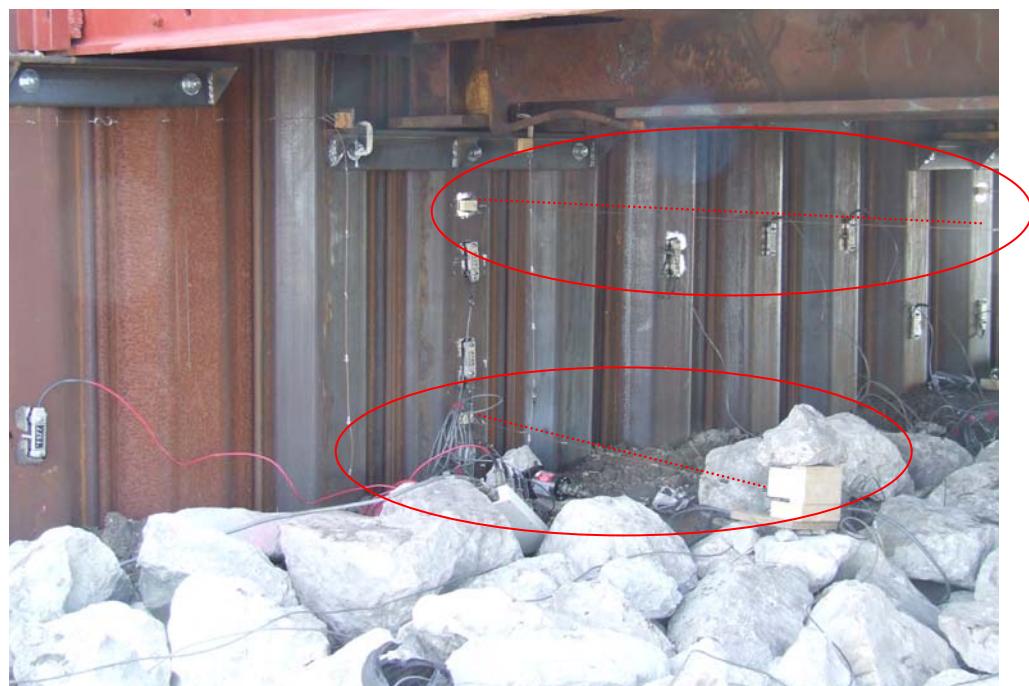
Figure B.12. Instrumentation measuring displacement in the direction of the bridge
