TR-541

**THE EFFECTS OF HEADCUT AND KNICKPOINT PROPAGATION ON
BRIDGES IN IOWA**

Final Report

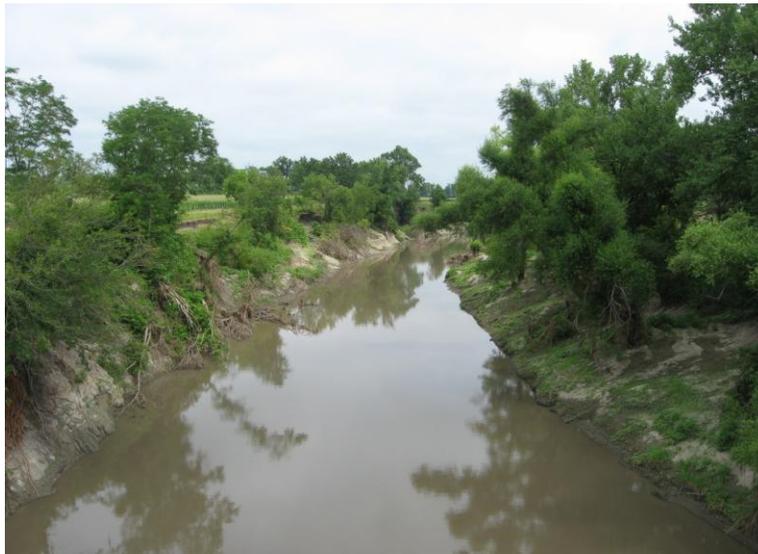
Figure 1. West Tarkio Creek in western Iowa. The steep banks are a reflection of the severe down-cutting of the channel in this system.

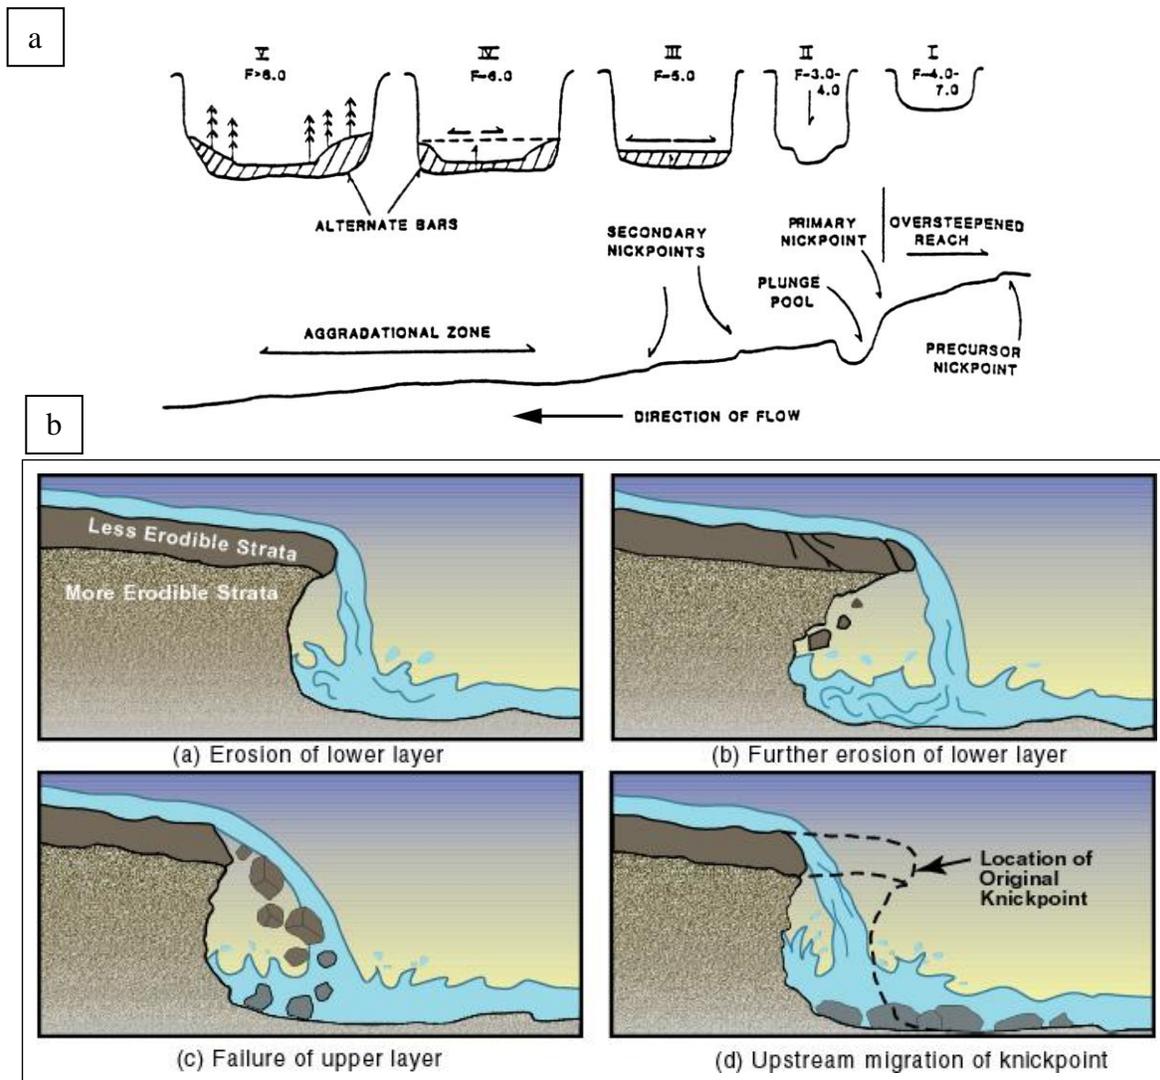
Figure 2. Types of knickpoints. (a) A definition sketch of headcut (primary knickpoint) and knickpoint (secondary knickpoint) formation. (b) A sketch of the steps involved in knickpoint migration.

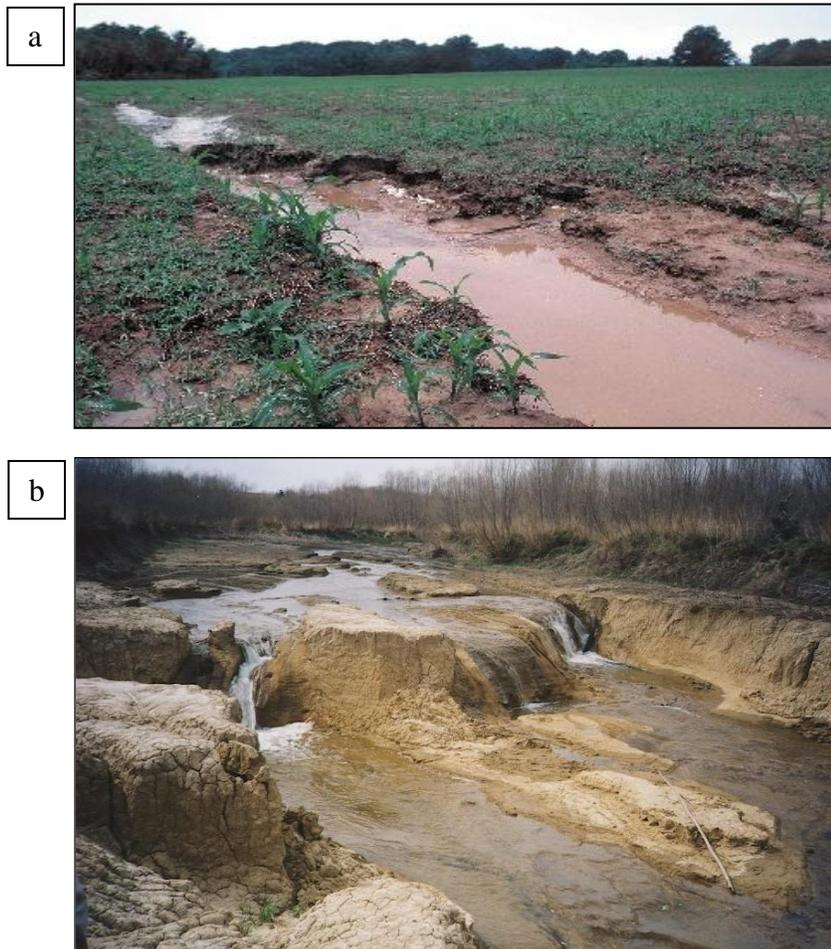
Figure 3. Headcut formation. (a) A headcut is shown developing into a gully at Treynor, Iowa. (b) Headcut progression up the Fox River, Missouri.

Headcuts are step-changes that occur at the heads of channel networks and may eventually lead to gully formation within fields (Figure 3; Bennett et al., 2000). Headcuts are fed by ephemeral or intermittent channels and tend to have smaller drainage areas than

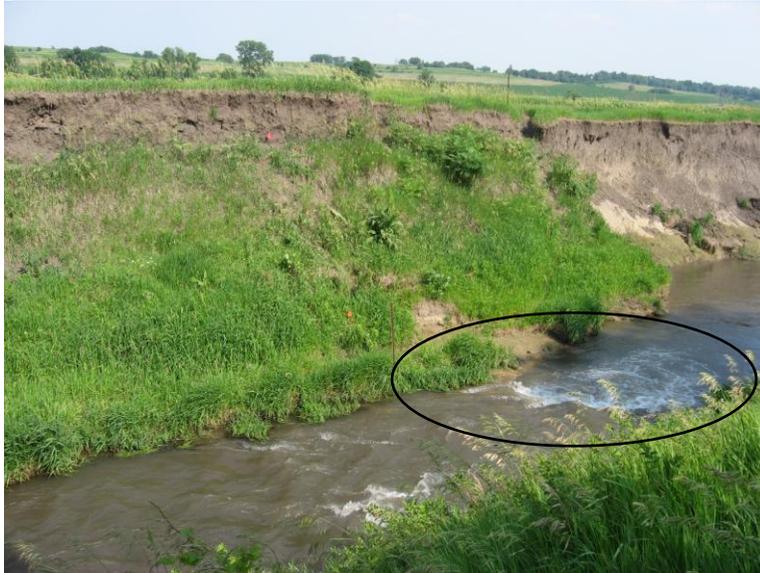
Figure 4. Knickpoint formation. The circled area is a knickpoint in Mud Creek, Iowa.

A step-change that is confined within the channel banks (Figure 4) is referred to as a knickpoint (Bennett et al., 2000). Knickpoint erosion often follows a particular sequence: gradual scour of a lower, more erosive layer leads to undercutting and, ultimately, collapse of a more resistant capping layer (Figure 2b). There are generally four mechanisms of mass failure observed at knickpoints (May, 1989):

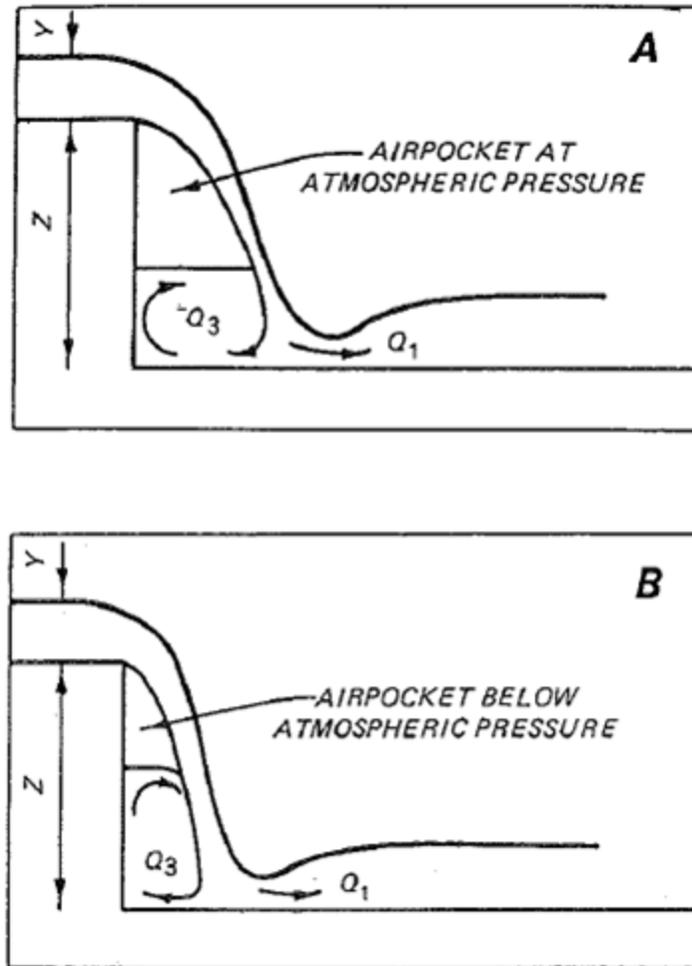
Figure 5. Hydrodynamic forces at a knickpoint. From May (1989). The (A) vented and (B) unvented conditions below the nappe of a knickpoint.

The hydraulic controls of knickpoint migration predominantly influence the angle of the impinging flow, which leads to scour and undercutting of sediments below the knickpoint. Two scenarios, namely the vented and unvented condition (Figure 5), occur under the nappe that affect the impact angle. In the vented condition, pressures under the nappe are equivalent to atmospheric pressure. The impact angle is controlled by the ratio of the knickpoint face height to the critical flow depth atop the knickpoint (May, 1989). When this ratio exceeds 8, the angle between the jet impact and the knickpoint face approaches 90 degrees. As the impinging jet is drawn closer to the knickpoint face, more of the flow is entrained into the reverse roller effect thereby enhancing scour. Under the unvented condition, pressures below the nappe are below atmospheric pressure (May, 1989). This pressure differential also draws the impinging jet closer to the knickpoint face producing scour. In addition, the pressure differential may induce suction of sediment from the face.

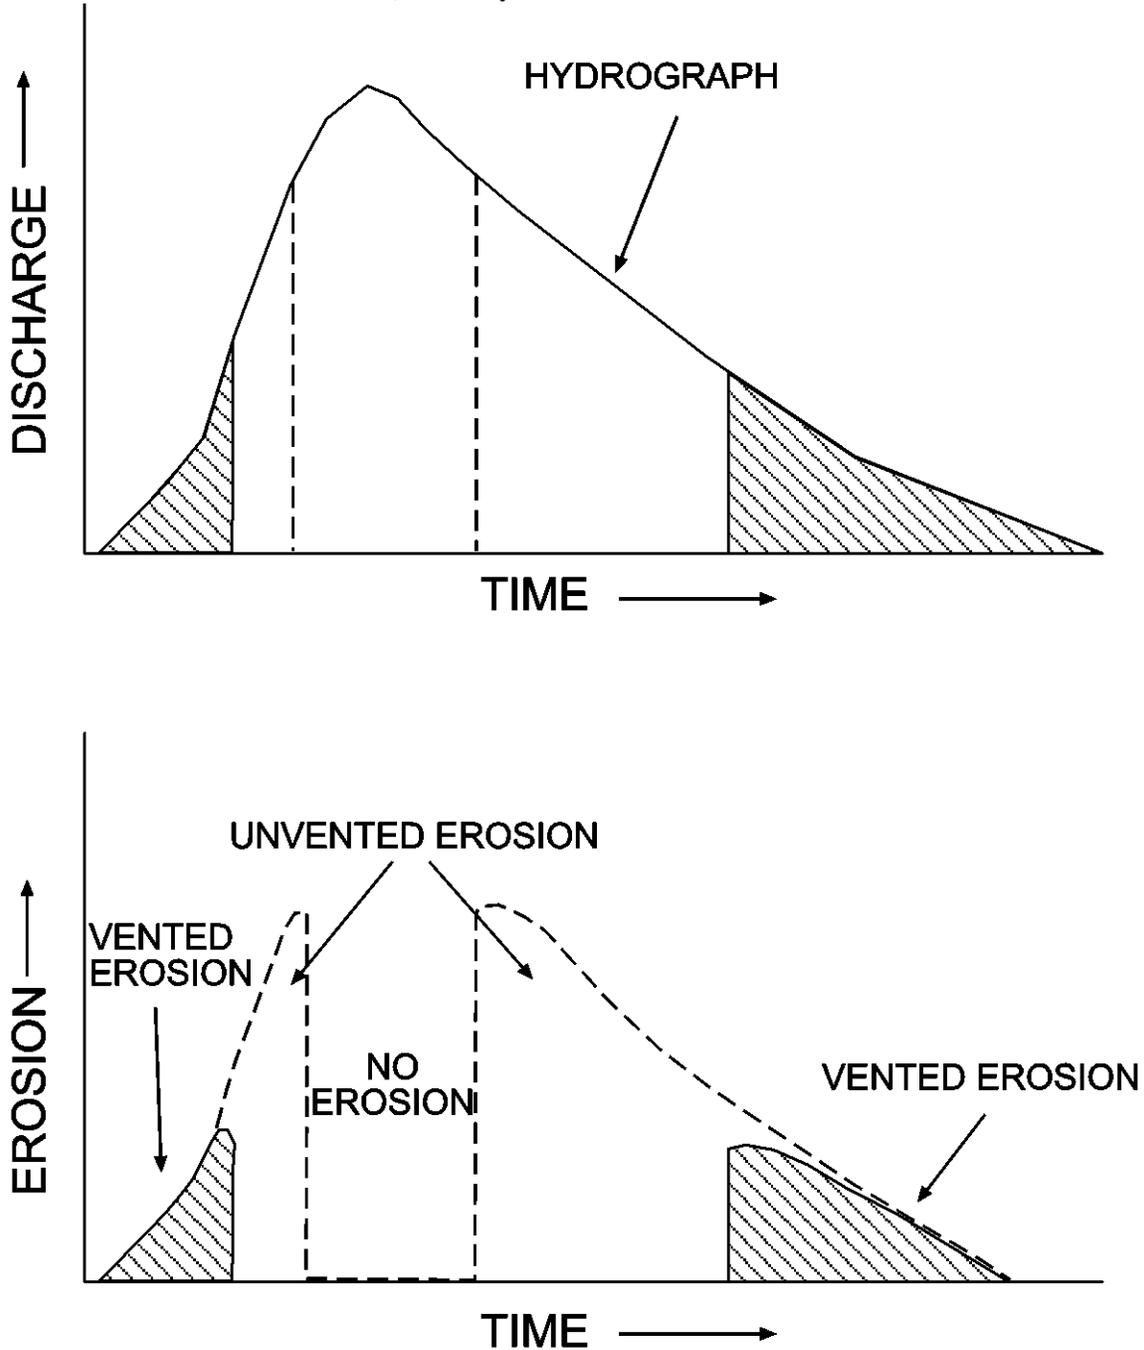
Figure 6. Scour during runoff events. From May (1989). The cross-hatched areas are the times during a runoff event when scour under vented conditions will occur. The dashed areas are conditions when unvented scour most likely will occur.

In both scenarios, low flows may be more influential on knickpoint erosion than higher flows because it is at these lower flows that the impinging jet is closest to the knickpoint causing more scour (May, 1989). Moreover, the unvented condition tends to produce more scour than the vented condition (May, 1989). During a runoff event, the relative amount of scour changes as the discharge changes (Figure 6), i.e., as flow increases the impinging jet moves further from

the knickpoint face thereby decreasing scour. Thus scour most likely occurs at the beginning and end of the runoff events.

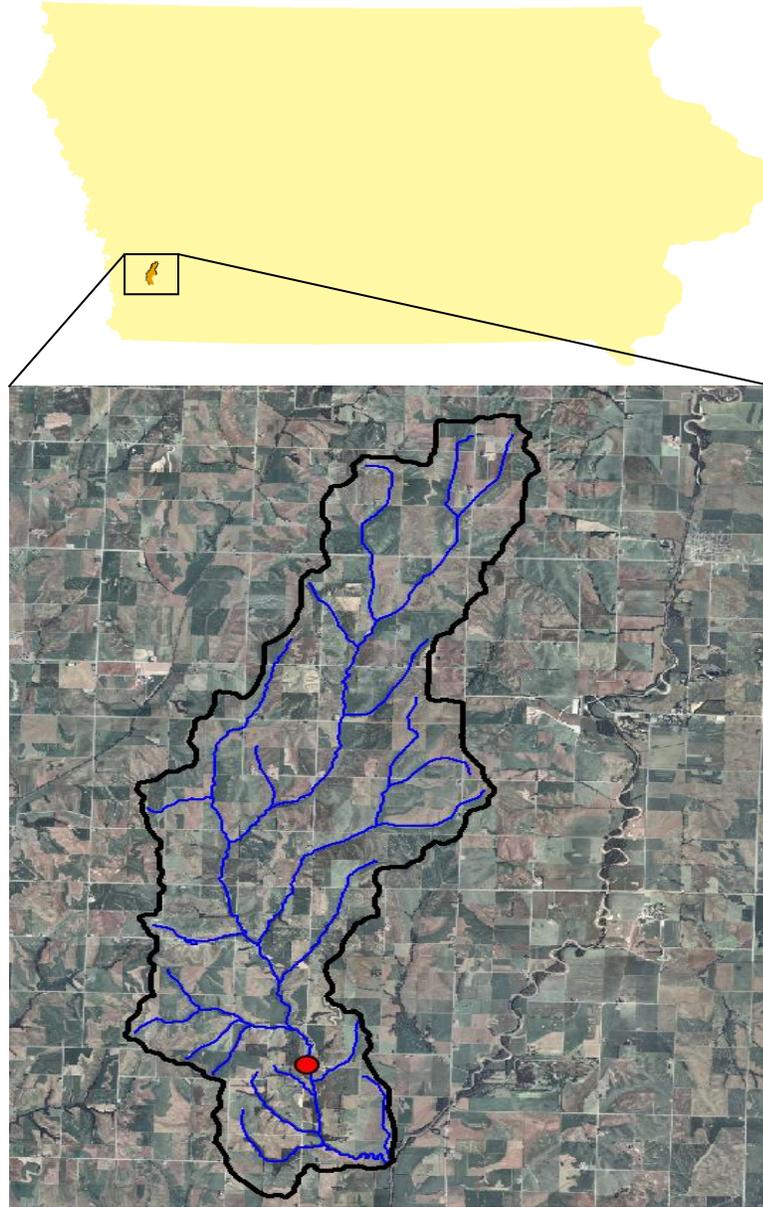
Figure 7. Study Site. Mud Creek, IA is a HUC-12 watershed in southwestern Iowa. The red circle is the focal point of this study.

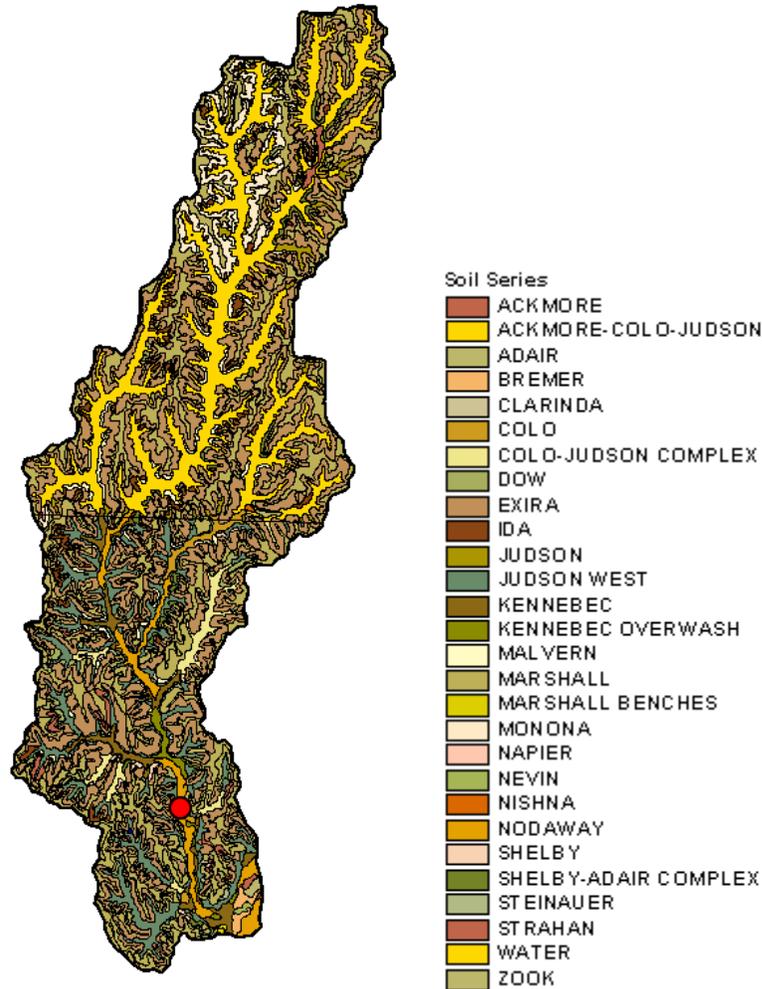
Figure 8. Soils Map. The Mud Creek watershed contains 28 soil series; however, three series cover 72% of the watershed.

Three soil series encompass 72% of the drainage area of Mud Creek (Figure 8). These three series (Marshall, Exira, Ackmore-Colo-Judson) transition across the landscape from the uplands to the floodplains. The Marshall series is characterized as loess-derived, well drained, upland soils. Marshall soils are silty clay loams with 2 to 4% organic matter (Nixon, 1982). Soils in the Exira series are similar to those in the Marshall series (Nixon, 1982); however, they are found lower on the landscape. The Ackmore-Colo-Judson Series is in the bottomlands and floodplains. These soils are silt loams to silty clay loams with high organic matter content (3 to 7%) and are primarily derived from alluvium (Nixon, 1982). The Ackmore and Colo series contain somewhat poorly to poorly drained soils, while the Judson series has soils that are moderately well drained (Nixon, 1982). The soils immediately adjacent the knickpoint study area belong to the Nodaway soil series (Figure 8). These soils are similar to those in the Ackmore series but are moderately well drained (Nixon, 1982). The Nodaway series is mainly in the lower part of the watershed, comprising only 2% of the total drainage area, and lies along the channel.

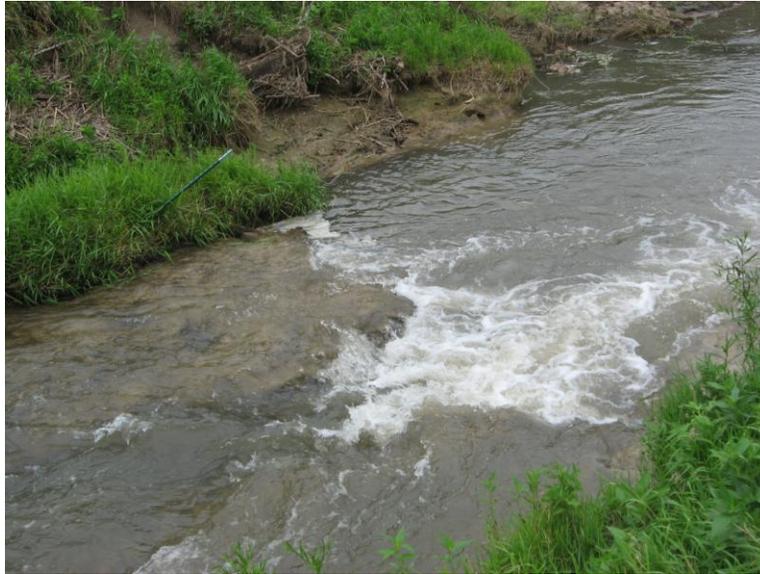
Figure 9. Knickpoint at study site. The knickpoint in Mud Creek below the Elderberry Rd. Bridge was the focal point of this study.

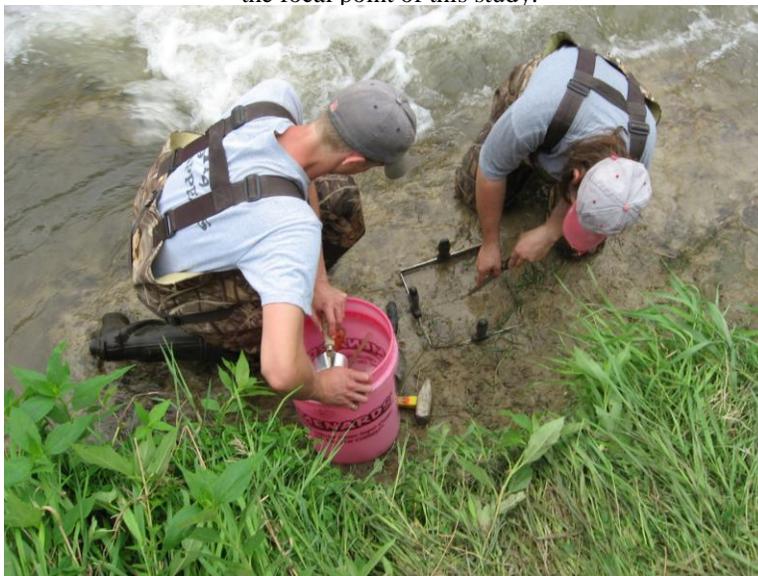
Figure 10. Bed and Bank Sampling. Samples of the stream bed and channel banks were collected for geotechnical analysis.

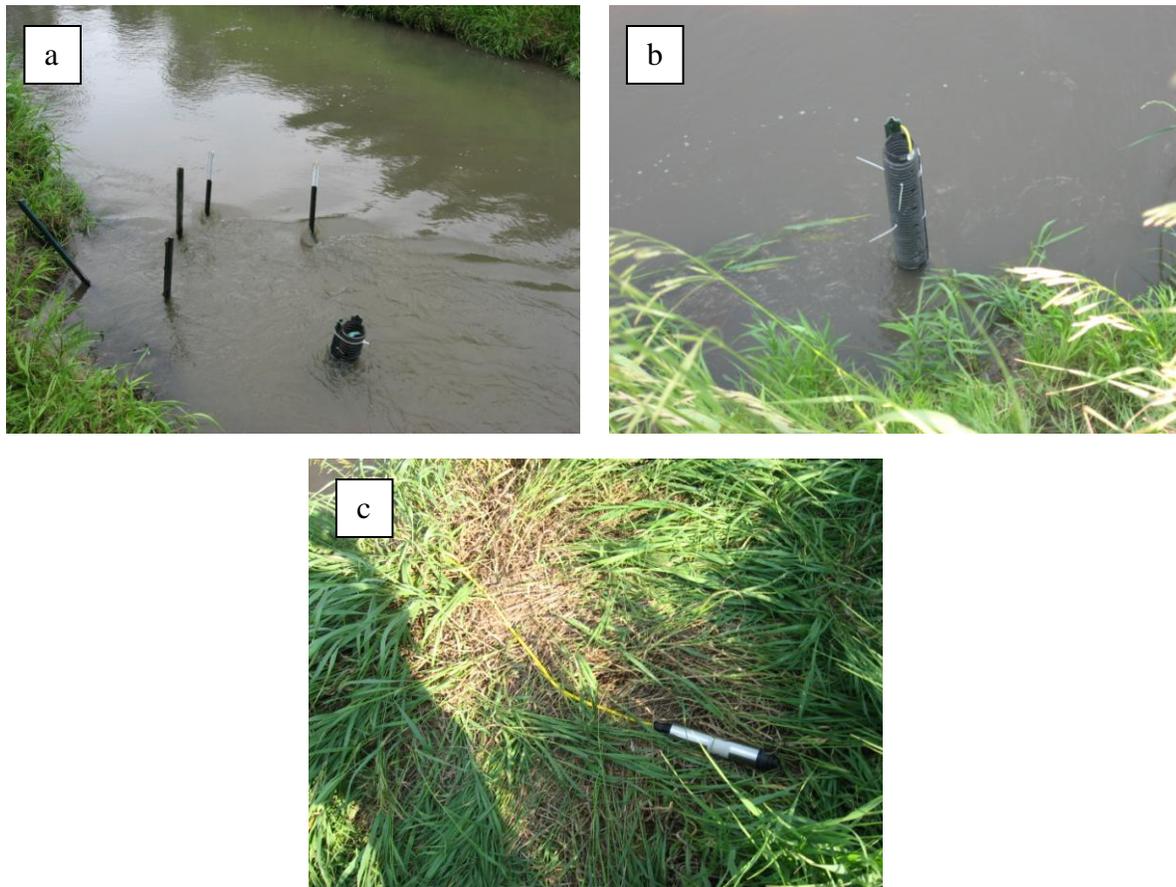
Figure 11. Pressure transducer. (a) Close up of the stilling well. (b) Pressure transducer installed in a stilling well among T-posts. (c) Enclosed datalogger that is attached to the pressure transducer.

transducer was mounted in a stilling well 10 cm above the streambed. At this depth, the pressure transducer was submerged during the entire study period. The stilling well was approximately 60 cm from the channel bank amid four fence posts that were sunk into the stream bed to limit the impact of debris flowing downstream during runoff events (Figure 11b). The pressure transducer was connected to a self-contained datalogger, which was mounted atop the bank, through a vented cable (Figure 11c). The vented cable allowed for equilibration with atmospheric pressure. The datalogger recorded the pressure of water above it at hourly intervals. This pressure was linearly related to the stage.

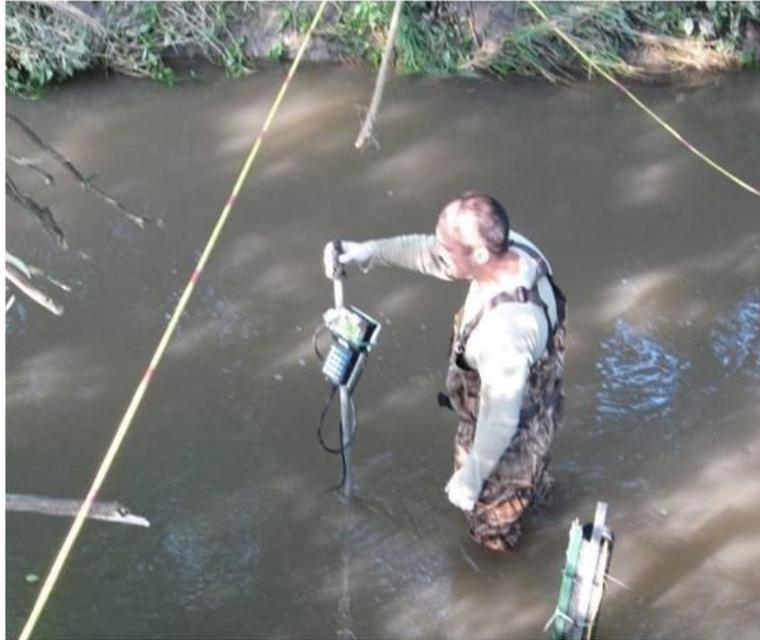
Figure 12. FlowTracker. Velocity measurements using a FlowTracker are needed to develop a stage-discharge rating curve.

measured velocity. It transmits to a datalogger attached to the instrument making it suitable for extensive field measurements.

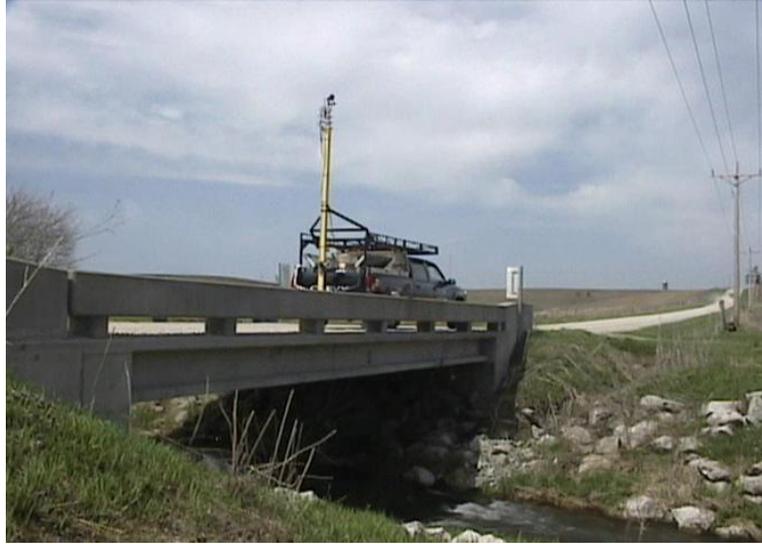
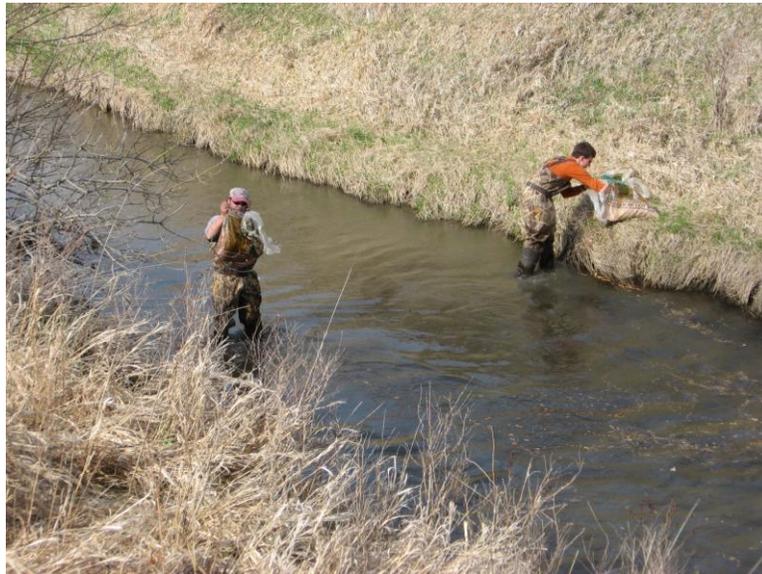
Figure 13. LSPIV. (a) The LSPIV truck collects video imagery of seeded particles in the stream to determine the free surface velocity. (b) Seeding of the stream with eco-safe mulch for LSPIV measurements.

At higher flows, Large-Scale Particle Image Velocimetry (LSPIV) was used to measure flow velocities and discharges (Figure 13a). LSPIV measures the free surface velocity based on the concept of pattern recognition used in human vision. Velocity vectors over an area are obtained by estimating displacements of floating fluid-markers using inexpensive video equipment and a geodetic survey to describe the region of interest (Figure 13b). The video images were subsequently digitized and processed using a commercial particle image velocimetry program (LSPIV2), which calculates the 2-D flow field on the water surface as a function of time. In conjunction with bathymetry data, the program estimated the flow discharge.

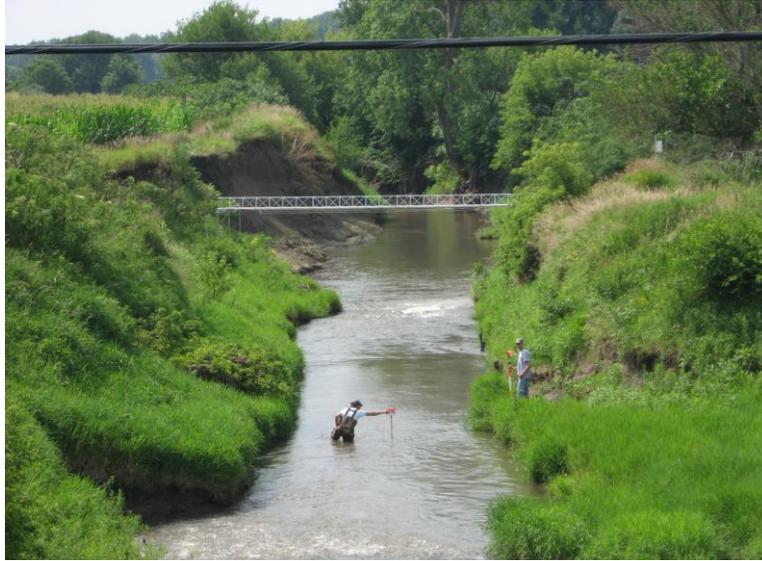
Figure 14. Survey of the knickpoint. Bi-annual surveys of the channel morphology were conducted at the knickpoint study site.

daily for three months from June until September 2008. These measurements provided exact positions of the top of knickpoint and scour hole.

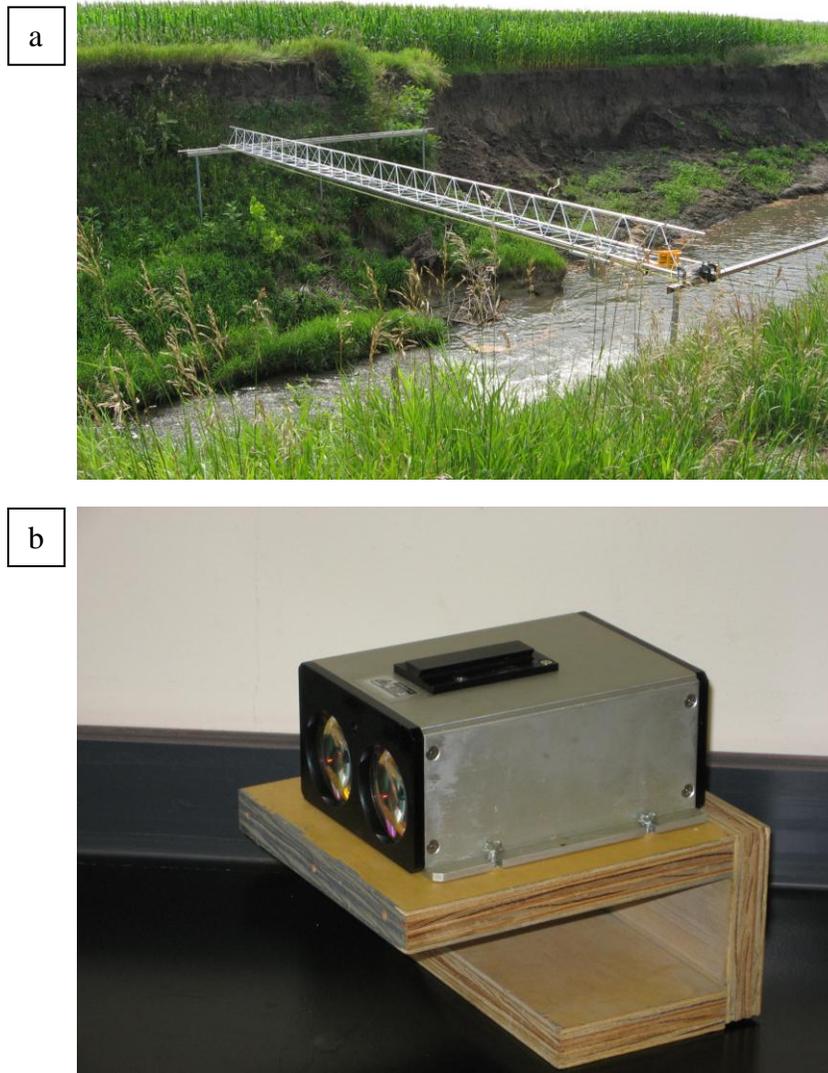
Figure 15. Laser Truss. (a) Measurements of the water surface were conducted at the knickpoint using a laser suspended from a radio antenna truss. (b) Laser level to measure distance from a fixed datum to the water surface.

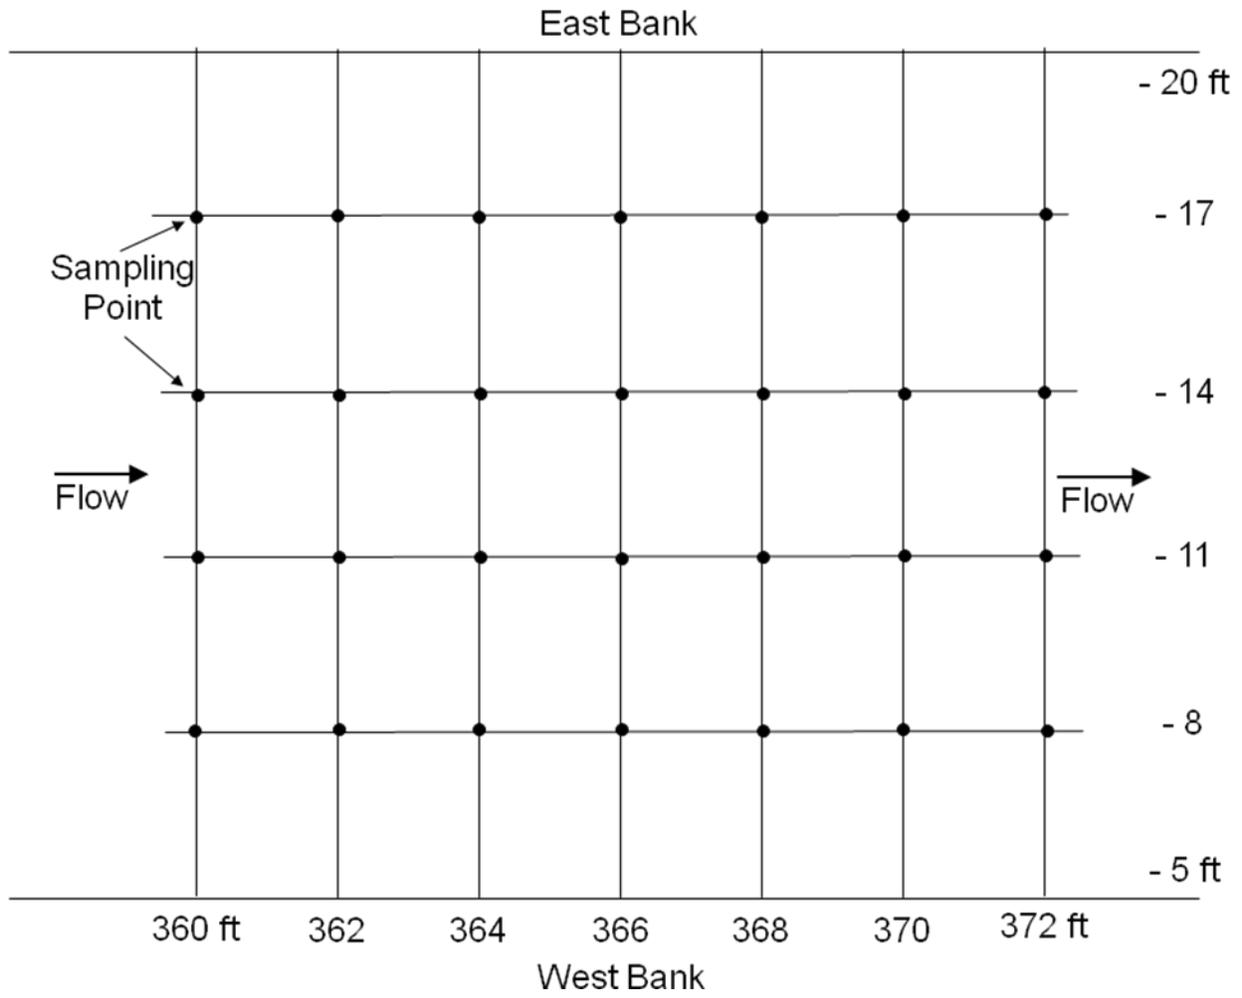
Figure 16. Laser measurement grid. A grid was developed to provide repeatable measurement locations for the laser level suspended over the knickpoint.

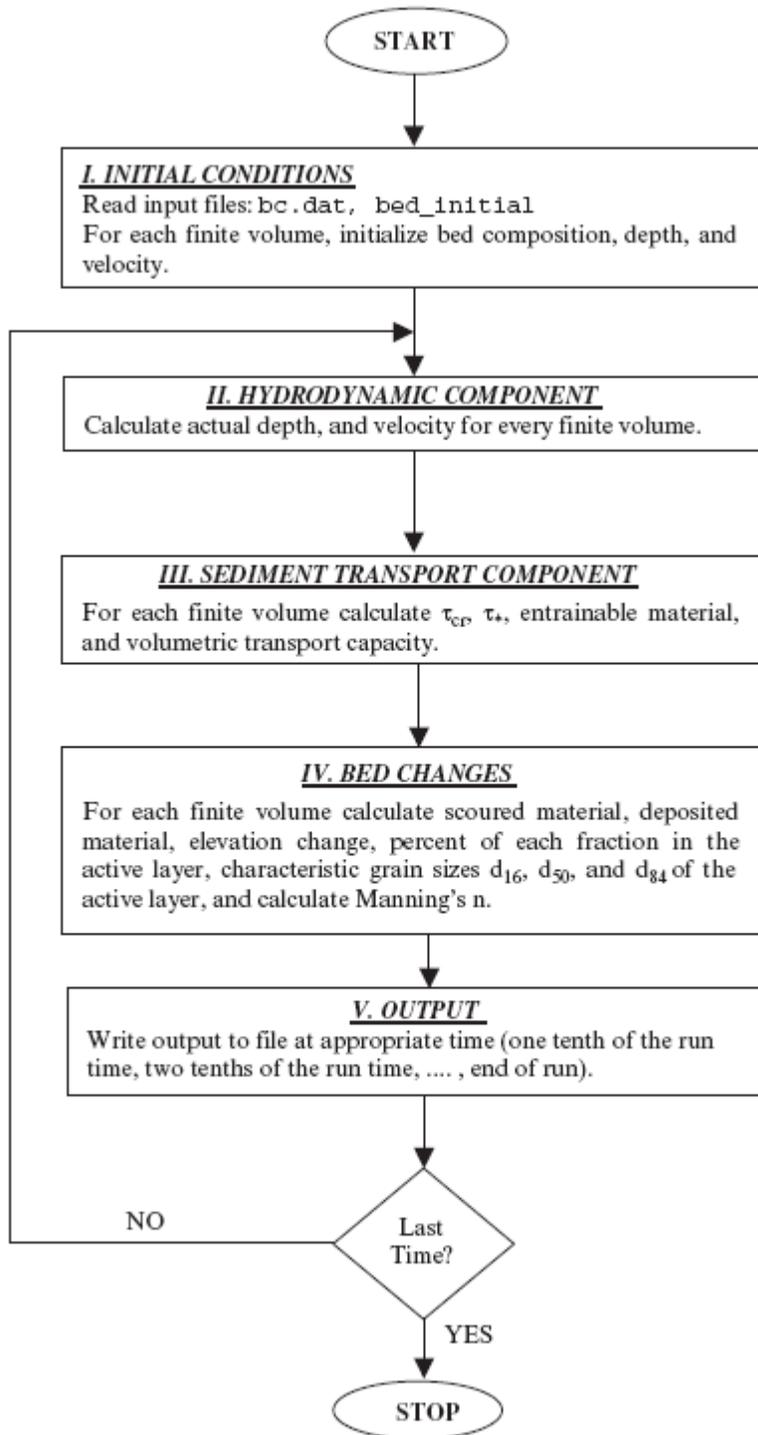
Figure 17. 3ST1D. From Papanicolaou et al. (2004). A flowchart showing the structure of 3ST1D, the model used to evaluate knickpoint formation and propagation.

Using the information gathered in the field, the Steep Stream Sediment Transport 1-D model (3ST1D; Papanicolaou et al., 2004) was used to model knickpoint erosion and predict future upstream migration. The model, 3ST1D (Figure 17), is generally used to calculate flow and sediment transport in steep mountain streams and is applicable to unsteady flow conditions that occur over transcritical flow stream reaches (i.e., subcritical to supercritical) such as flow over step-pool sequences or knickpoints. 3ST1D consists of two coupled components, the hydrodynamic and the sediment transport. The flow component in 3ST1D is addressed by solving the unsteady form of the Saint-Venant equations. The Total Variation Diminishing Dissipation (TVD)-MacCormack scheme, which is a shock-capturing scheme capable of rendering the solution oscillation free, is employed to approximate the hydrodynamic solution over the knickpoint face. The sediment component of the model accounts for multifractional sediment transport and incorporates a series of various incipient motion criteria and frictional formulas applicable to cohesive sediment beds (Sanford and Papanicolaou, 2005). In addition, sediment entrainability is estimated based on a state-of-the-art formula that accounts for the bed porosity, turbulent bursting frequency, probability of occurrence of strong episodic turbulent events, and sediment availability in the unit bed area. Thus, 3ST1D is one of the few models that can be used accurately in this study for testing different scenarios. It will prove useful for additional studies at other knickpoints in the state.

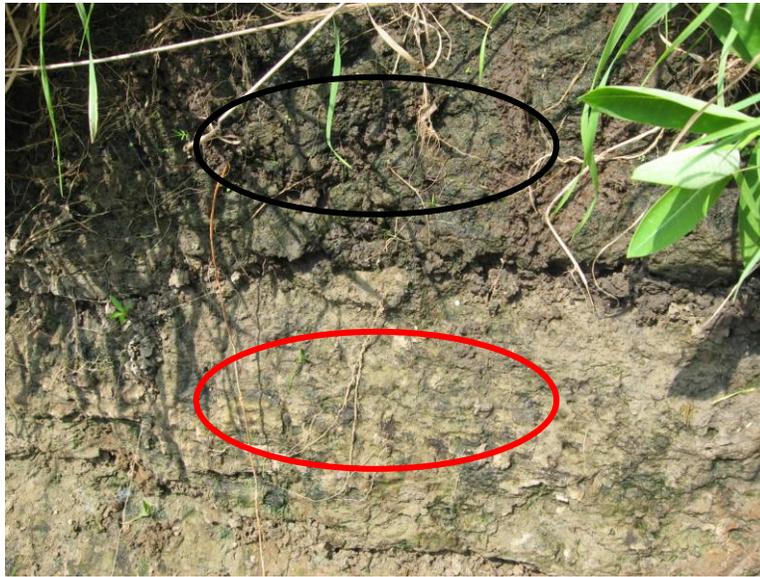
Figure 18. Stratigraphic discontinuity. There appears to be a stratigraphic discontinuity close to the knickpoint with a darker sediment (in the black circle) overlaying a lighter-colored sediment (in the red circle).

Additional visible evidence for supporting a stratigraphic discontinuity at the knickpoint site can be seen in Figure 18, which shows the different sediments, as well as what appears to be a “fault” between the two layers. These findings appear similar to those in the loess region of Mississippi (Whitten and Patrick, 1981).

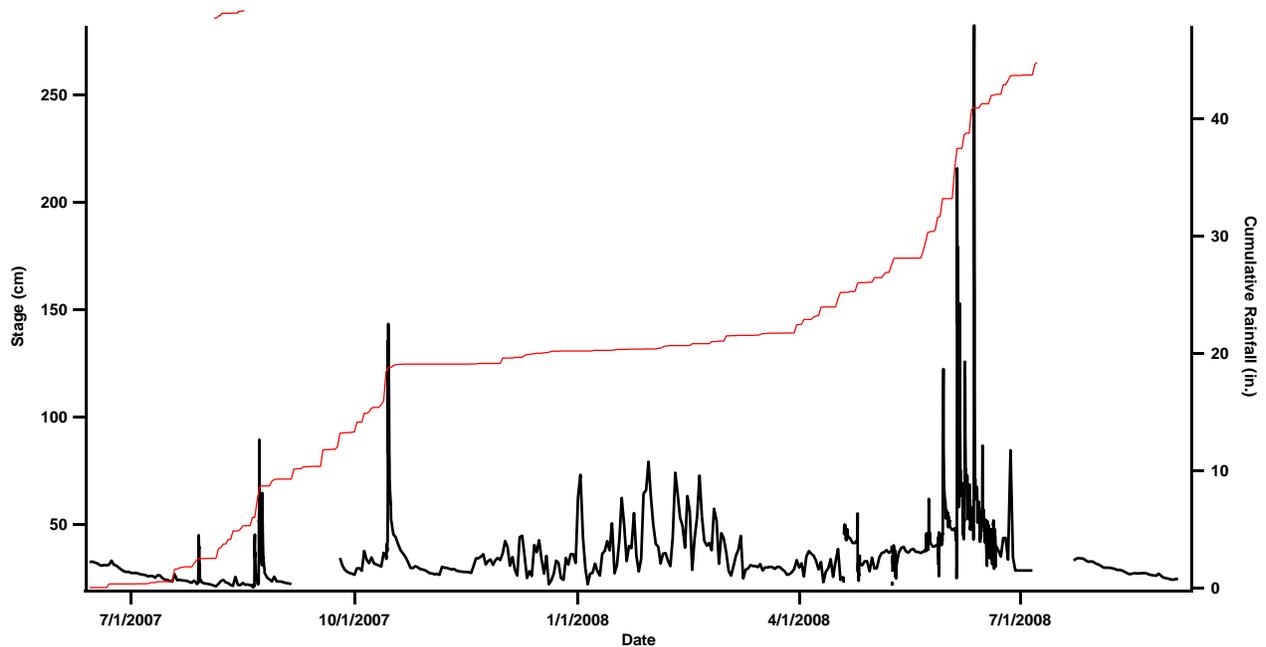
Figure 19. Flow hydrograph. The stage (black line) measured at the installed pressure transducer at the knickpoint study site provided a flow hydrograph for the study period. The cumulative rainfall (red line) is also displayed in the figure.

The total amount of rainfall between June 2007 and November 2007 was 484 mm (Figure 19), which was 37 mm below the annual average amount for this period. Daily precipitation amounts exceeded 25.4 mm on six occasions. The stage hydrograph for the knickpoint reach documented 4 of these runoff events (Figure 19). Another two runoff events occurred in September 2007 when the datalogger was not functioning. The highest recorded stage was 144 cm that resulted from a 63 mm rainfall on Oct. 14, 2007.

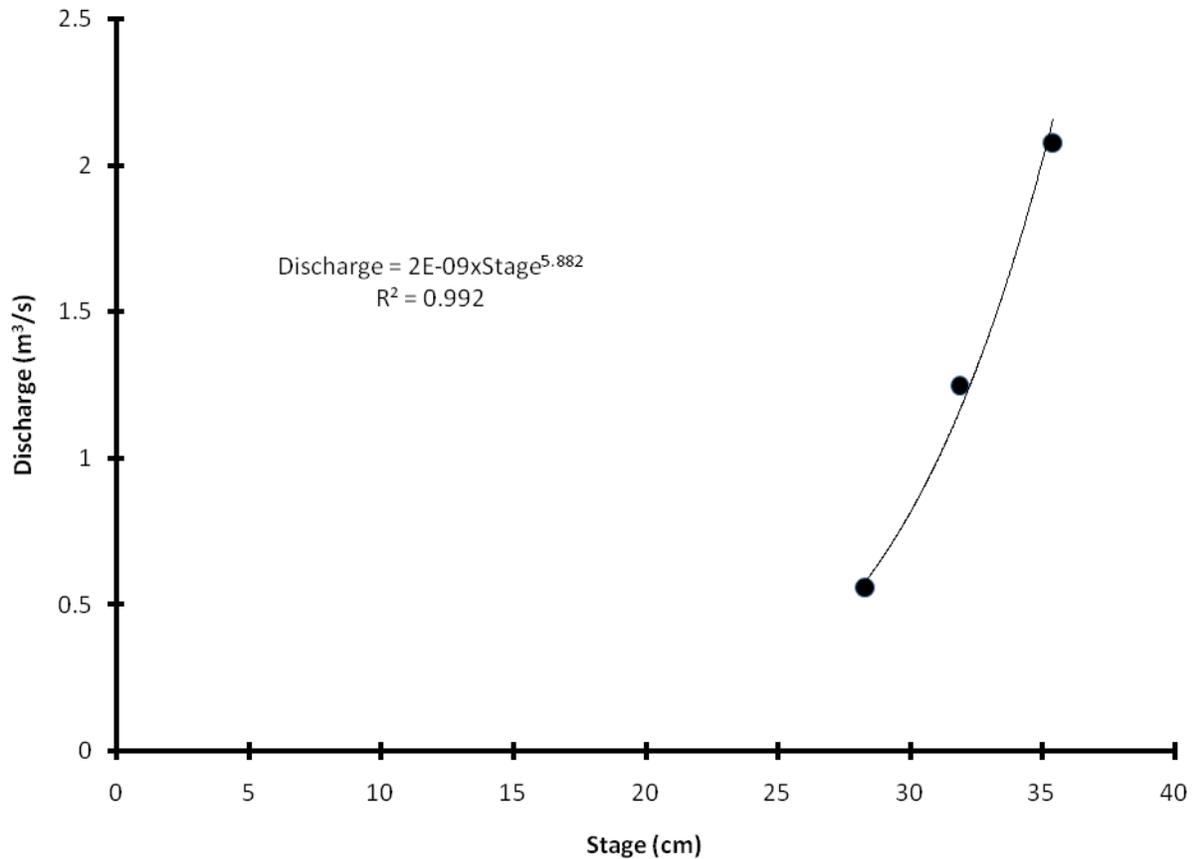
Figure 20. Rating curve. A stage-flow rating curve was developed for this site based on ADV FlowTracker and LSPIV measurements.

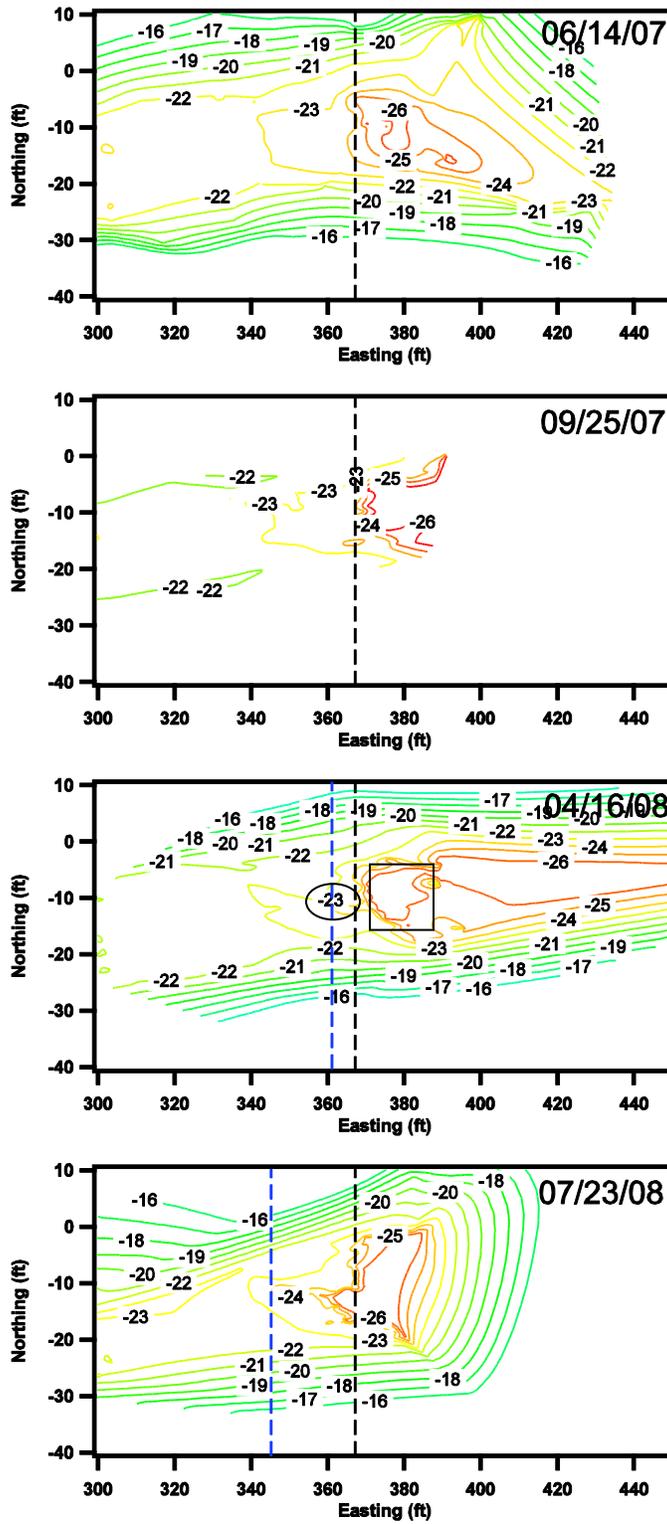
Figure 21. Channel surveys. Bi-annual surveys of the knickpoint show the progression of a finger-like projection (extent of -24 ft. contour line, or position of blue dashed line relative to black dashed line) and an increase in the dimensions of the scour hole (area enclosed by -26 ft. contour line).

The second survey (Figure 21) was conducted in late September 2007. Little change was observed between this survey and the previous survey as seen through similar locations of the -24 ft. contour line. During this period there was no visible movement of the knickpoint face. In support of this finding, there were no major runoff events, which would trigger mass failure of the knickpoint face resulting in upstream migration.

The third survey (Figure 21) was conducted in April 2008 following the winter months when periods of freeze-thaw would weaken the knickpoint face facilitating mass failure. Two noticeable differences were observed between this survey and the previous two surveys. The majority of the knickpoint face (-24 ft. contour) remained in a similar location as in the two previous surveys; however, a small finger-like projection extending upstream was noticeable (see circled region in Figure 21). This projection extended upstream 1.5 m. Using the extent of this projection to determine the annual upstream migration rate, the knickpoint advanced at a rate of 2 m/yr. The second observable difference from this survey was an increase in the size of the scour hole (represented by the -26 ft. contour; see squared area in Figure 21). The downstream length of the scour hole increased from 2.3 m to 4.4 m, while the cross-stream width increased from 2.1 m to 2.7 m between June 2007 and April 2008.
