TR-541

**THE EFFECTS OF HEADCUT AND KNICKPOINT PROPAGATION ON
BRIDGES IN IOWA**

Final Report

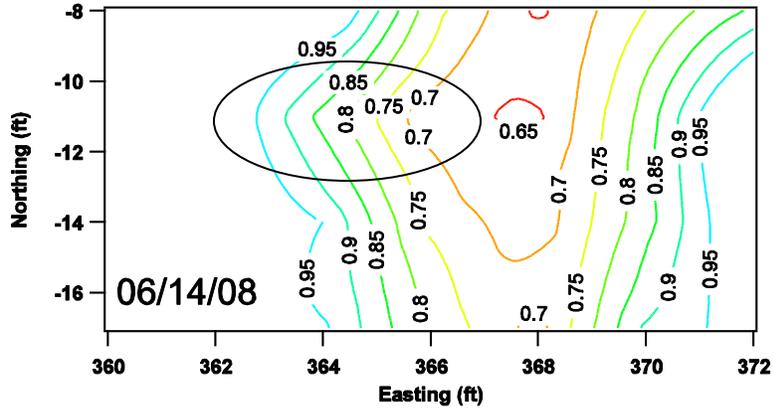
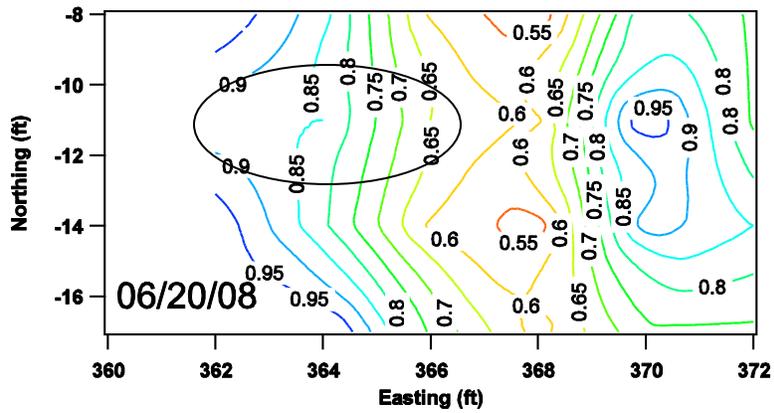
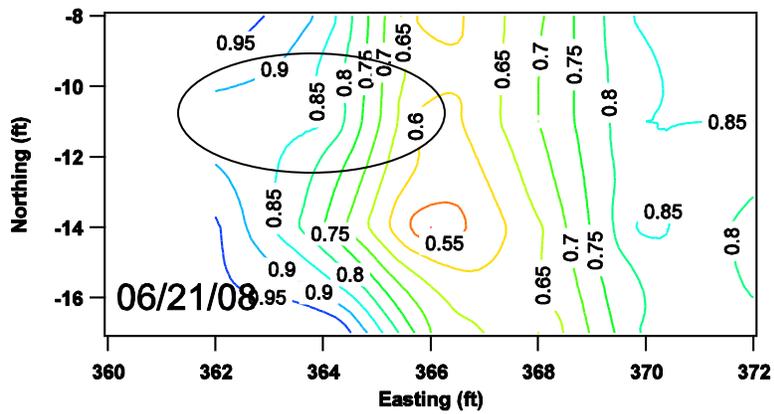
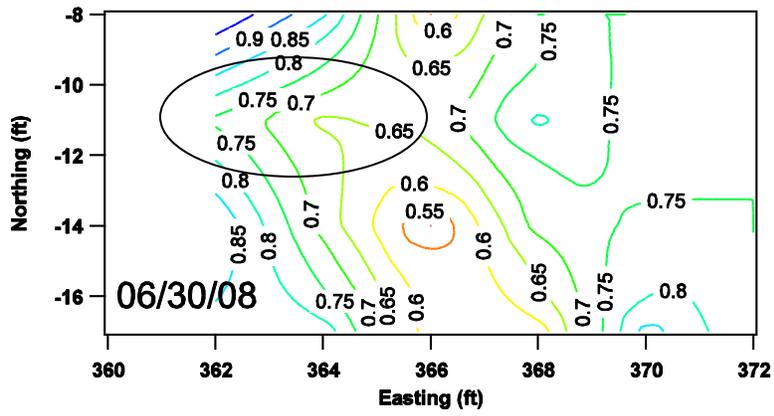
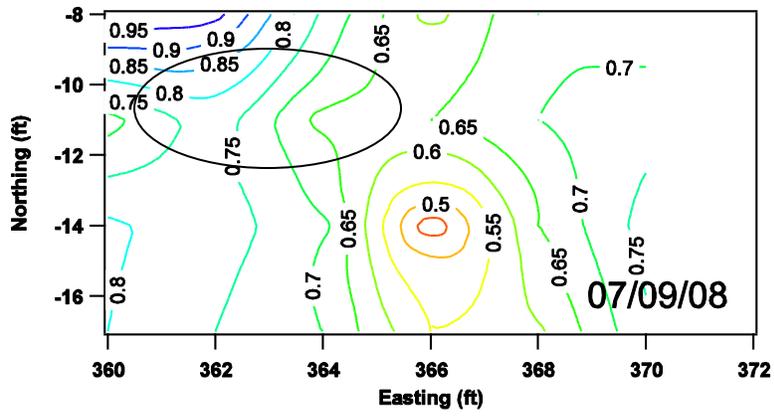
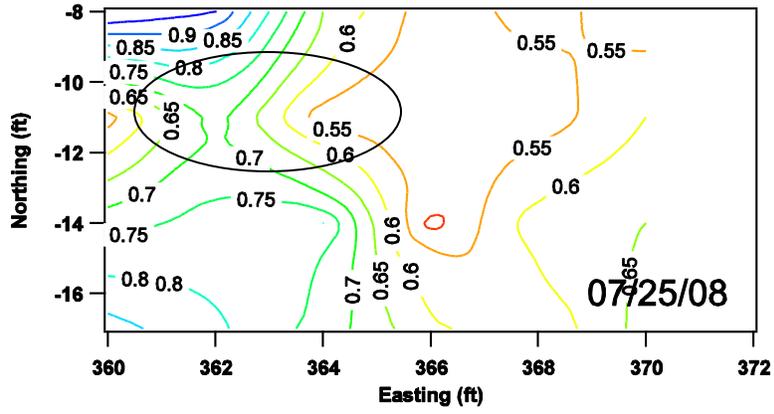
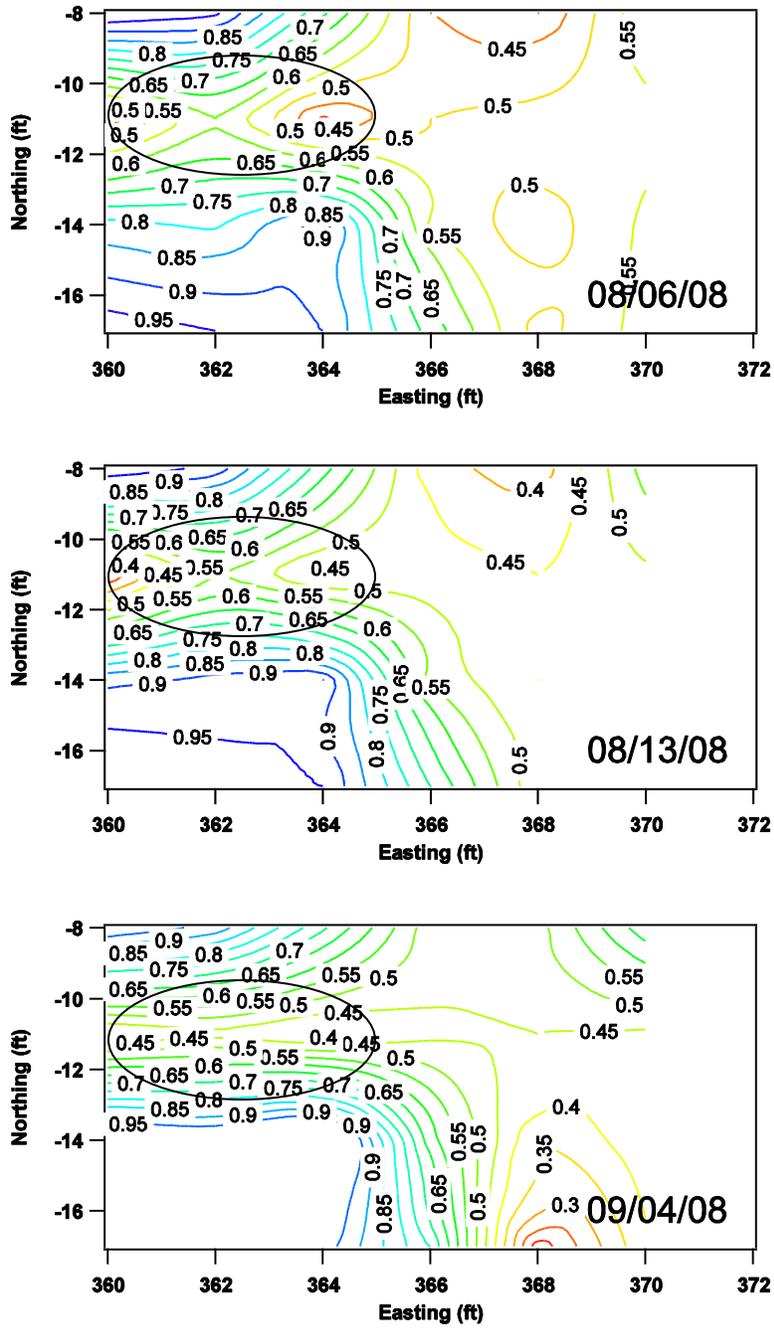
Figure 22. Water level surveys. Select daily measurements of the water level over the knickpoint from a fixed datum show the progression of the knickpoint face.

The finger-like projection observed in the surveys can be seen in the initial water level contour map from June 14th (Figure 22). The circled area in this figure and all subsequent figures highlight this projection as it advanced. Over this study period, the length of this projection increased 5 m, which was beyond the sampling grid, so knickpoint advancement rates were unobtainable from this method; however, these figures showed well the daily advancements of the projection.

Another feature on these figures, which was useful in determining movement of the knickpoint, was the position of the lowest contour, which represents the lowest water level. In the first two graphs (Figures 22), the center of the lowest contour was located at (368, -11). A 2-ft shift upstream of the position of this lowest contour was noticed between June 20th and June 21st (Figures 22). This shift corresponded with a runoff event from an 18 mm rainfall between June 19th and 20th. It is important to note that large runoff events were observed a few weeks prior to this event with no observable shift in the position of the knickpoint.

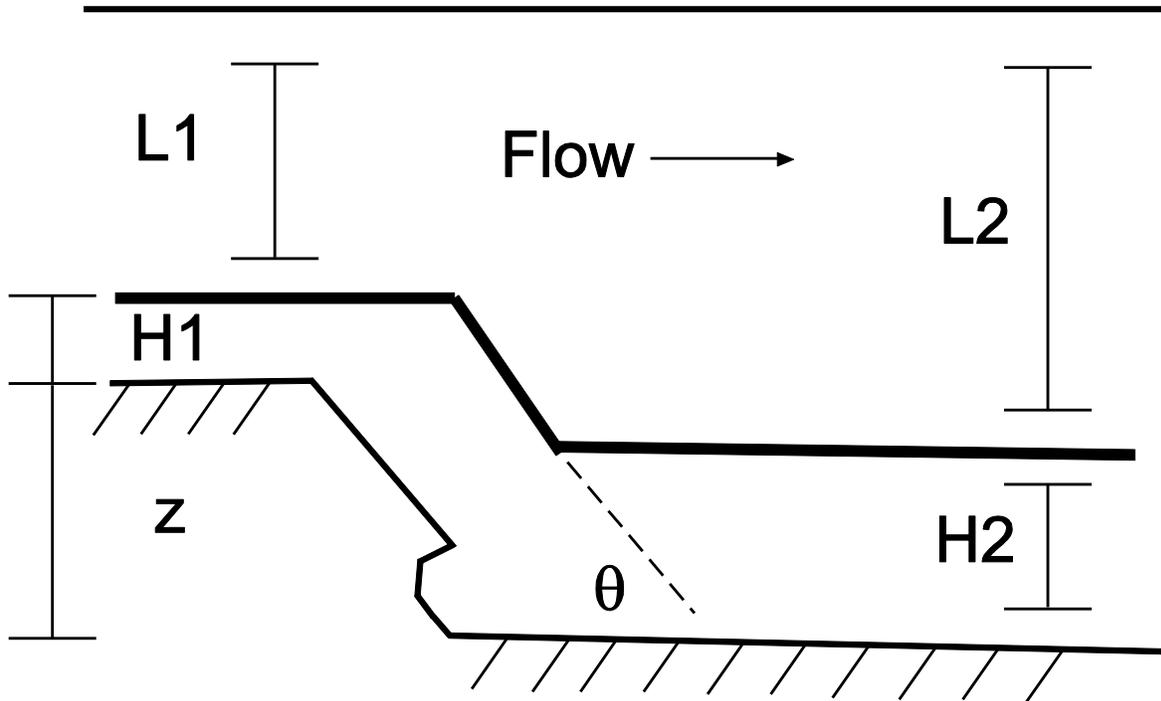
Figure 23. 3ST1D Visualization. A schematic of the representative knickpoint used for the 3ST1D simulations where H1 and H2 are the depths of flow above and below the knickpoint, respectively. L1 and L2 are the distance of the laser from the fixed datum to the water surface (bold line). The height of the knickpoint is z and q is the impact angle of the impinging jet.

Determination of the hydraulic conditions around the knickpoint for case (1), i.e., the fixed bed scenario, allowed for classification of the flow at the knickpoint as vented or unvented for different flow events. Identification of the flow type at the knickpoint was conducted by determining the ratio $H1/z$, where $H1$ is the water depth over the crest of the knickpoint, obtained from the numerical simulation, and z is the fixed height of the knickpoint face, obtained from the survey maps and sequentially the angle of attack (or impingement angle, θ) of the flow (Figure 23). It has been reported in the literature that when the ratio $H1/z < 1/8$ then vented conditions occur and knickpoint erosion is controlled by the knickpoint geometry and prevailing flow (May, 1989). On the contrary, unvented erosion occurs when the ratio $H1/z > 1/8$. Results from the numerical simulations for the fixed bed conditions, under different flow events, provided the water surface profiles along the whole stream reach and, thus, the flow depths at the crest of the knickpoint. Evaluation of the ratio $H1/z$ indicated that unvented conditions occurred for all the flow events (Table 1). In addition, the angle θ at which the jet strikes the bed was determined, based on the water surface profiles. A plot of the different discharges Q vs. the angles θ was produced (Figure 24), and the results compared favorably with literature reported values (e.g., May, 1989).

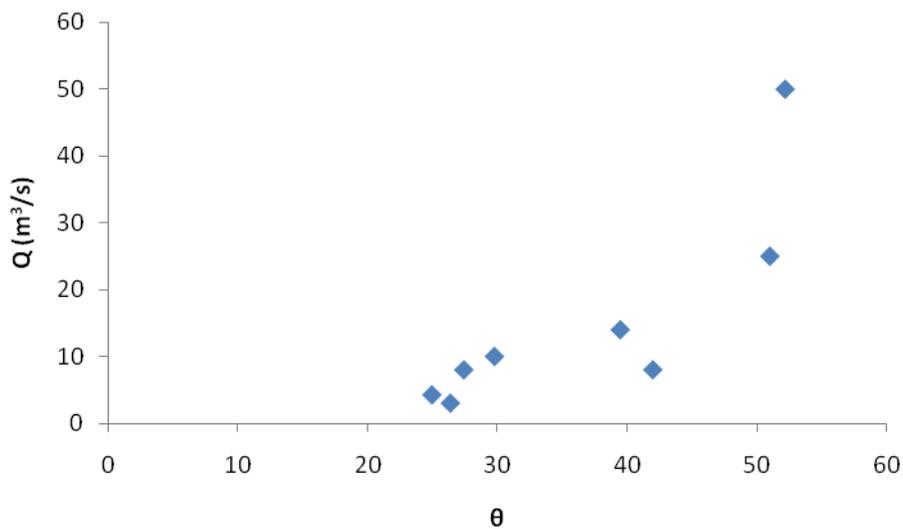
Figure 24. The discharge Q vs. the angle of impact θ .

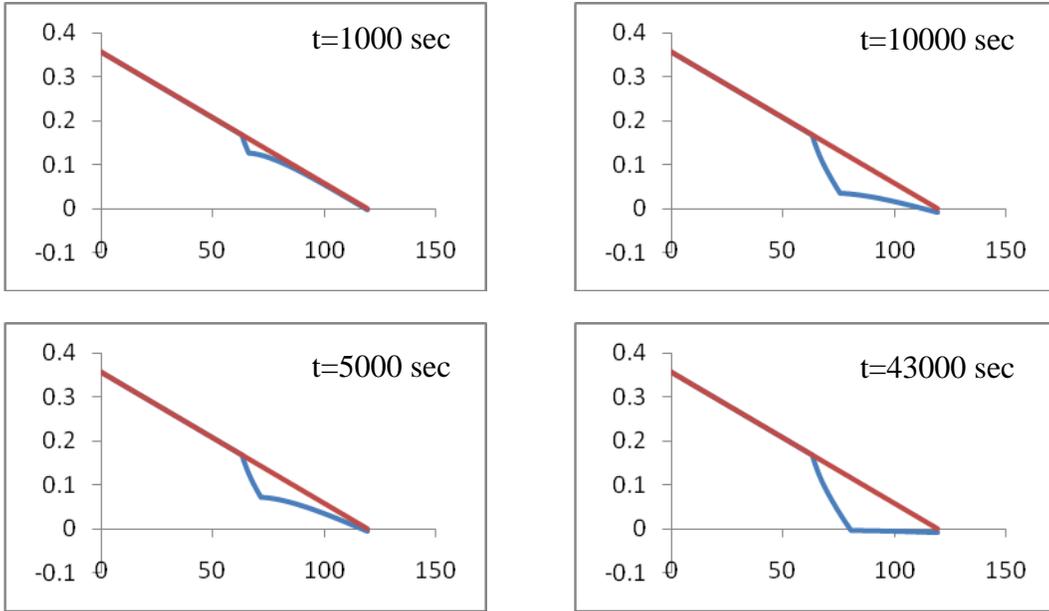
Figure 25. Scour formation downstream of the location of the knickpoint (red line = Initial bed, blue line = Final bed). X-axis is the longitudinal direction (in m) and Y-axis is the elevation (in m).

Cases (2) and (3) i.e., the moveable bed scenarios, focused on the evolution of the knickpoint. In case (2), a flat bed condition was considered with homogenous bed as the initial bed condition. The bed critical erosional strength was assumed to be 10 Pa, an erosional strength value corresponding to a well compacted cohesive sediment bed (Papanicolaou and Maxwell, 2006). Case (2) simulations were performed for high flow conditions, $Q=10 \text{ m}^3/\text{s}$. It was found that a scour hole developed within approximately 5,000 sec from the start of the simulations. After a half-day period (~43,000 sec) with a $Q=10 \text{ m}^3/\text{s}$, the volume of the scour hole increased dramatically and reached equilibrium. The equilibrium scour hole depth was predicted to be roughly 20 cm (Figure 25). If a different critical erosional strengths and Q s were assumed, 3ST1D would have produced scour holes of different volumes. Further, the equilibrium conditions would have been reached at different time periods.

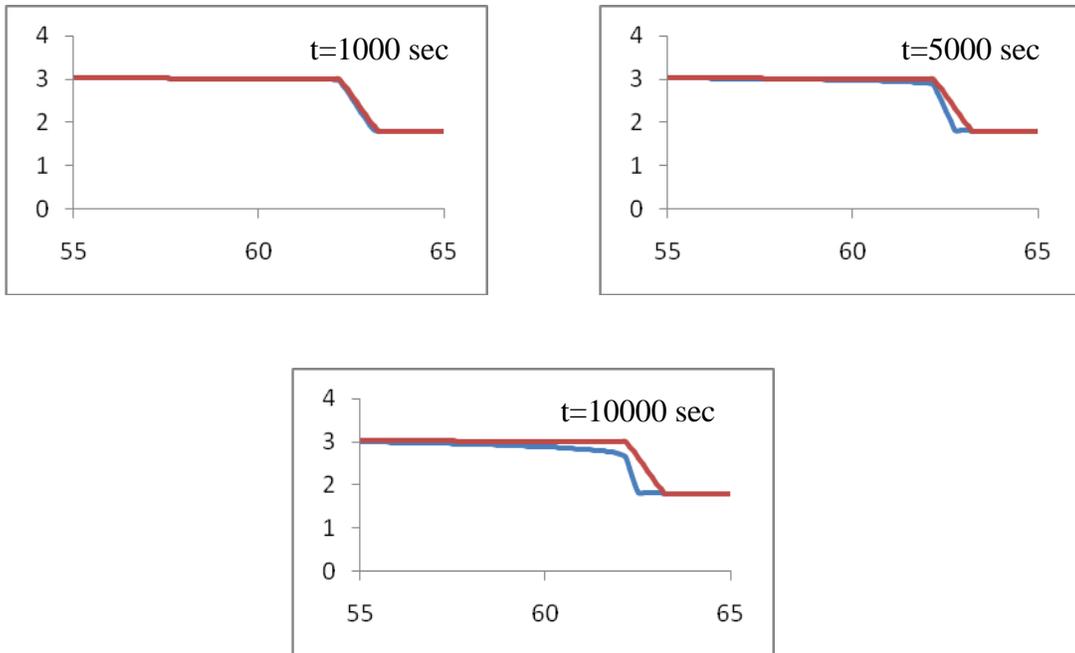
Figure 26. Propagation of the frontal face of the knickpoint (red line = Initial bed, blue line = Final bed). X-axis is the longitudinal direction (in m) and Y-axis is the elevation (in m).

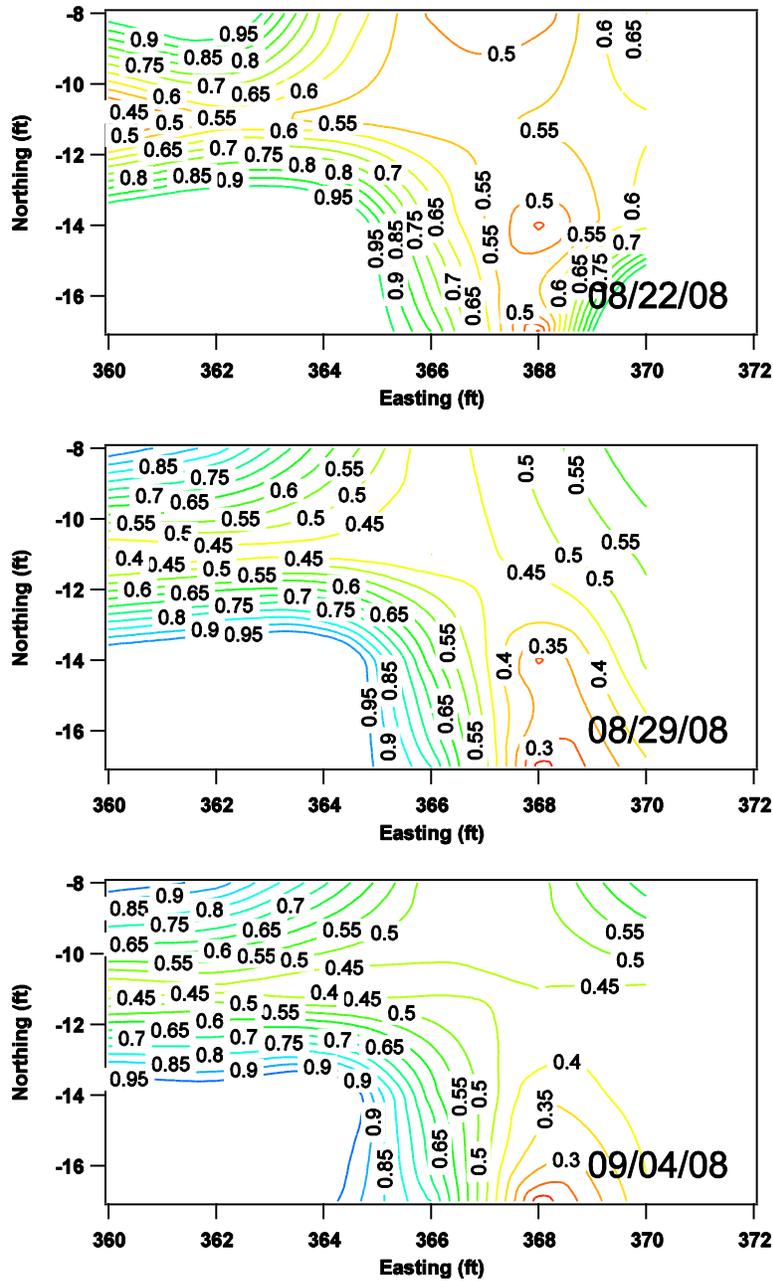
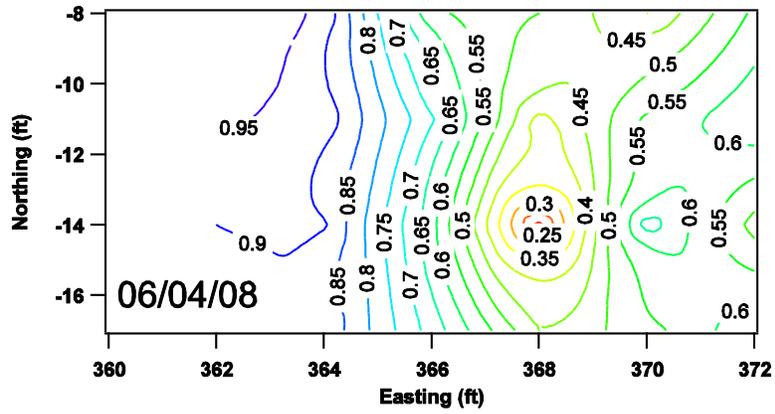
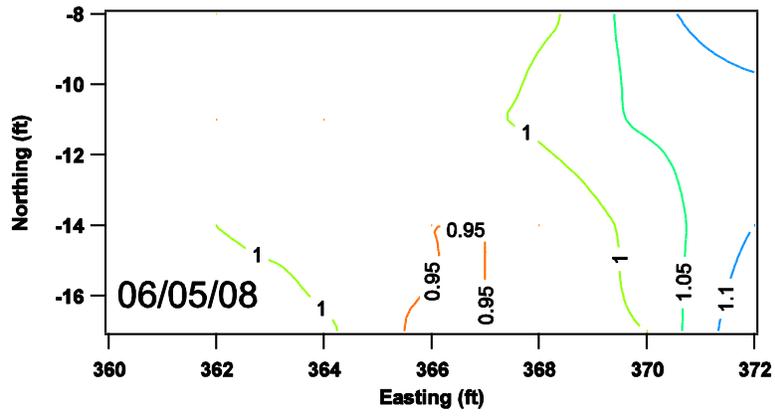
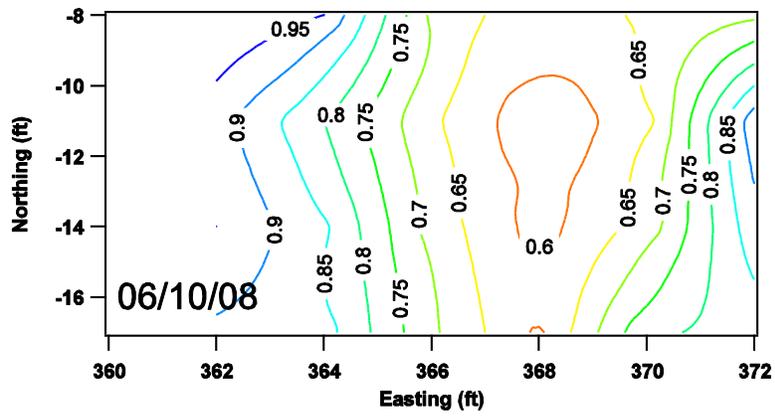
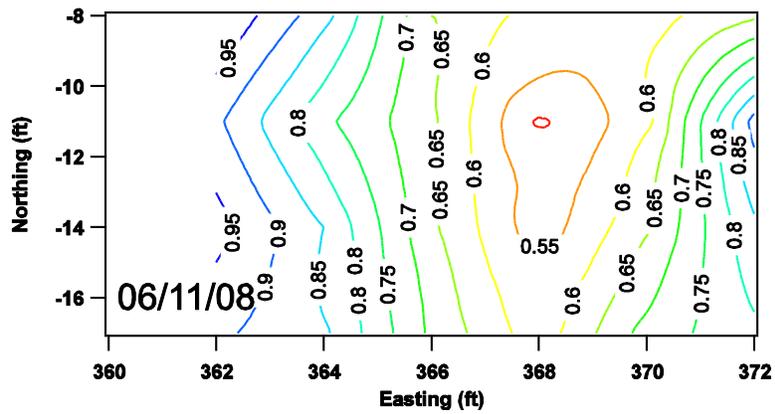
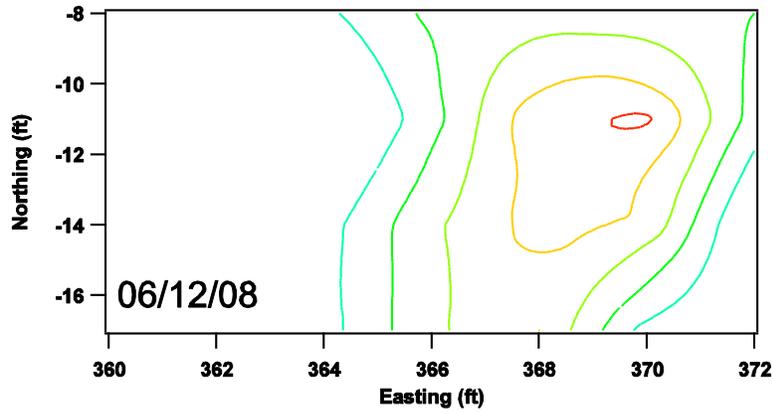
APPENDIX 1: Water level measurements over the knickpoint

Figure 22. Water level surveys. Daily measurements of the water level over the knickpoint from a fixed datum show the progression of the knickpoint face.
