Test and Evaluation Report

Testing and Evaluation of the Iowa DOT FRP Temporary Bypass Bridge

November 22, 2005

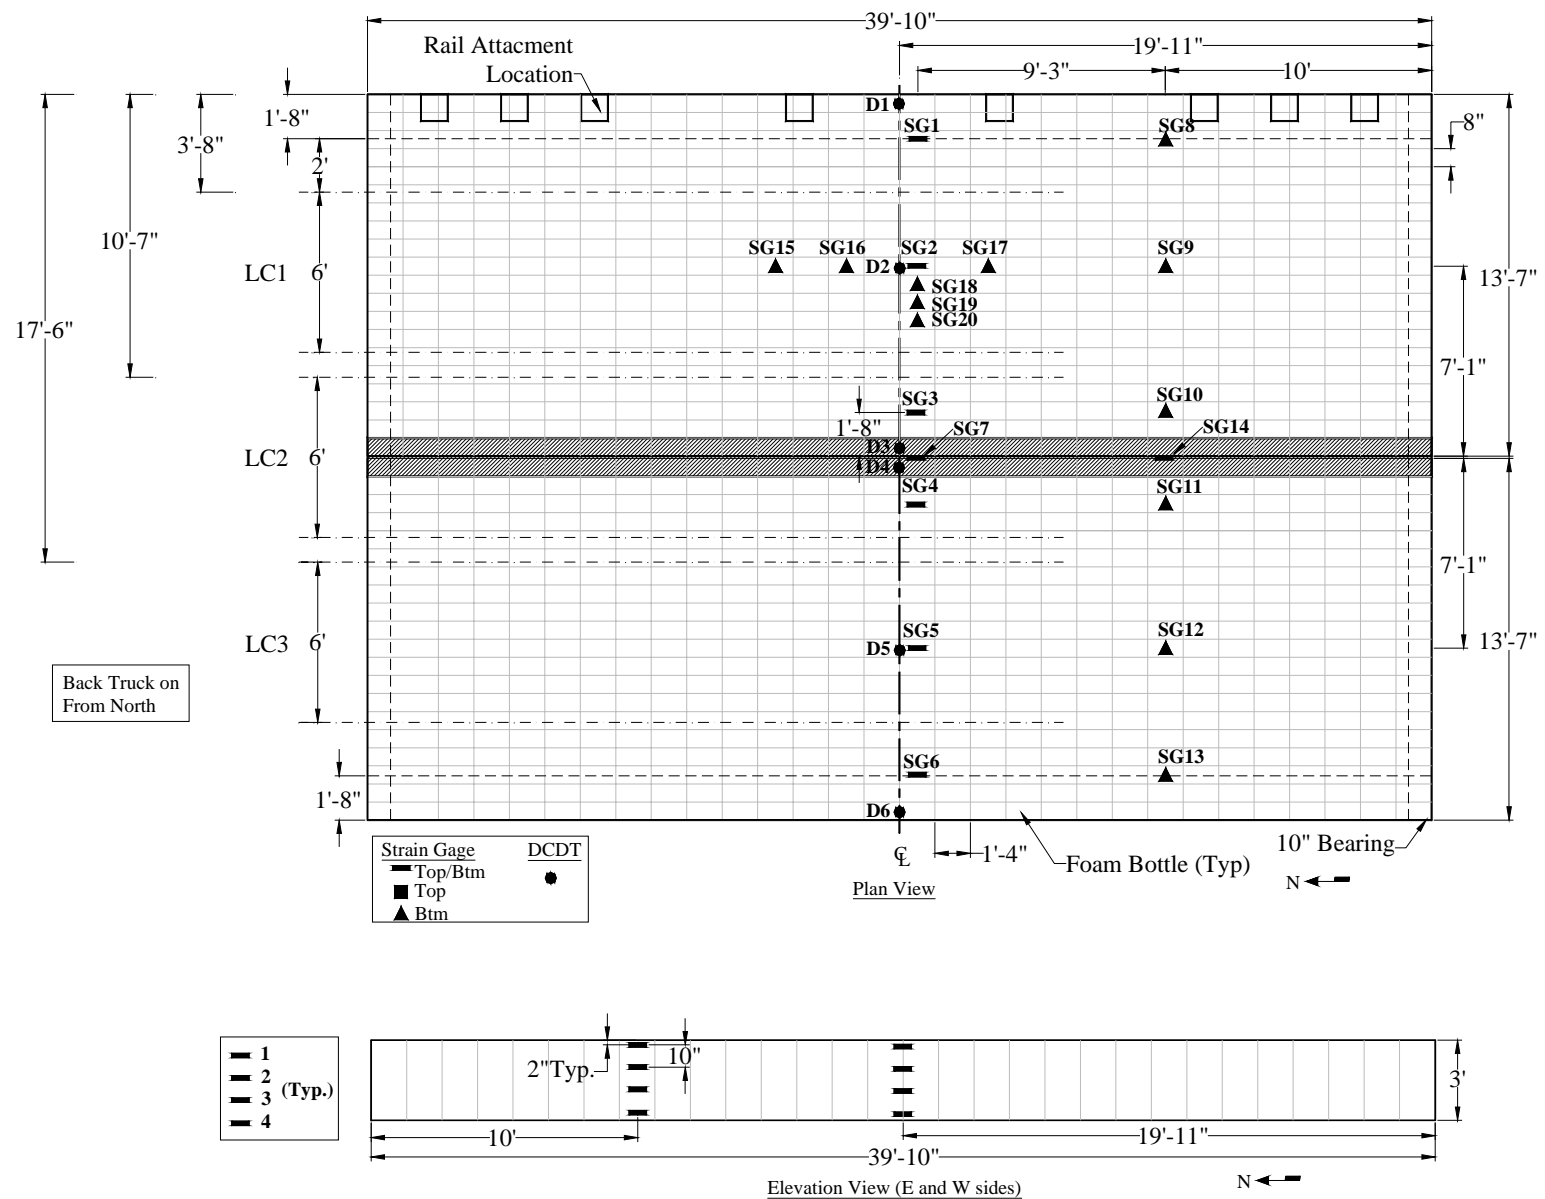
Figure 1. Instrumentation layout, Test 1, FRP Deck Bridge (vehicle facing north).

Test 2 was conducted after evaluating the Test 1 data to clarify some observations and included fewer (and, in some cases different) instrumentation locations than used in Test 1 see; Fig. 1 and 2 for instrumentation layouts. Strain data were collected on the top and bottom of the deck panels near mid-span of the 39' 10" long panels (Test 1 and 2), and on the bottom only at the quarter-span of the panels on the south half (Test 1 only). In addition, deflection data were collected at the mid-span of the panels (Test 1 only). The collected strain and deflection data are the basis of the results and conclusions made herein. For reference, the gages are numbered from east to west (i.e. looking south). Top and bottom gages are specified in the text below with a (T) and (B), respectively.

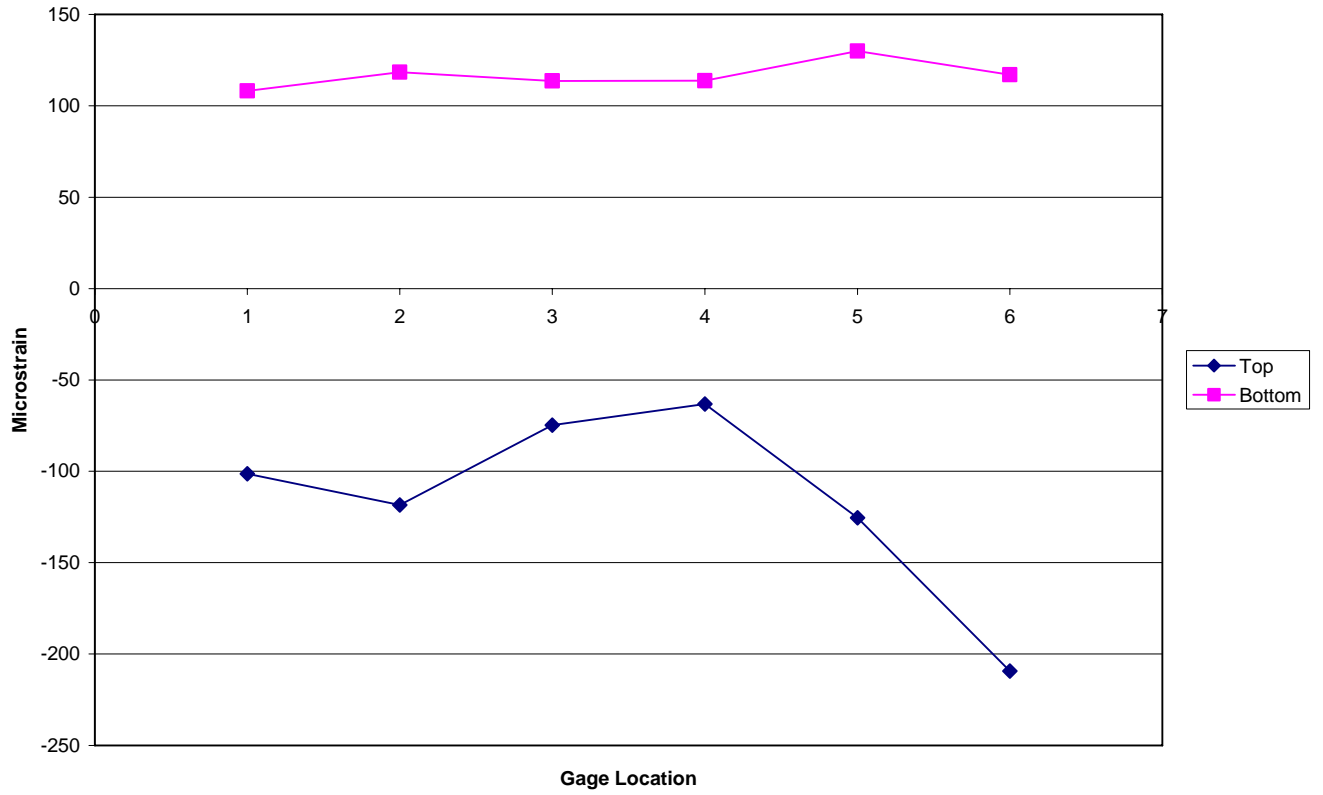
Figure 3. Top and Bottom strain profile at mid-span, LC2.

Illustrated in Figure 3 is the strain profile for the top and bottom gages at mid-span for load case 2 (LC2) for Test 1, which is a symmetrical transverse truck position, and is generally representative of all three load cases for Test 1. The overall response is symmetric except at SG6 (T), near the west edge of the bridge. The generally symmetric behavior suggests a neutral axis near mid-depth of the panel (as would be expected) across the width of the bridge. Figure 4 compares top (T) panel strains at gages SG1, SG3, SG4 and SG6 for Test 1 with corresponding strains from gages SG2, SG3, SG4 and SG5 for Test 2 across the transverse mid-span for LC3. From Fig. 4, it would appear that the strain measured at SG6 (T) for the Test 1 is suspect. It is unclear whether this is due to localized effects from the close proximity of the rear axles, gage bonding issues, or other effects.

From Fig. 3 and 6, it is evident that, for the most part, the neutral axis is near mid depth of the panels. A similar approximation of the neutral axis was not as consistent when using strains measured on the side of the panels. Three vertical cross-sections were instrumented on both the East and West side of the bridge (1ft south of centerline, centerline, and 2 ft north of centerline), with four gages vertically symmetrically placed at each cross-section. Figures 9 and 10 illustrate the vertical strain distribution at each location for the East and West sides, respectively for LC2 which is representative of all load cases. The figures suggest that there are differences in the neutral axis location from cross section to cross section, likely a result of the non-homogeneous nature of the materials/bridge.

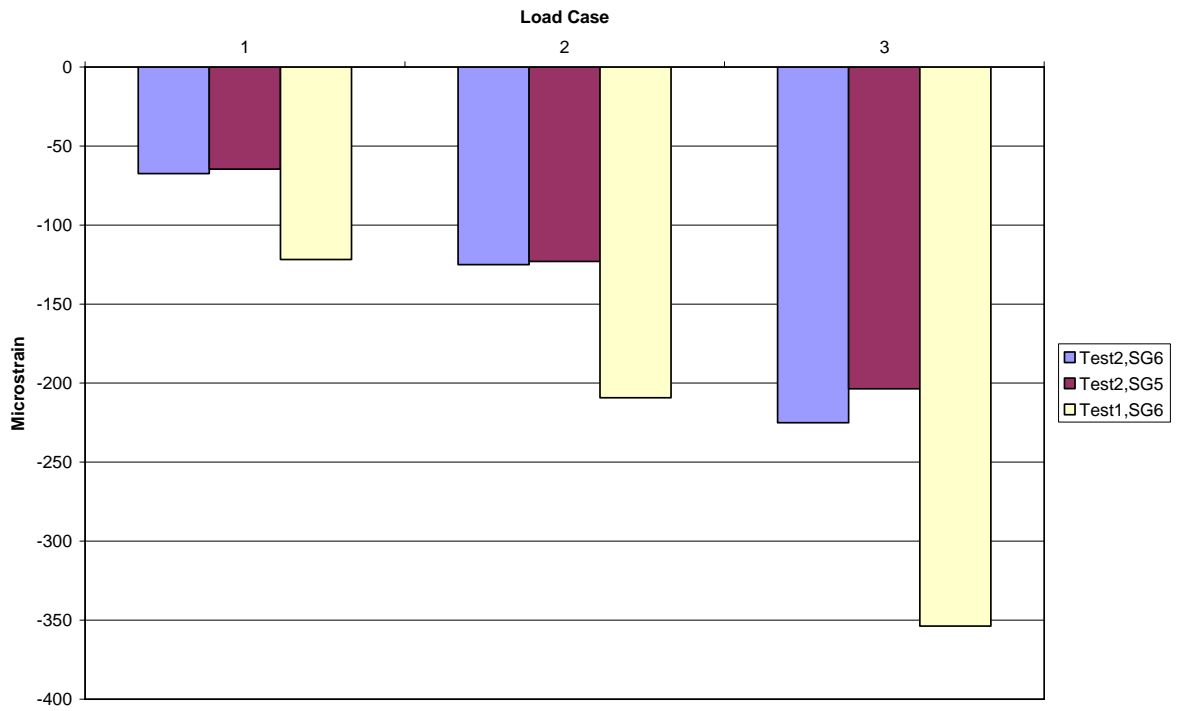
Figure 5. Strain comparison near SG6, Tests 1 and 2.

For Test 2, an additional gage was installed on the top of the panel approximately 1ft south of gages SG1 and SG6, to validate the measured strains from Test 1. Illustrated in Fig. 5 are the top strains measured at gages SG6 for Test 1, and SG5 and SG6 for Test 2

for all three load cases. Combined, the data further suggest that the data obtained from gage SG6 (T) during Test 1 may be incorrect as noted above. Replacing the measured strain at SG6 for Test 1 with the measured strain at SG5 for Test 2, a more symmetric top and bottom strain profile is obtained, as shown in Fig. 6.

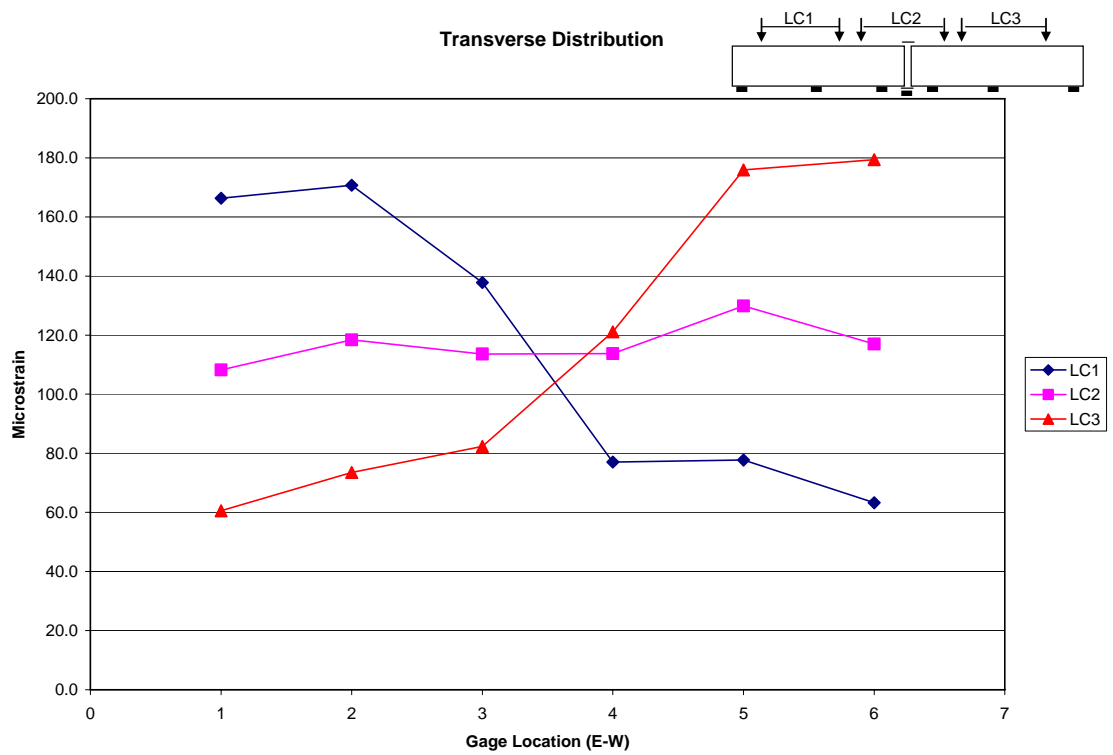
Figure 7. Transverse load distribution at mid-span for all three load cases.

Figures 7 and 8 illustrate the transverse distribution of strain at mid-span for a single lane loaded and two lanes loaded, respectively (similar transverse distribution was calculated at quarter-span but is not shown here). The two lanes loaded case was approximated by superposition of LC 1 and 3. As shown, it is evident that the distribution of strain is relatively symmetric about the longitudinal centerline of the bridge, which suggests adequate load transfer from panel to panel by the steel connection plates. Note that SG7 strain data are not shown in Fig. 7 or 8. These data represent the strain on the steel connection plates. Generally, the flexural strain measured in the steel connection plates were smaller in magnitude than those in the FRP, possibly the result of slip occurring between the connection plate and the panels as well as other factors.
