Ames Municipal Airport

Pavement Management Report

JULY 2023

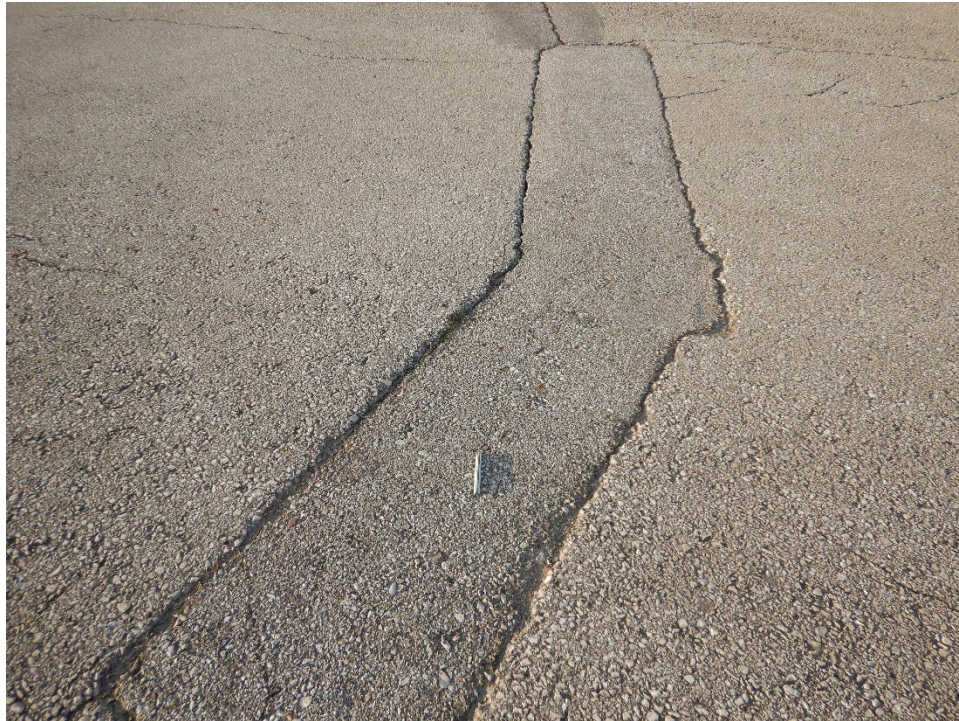
A01AM-01. Patching (Sample Unit No. 11).

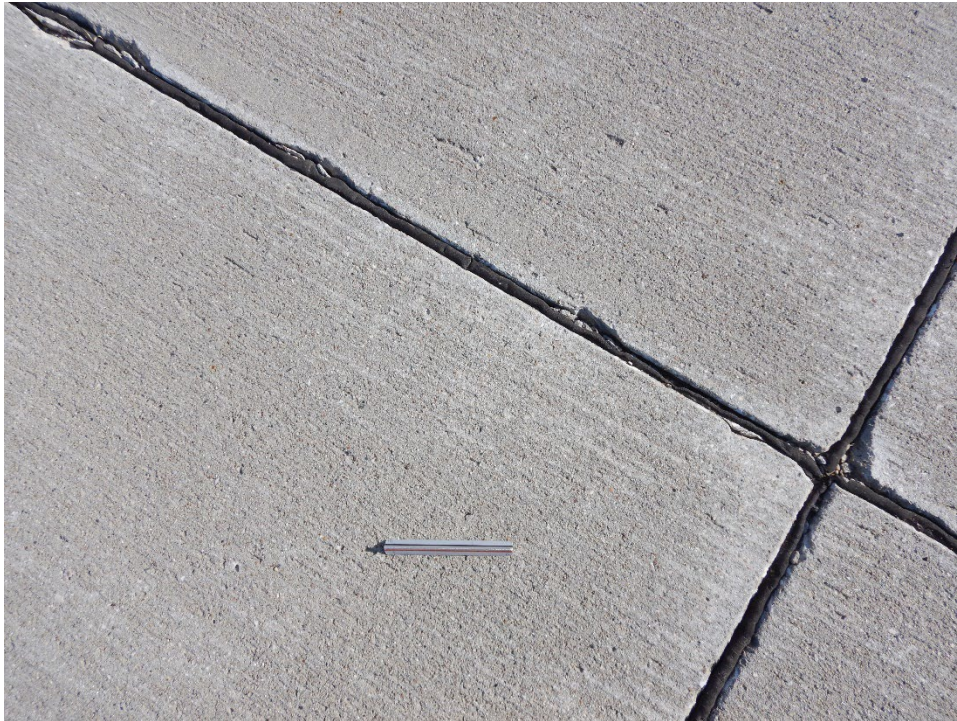
A01AM-02. Joint Seal Damage (Sample Unit No. 14).

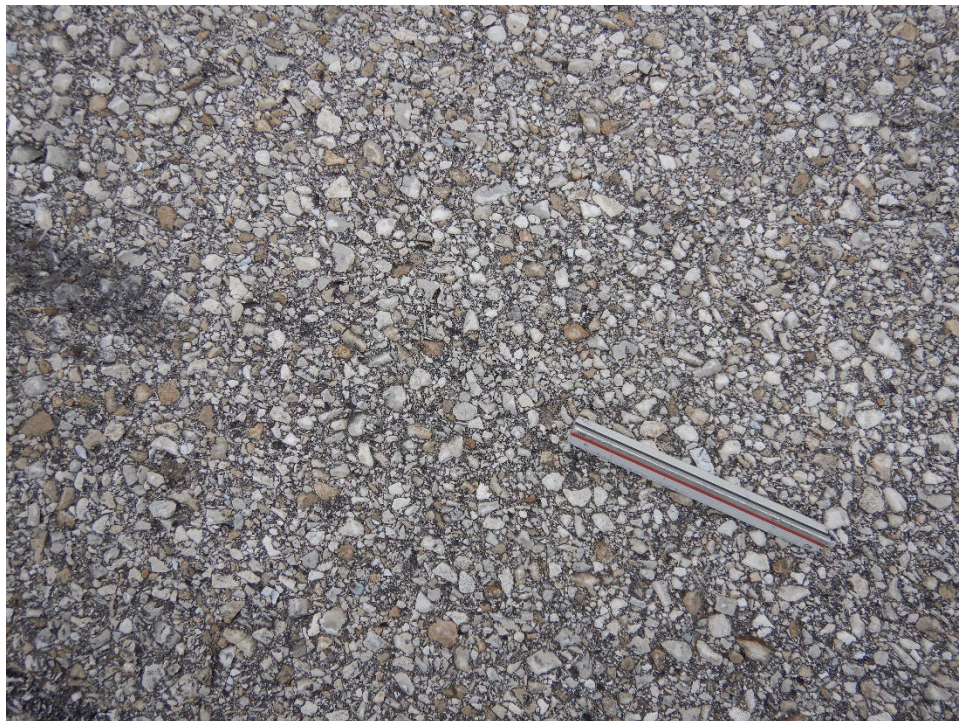
R01AM-01. Weathering (Sample Unit No. 22).

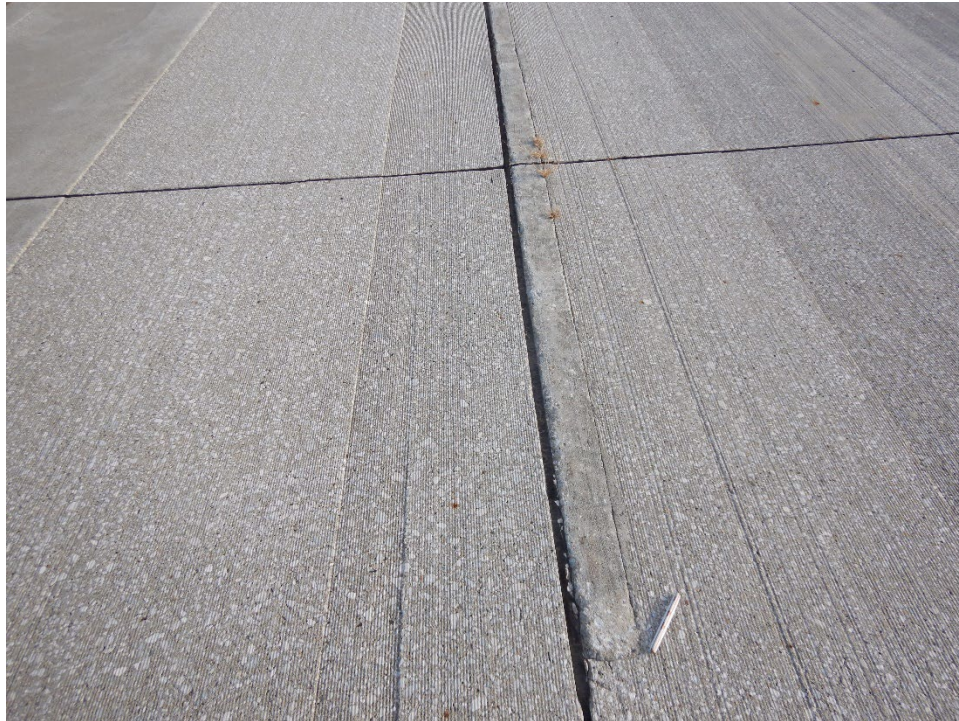
R13AM-01. Large Patching (Sample Unit No. 75).

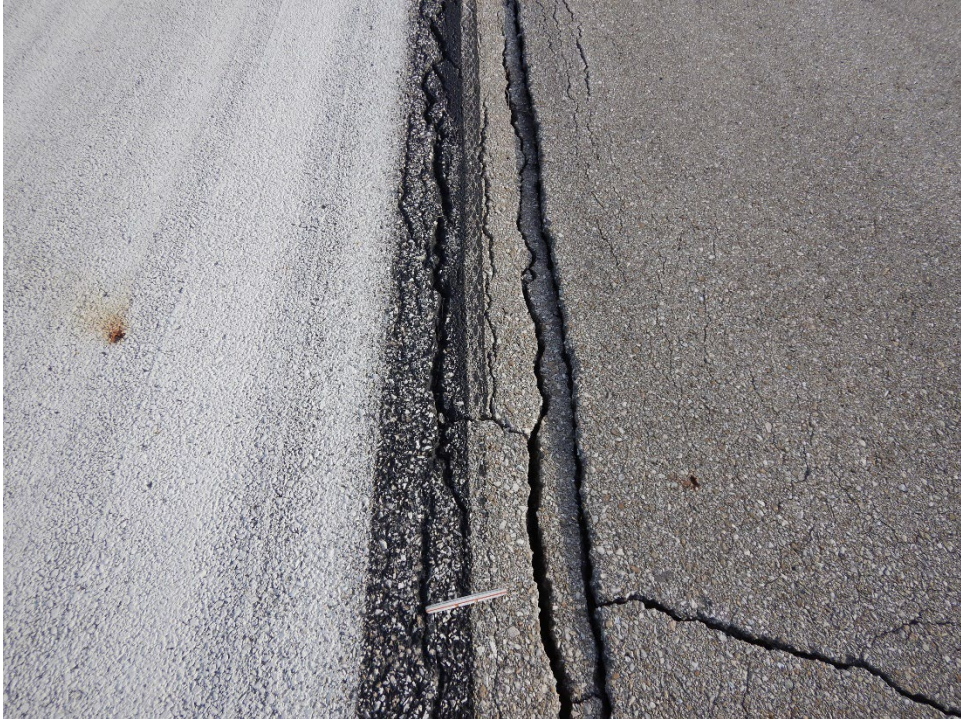
R13AM-02. L&T Cracking (Sample Unit No. 01).

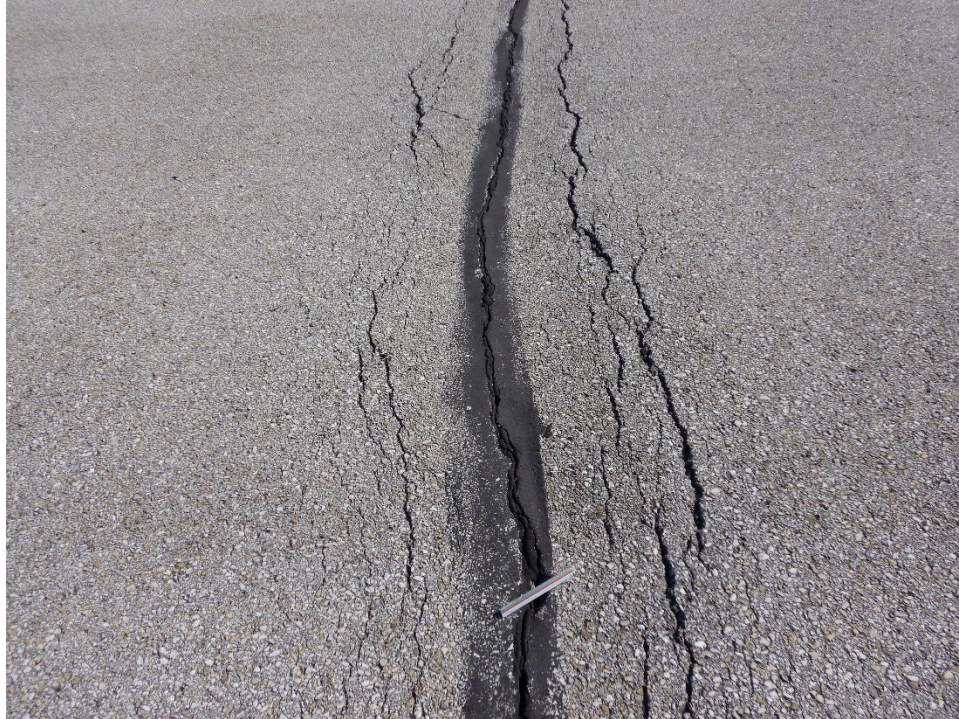
T01AM-02. L&T Cracking (Sample Unit No. 10).

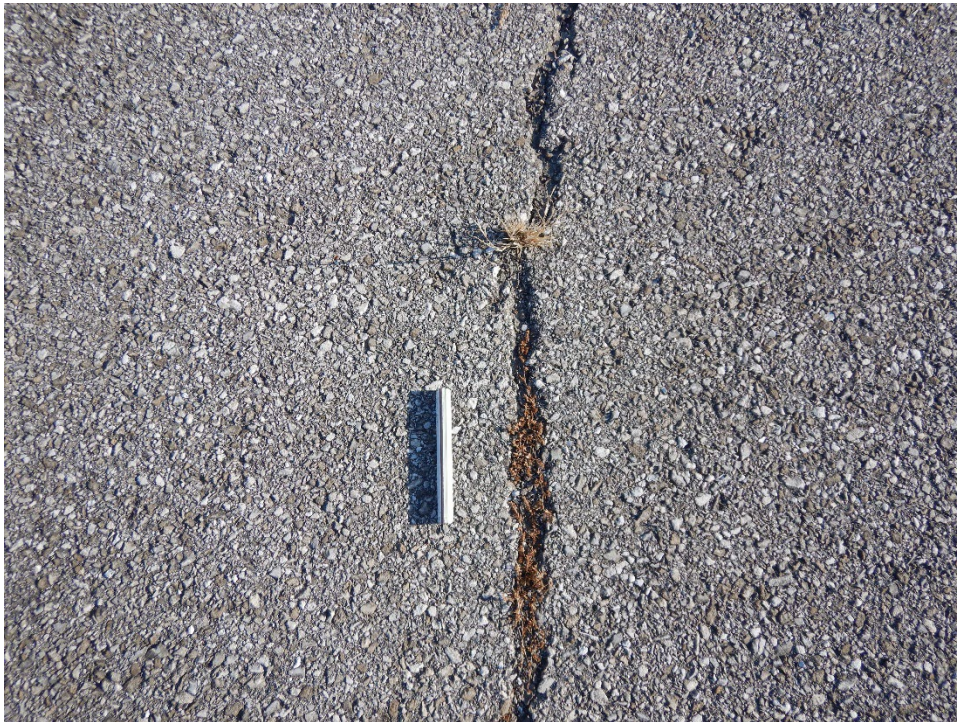
T01AM-03. L&T Cracking (Sample Unit No. 01).

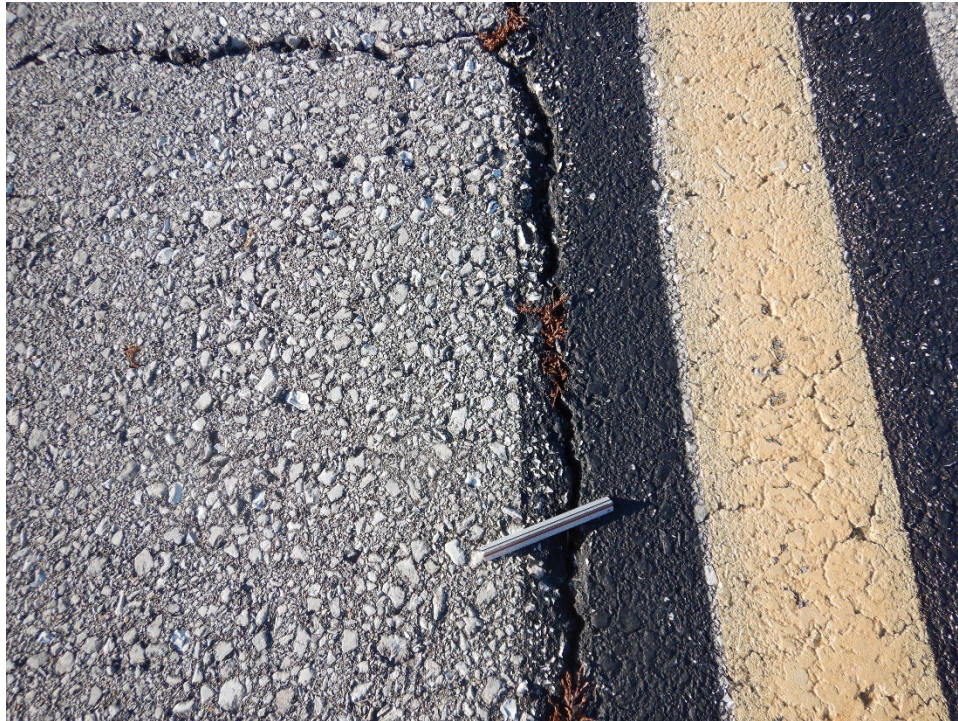
T02AM-04. L&T Cracking (Sample Unit No. 10).

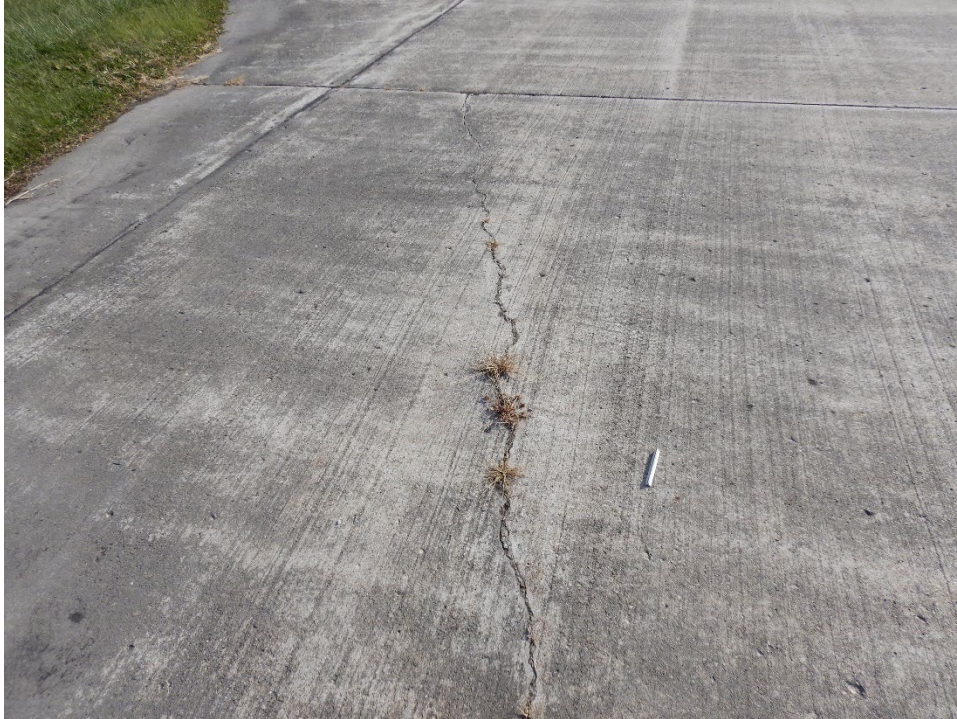
T11AM-01. LTD Cracking (Sample Unit No. 02).
