Atlantic Municipal Airport

PAVEMENT MANAGEMENT REPORT

JULY 2021

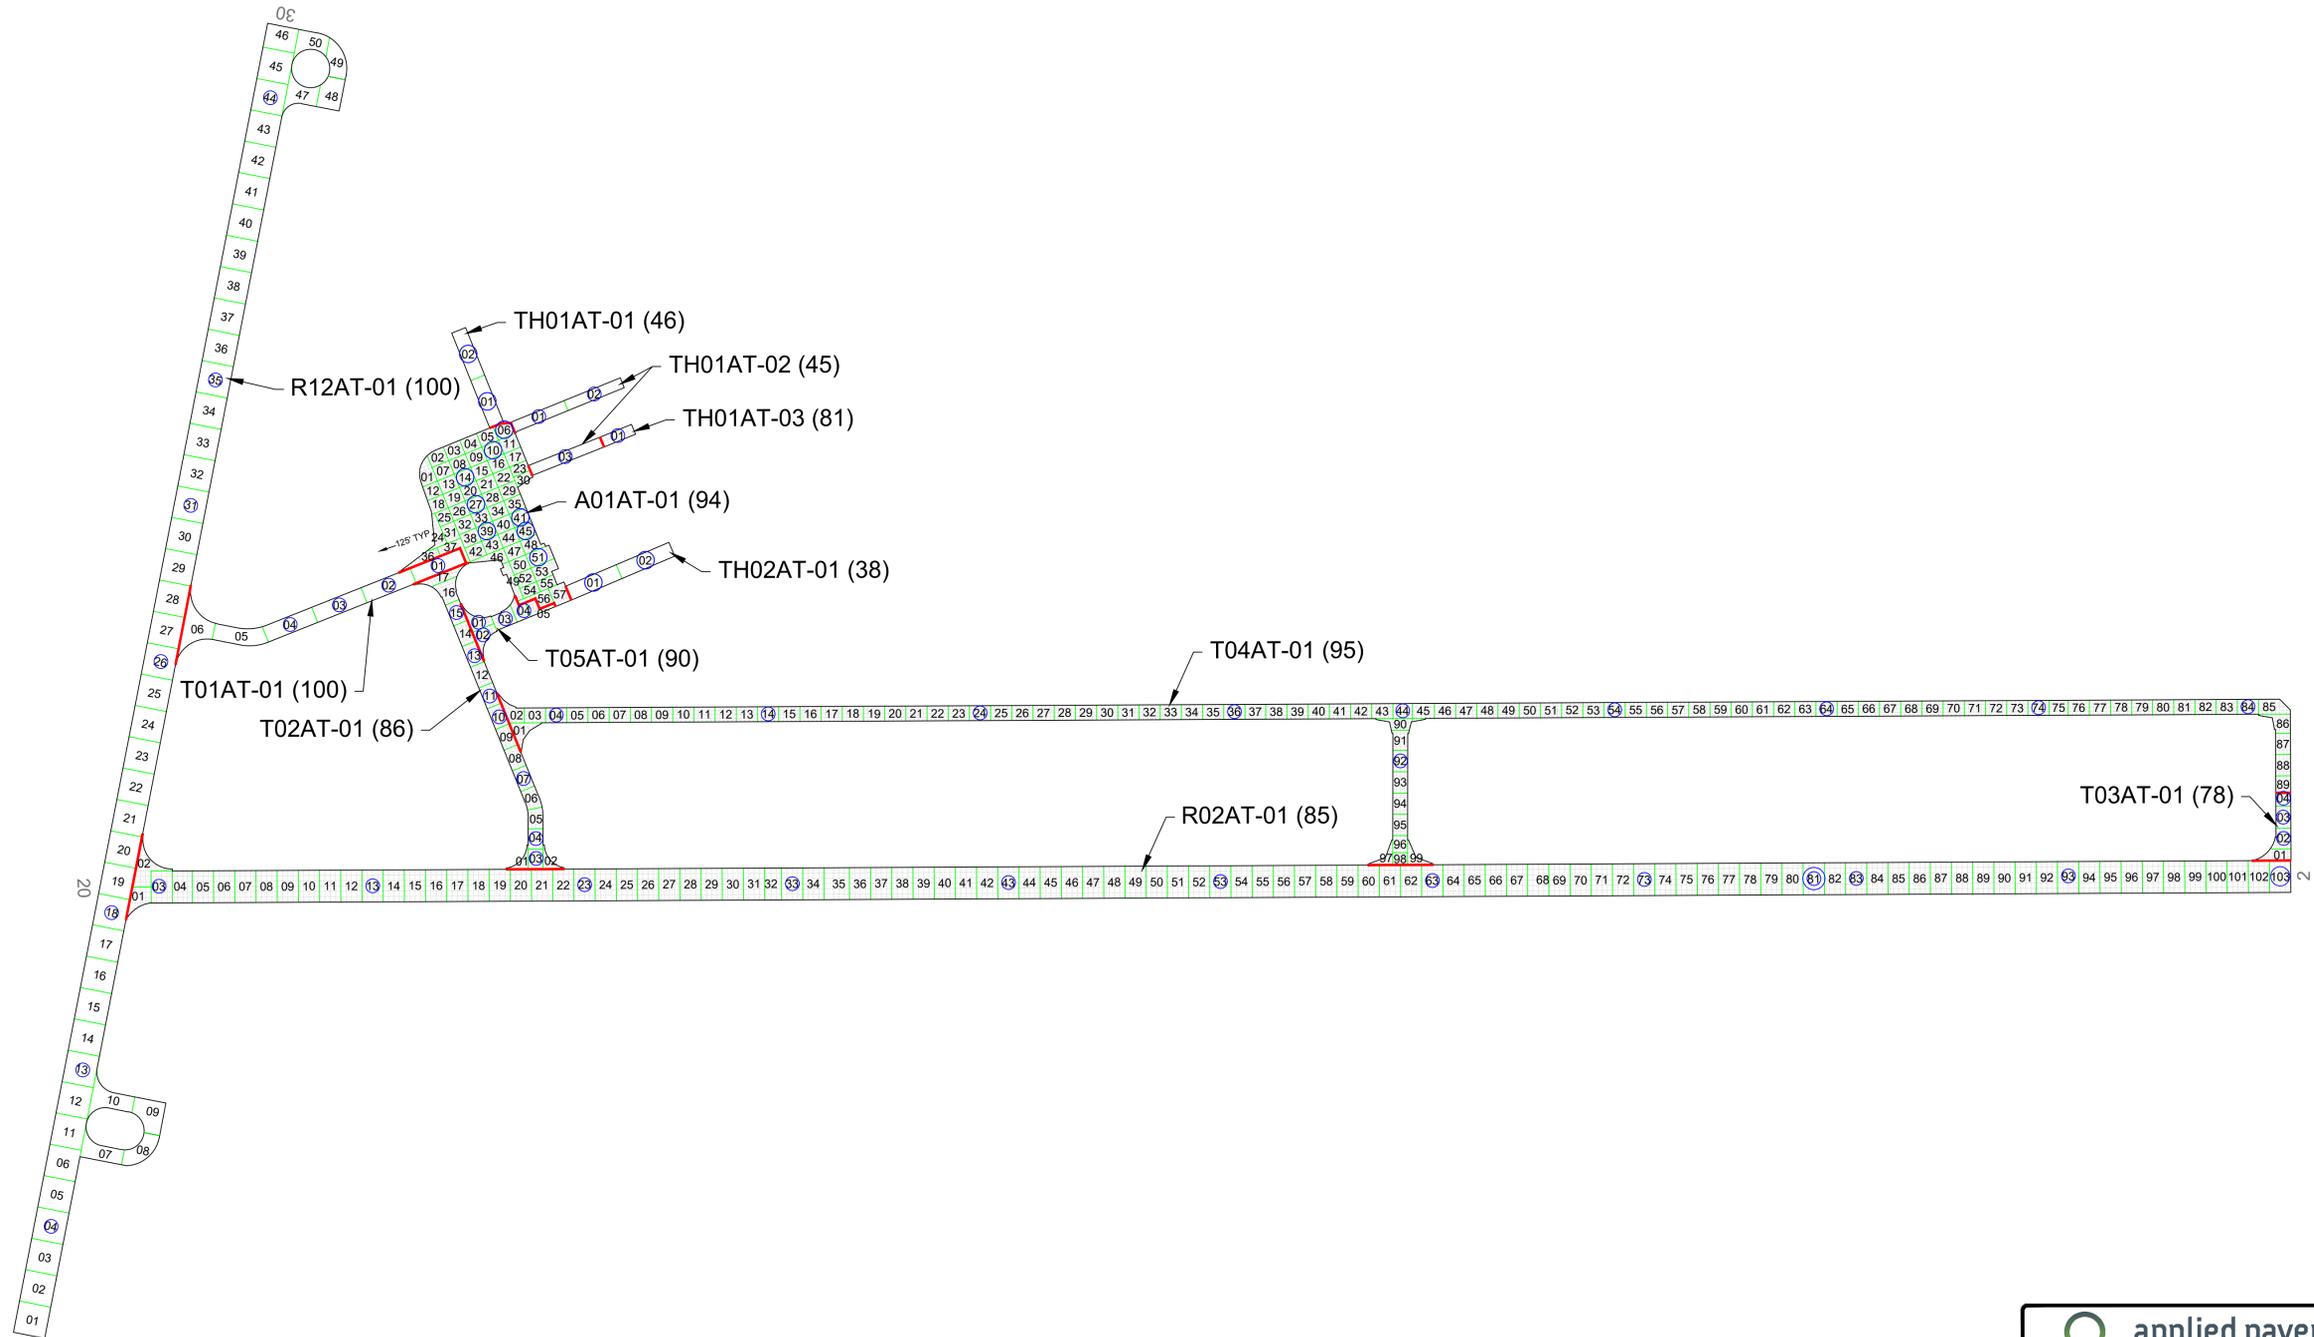
FIGURE 3. NETWORK DEFINITION MAP.

Approximately 1,010,700 square feet of pavement were evaluated at Atlantic Municipal Airport, as illustrated in Figure 2. This figure also shows the area-weighted age, in years of the pavements, at the time of the inspection. Figure 3 provides a map that details how the pavement network was divided into management units and identifies the sample units that were evaluated during the pavement inspection at Atlantic Municipal Airport.

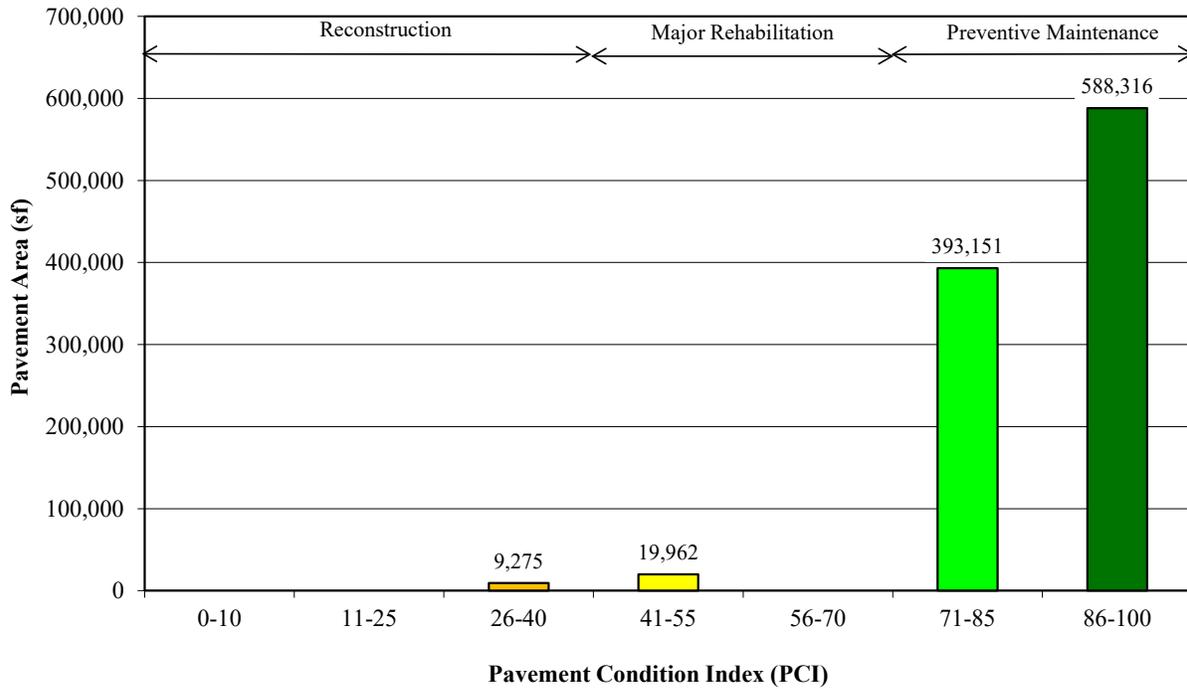
Figure 6. Pavement area by PCI range at Atlantic Municipal Airport.

Figure 6 summarizes the overall condition of the pavements at Atlantic Municipal Airport, and Figure 7 presents area-weighted condition (average PCI adjusted to account for the relative size of the pavement sections) by branch use. Figure 8 is a map that displays the condition of the evaluated pavements. Table 1 summarizes the results of the pavement evaluation. Appendix B presents photographs taken during the PCI inspection, and Appendix C contains detailed information on the distresses observed during the visual survey. Appendix D includes detailed work history information that was collected during the record review process.

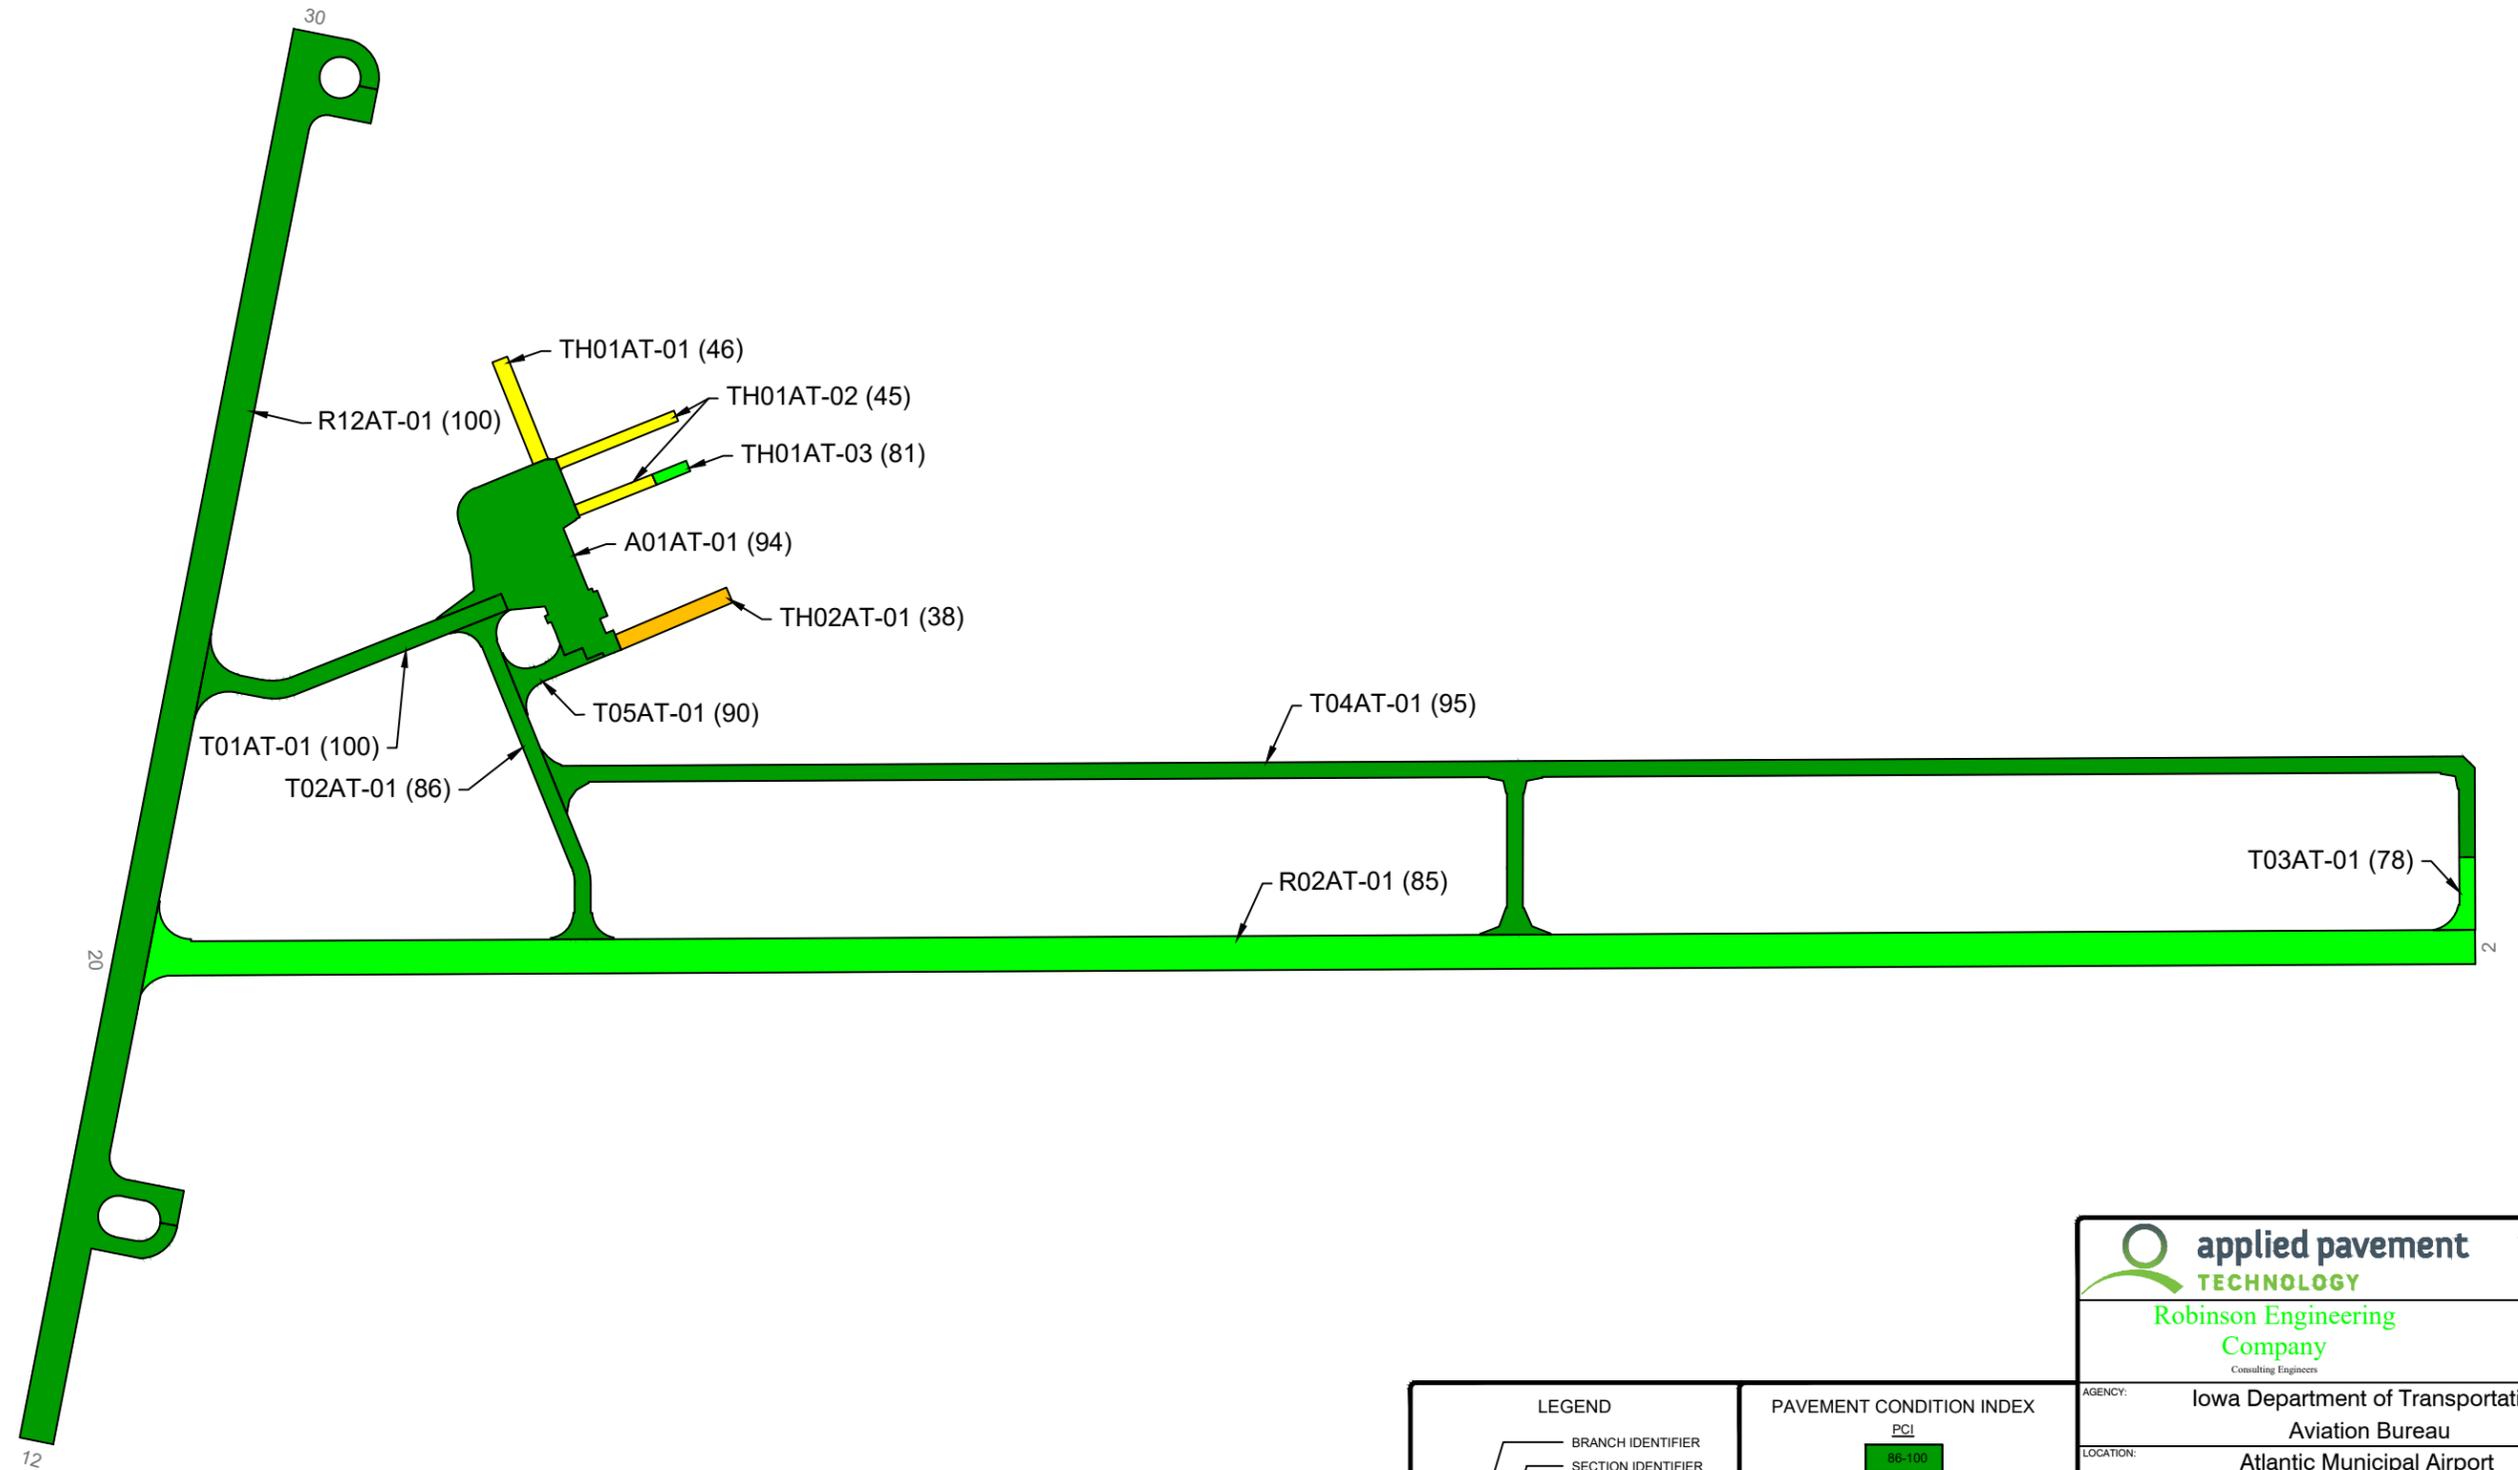
FIGURE 8. PCI MAP.

The pavements at Atlantic Municipal Airport were inspected in November 2020. The 2020 area-weighted condition of Atlantic Municipal Airport is 91, with conditions ranging from 38 to 100 (on a scale of 0 [failed] to 100 [excellent]). During the previous pavement inspection in 2017, the area-weighted PCI of the airport was 75.
