Atlantic Municipal Airport

Pavement Management Report

JULY 2024

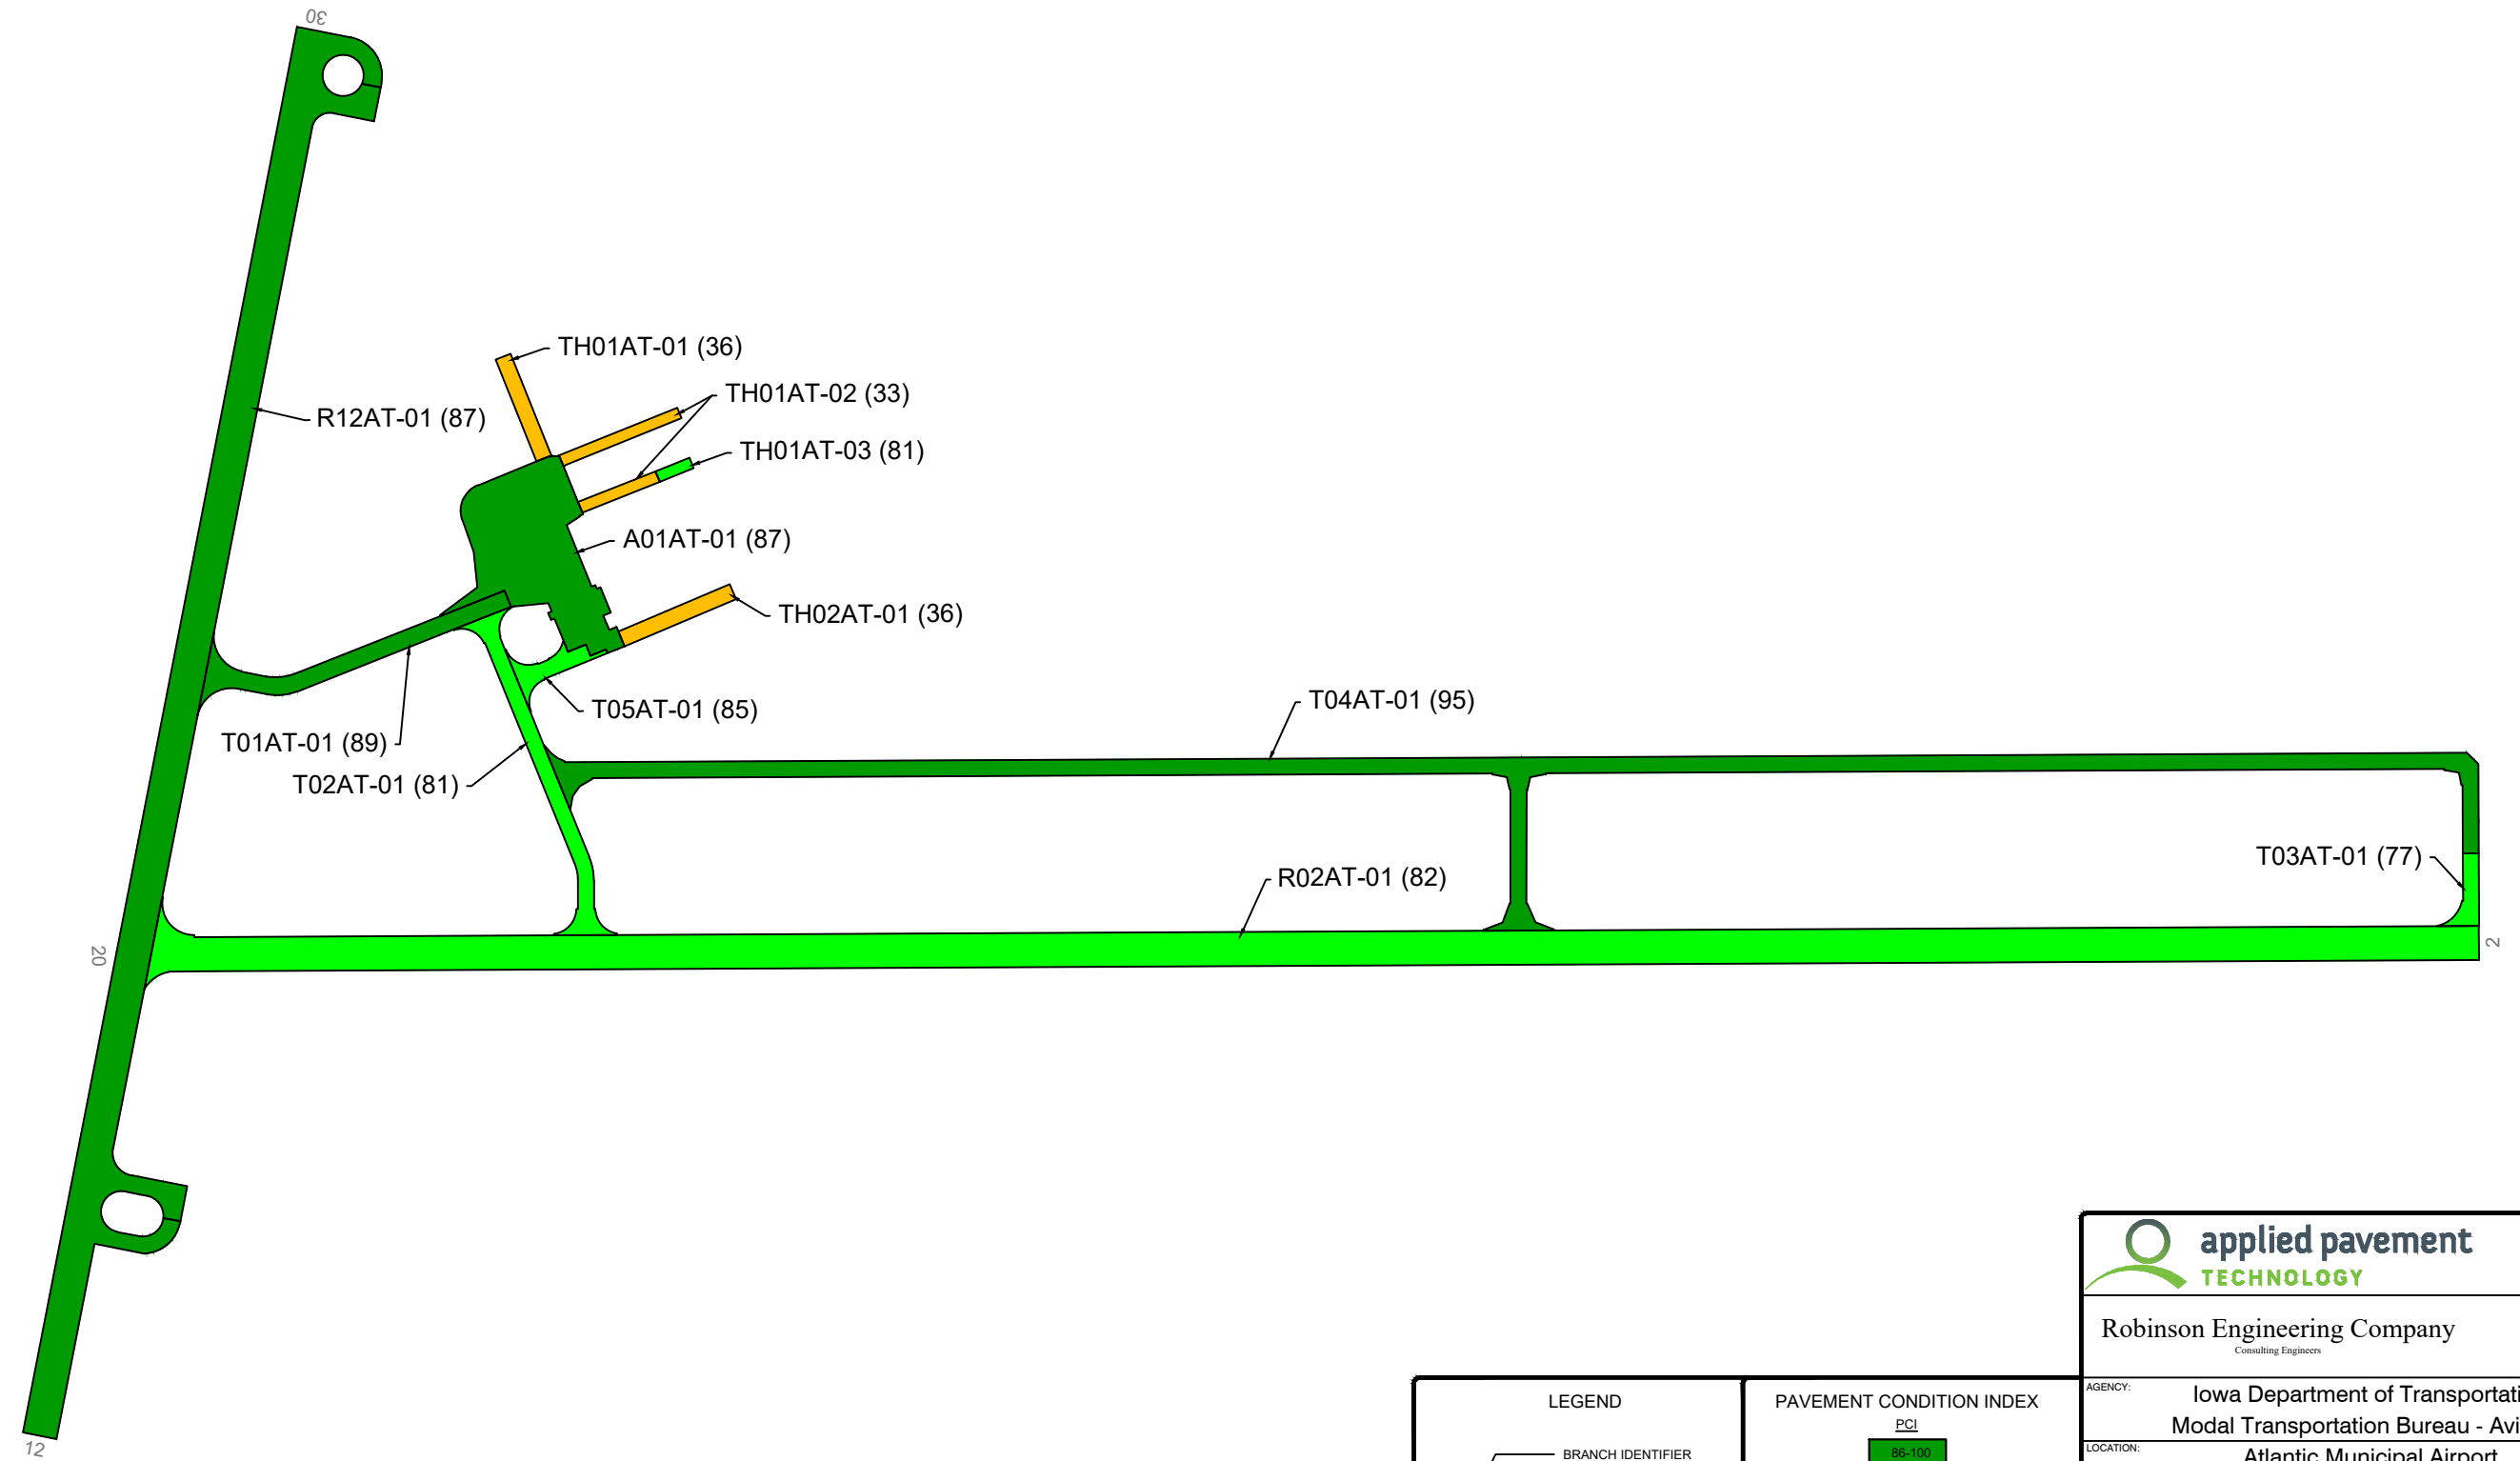
FIGURE 8. PCI MAP.

The pavements at Atlantic Municipal Airport were inspected in November 2023. The 2023 area-weighted condition of Atlantic Municipal Airport is 85, with conditions ranging from 33 to 95 (on a scale of 0 [failed] to 100 [excellent]). During the previous pavement inspection in 2020, the area-weighted PCI of the airport was 91.

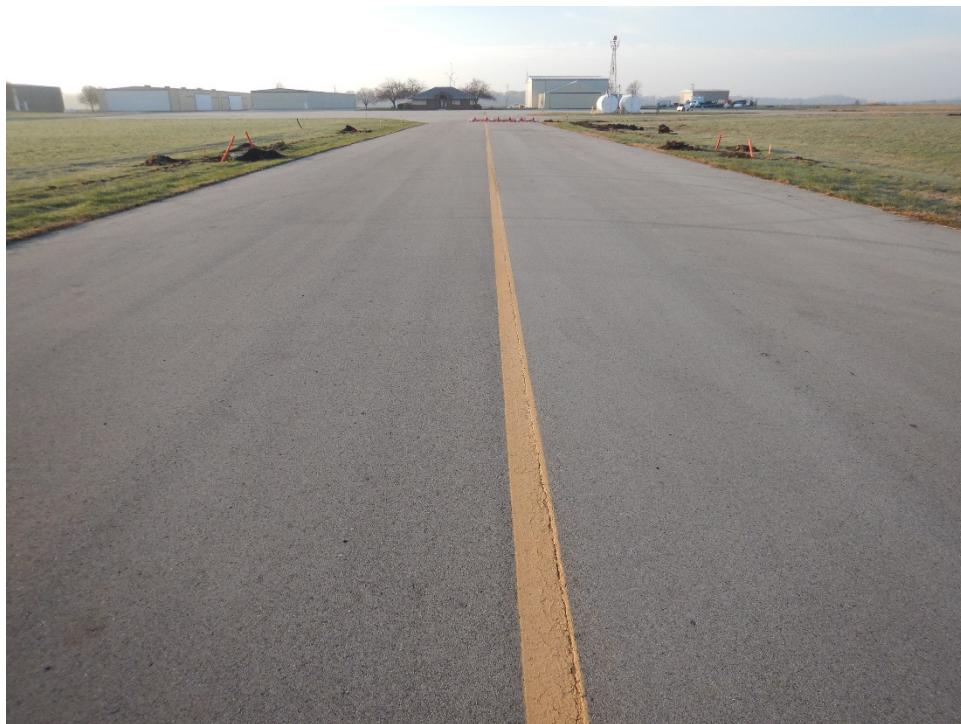
T01AT-01. Overview.

Taxiway 01 was defined by one section that connected the apron area to Runway 12/30. Low-severity L&T cracking in the unsealed condition and weathering were observed during the inspection.
