Audubon County Airport

PAVEMENT MANAGEMENT REPORT

JUNE 2018

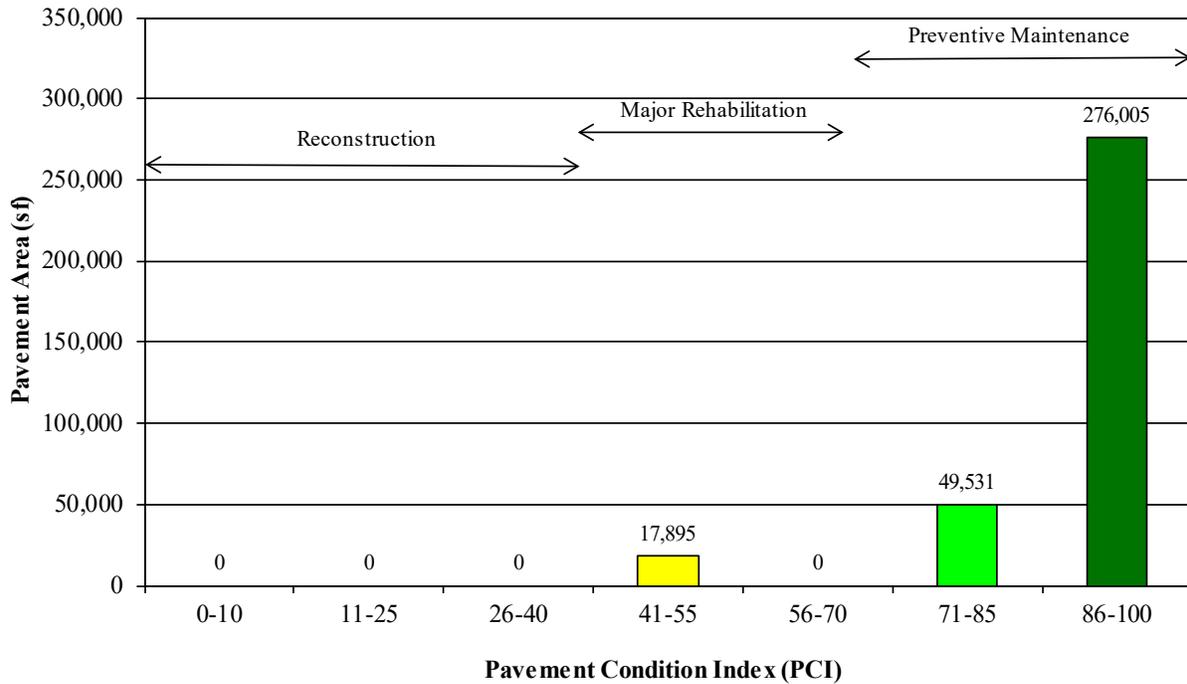
Figure 6. Pavement area by PCI range at Audubon County Airport.

The pavements at Audubon County Airport were inspected on December 7, 2017. The 2017 area-weighted condition of Audubon County Airport is 91, with conditions ranging from 46 to 98 (on a scale of 0 [failed] to 100 [excellent]). During the previous pavement inspection in 2014, the area-weighted PCI of the airport was 92.
