Audubon County Airport

PAVEMENT MANAGEMENT REPORT

JULY 2021

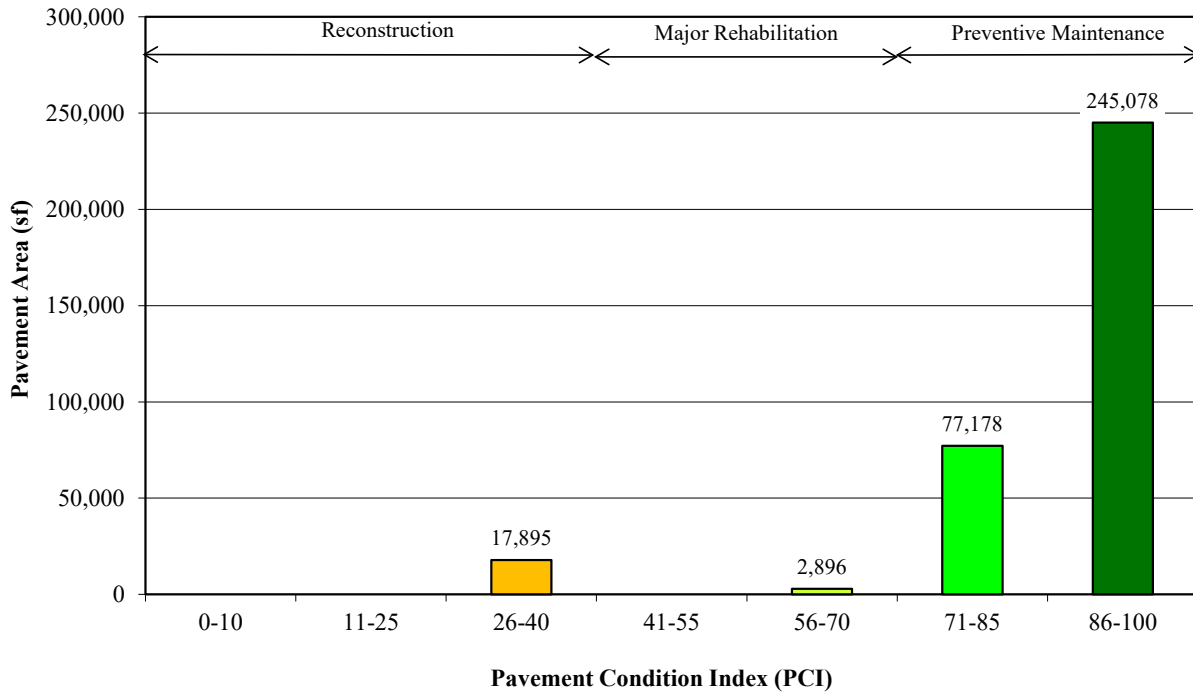
Figure 6. Pavement area by PCI range at Audubon County Airport.

The pavements at Audubon County Airport were inspected in November 2020. The 2020 area-weighted condition of Audubon County Airport is 89, with conditions ranging from 28 to 98 (on a scale of 0 [failed] to 100 [excellent]). During the previous pavement inspection in 2017, the area-weighted PCI of the airport was 91.

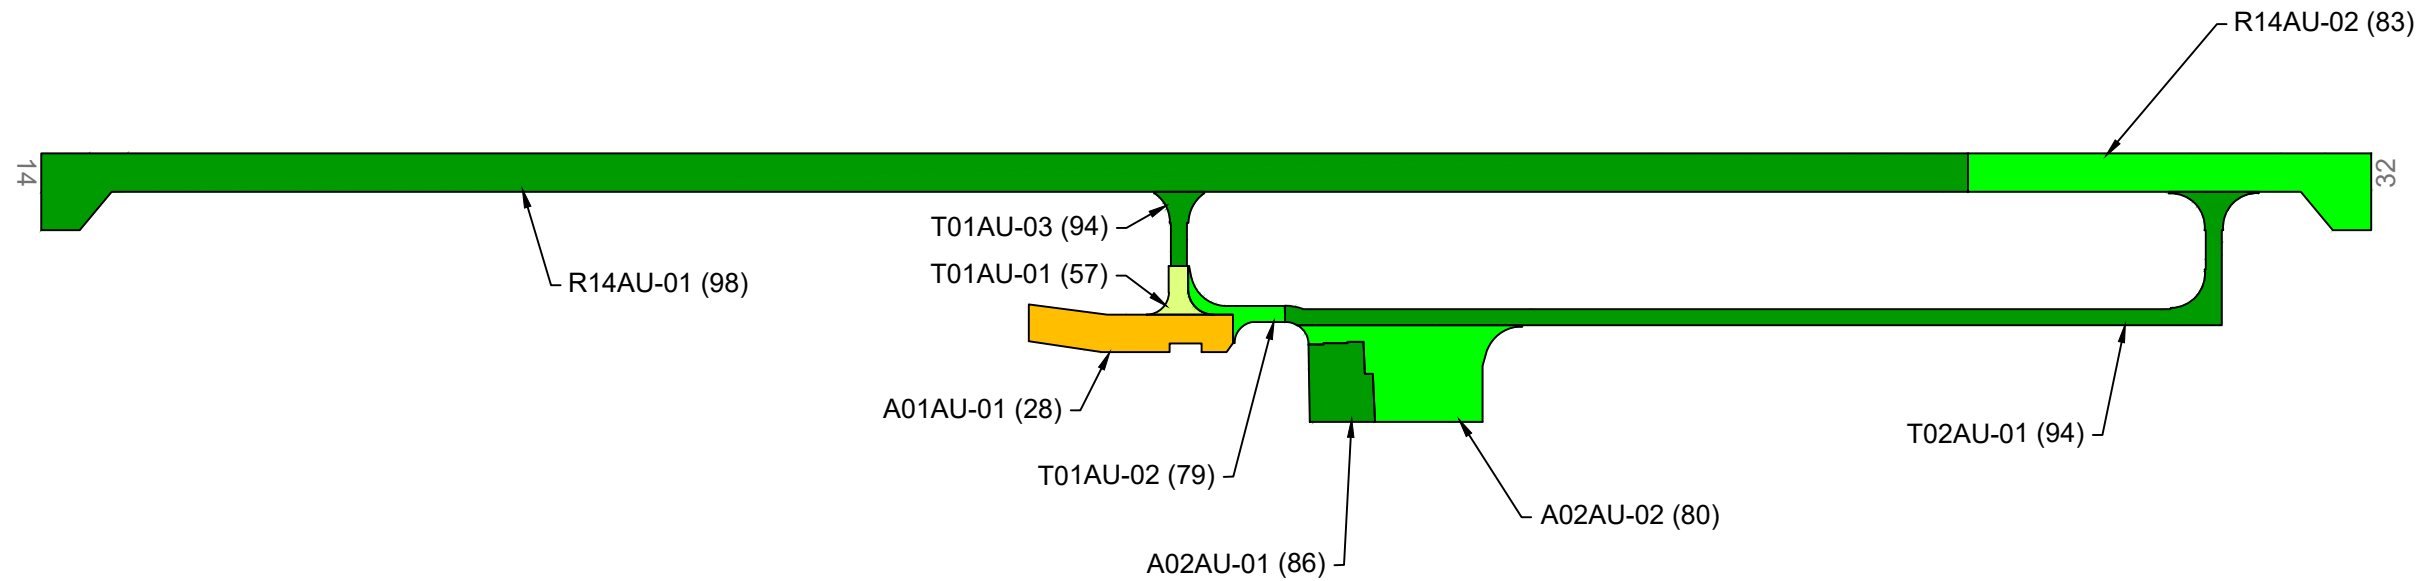
FIGURE 8. PCI MAP.

Figure 6 summarizes the overall condition of the pavements at Audubon County Airport, and Figure 7 presents area-weighted condition (average PCI adjusted to account for the relative size of the pavement sections) by branch use. Figure 8 is a map that displays the condition of the evaluated pavements. Table 1 summarizes the results of the pavement evaluation. Appendix B presents photographs taken during the PCI inspection, and Appendix C contains detailed information on the distresses observed during the visual survey. Appendix D includes detailed work history information that was collected during the record review process.
