Bloomfield Municipal Airport

PAVEMENT MANAGEMENT REPORT

JULY 2022

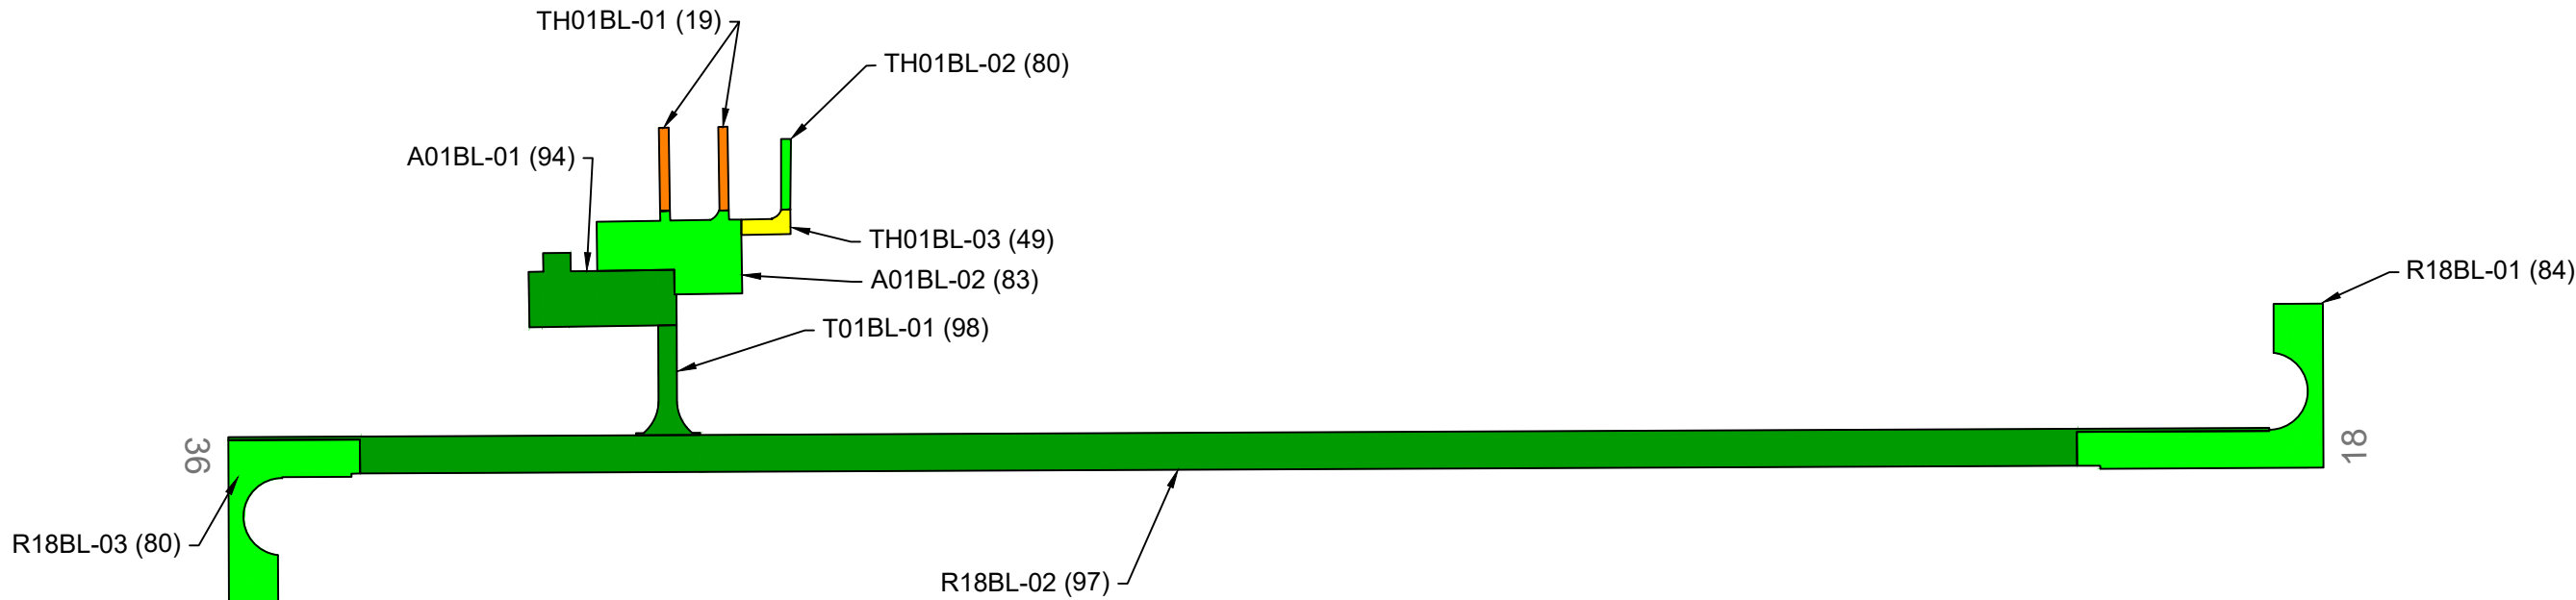
FIGURE 8. PCI MAP.

The pavements at Bloomfield Municipal Airport were inspected in November 2021. The 2021 area-weighted condition of Bloomfield Municipal Airport is 91, with conditions ranging from 19 to 98 (on a scale of 0 [failed] to 100 [excellent]). During the previous pavement inspection in 2018, the area-weighted PCI of the airport was 95.
