Boone Municipal Airport

PAVEMENT MANAGEMENT REPORT

JULY 2021

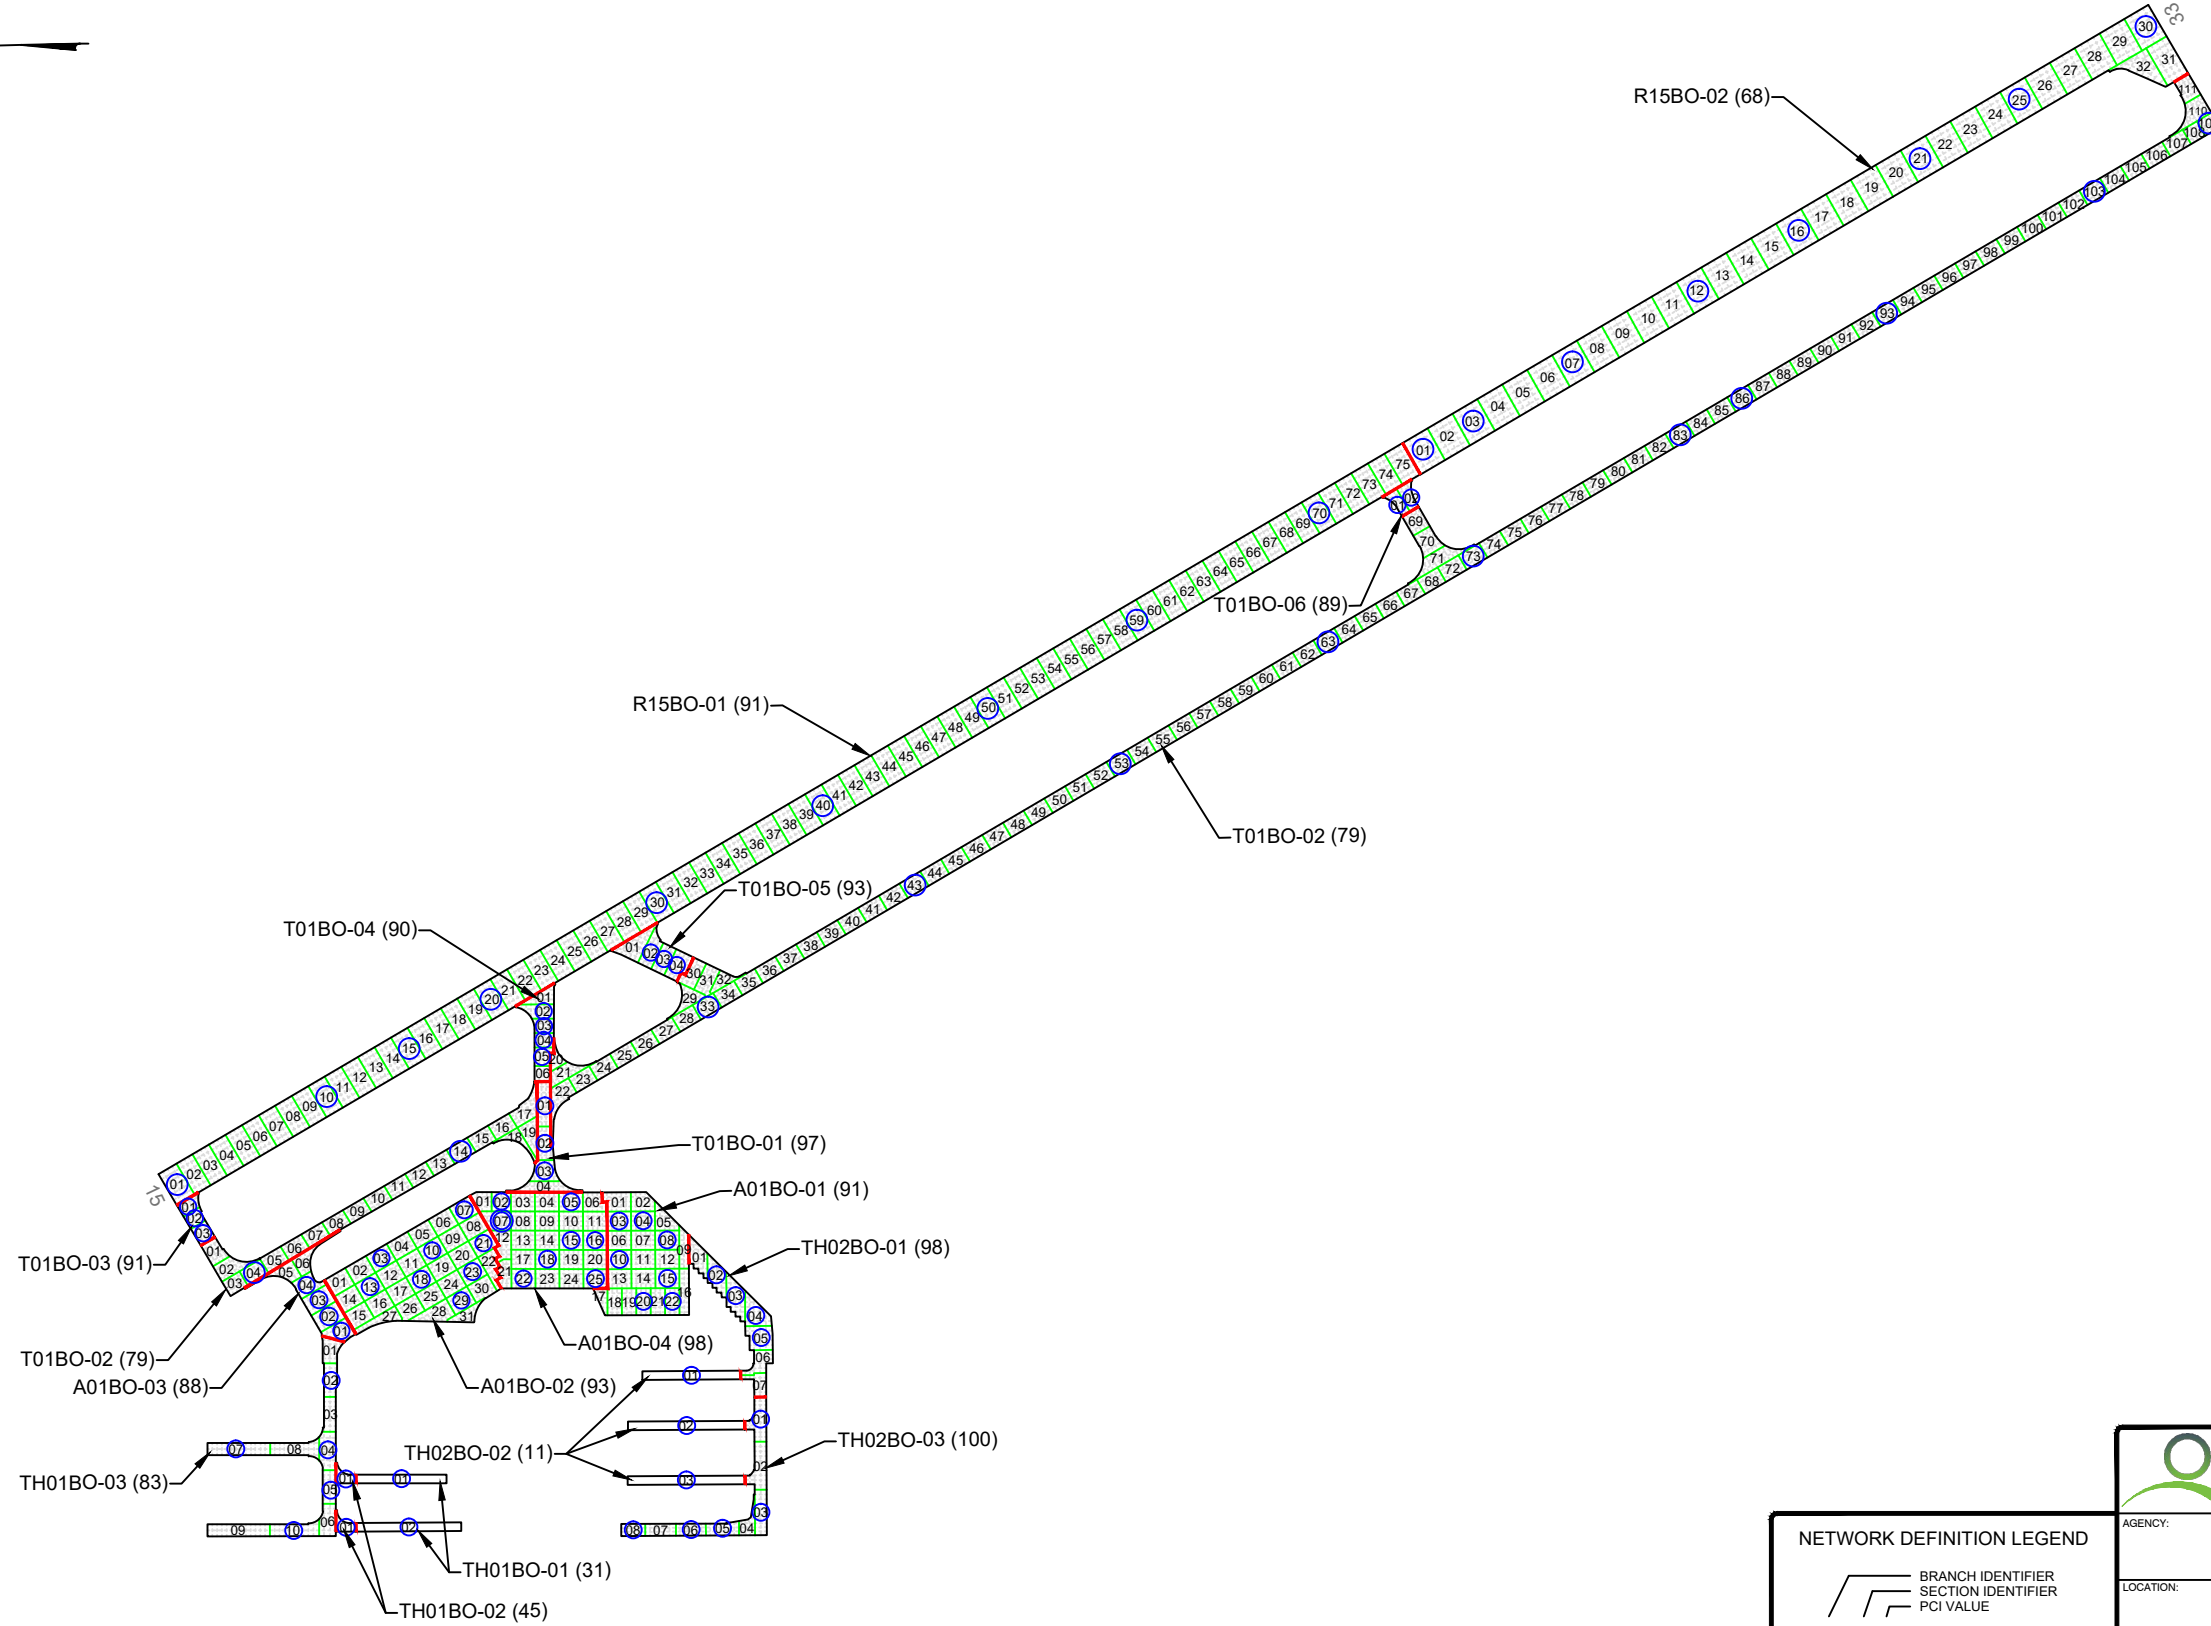
FIGURE 3. NETWORK DEFINITION MAP.

Approximately 838,500 square feet of pavement were evaluated at Boone Municipal Airport, as illustrated in Figure 2. This figure also shows the area-weighted age, in years of the pavements, at the time of the inspection. Figure 3 provides a map that details how the pavement network was divided into management units and identifies the sample units that were evaluated during the pavement inspection at Boone Municipal Airport.

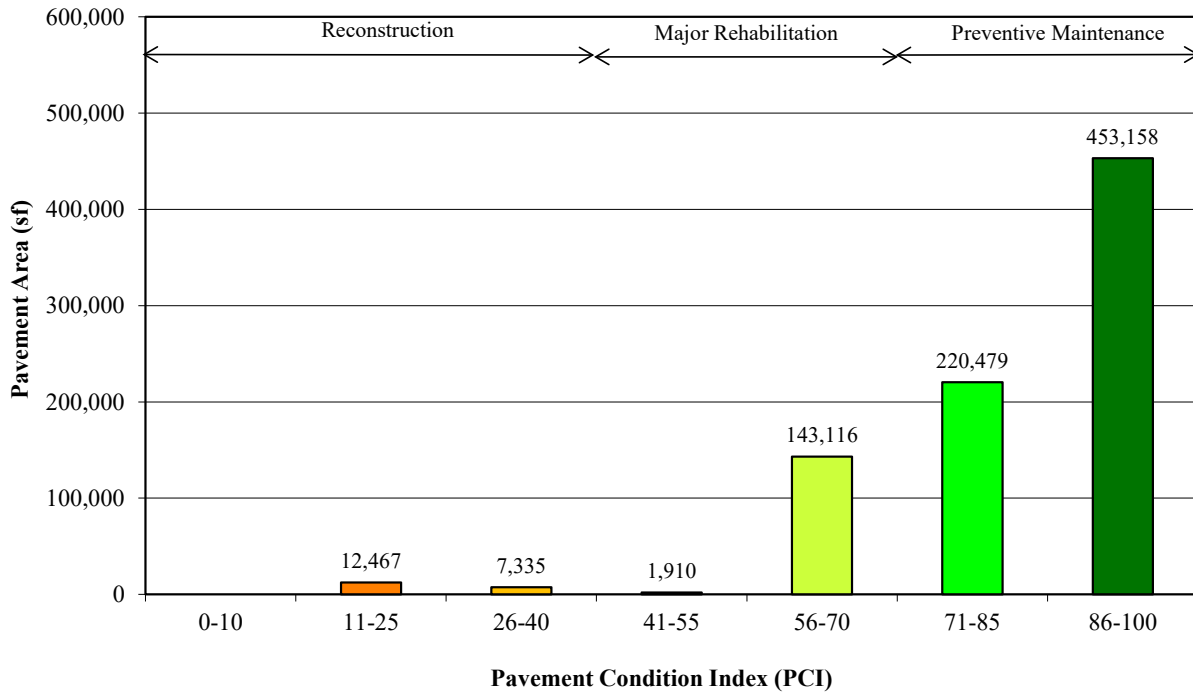
Figure 6. Pavement area by PCI range at Boone Municipal Airport.

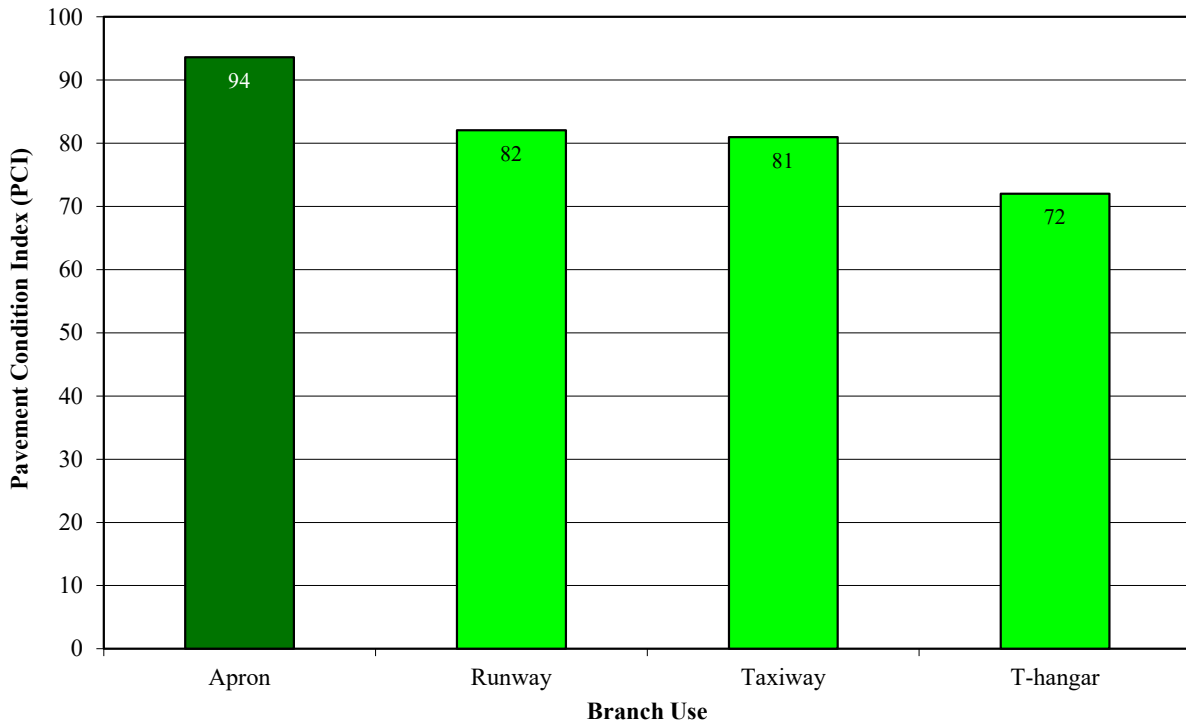
Figure 7. Area-weighted PCI by branch use at Boone Municipal Airport.
(Values on chart are area-weighted)

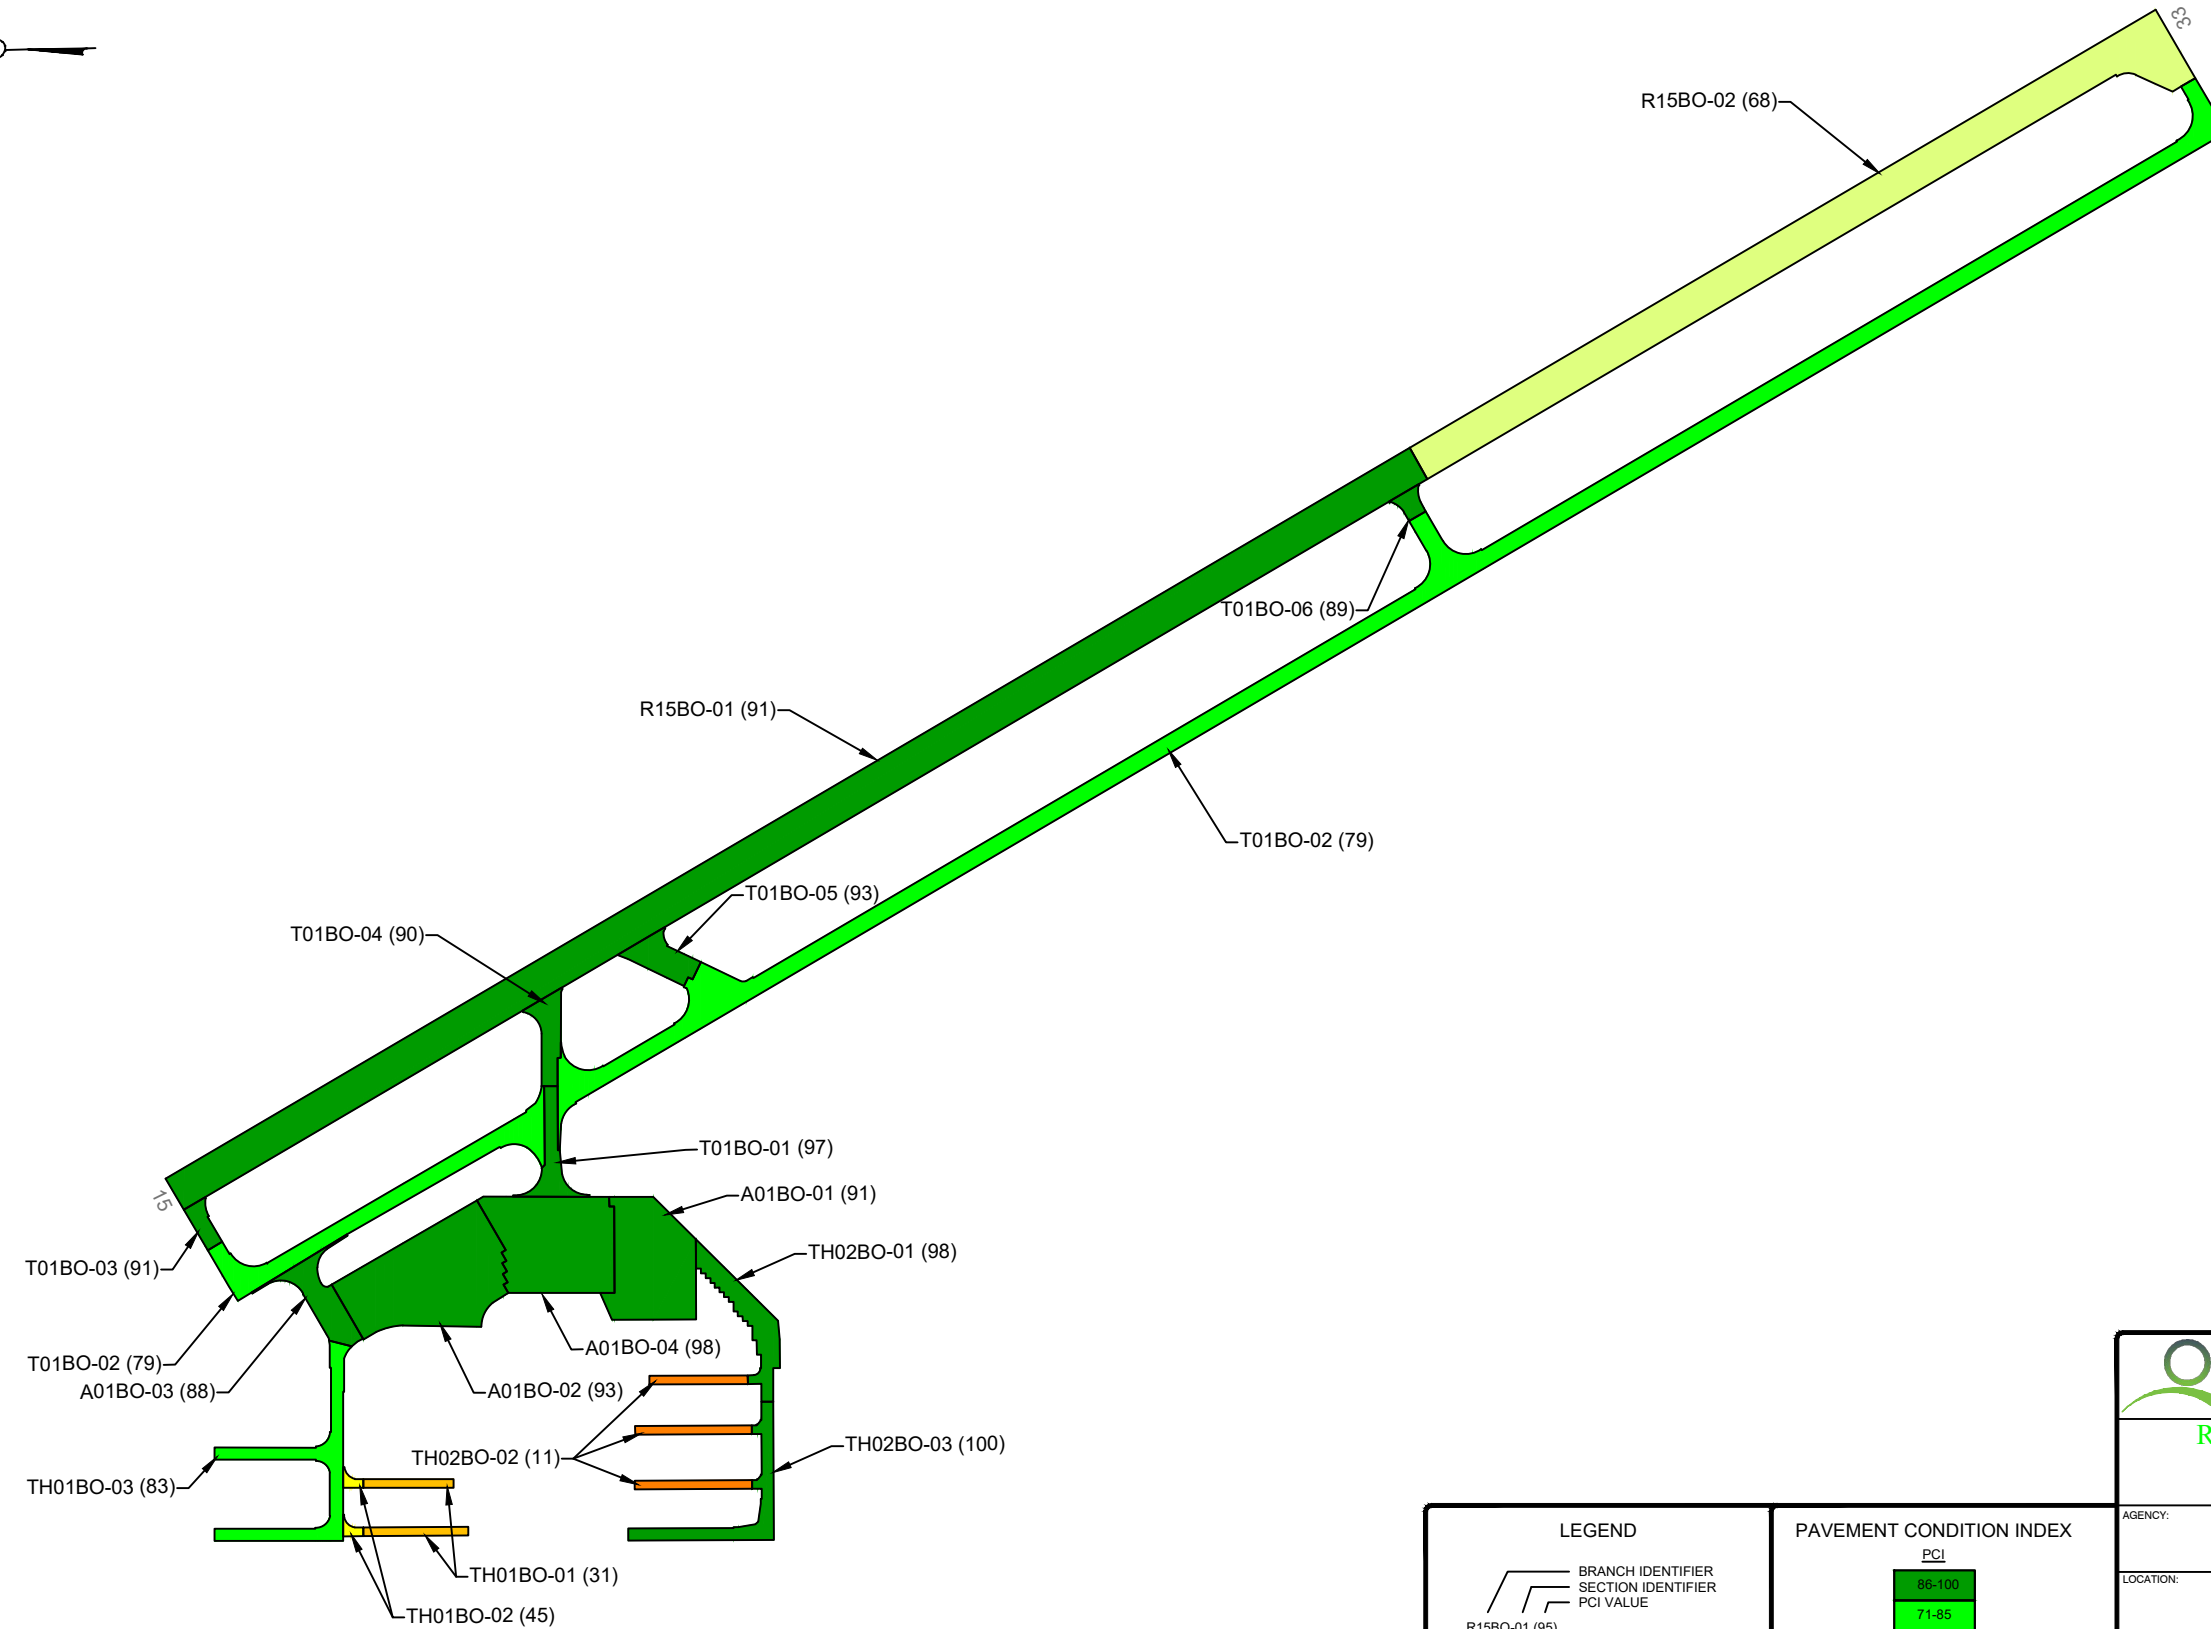
FIGURE 8. PCI MAP.

The pavements at Boone Municipal Airport were inspected in November 2020. The 2020 area-weighted condition of Boone Municipal Airport is 83, with conditions ranging from 11 to 100 (on a scale of 0 [failed] to 100 [excellent]). During the previous pavement inspection in 2017, the area-weighted PCI of the airport was 87.

Figure 6 summarizes the overall condition of the pavements at Boone Municipal Airport, and Figure 7 presents area-weighted condition (average PCI adjusted to account for the relative size of the pavement sections) by branch use. Figure 8 is a map that displays the condition of the evaluated pavements. Table 1 summarizes the results of the pavement evaluation. Appendix B presents photographs taken during the PCI inspection, and Appendix C contains detailed information on the distresses observed during the visual survey. Appendix D includes detailed work history information that was collected during the record review process.

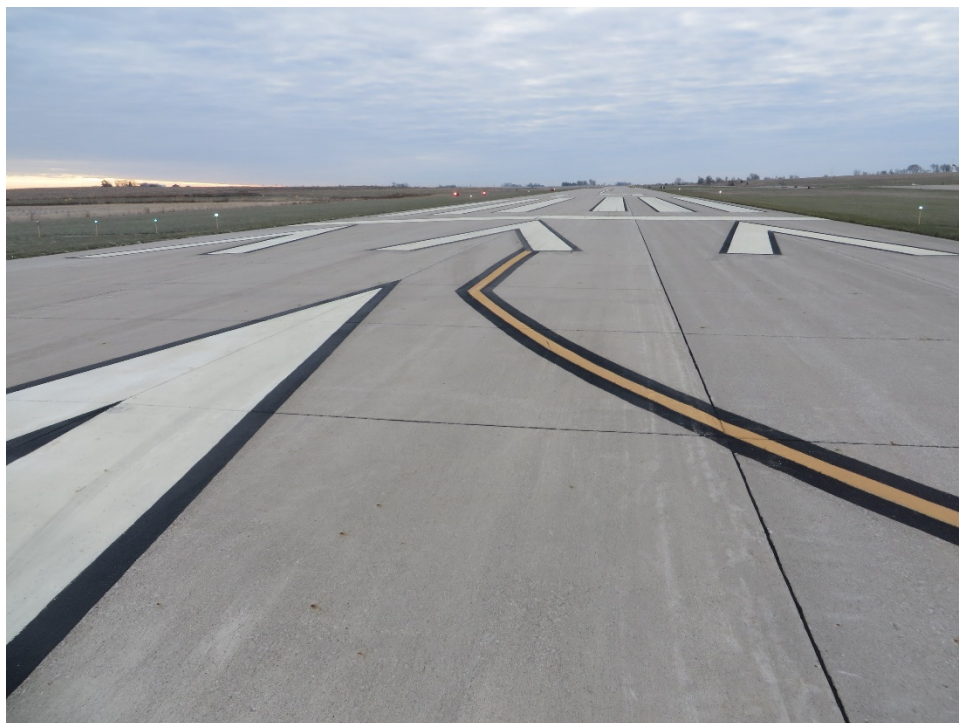
R15BO-01. Overview.

Runway 15/33 was defined by two sections. Areas of low-severity faulting and longitudinal, transverse, and diagonal (LTD) cracking and medium-severity corner spalling and joint seal damage were recorded in Section 01. Low-severity corner spalling, joint spalling, small patching, large patching, and LTD cracking; popouts; and medium-severity joint seal damage were identified in Section 02. In addition, suspected low- and medium-severity alkali-silica reaction (ASR) were recorded in accordance with ASTM D5340-20. It should be noted that laboratory testing in the form of petrographic analysis is the only definitive way to validate the presence of ASR; however, the formation of a precipitate is evidence of a reaction consistent with this type of materials-related distress.
