Southeast Iowa Regional Airport

PAVEMENT MANAGEMENT REPORT

JULY 2022

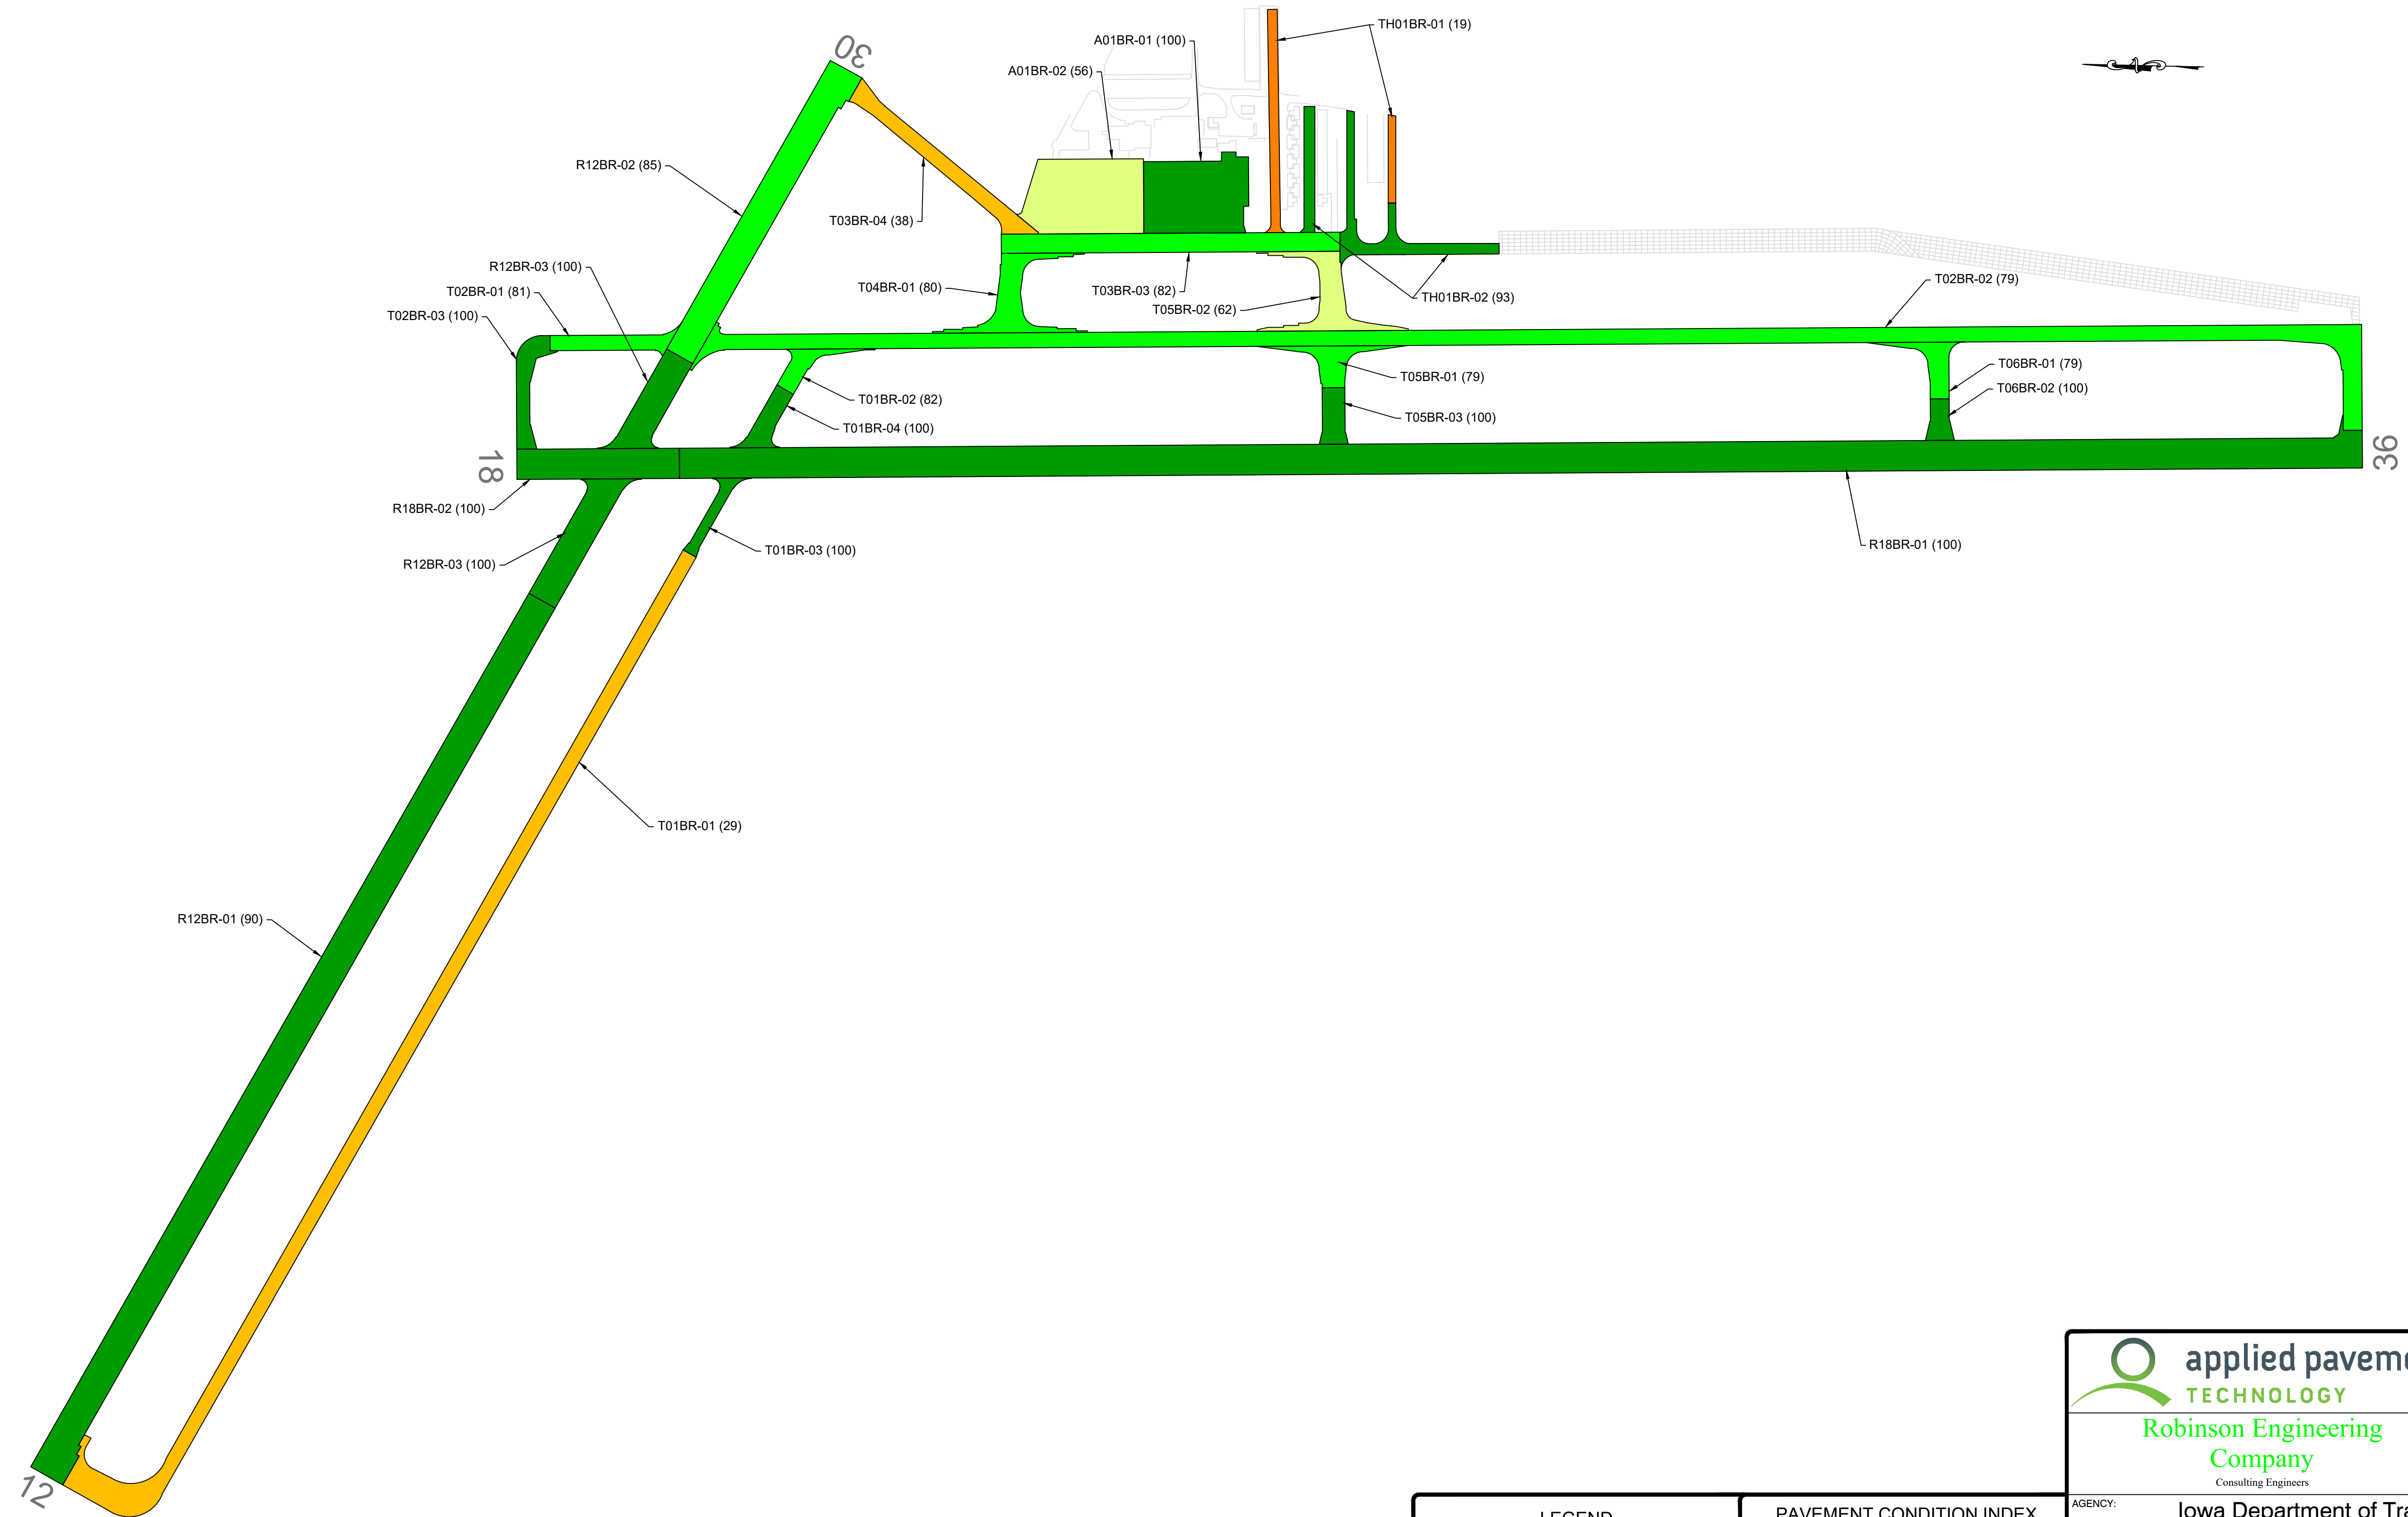
FIGURE 8. PCI MAP.

The pavements at Southeast Iowa Regional Airport were inspected in November 2021. The 2021 area-weighted condition of Southeast Iowa Regional Airport is 82, with conditions ranging from 19 to 100 (on a scale of 0 [failed] to 100 [excellent]). During the previous pavement inspection in 2018, the area-weighted PCI of the airport was 64.

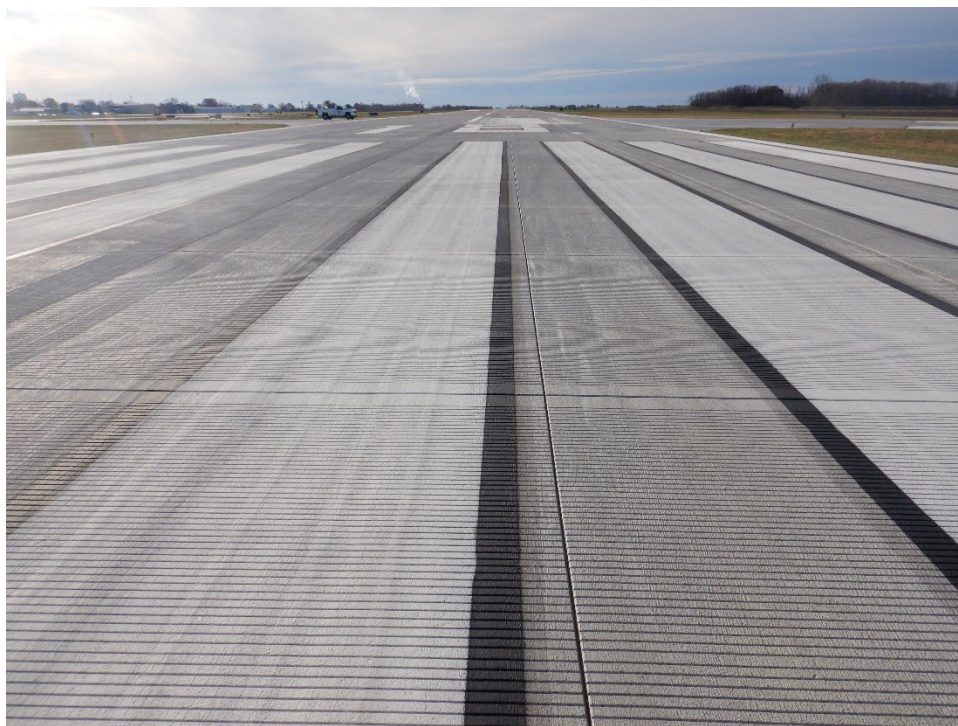
R18BR-02. Overview.

Runway 18/36 was defined by two, recently reconstructed sections that were in excellent condition. No distress was noted in either section at the time of inspection.

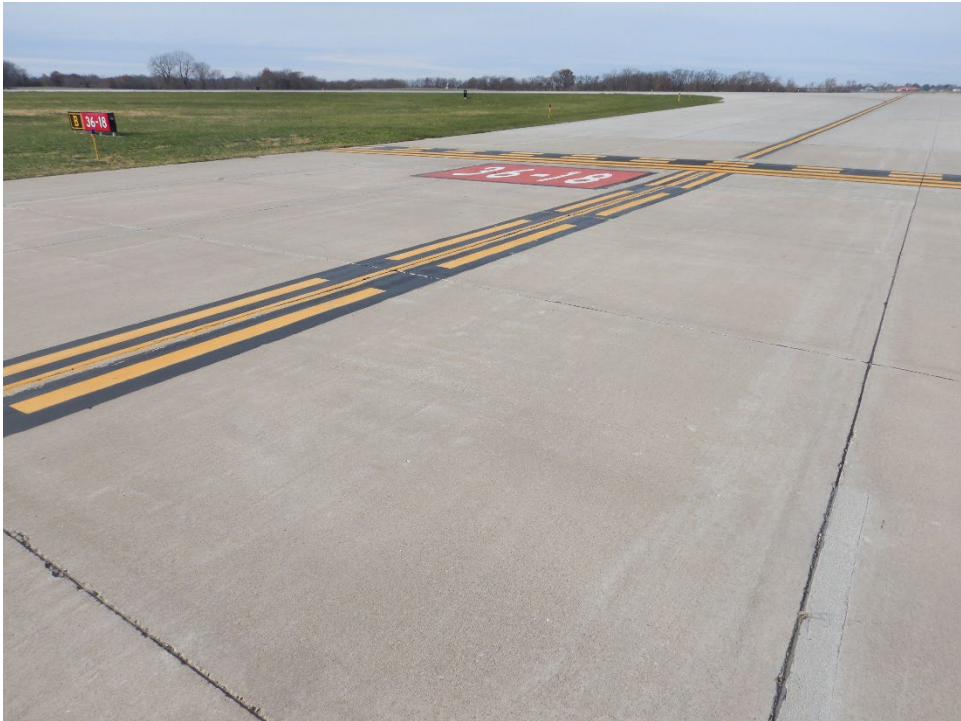
T01BR-02. Overview.

T01BR	02	PCC	12,890	1/1/2003	82	0	66	34	Corner Spalling, Faulting, Joint Spalling, Joint Seal Damage, Large Patch, Small Patch
T01BR	03	PCC	11,350	6/3/2021	100	0	0	0	No Distresses
T01BR	04	PCC	15,250	6/3/2021	100	0	0	0	No Distresses
T02BR	01	PCC	20,640	1/1/2003	81	61	33	6	ASR, Corner Break, Joint Seal Damage, LTD Cracking
T02BR	02	PCC	298,130	1/1/2003	79	8	47	45	ASR, Corner Spalling, Faulting, Joint Spalling, Joint Seal Damage, Large Patch, LTD Cracking, Small Patch
T02BR	03	PCC	21,785	6/3/2021	100	0	0	0	No Distresses

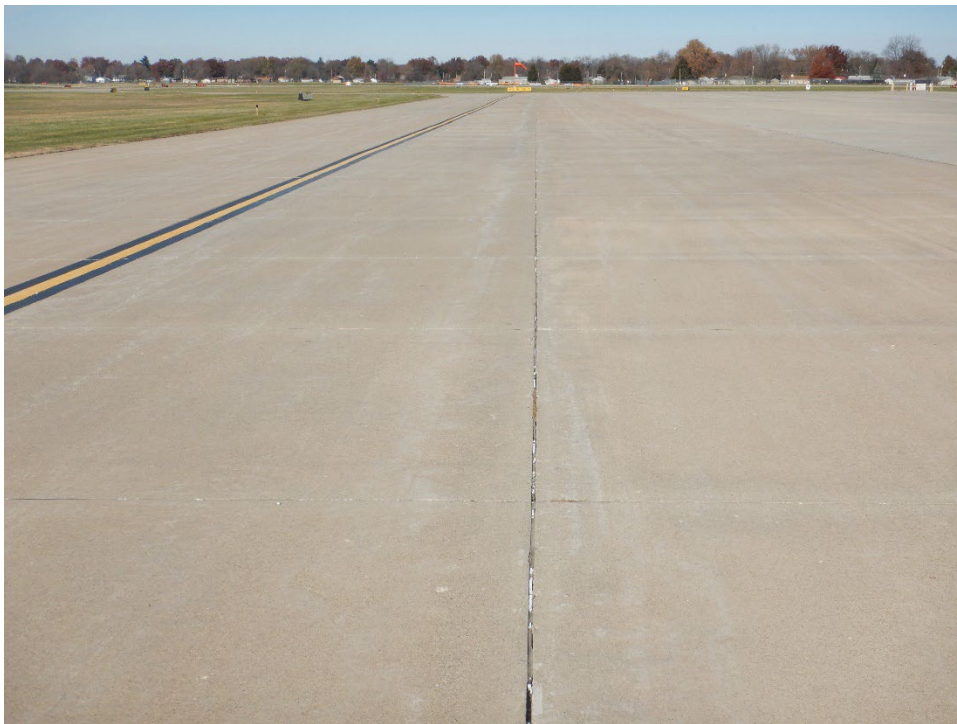
T03BR-03. Overview.

Branch	Section	Surface Type	Section Area (sf)	LCD	2021 PCI	% Distress Due to Load	% Distress Due to Climate/Durability	% Distress Due to Other	Type of Distress
T03BR	03	PCC	70,854	1/1/2003	82	17	62	21	ASR, Corner Break, Corner Spalling, Joint Spalling, Joint Seal Damage, LTD Cracking, Small Patch
T03BR	04	APC	39,660	6/1/2005	38	26	74	0	Alligator Cracking, Block Cracking, Joint Reflection Cracking, Patching, Raveling, Weathering
T04BR	01	PCC	32,954	1/1/2003	80	2	41	57	ASR, Corner Break, Corner Spalling, Joint Seal Damage, Large Patch, Small Patch
T05BR	01	PCC	18,395	1/1/2003	79	0	51	49	ASR, Faulting, Joint Spalling, Joint Seal Damage, Large Patch, Shrinkage Cracking, Small Patch
T05BR	02	PCC	33,565	1/1/2003	62	0	32	68	ASR, Corner Spalling, Joint Spalling, Joint Seal Damage, Shrinkage Cracking, Small Patch
T05BR	03	PCC	14,510	6/3/2021	100	0	0	0	No Distresses
T06BR	01	PCC	16,245	1/1/2003	79	0	40	60	ASR, Corner Spalling, Joint Spalling, Joint Seal Damage, Small Patch

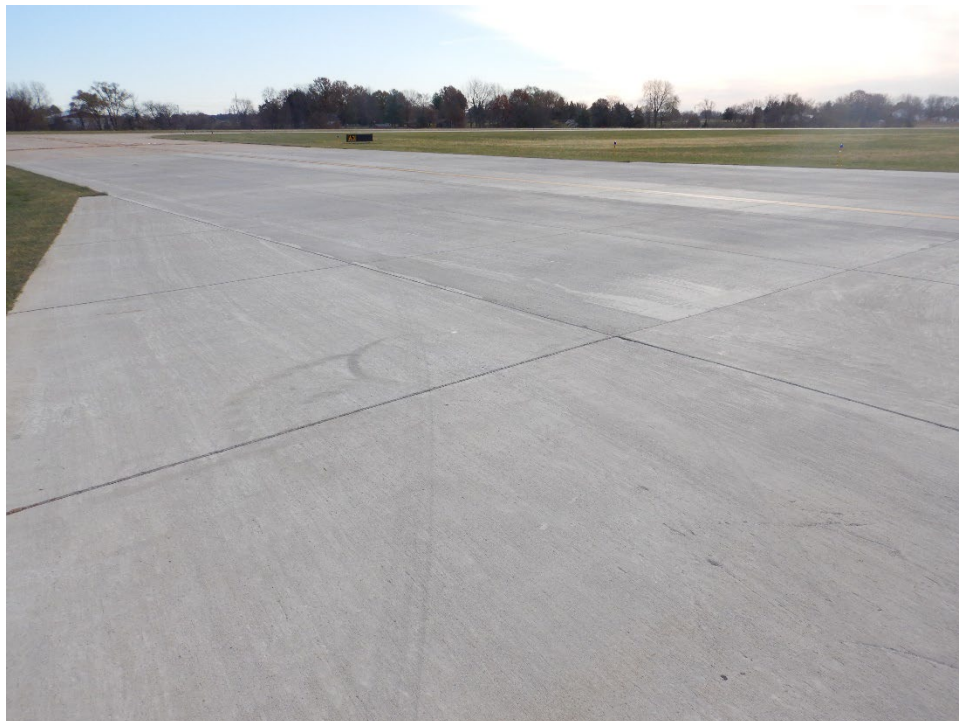
T06BR-02. Overview.

T06BR	02	PCC	9,770	6/3/2021	100	0	0	0	No Distresses
TH01BR	01	AC	30,884	7/3/1995	19	28	70	2	Alligator Cracking, Bleeding, L&T Cracking, Patching, Raveling, Rutting, Swelling
TH01BR	02	PCC	51,850	8/3/2012	93	35	61	4	Joint Spalling, Joint Seal Damage, Large Patch, LTD Cracking, Shattered Slab
