# Carroll-Arthur N Neu Airport

## Pavement Management Report

**JULY 2024**

# CARROLL-ARTHUR N NEU AIRPORT PAVEMENT MANAGEMENT REPORT

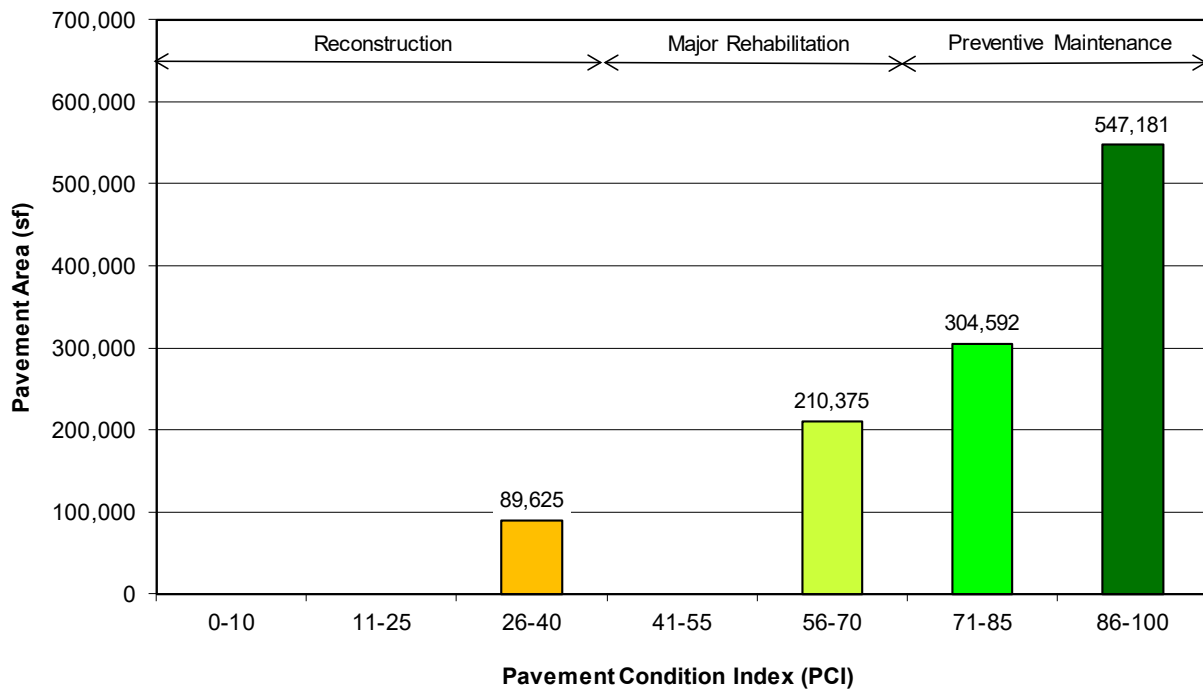
Figure 6. Pavement area by PCI range at Carroll-Arthur N Neu Airport.

The pavements at Carroll-Arthur N Neu Airport were inspected in November 2023. The 2023 area-weighted condition of Carroll-Arthur N Neu Airport is 80, with conditions ranging from 39 to 98 (on a scale of 0 [failed] to 100 [excellent]). During the previous pavement inspection in 2020, the area-weighted PCI of the airport was 87.

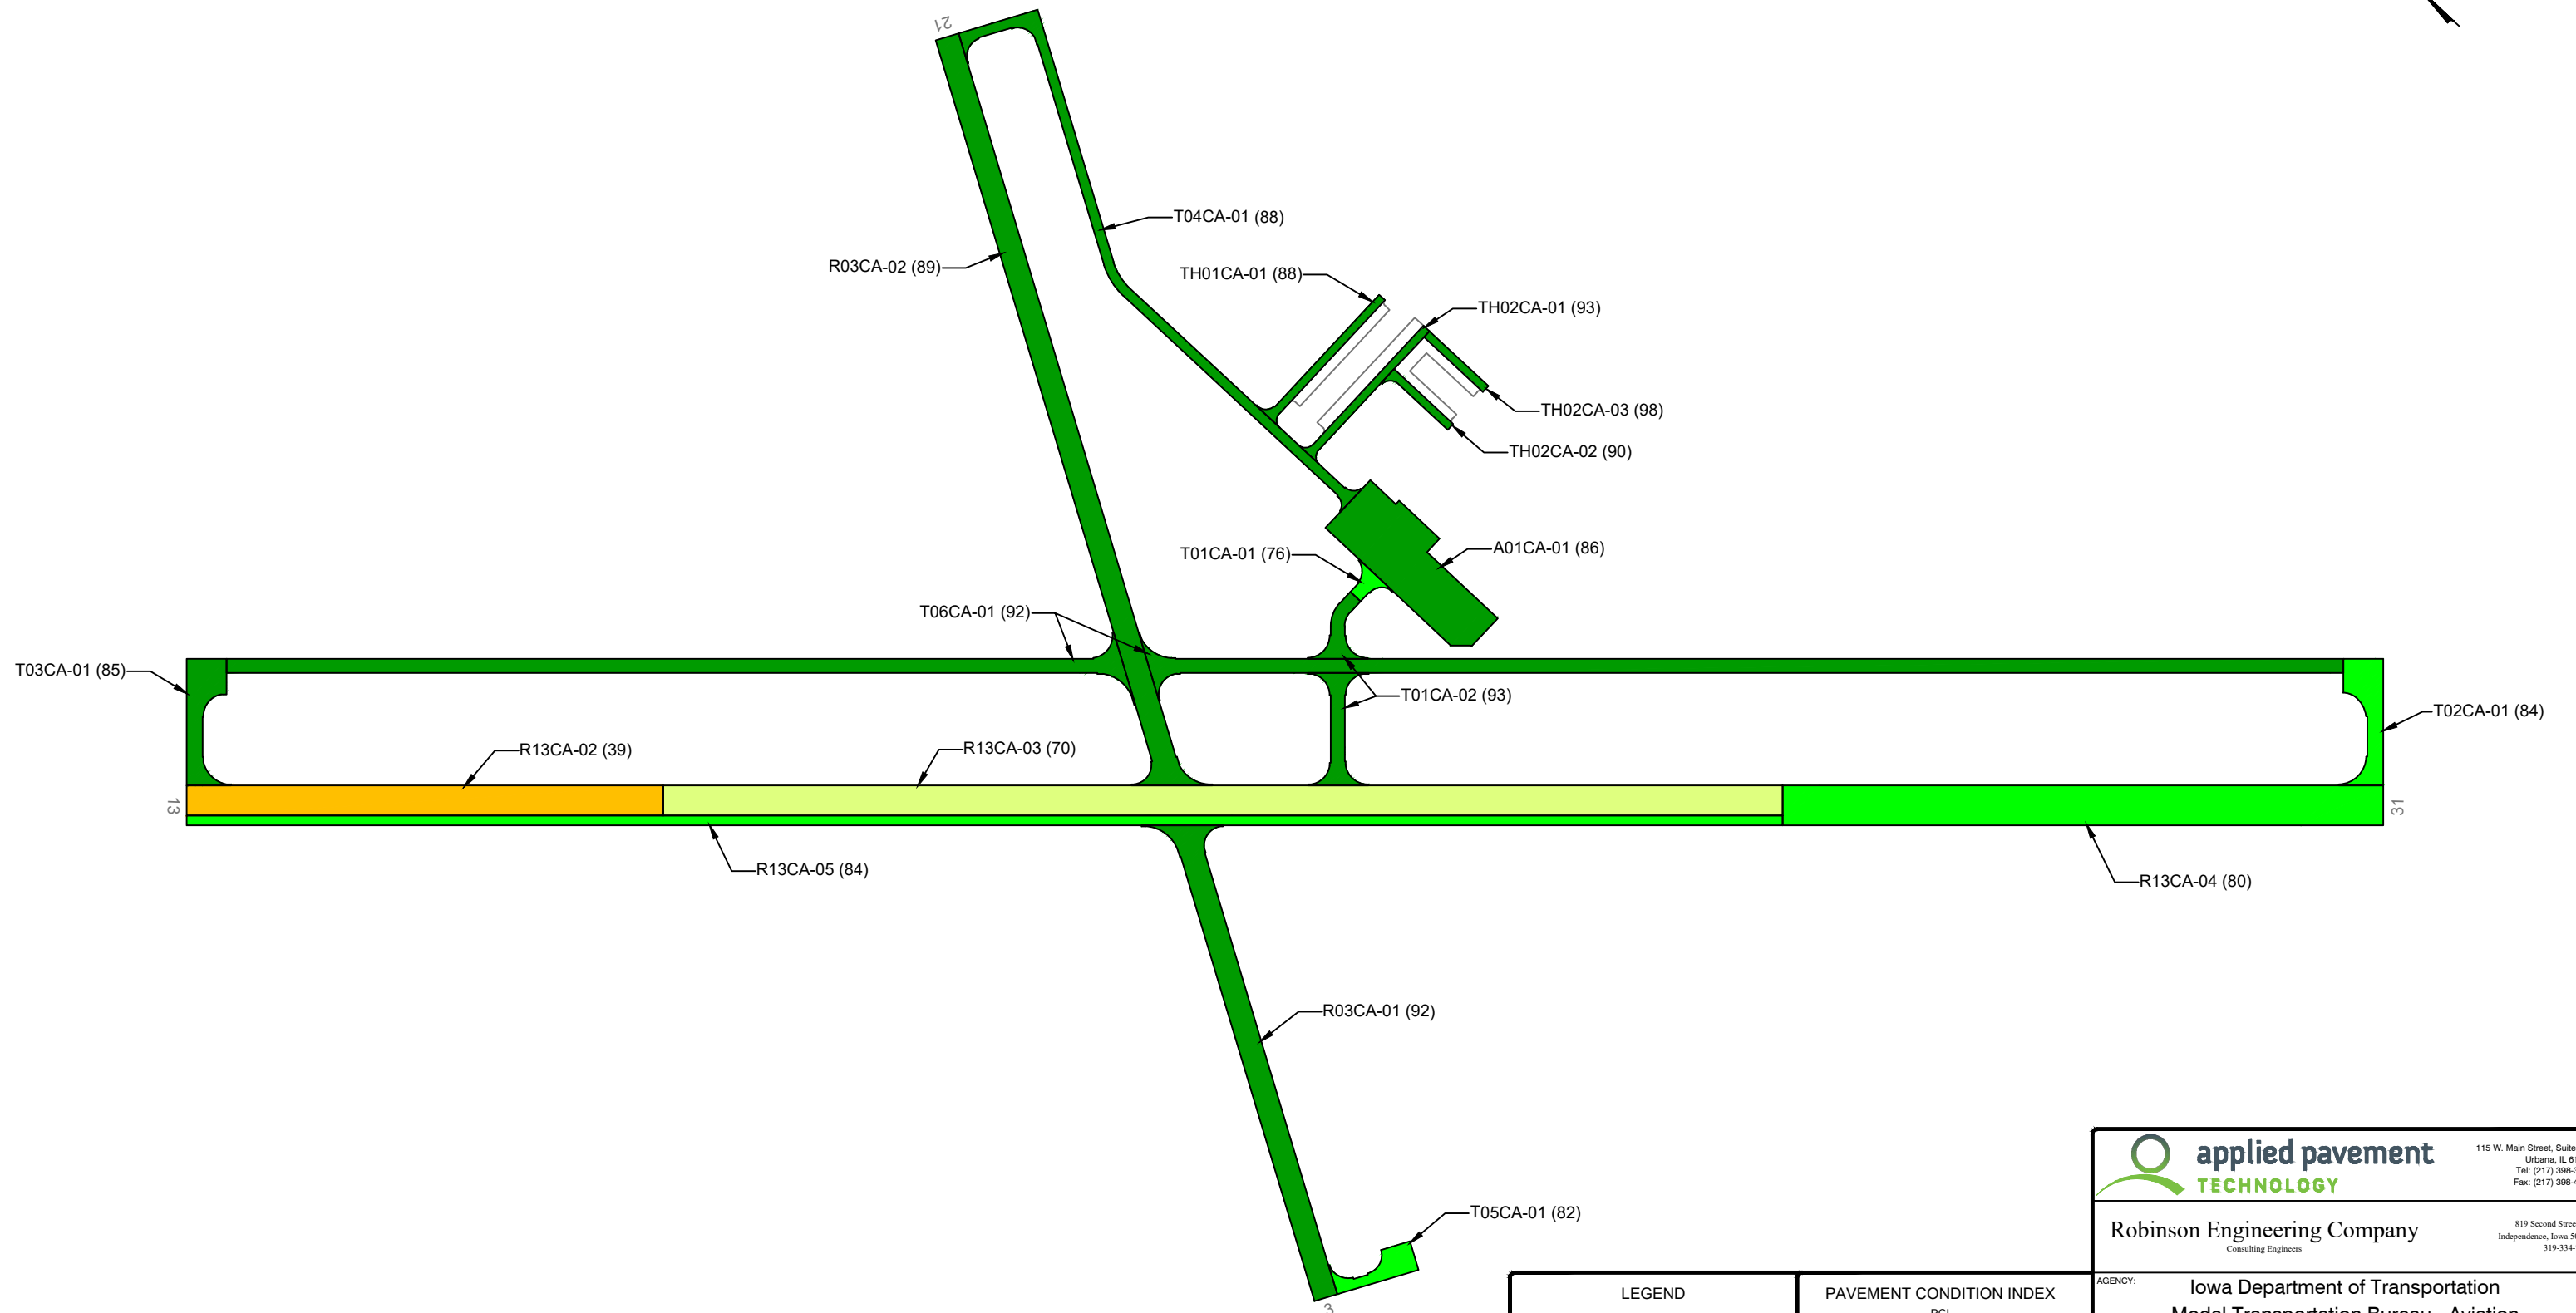
FIGURE 8. PCI MAP.

Figure 6 summarizes the overall condition of the pavements at Carroll-Arthur N Neu Airport, and Figure 7 presents area-weighted condition (average PCI adjusted to account for the relative size of the pavement sections) by branch use. Figure 8 is a map that displays the condition of the evaluated pavements. Table 1 summarizes the results of the pavement evaluation. Appendix B presents photographs taken during the PCI inspection, and Appendix C contains detailed information on the distress types observed during the visual survey. Appendix D includes detailed work history information that was collected during the record review process.
