# Cresco-Ellen Church Field Airport

**PAVEMENT MANAGEMENT REPORT**

**AUGUST 2019**

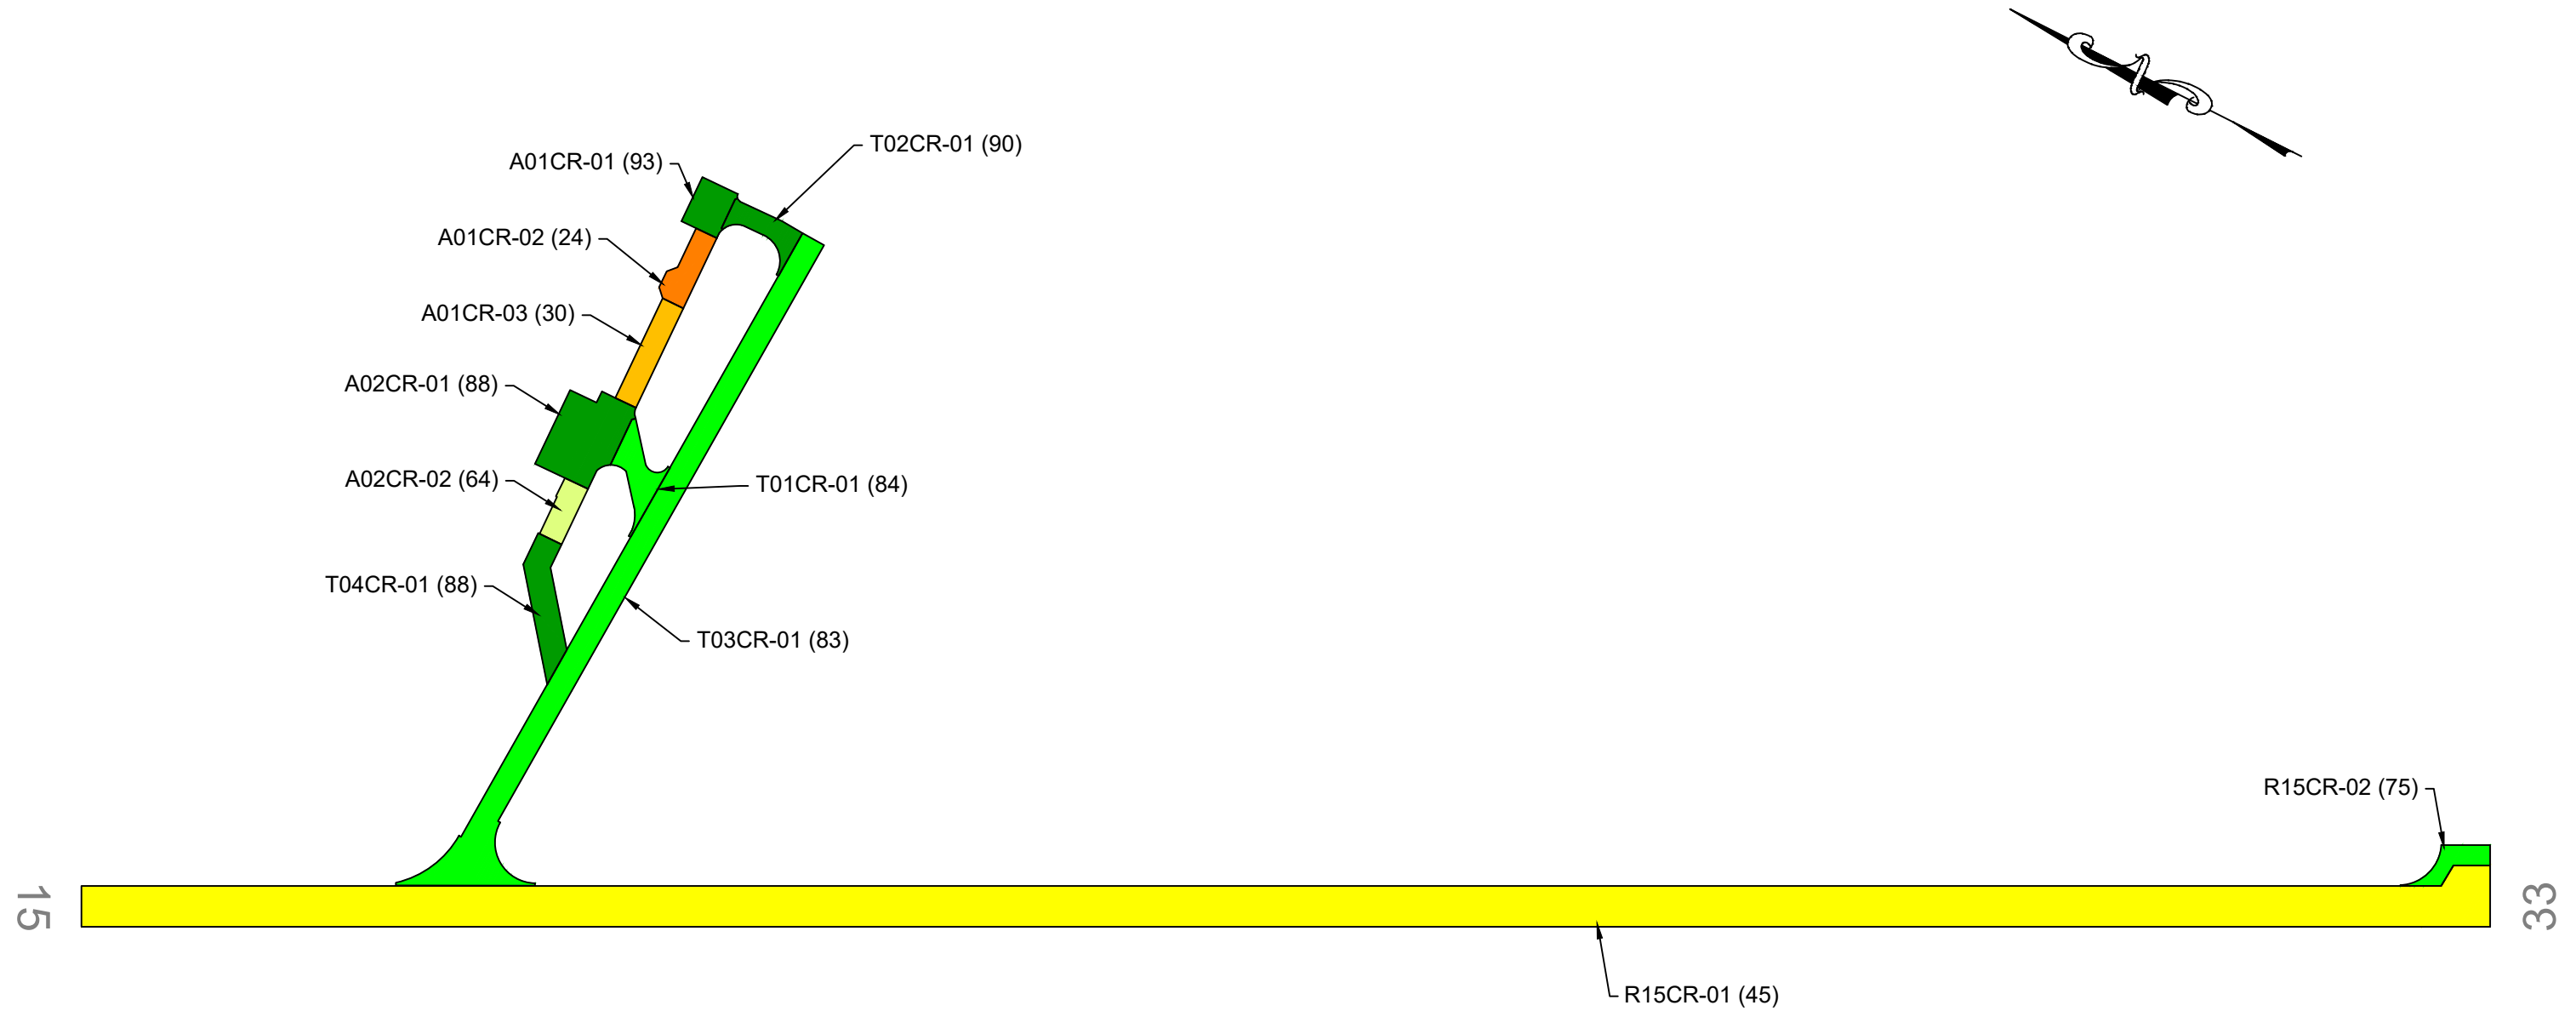
FIGURE 8. PCI MAP.

The pavements at Cresco-Ellen Church Field Airport were inspected on November 14, 2018. The 2018 area-weighted condition of Cresco-Ellen Church Field Airport is 55, with conditions ranging from 24 to 93 (on a scale of 0 [failed] to 100 [excellent]). During the previous pavement inspection in 2012, the area-weighted PCI of the airport was 77.

Figure 6 summarizes the overall condition of the pavements at Cresco-Ellen Church Field Airport, and Figure 7 presents area-weighted condition (average PCI adjusted to account for the relative size of the pavement sections) by branch use. Figure 8 is a map that displays the condition of the evaluated pavements. Table 1 summarizes the results of the pavement evaluation. Appendix B presents photographs taken during the PCI inspection, and Appendix C contains detailed information on the distresses observed during the visual survey. Appendix D includes detailed work history information that was collected during the record review process.

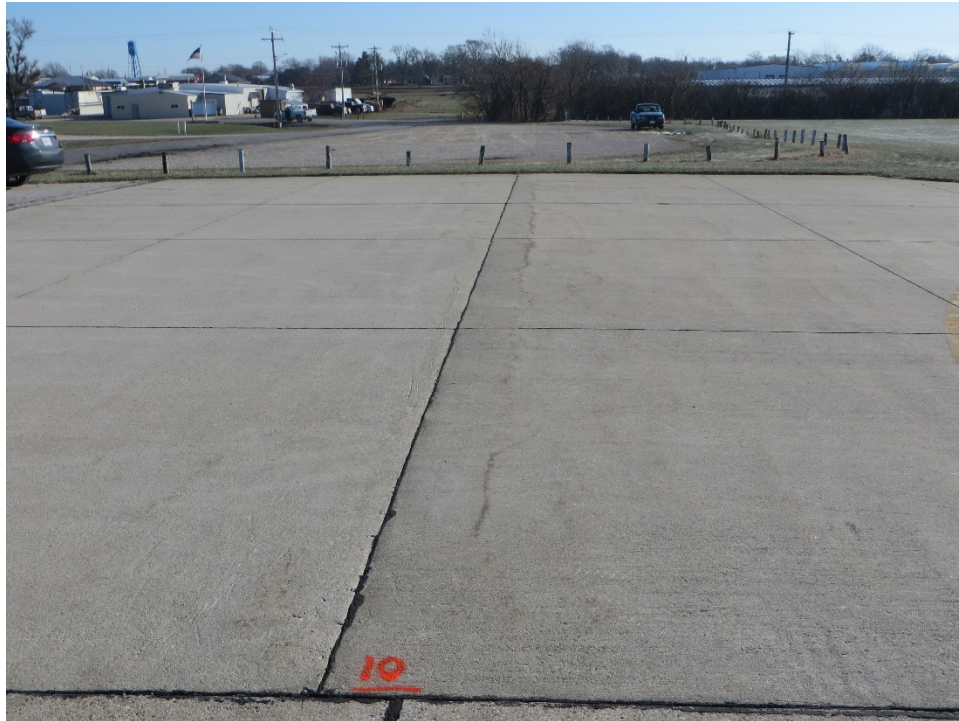
A01CR-01. Overview.

Apron 01 was defined by three sections. Section 01 had medium-severity joint seal damage recorded throughout. Section 02 was in poor condition with low- and medium-severity corner break, corner spalling, and LTD cracking and medium-severity joint seal damage and shattered slab observed. Section 03 was also in poor condition with low-severity corner break and corner spalling, medium-severity joint seal damage, and low- and medium-severity LTD cracking and shattered slab identified.

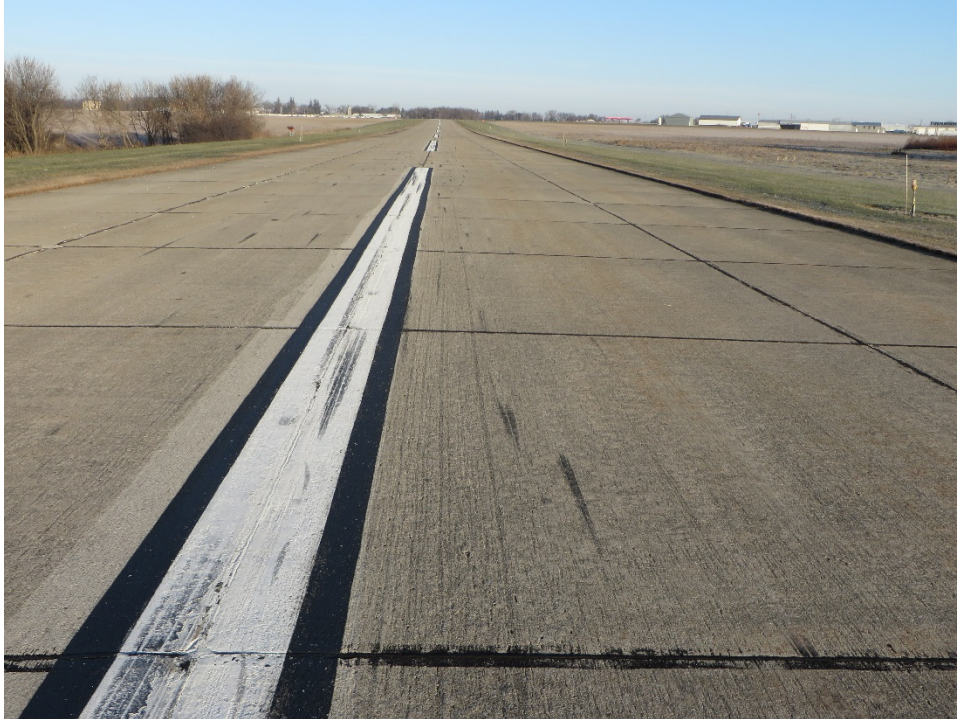
R15CR-01. Overview.

Runway 15/33 was defined by two sections. Section 01 comprised the majority of Runway 15/33. Low- and medium-severity ASR, corner break, large patching, faulting, and longitudinal, transverse, and diagonal (LTD) cracking; all severities of corner spalling, joint spalling, and small patching; and medium- and high-severity joint seal damage were recorded throughout the section. Section 02, located at the Runway 33 approach, had medium-severity joint seal damage and low-severity alkali-silica reaction (ASR), joint spalling, LTD cracking, and small patching observed during the inspection. The suspected ASR was recorded in accordance with ASTM D5340-12. Laboratory testing and analysis is the only definitive way to validate the presence of ASR.

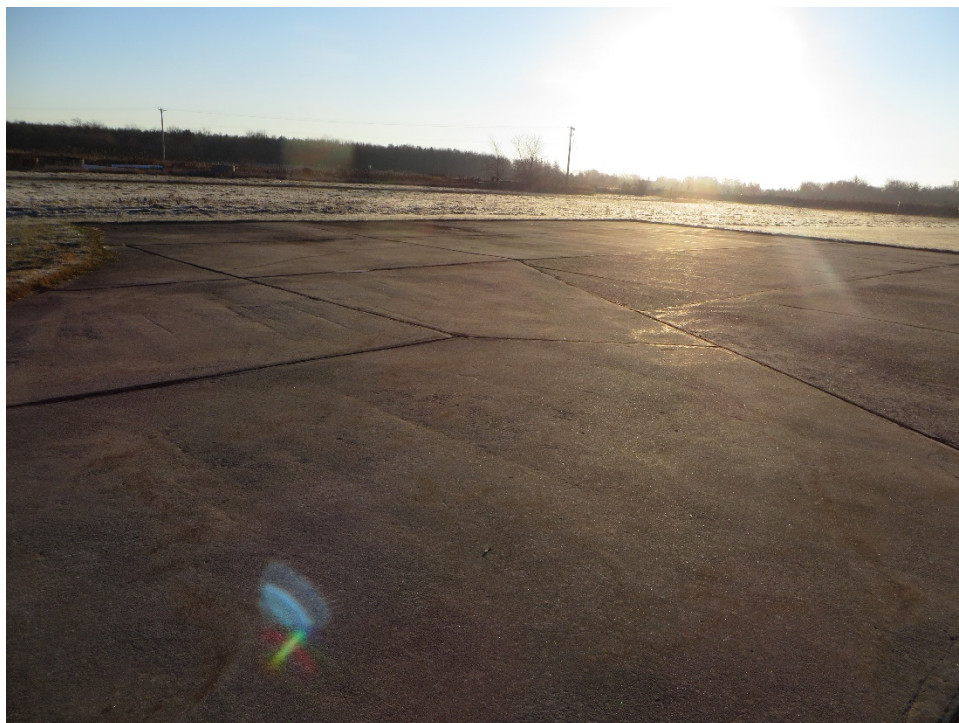
R15CR-02. Overview.

R15CR	02	PCC	2,329	6/1/1981	75	23	25	52	ASR, Joint Seal Damage, Joint Spalling, LTD Cracking, Small Patch
T01CR	01	PCC	3,364	6/2/2008	84	61	39	0	Joint Seal Damage, LTD Cracking
T02CR	01	PCC	2,815	6/2/2008	90	0	69	31	Joint Seal Damage, Joint Spalling, Shrinkage Cracking
T03CR	01	PCC	30,406	6/2/2008	83	55	38	7	Corner Spalling, Faulting, Joint Seal Damage, LTD Cracking
T04CR	01	PCC	5,224	6/1/2018	88	0	100	0	Joint Seal Damage

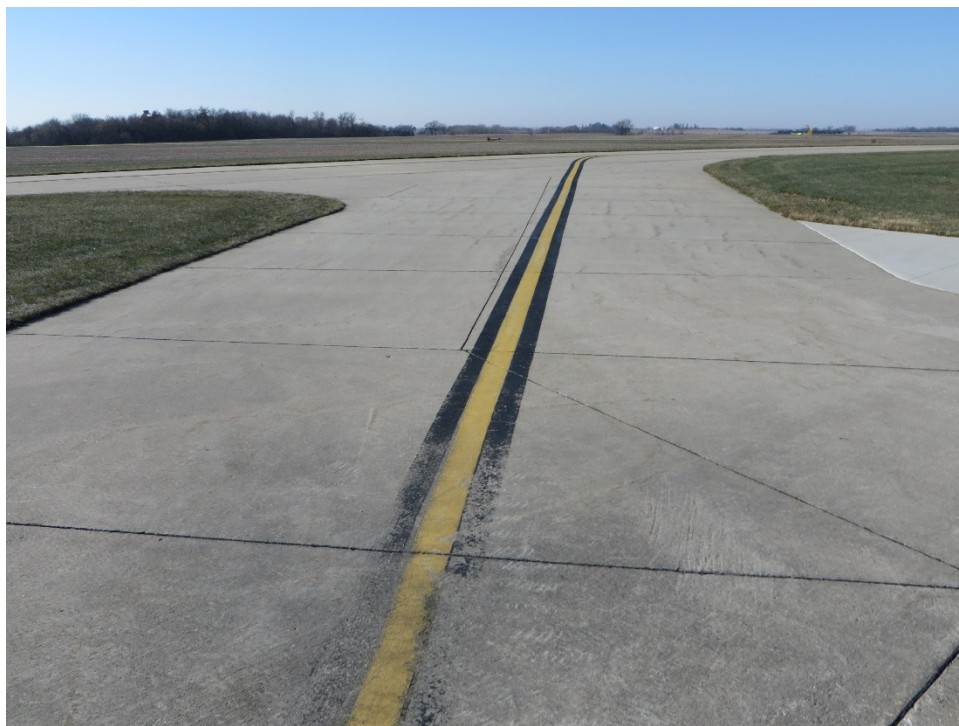
T01CR-01. Overview.

Taxiway 01 consisted of one section with medium-severity joint seal damage and low- and medium-severity LTD cracking.

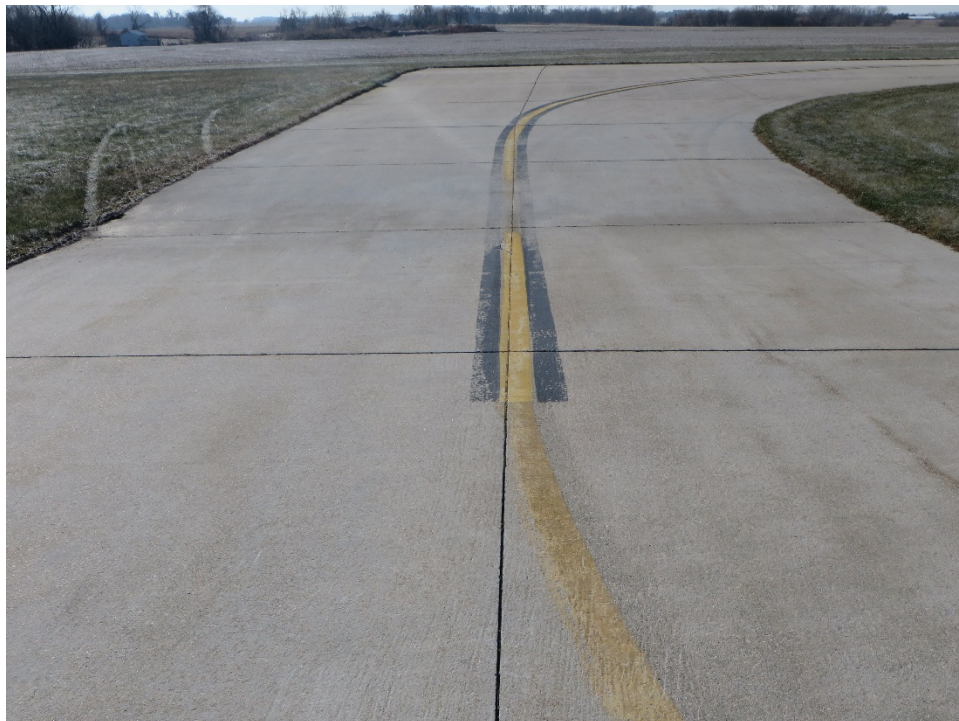
T02CR-01. Overview.

Taxiway 02 contained one section. Medium-severity joint seal damage, low-severity joint spalling, and shrinkage cracking were recorded.

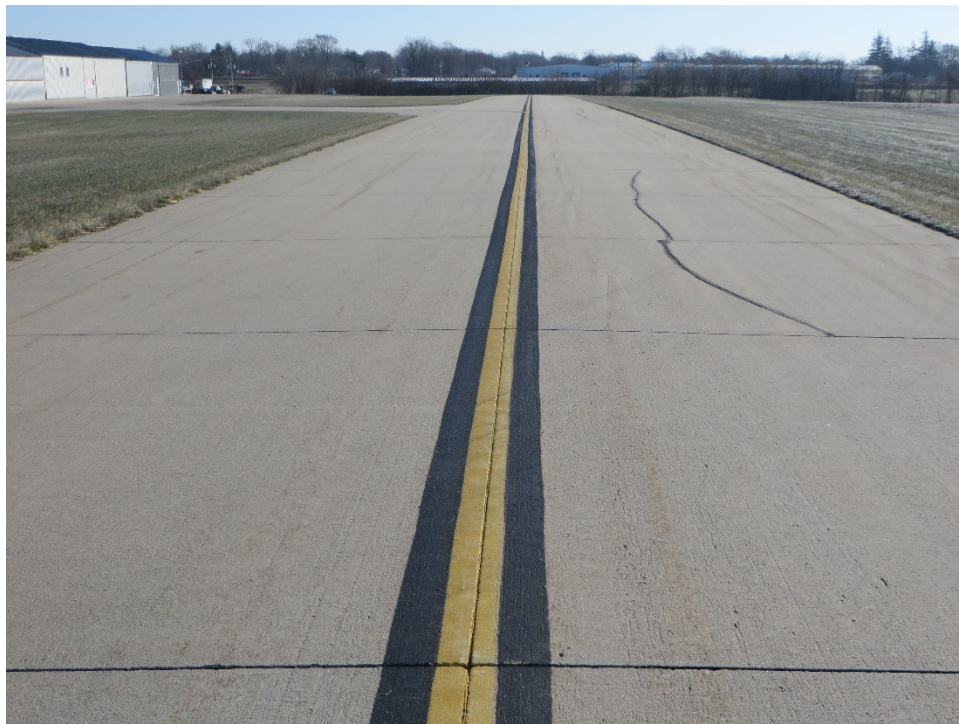
T03CR-01. Overview.

Taxiway 03 was defined by one section with low-severity corner spalling and faulting and low- and medium-severity joint seal damage and LTD cracking observed.

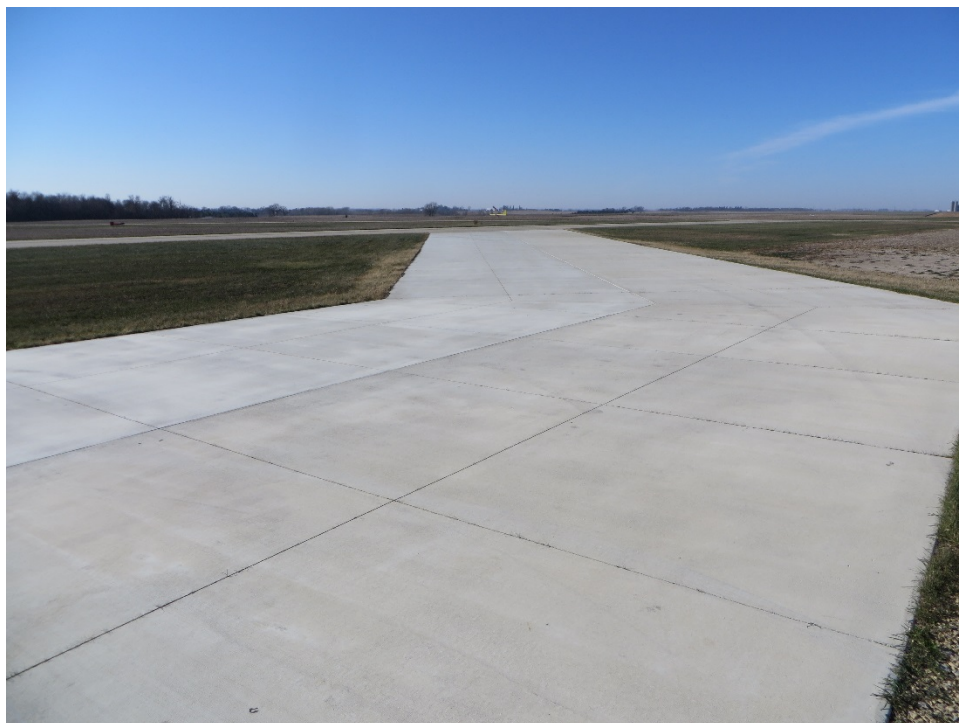
T04CR-01. Overview.

Taxiway 04 consisted of one recently constructed section with high-severity joint seal damage identified.
