Davenport Municipal Airport

Pavement Management Report

JULY 2023

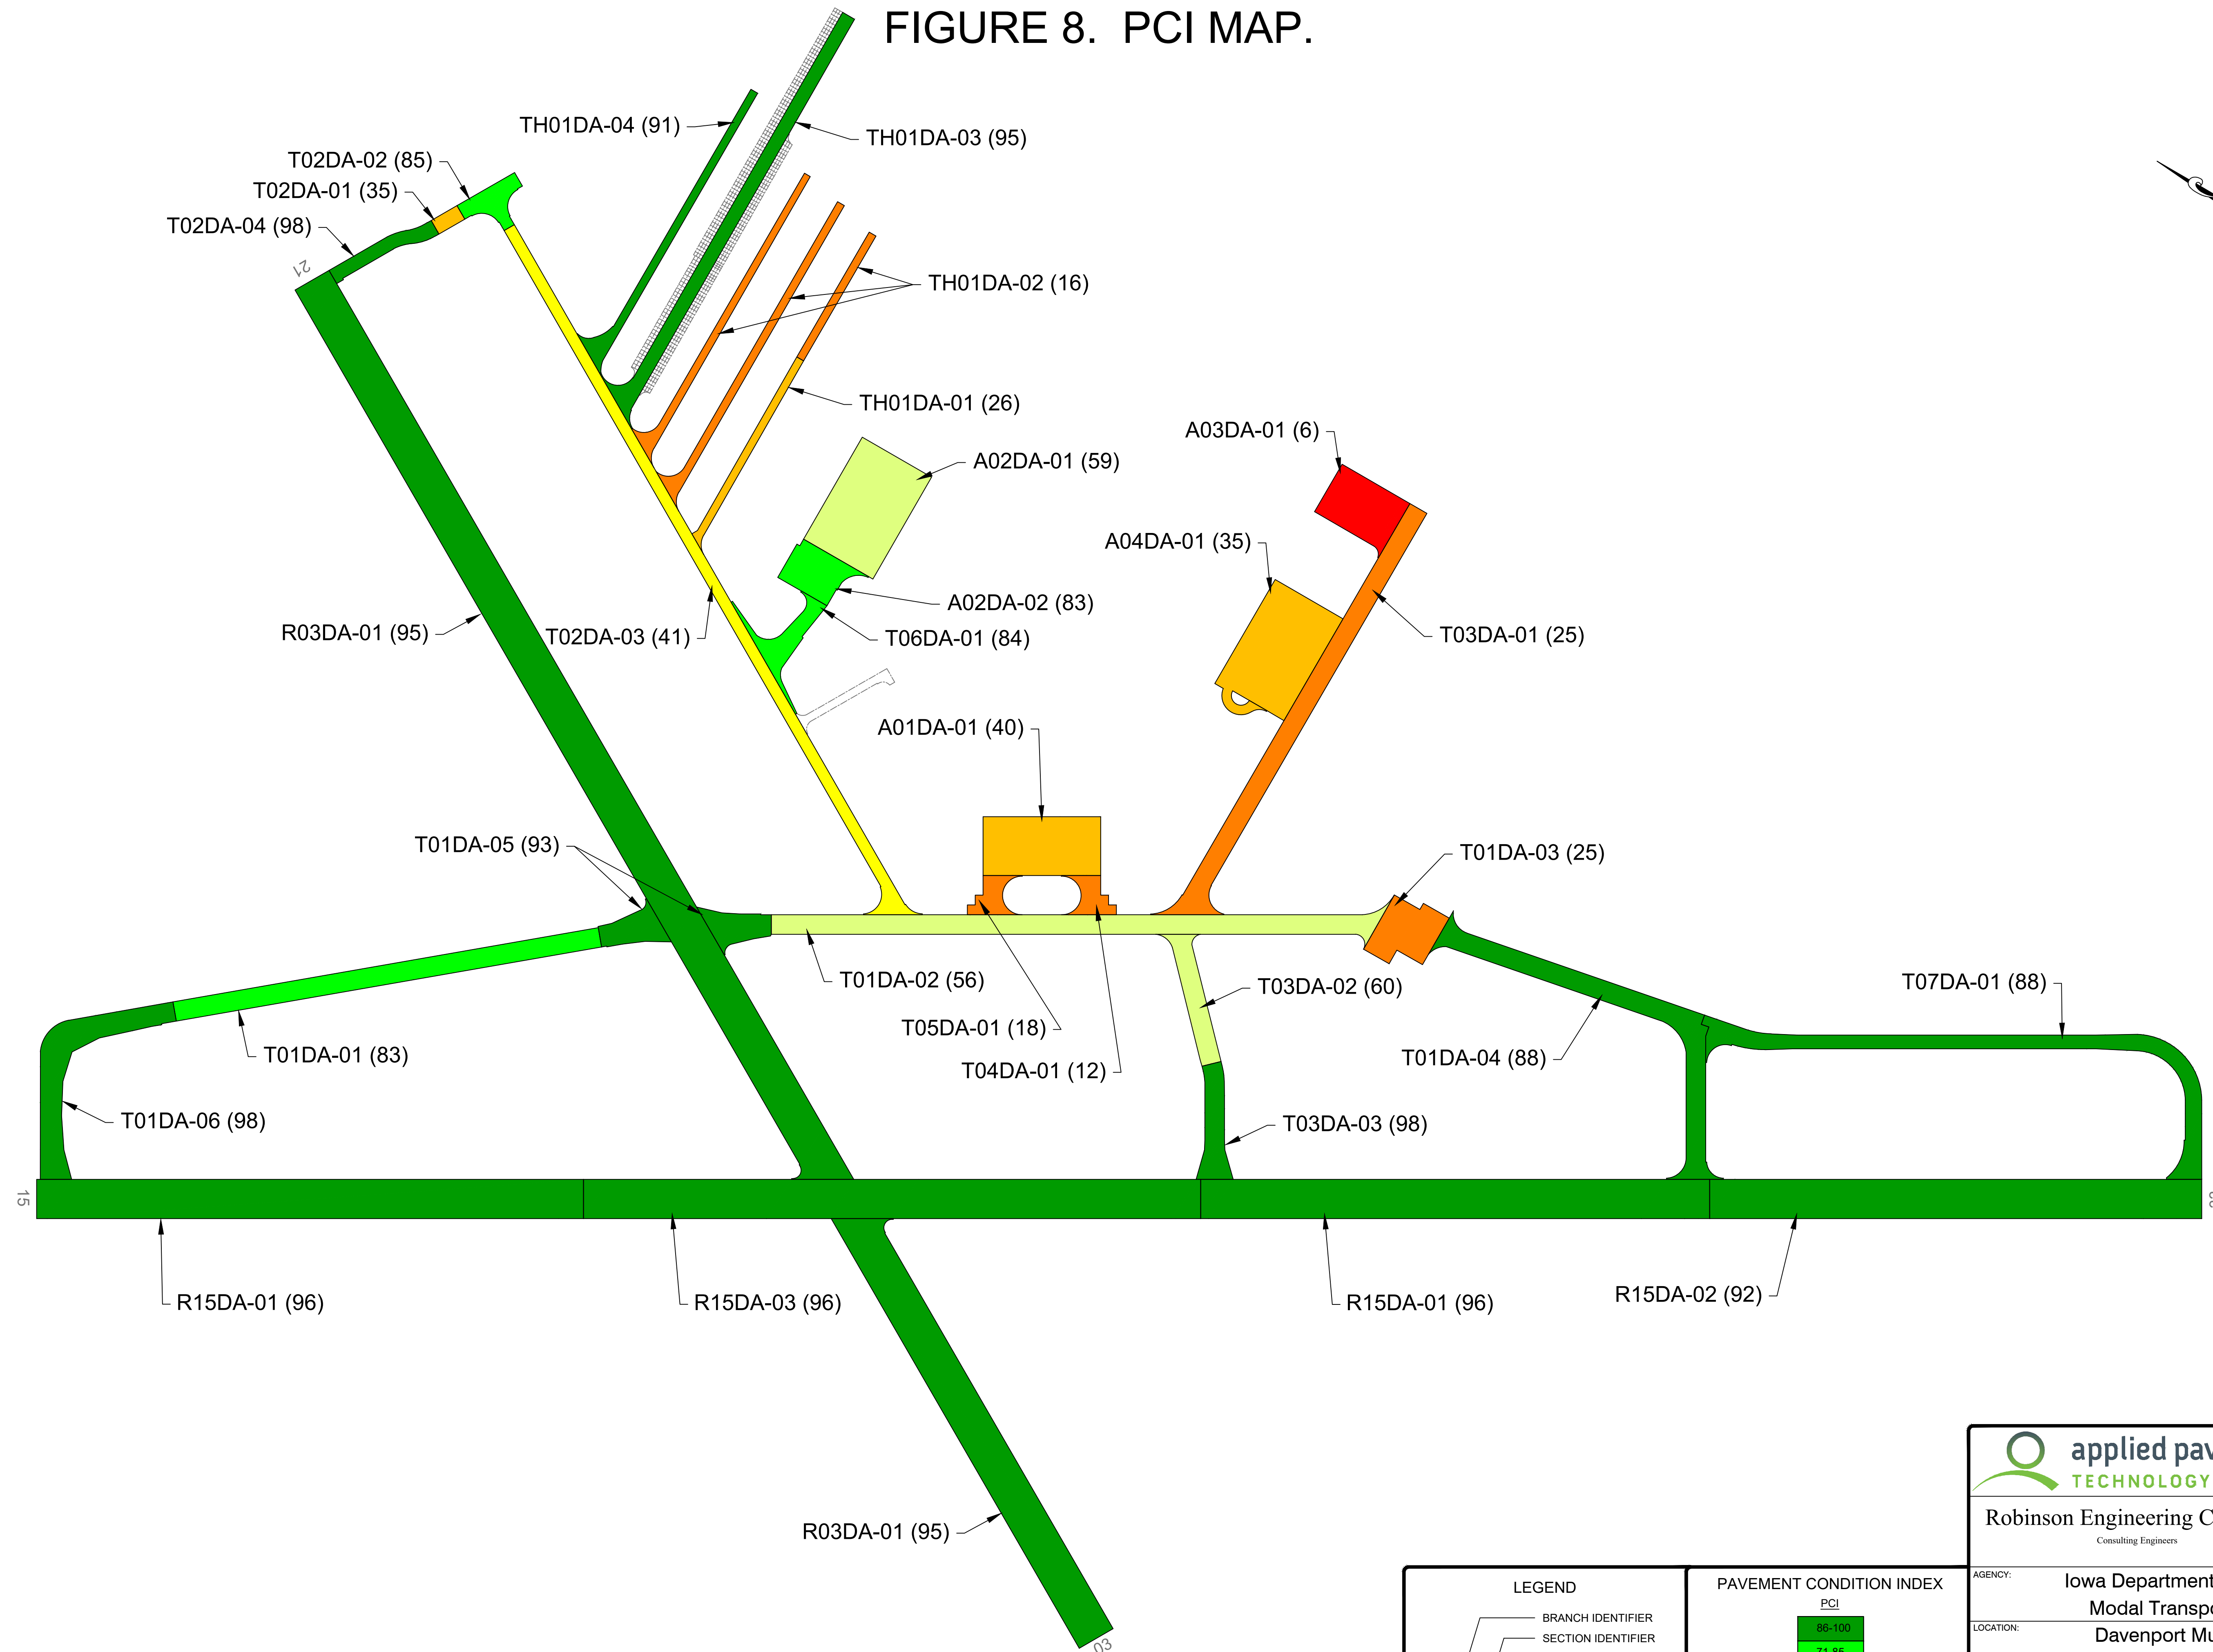
FIGURE 8. PCI MAP.

The pavements at Davenport Municipal Airport were inspected in February 2023. The 2022 area-weighted condition of Davenport Municipal Airport is 78, with conditions ranging from 6 to 98 (on a scale of 0 [failed] to 100 [excellent]). During the previous pavement inspection in 2019, the area-weighted PCI of the airport was 74.

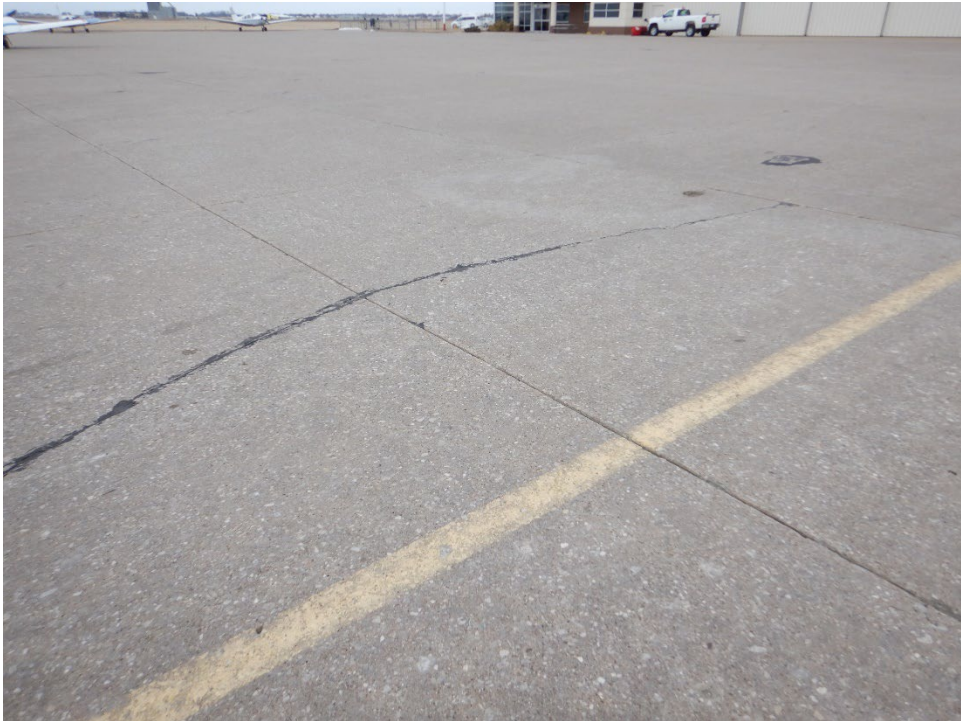
A01DA-01. Overview.

Branch	Section	Surface Type	Section Area (sf)	LCD	2022 PCI	% Distress Due to Load	% Distress Due to Climate/Durability	% Distress Due to Other	Type of Distress
A01DA	01	PCC	45,000	6/2/1949	40	39	12	49	ASR, Corner Break, Corner Spalling, Joint Spalling, Joint Seal Damage, LTD Cracking, Popouts, Pumping, Shrinkage Cracking, Small Patch
A02DA	01	PCC	61,421	6/1/2001	59	53	10	37	ASR, Corner Break, Corner Spalling, Faulting, Joint Spalling, Joint Seal Damage, LTD Cracking, Scaling, Shattered Slab, Shrinkage Cracking, Small Patch
A02DA	02	PCC	17,878	8/1/1996	83	24	71	5	Corner Break, Corner Spalling, Joint Spalling, Joint Seal Damage, LTD Cracking
A03DA	01	PCC	28,137	6/2/1949	6	78	7	15	Corner Break, Corner Spalling, Joint Spalling, Joint Seal Damage, LTD Cracking, Shattered Slab
A04DA	01	PCC	63,183	6/2/1949	35	81	12	7	Corner Break, Corner Spalling, Joint Spalling, Joint Seal Damage, LTD Cracking, Shattered Slab, Shrinkage Cracking

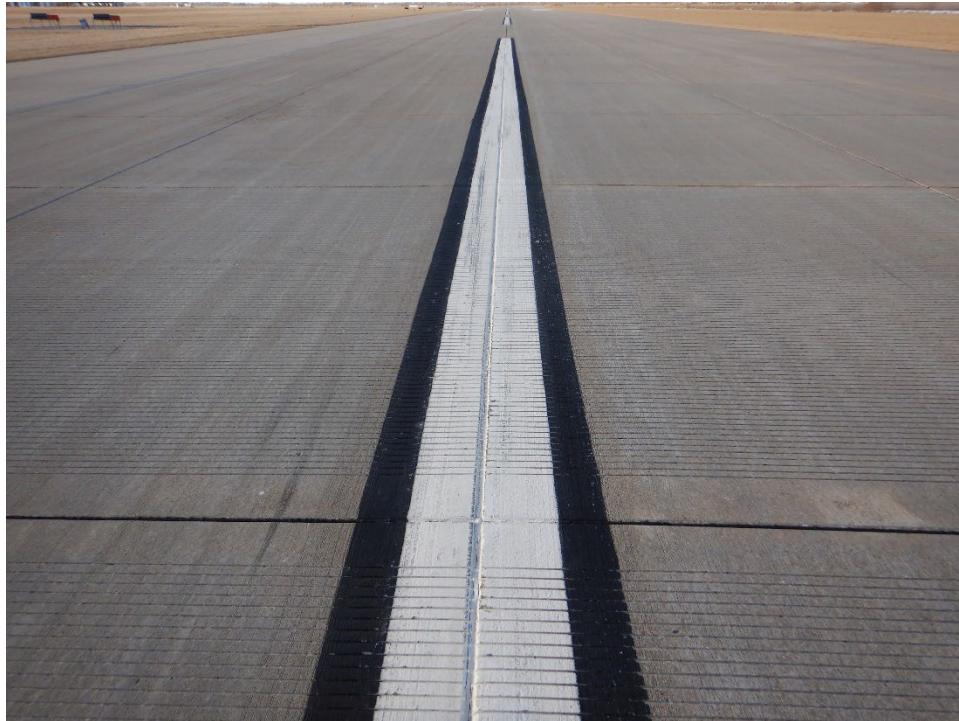
R03DA-01. Overview.

R03DA	01	PCC	389,389	6/3/2015	95	0	90	10	Faulting, Joint Seal Damage
R15DA	01	PCC	270,860	4/3/2019	96	0	100	0	Joint Seal Damage
R15DA	02	PCC	125,500	6/30/1994	92	0	85	15	Corner Spalling, Faulting, Joint Seal Damage, Popouts, Small Patch
R15DA	03	PCC	157,200	6/3/2015	96	0	100	0	Joint Seal Damage
T01DA	01	PCC	55,043	6/2/1949	83	13	25	62	ASR, Faulting, Joint Spalling, Joint Seal Damage, LTD Cracking, Scaling, Shrinkage Cracking

Runway 03/21 was defined by one section in excellent condition with areas of low-severity faulting and low- and medium-severity joint seal damage identified.

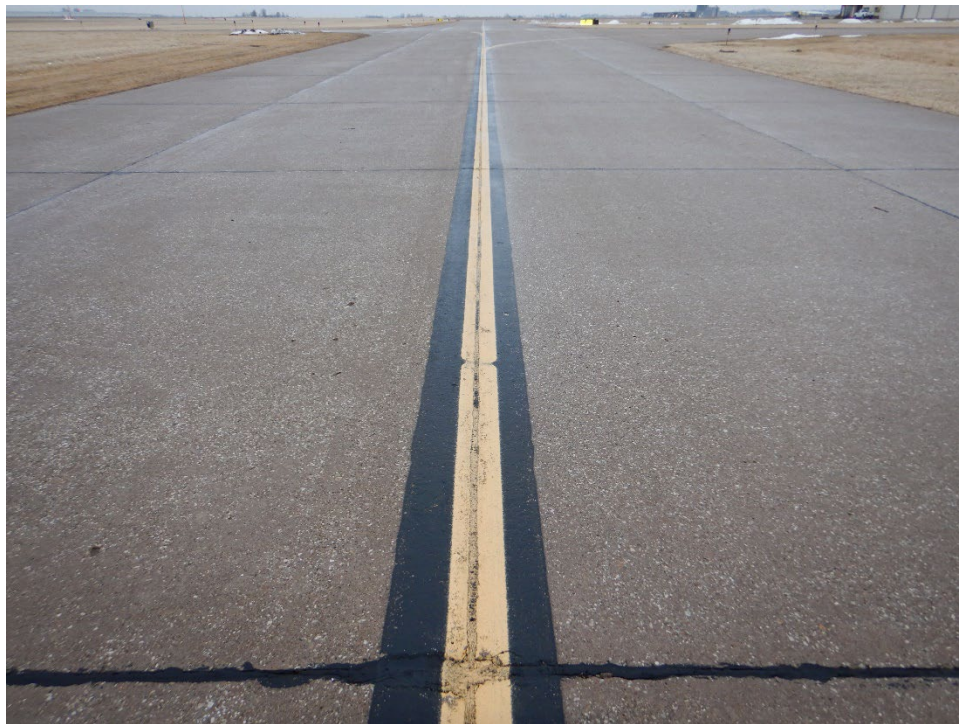
T01DA-02. Overview.

Branch	Section	Surface Type	Section Area (sf)	LCD	2022 PCI	% Distress Due to Load	% Distress Due to Climate/Durability	% Distress Due to Other	Type of Distress
T01DA	02	PCC	78,251	6/1/1949	56	7	25	68	ASR, Corner Break, Corner Spalling, Joint Spalling, Joint Seal Damage, Large Patch, LTD Cracking, Popouts, Shrinkage Cracking, Small Patch
T01DA	03	PCC	22,277	6/2/1949	25	35	11	54	ASR, Corner Break, Joint Spalling, Joint Seal Damage, Large Patch, LTD Cracking, Small Patch
T01DA	04	PCC	57,742	6/2/1949	88	0	13	87	ASR, Corner Spalling, Joint Spalling, Joint Seal Damage, Large Patch, Popouts, Scaling, Shrinkage Cracking, Small Patch
T01DA	05	PCC	23,533	6/3/2015	93	77	23	0	Corner Break, Joint Seal Damage, LTD Cracking
T01DA	06	PCC	40,715	4/3/2019	98	35	65	0	Joint Seal Damage, LTD Cracking
T02DA	01	PCC	3,040	6/1/1979	35	25	13	62	ASR, Corner Break, Faulting, Joint Seal Damage, LTD Cracking, Popouts, Shattered Slab

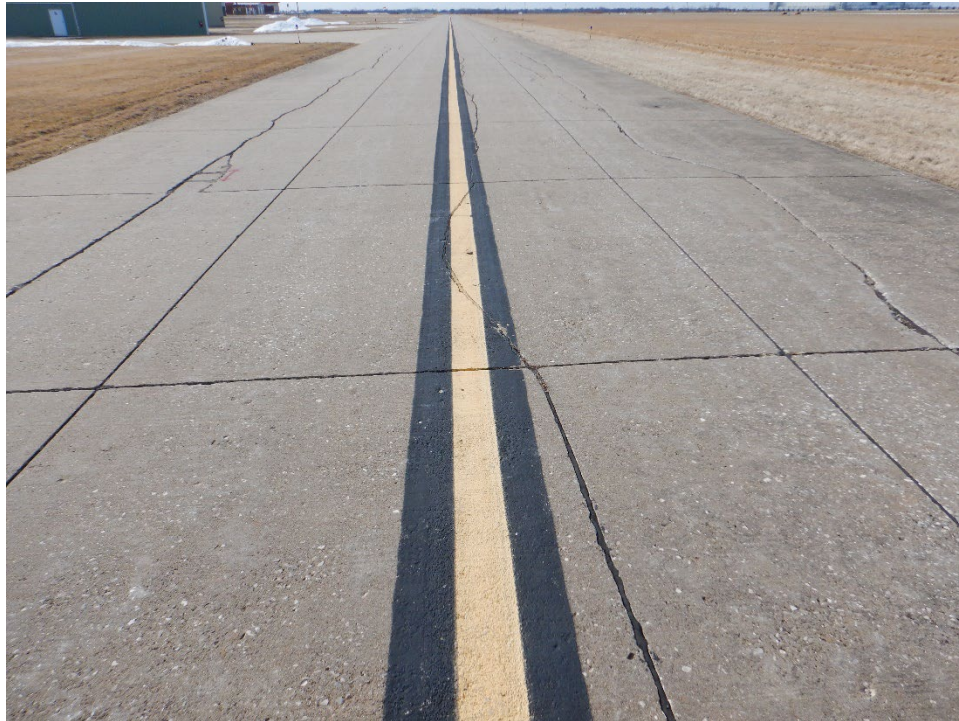
T02DA-03. Overview.

T02DA	02	PCC	10,494	1/1/2005	85	27	8	65	ASR, Corner Break, Corner Spalling, Joint Spalling, Joint Seal Damage, LTD Cracking, Popouts
T02DA	03	PCC	62,872	6/1/1979	41	75	12	13	ASR, Corner Spalling, Faulting, Joint Spalling, Joint Seal Damage, LTD Cracking, Shattered Slab
T02DA	04	PCC	10,542	6/3/2015	98	0	100	0	Joint Seal Damage
T03DA	01	PCC	62,394	6/2/1949	25	78	12	10	Corner Break, Corner Spalling, Joint Spalling, Joint Seal Damage, LTD Cracking, Shattered Slab, Shrinkage Cracking

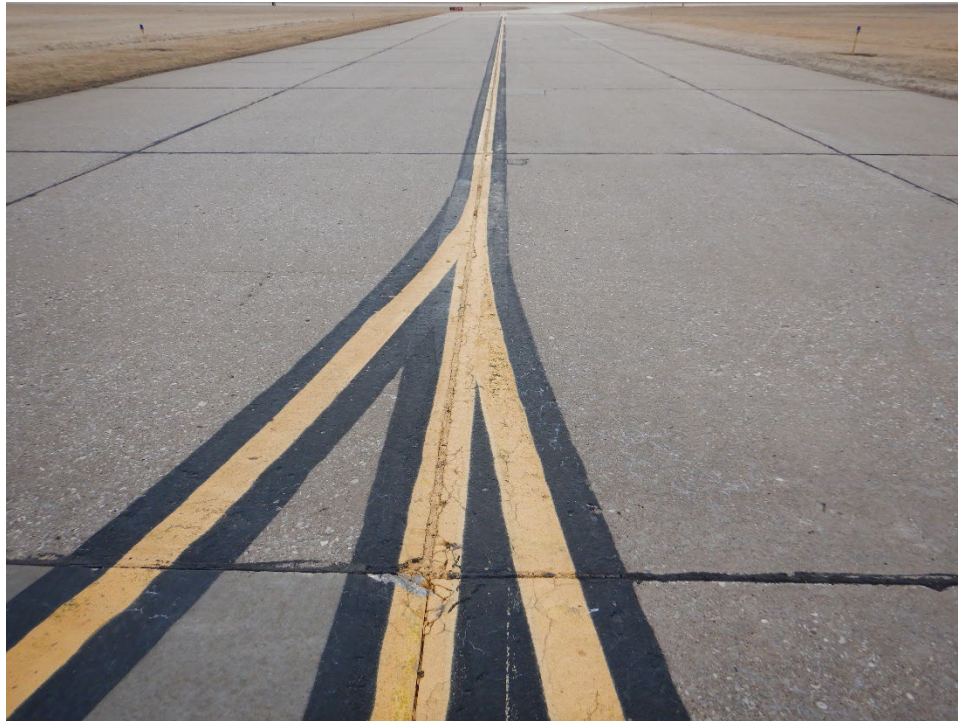
T03DA-02. Overview.

Branch	Section	Surface Type	Section Area (sf)	LCD	2022 PCI	% Distress Due to Load	% Distress Due to Climate/Durability	% Distress Due to Other	Type of Distress
T03DA	02	PCC	17,612	6/1/1947	60	3	4	93	ASR, Joint Spalling, Joint Seal Damage, Large Patch, LTD Cracking, Shrinkage Cracking, Small Patch
T03DA	03	PCC	16,547	4/3/2019	98	0	100	0	Joint Seal Damage
T04DA	01	PCC	7,628	6/1/1948	12	42	8	50	ASR, Joint Seal Damage, Large Patch, LTD Cracking, Popouts, Shattered Slab, Small Patch
T05DA	01	PCC	7,628	6/1/1948	18	44	8	48	ASR, Corner Break, Faulting, Joint Seal Damage, Large Patch, LTD Cracking, Popouts, Shattered Slab
T06DA	01	PCC	13,887	8/1/1996	84	24	68	8	Corner Spalling, Joint Spalling, Joint Seal Damage, LTD Cracking
T07DA	01	PCC	62,407	6/30/1994	88	0	71	29	ASR, Faulting, Joint Spalling, Joint Seal Damage
TH01DA	01	AAC	10,915	6/1/2008	26	56	44	0	Alligator Cracking, L&T Cracking, Weathering
TH01DA	02	AC	42,929	1/2/1949	16	52	42	6	Alligator Cracking, Block Cracking, L&T Cracking, Patching, Raveling, Rutting, Swelling, Weathering

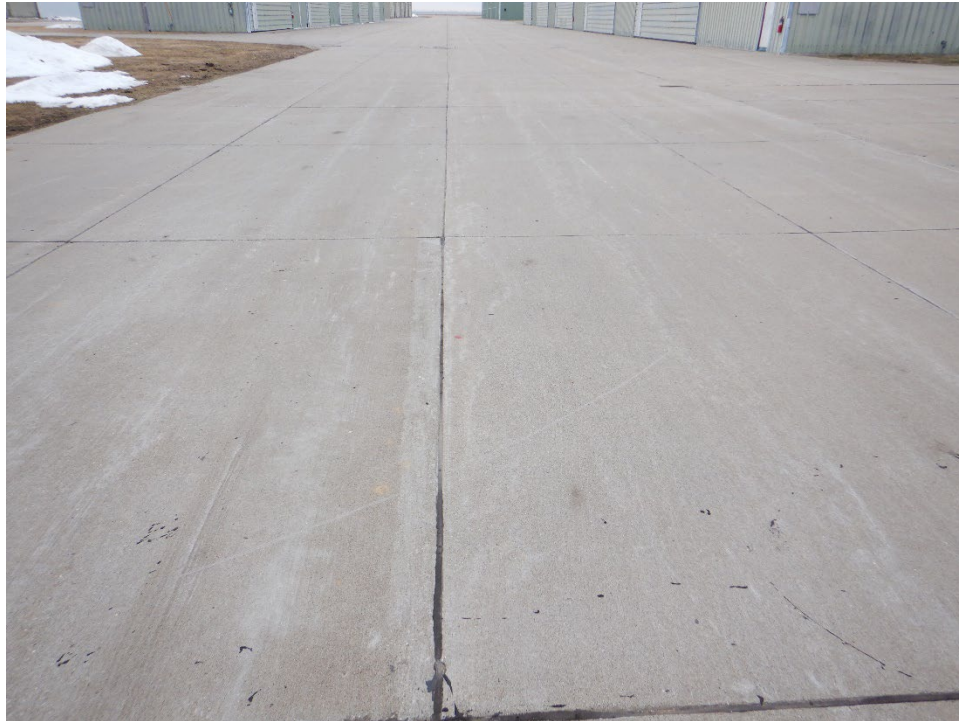
TH01DA-03. Overview.

TH01DA	03	PCC	42,763	10/1/2010	95	17	31	52	Faulting, Joint Seal Damage, Large Patch, LTD Cracking
TH01DA	04	PCC	18,886	10/2/2005	91	20	65	15	Corner Break, Corner Spalling, Joint Spalling, Joint Seal Damage, LTD Cracking
