Eagle Grove Municipal Airport

PAVEMENT MANAGEMENT REPORT

AUGUST 2019

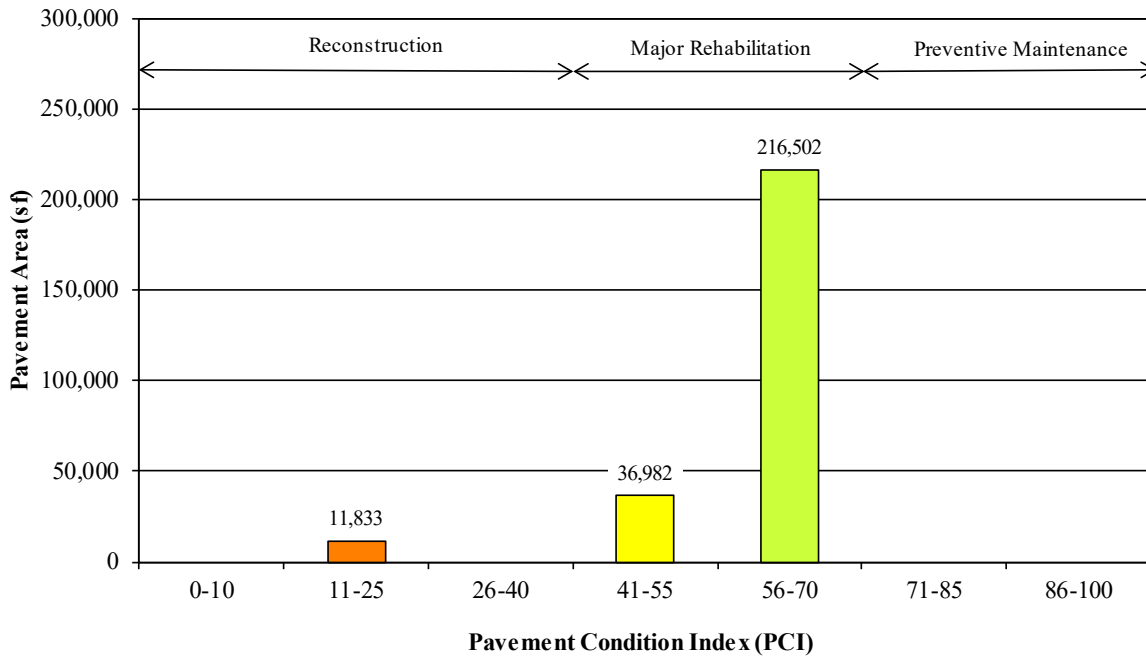
Figure 6. Pavement area by PCI range at Eagle Grove Municipal Airport.

The pavements at Eagle Grove Municipal Airport were inspected on November 16, 2018. The 2018 area-weighted condition of Eagle Grove Municipal Airport is 61, with conditions ranging from 23 to 68 (on a scale of 0 [failed] to 100 [excellent]). During the previous pavement inspection in 2012, the area-weighted PCI of the airport was 77.

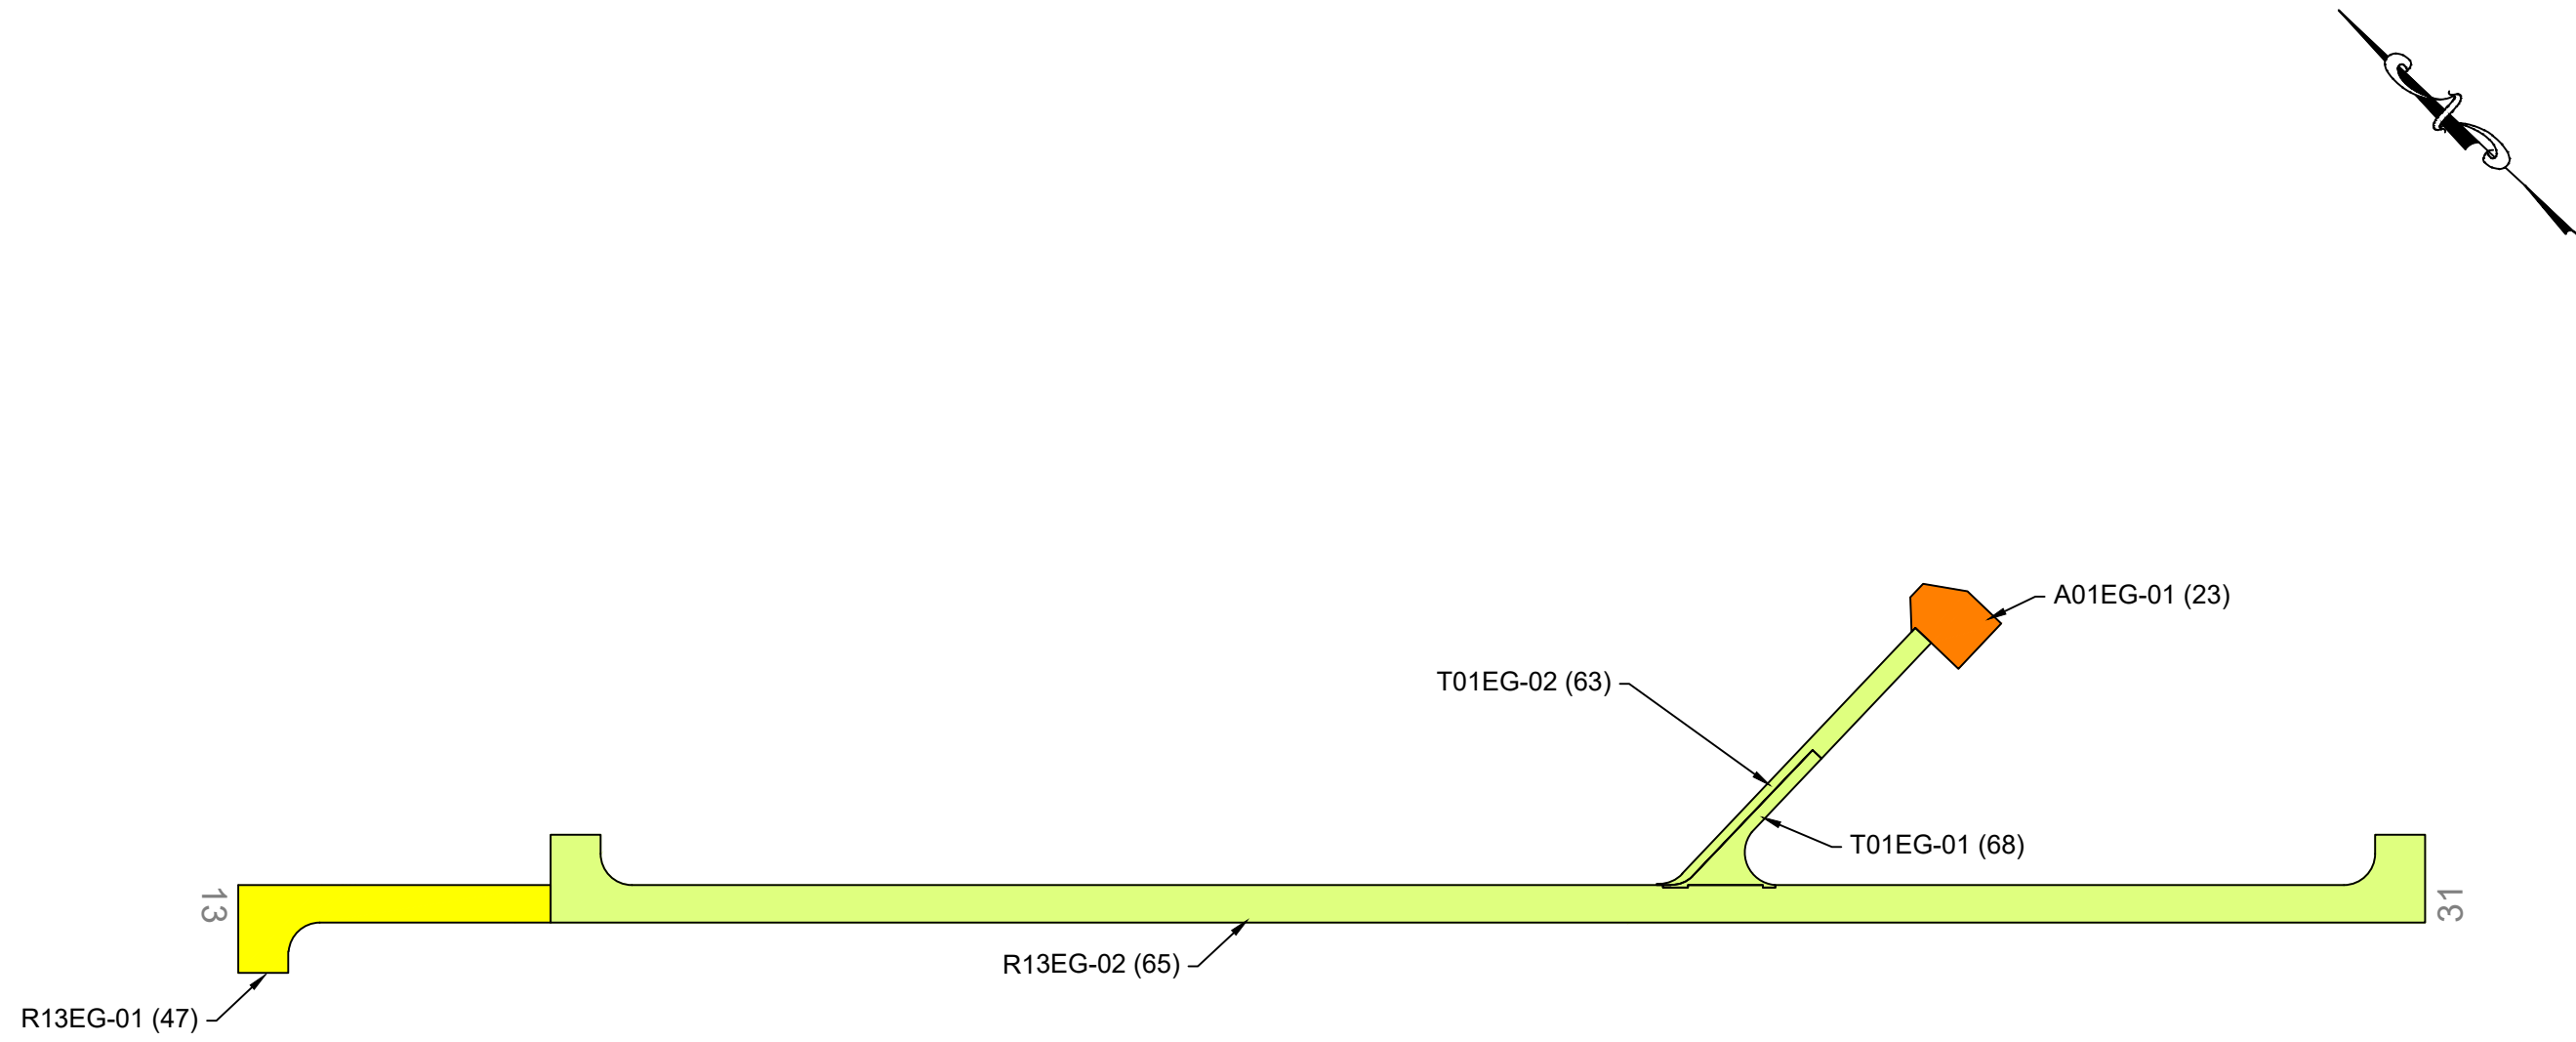
FIGURE 8. PCI MAP.

R13EG-01 (47)

R13EG-02 (65)
