EMMETSBURG MUNICIPAL AIRPORT PAVEMENT MANAGEMENT REPORT

Prepared For:
Iowa Department of Transportation
Office of Aviation

Prepared By:
Applied Pavement Technology, Inc.

April 2016

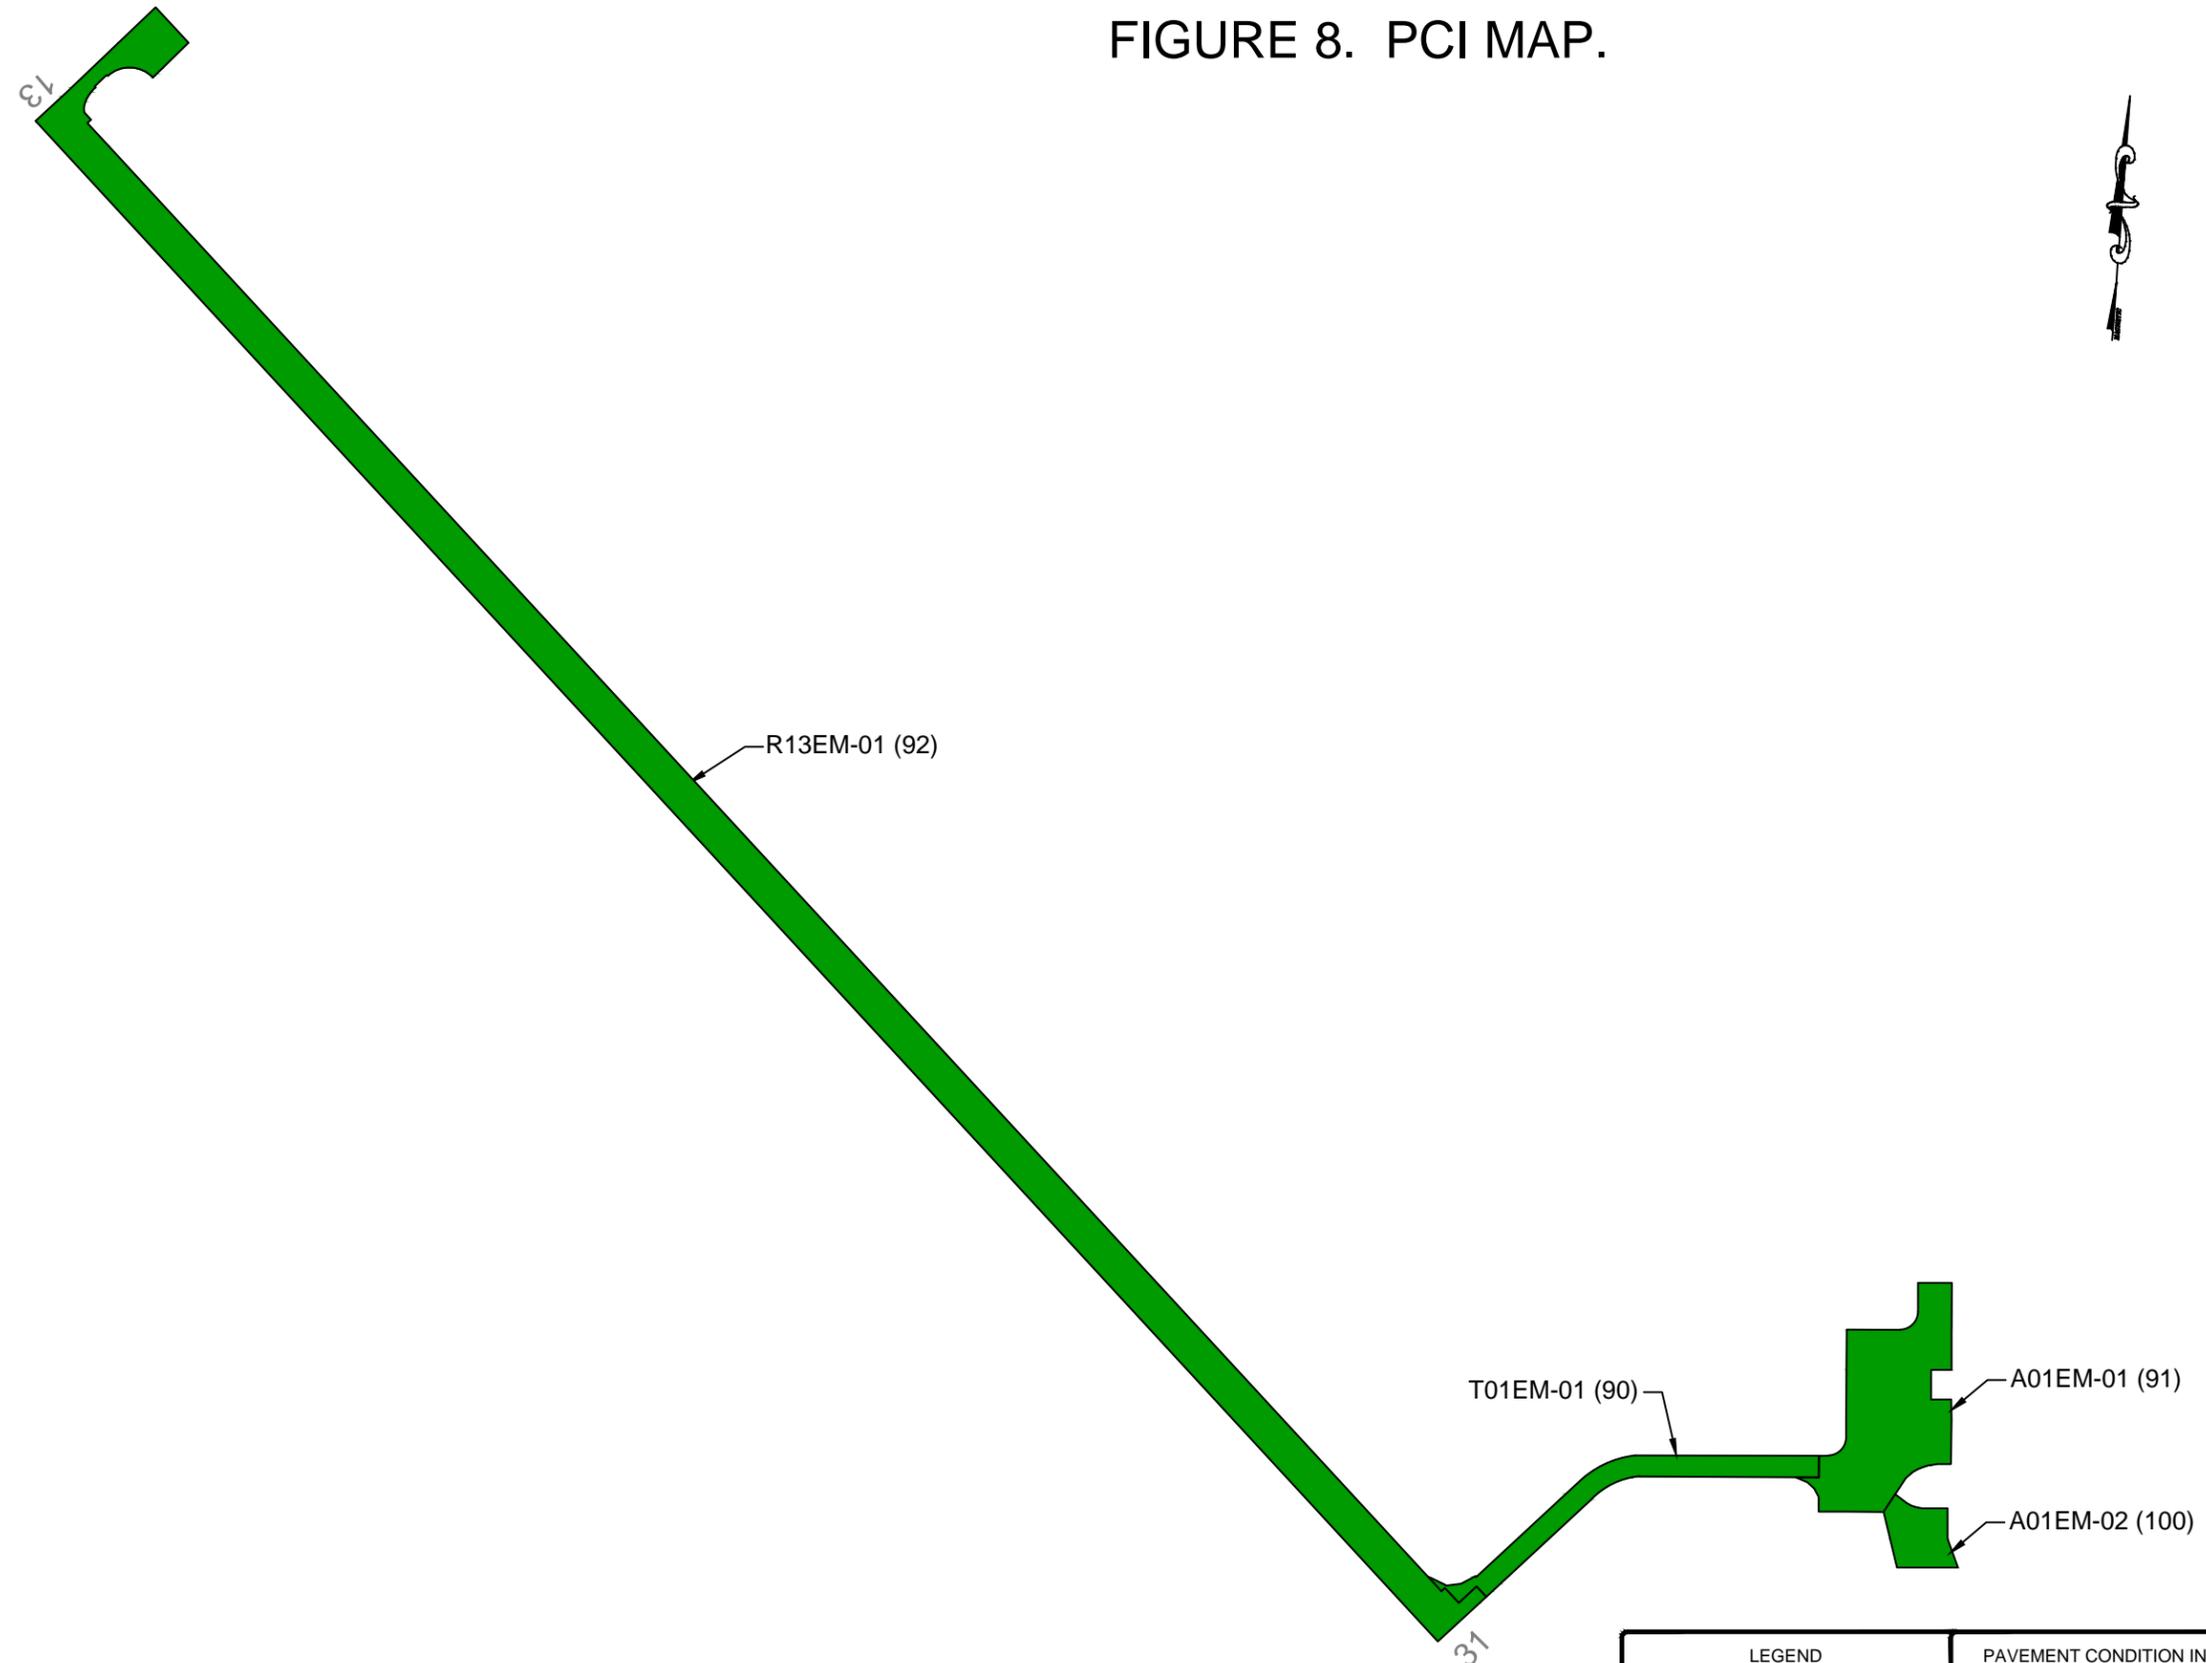
FIGURE 8. PCI MAP.

The pavements at Emmetsburg Municipal Airport were inspected on November 7, 2015. The 2015 area-weighted condition of Emmetsburg Municipal Airport is 92, with conditions ranging from 90 to 100 (on a scale of 0 [failed] to 100 [excellent]). During the previous pavement inspection in 2012, the area-weighted PCI of the airport was 93.

Figure 6 summarizes the overall condition of the pavements at Emmetsburg Municipal Airport and Figure 7 presents area-weighted condition (average PCI adjusted to account for the relative size of the pavement sections) by branch use. Figure 8 is a map that displays the condition of the evaluated pavements. Table 1 summarizes the results of the pavement evaluation. Appendix B presents photographs taken during the PCI inspection, and Appendix C contains detailed information on the distresses observed during the visual survey. Appendix D includes detailed work history information that was collected during the record review process.
