Emmetsburg Municipal Airport

Pavement Management Report

JULY 2023

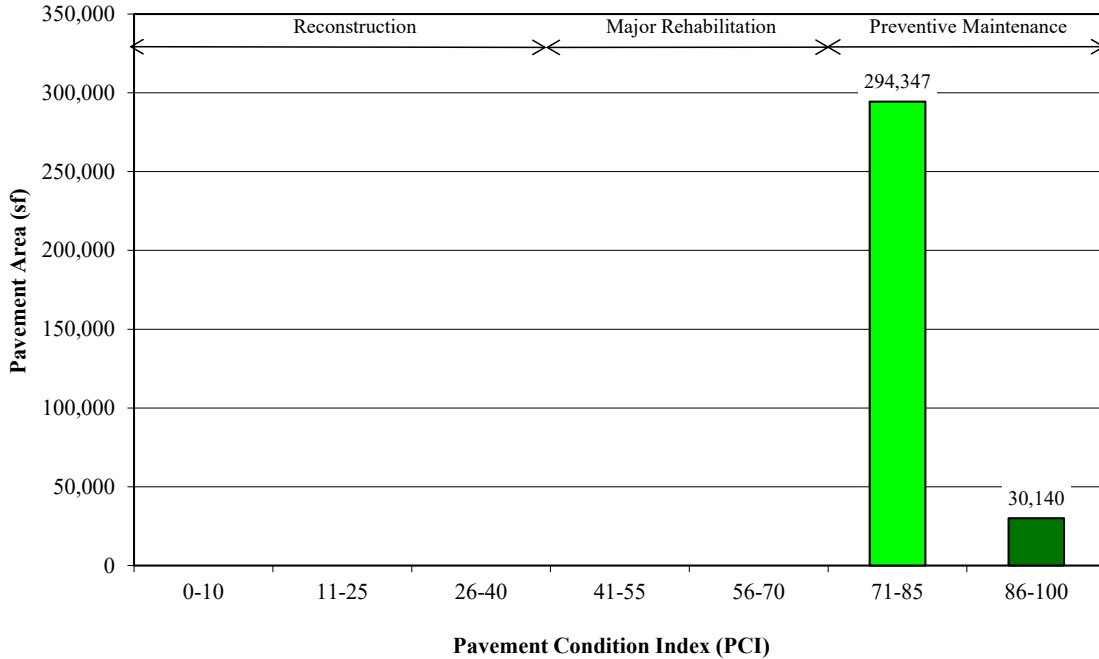
Figure 6. Pavement area by PCI range at Emmetsburg Municipal Airport.

The pavements at Emmetsburg Municipal Airport were inspected in November 2022. The 2022 area-weighted condition of Emmetsburg Municipal Airport is 85, with conditions ranging from 83 to 89 (on a scale of 0 [failed] to 100 [excellent]). During the previous pavement inspection in 2019, the area-weighted PCI of the airport was 79.

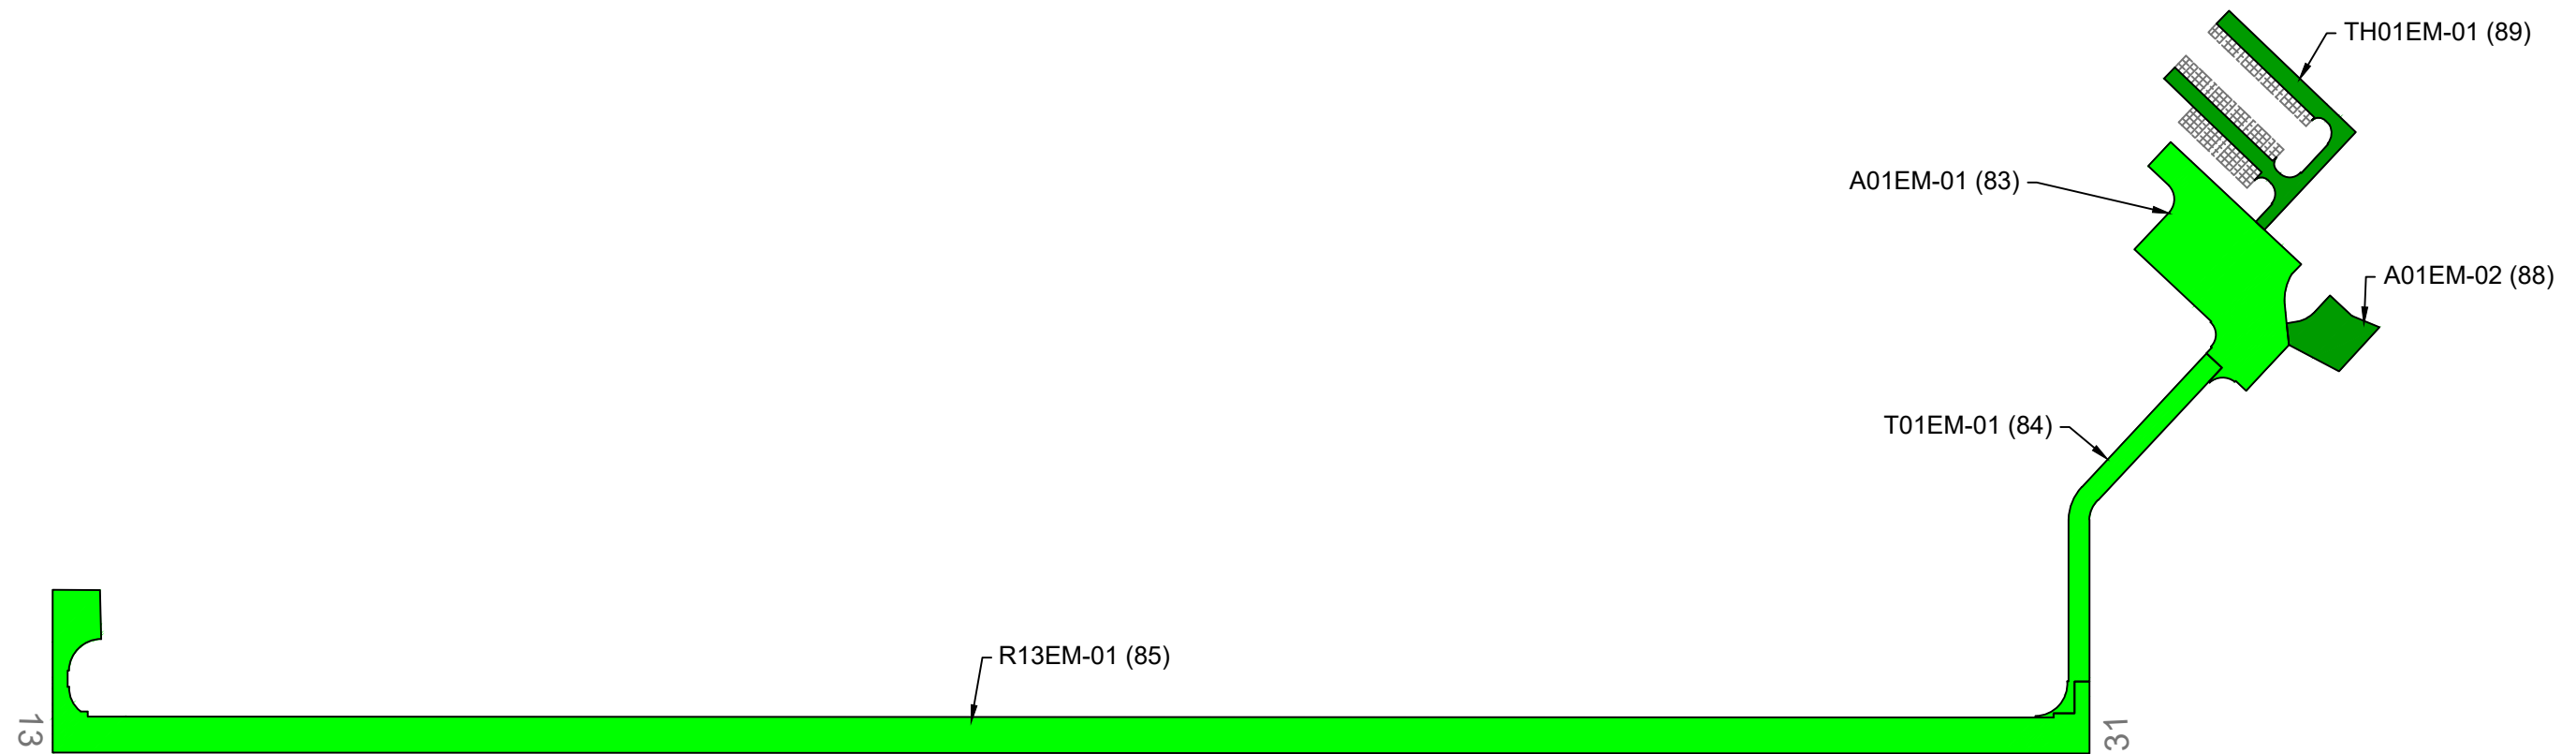
FIGURE 8. PCI MAP.

Figure 6 summarizes the overall condition of the pavements at Emmetsburg Municipal Airport, and Figure 7 presents area-weighted condition (average PCI adjusted to account for the relative size of the pavement sections) by branch use. Figure 8 is a map that displays the condition of the evaluated pavements. Table 1 summarizes the results of the pavement evaluation. Appendix B presents photographs taken during the PCI inspection, and Appendix C contains detailed information on the distress types observed during the visual survey. Appendix D includes detailed work history information that was collected during the record review process.
