# Estherville Municipal Airport

## Pavement Management Report

**JULY 2023**

# ESTHERVILLE MUNICIPAL AIRPORT PAVEMENT MANAGEMENT REPORT

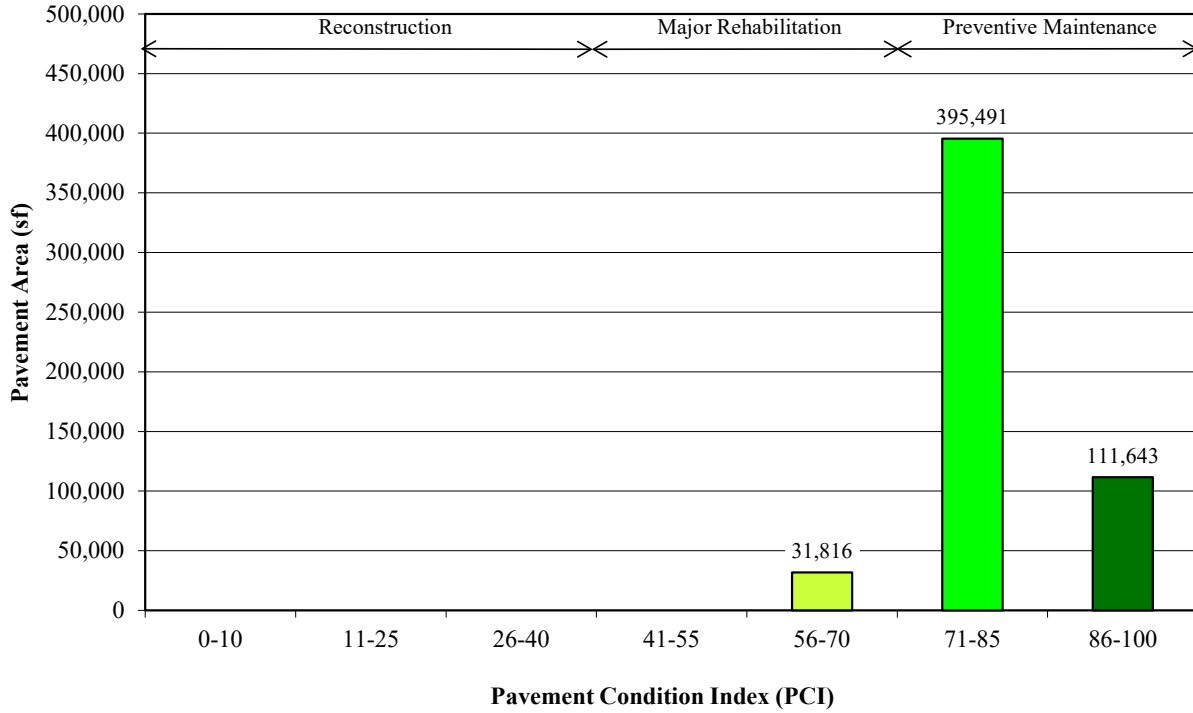
Figure 6. Pavement area by PCI range at Estherville Municipal Airport.

The pavements at Estherville Municipal Airport were inspected in November 2022. The 2022 area-weighted condition of Estherville Municipal Airport is 83, with conditions ranging from 61 to 96 (on a scale of 0 [failed] to 100 [excellent]). During the previous pavement inspection in 2019, the area-weighted PCI of the airport was 82.

Figure 6 summarizes the overall condition of the pavements at Estherville Municipal Airport, and Figure 7 presents area-weighted condition (average PCI adjusted to account for the relative size of the pavement sections) by branch use. Figure 8 is a map that displays the condition of the evaluated pavements. Table 1 summarizes the results of the pavement evaluation. Appendix B presents photographs taken during the PCI inspection, and Appendix C contains detailed information on the distress types observed during the visual survey. Appendix D includes detailed work history information that was collected during the record review process.
