# FOREST CITY MUNICIPAL AIRPORT PAVEMENT MANAGEMENT REPORT

**Prepared For:**  
Iowa Department of Transportation  
Office of Aviation

**Prepared By:**  
Applied Pavement Technology, Inc.

April 2016

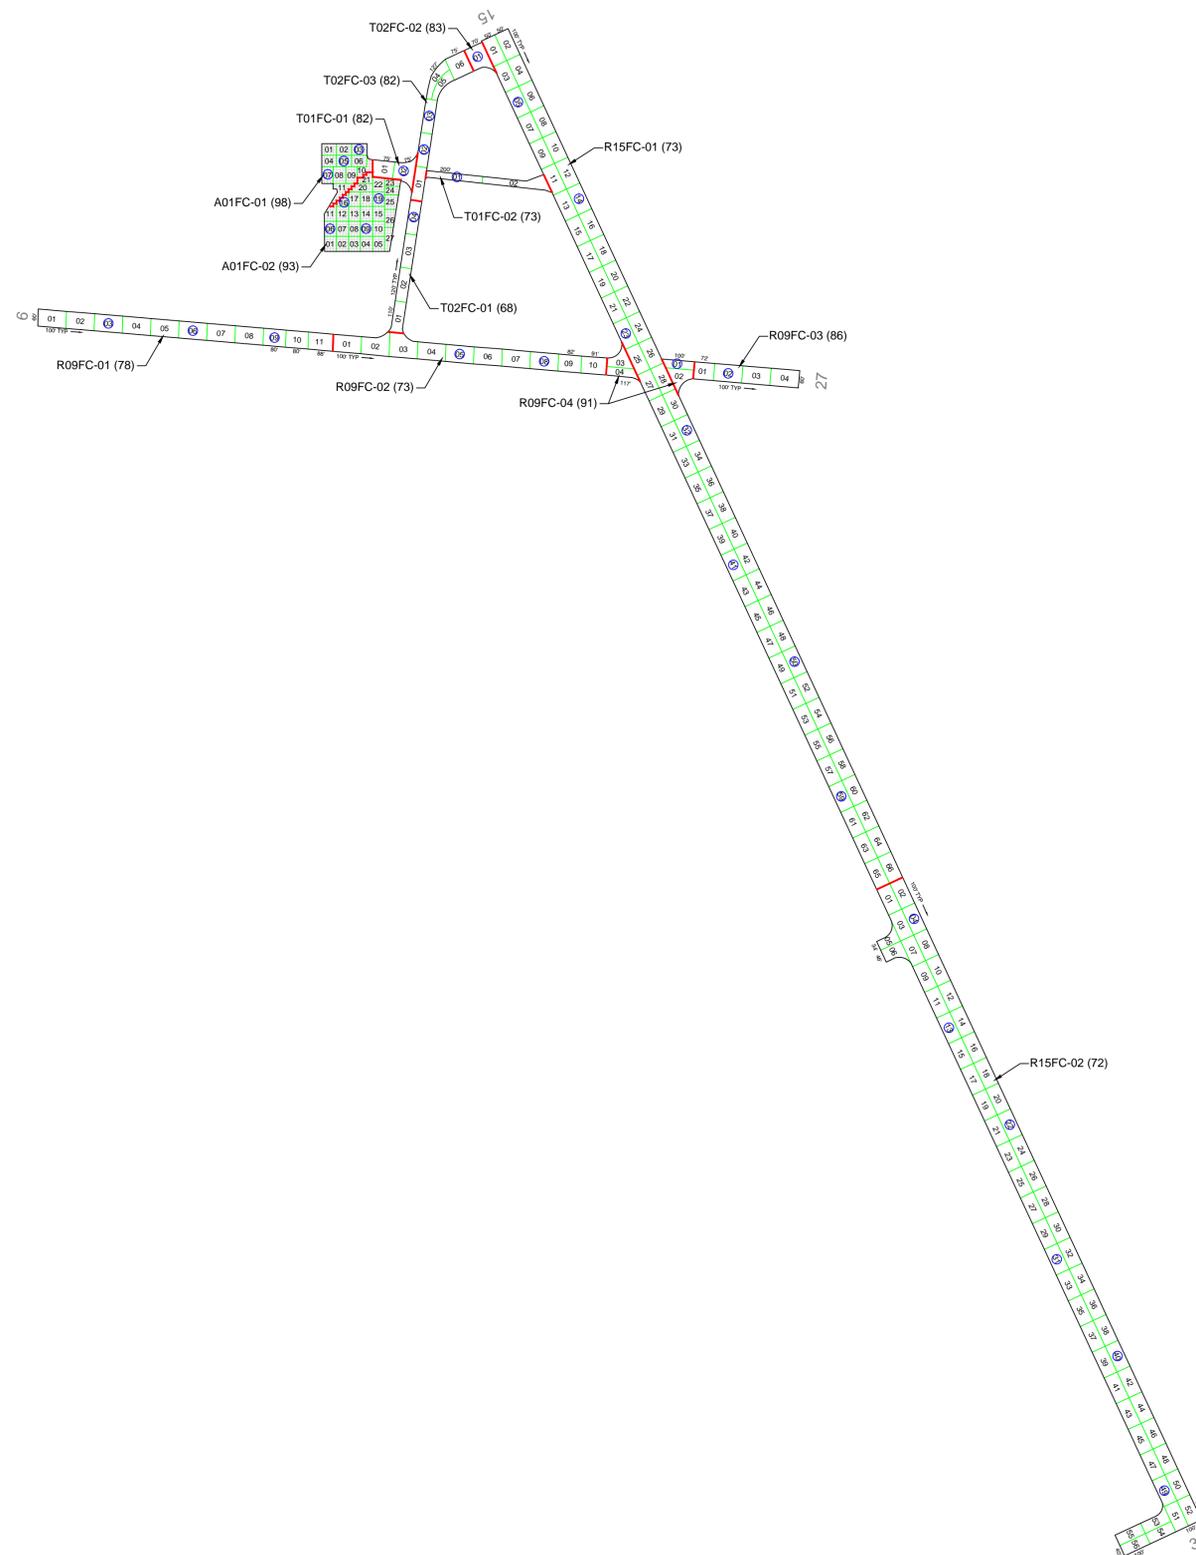
# FIGURE 3. NETWORK DEFINITION MAP.

Runway 15-33 consisted of two sections in similar condition. Moderate amounts of low- and medium-severity longitudinal and transverse (L&T) cracking were observed in both sections. In addition, low- and medium-severity weathering in Section 01, and low-severity weathering and patching in Section 02 were identified. The majority of the low-severity cracking was sealed with the crack sealant in good condition, while the medium-severity cracking was recorded in areas where the crack sealant had failed.

Runway 9-27 was defined by four sections. Sections 01 and 02 were in similar condition with moderate amounts of low- and medium-severity L&T cracking and low-severity weathering identified. Sections 03 and 04 had smaller quantities of low-severity L&T cracking and weathering observed. The low-severity cracking was mostly sealed with the crack sealant in good condition. The medium-severity cracking was recorded where the crack sealant had failed.

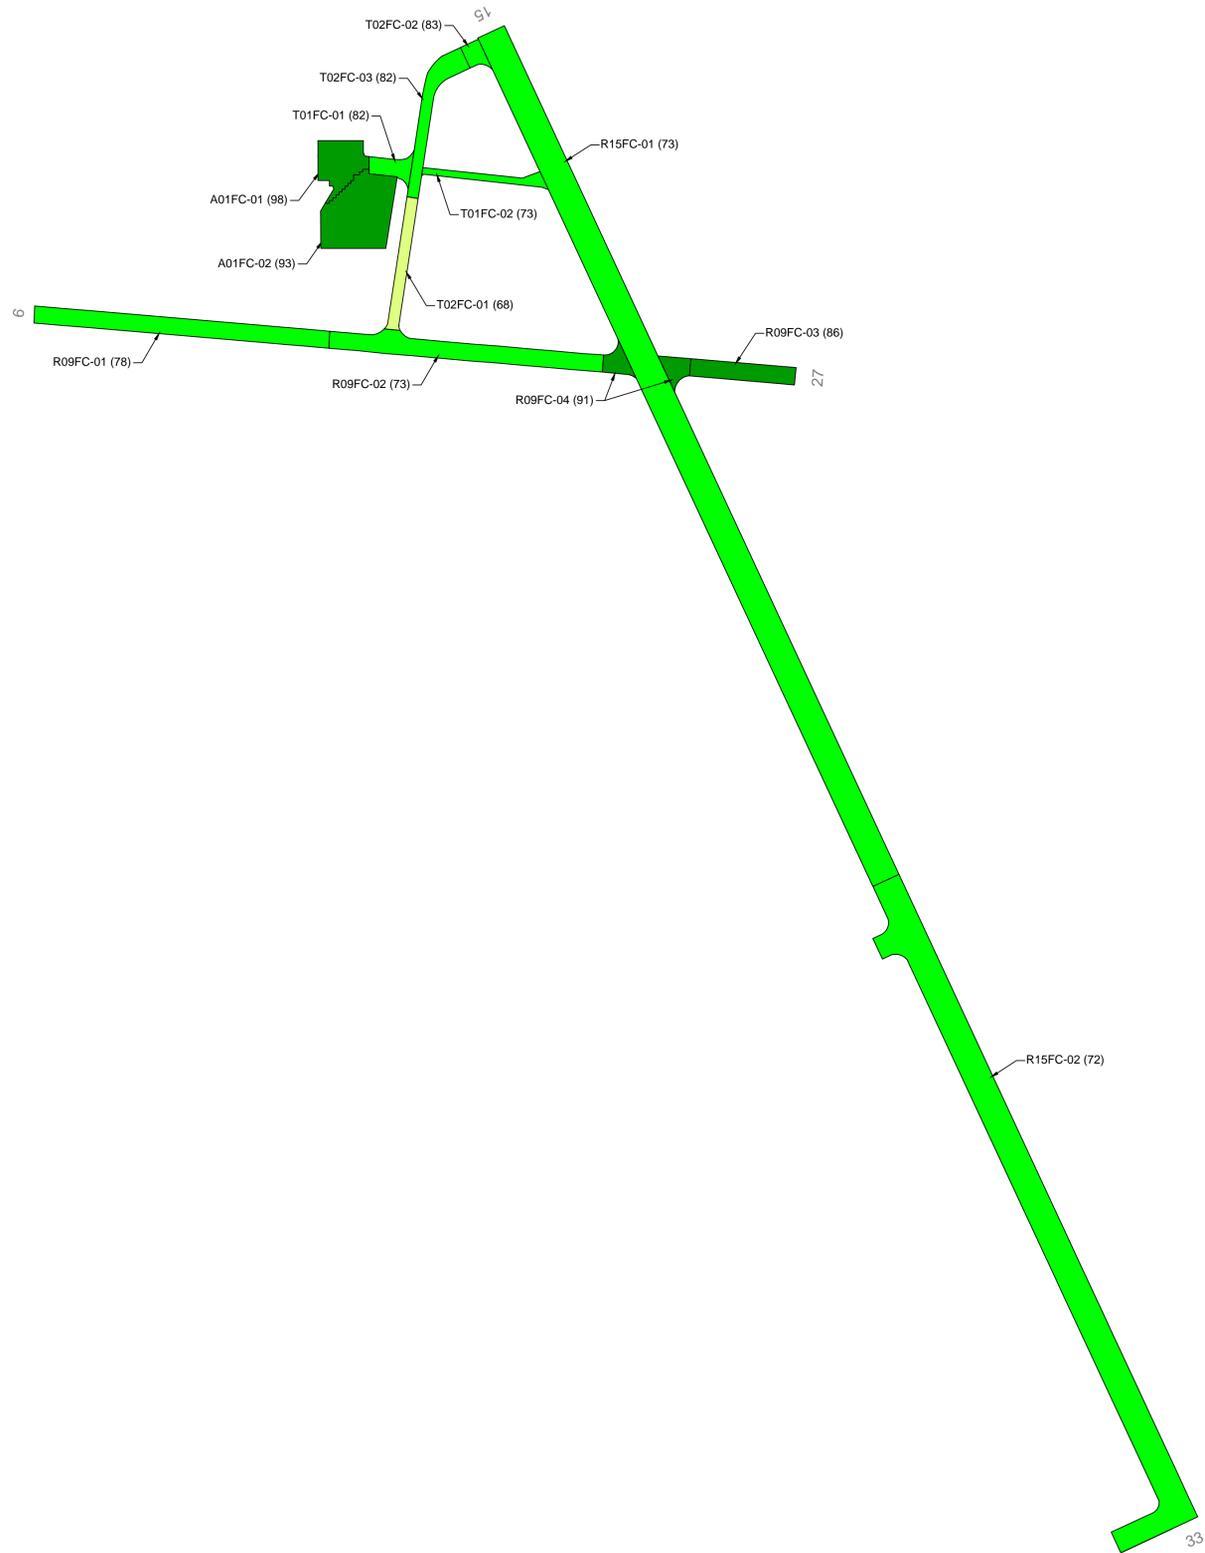
FIGURE 8. PCI MAP.

The pavements at Forest City Municipal Airport were inspected on November 10, 2015. The 2015 area-weighted condition of Forest City Municipal Airport is 76, with conditions ranging from 68 to 98 (on a scale of 0 [failed] to 100 [excellent]). During the previous pavement inspection in 2012, the area-weighted PCI of the airport was 85.

Figure 6 summarizes the overall condition of the pavements at Forest City Municipal Airport and Figure 7 presents area-weighted condition (average PCI adjusted to account for the relative size of the pavement sections) by branch use. Figure 8 is a map that displays the condition of the evaluated pavements. Table 1 summarizes the results of the pavement evaluation. Appendix B presents photographs taken during the PCI inspection, and Appendix C contains detailed information on the distresses observed during the visual survey. Appendix D includes detailed work history information that was collected during the record review process.
