Fort Dodge Regional Airport

Pavement Management Report

JULY 2023

FORT DODGE REGIONAL AIRPORT PAVEMENT MANAGEMENT REPORT

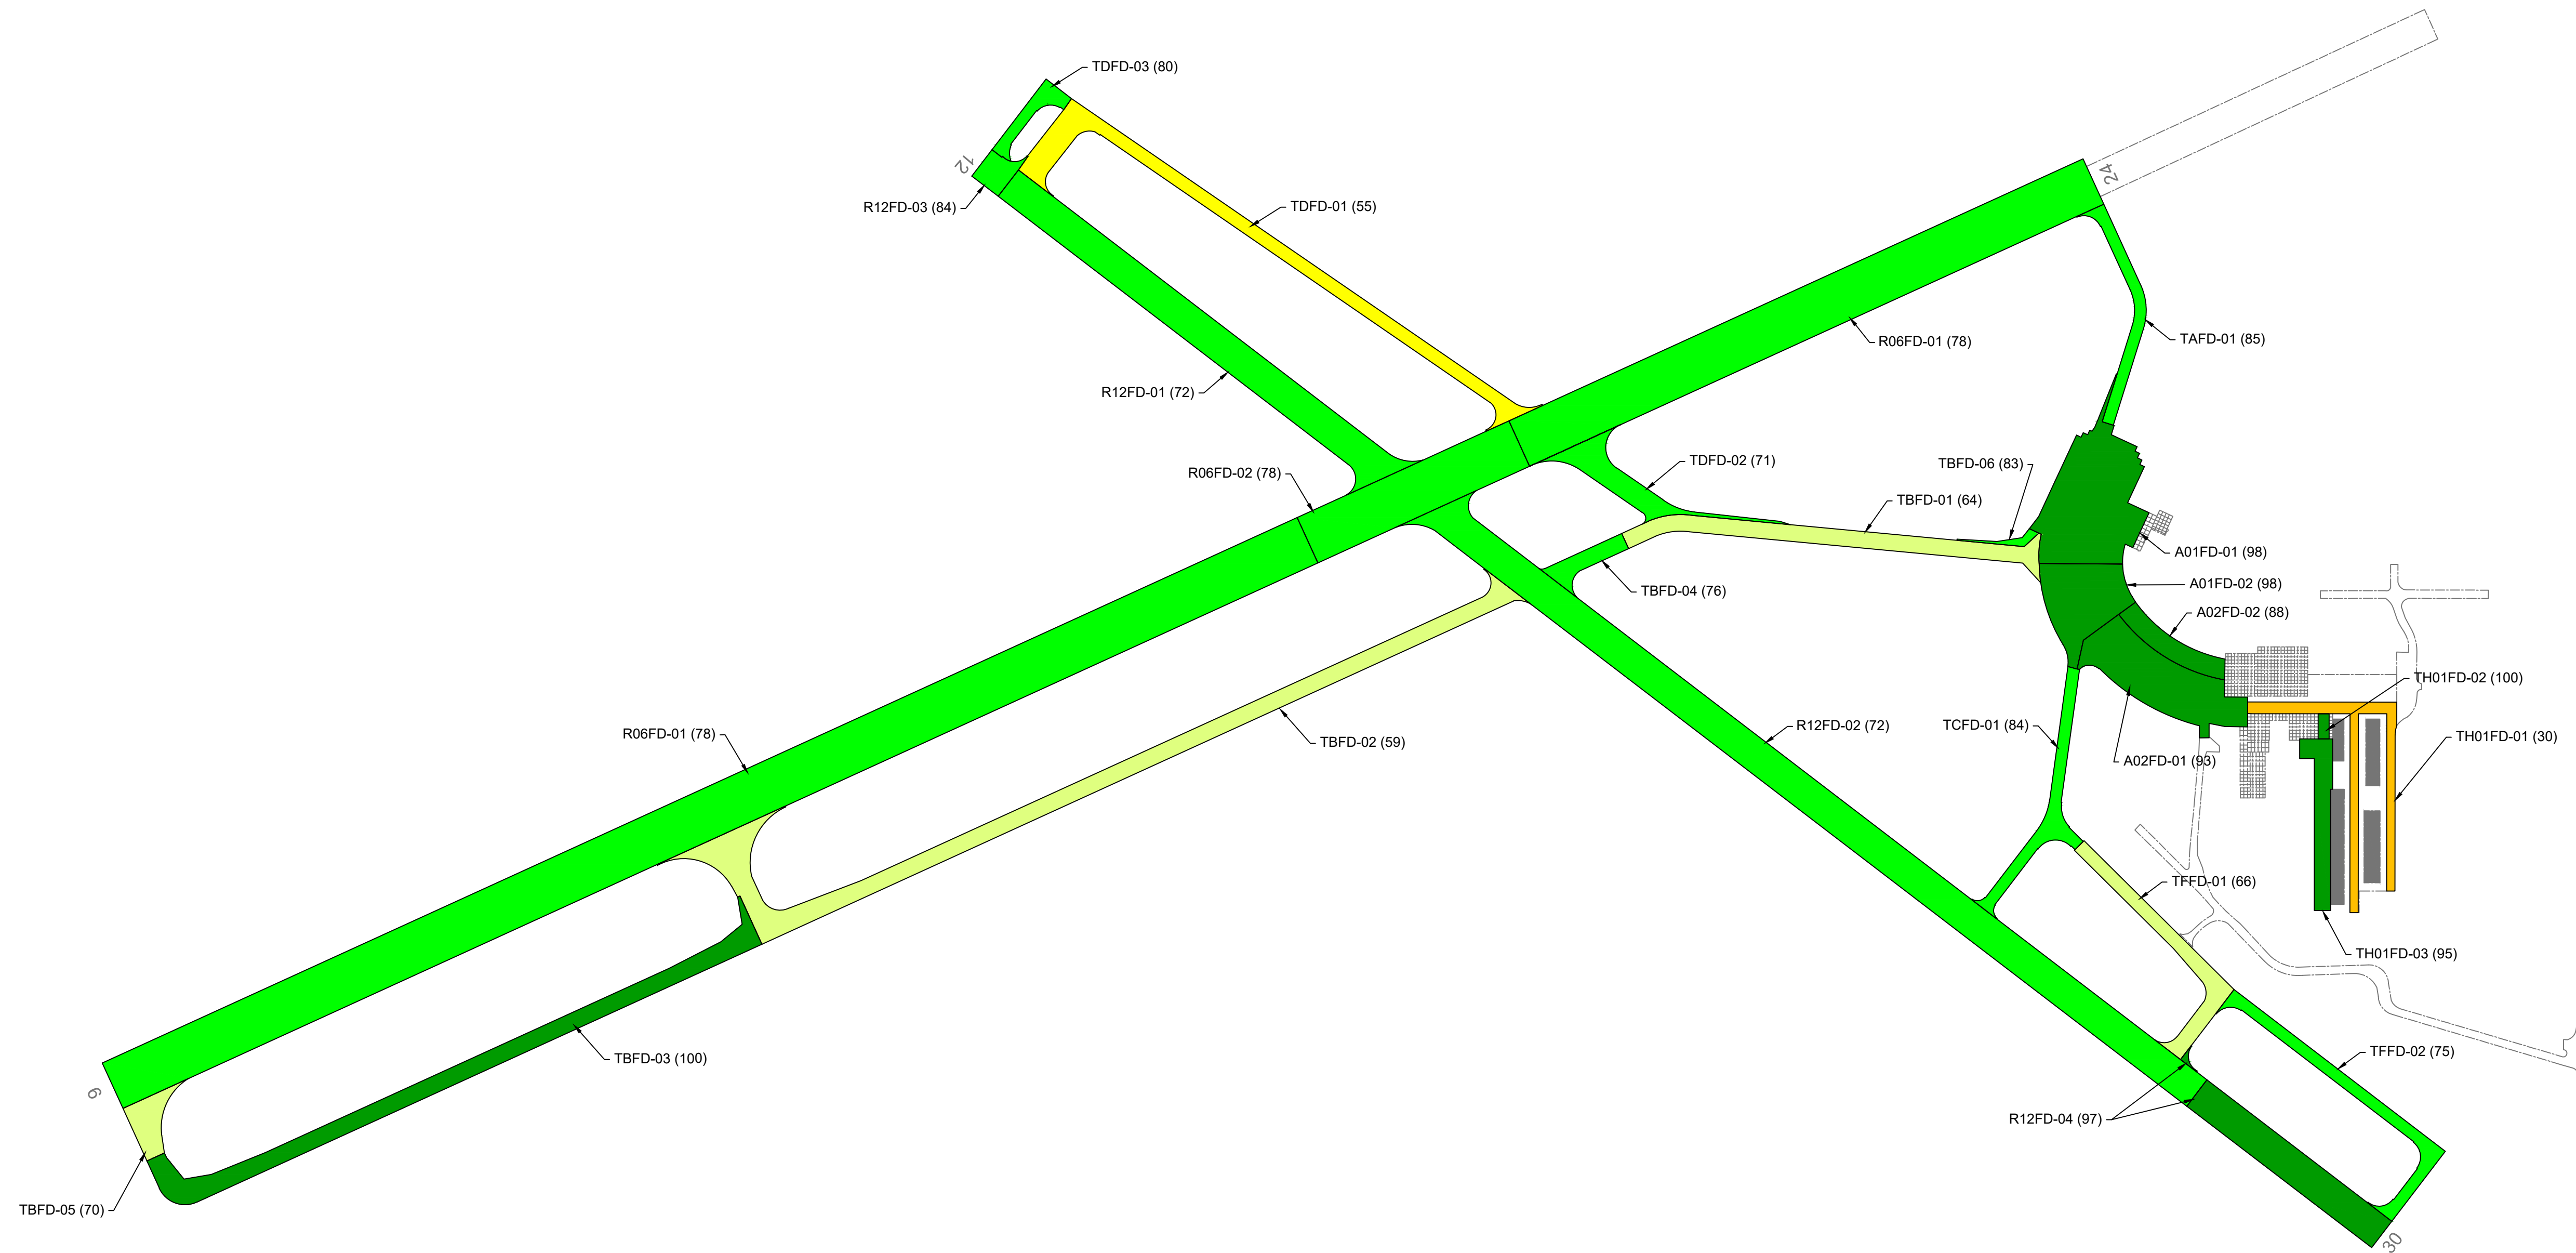
FIGURE 8. PCI MAP.

The pavements at Fort Dodge Regional Airport were inspected in November 2022. The 2022 area-weighted condition of Fort Dodge Regional Airport is 77, with conditions ranging from 30 to 100 (on a scale of 0 [failed] to 100 [excellent]). During the previous pavement inspection in 2019, the area-weighted PCI of the airport was 83.

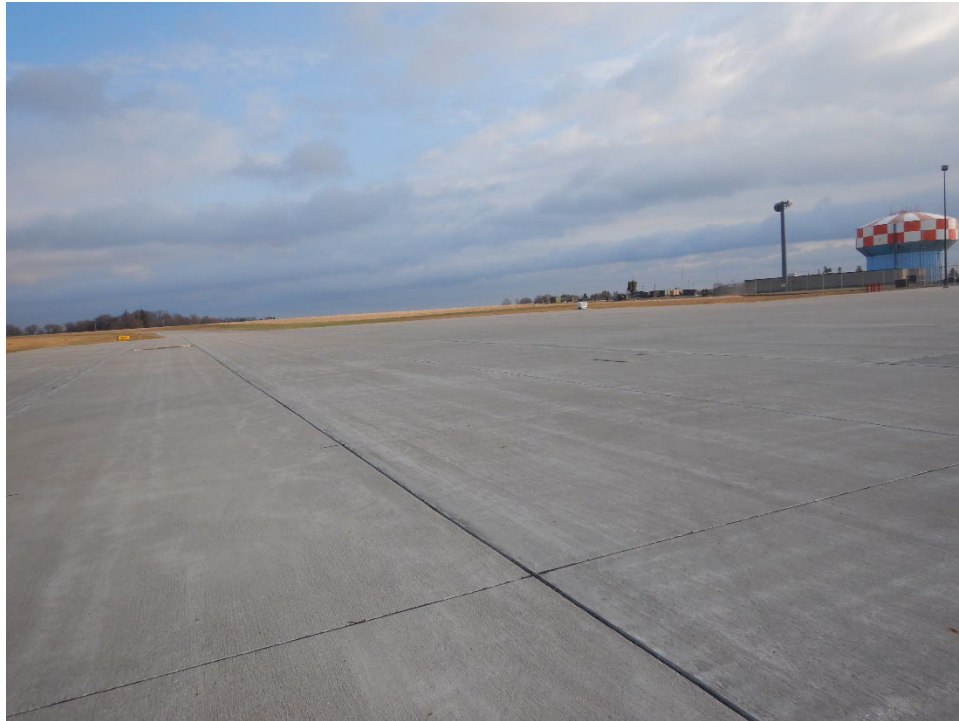
A01FD-01. Overview.

| Branch | Section | Surface Type | Section Area (sf) | LCD | 2022 PCI | % Distress Due to Load | % Distress Due to Climate/Durability | % Distress Due to Other | Type of Distress |
|---|---|---|---|---|---|---|---|---|--|
| A01FD | 01 | PCC | 102,275 | 6/3/2019 | 98 | 0 | 100 | 0 | Joint Seal Damage |

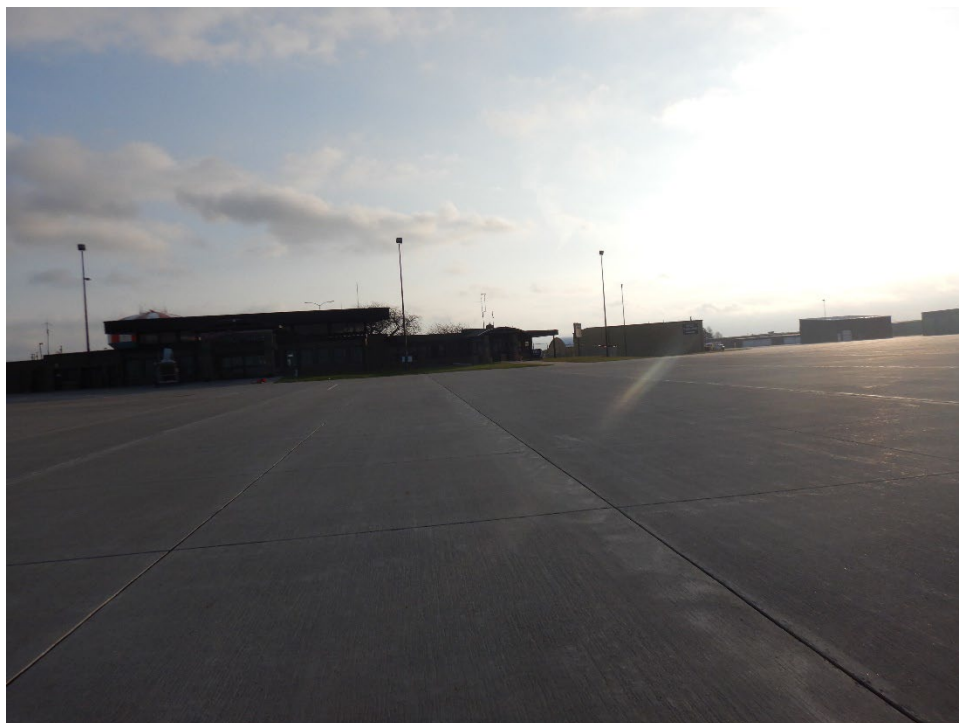
A01FD-02. Overview.

| Branch | Section | Surface Type | Section Area (sf) | LCD | 2022 PCI | % Distress Due to Load | % Distress Due to Climate/Durability | % Distress Due to Other | Type of Distress |
|---|---|---|---|---|---|---|---|---|--|
| A01FD | 02 | PCC | 53,202 | 6/3/2019 | 98 | 0 | 70 | 30 | Corner Spalling, Joint Seal Damage |

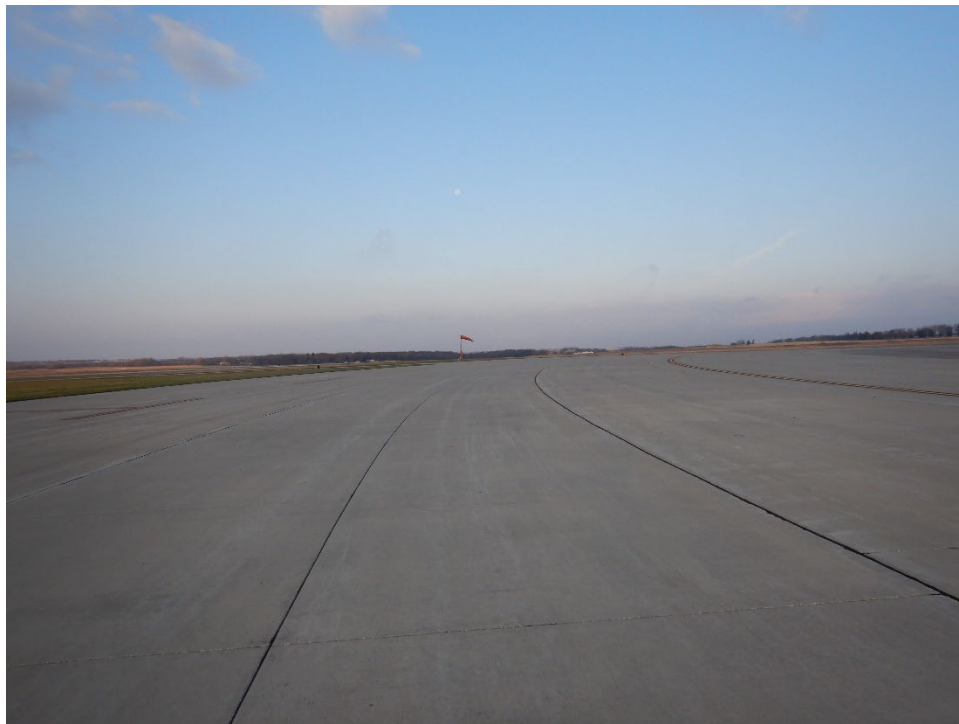
A02FD-01. Overview.

| Branch | Section | Surface Type | Section Area (sf) | LCD | 2022 PCI | % Distress Due to Load | % Distress Due to Climate/Durability | % Distress Due to Other | Type of Distress |
|---|---|---|---|---|---|---|---|---|--|
| A02FD | 01 | PCC | 76,791 | 6/3/2019 | 93 | 12 | 80 | 8 | Corner Spalling, Joint Seal Damage, LTD Cracking, Shrinkage Cracking |

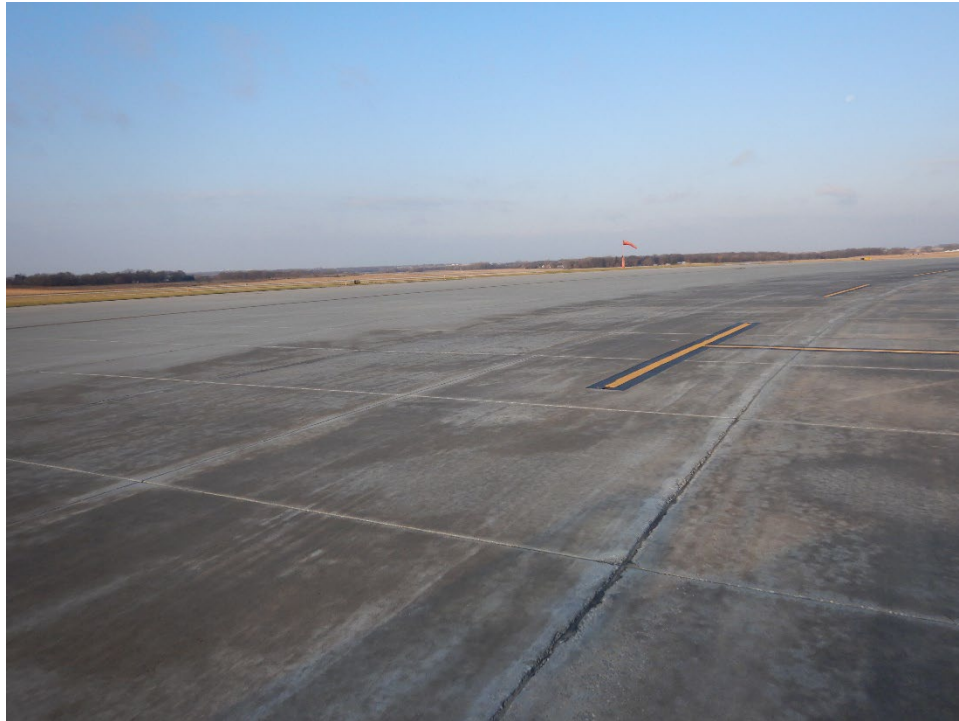
A02FD-02. Overview.

| Branch | Section | Surface Type | Section Area (sf) | LCD | 2022 PCI | % Distress Due to Load | % Distress Due to Climate/Durability | % Distress Due to Other | Type of Distress |
|---|---|---|---|---|---|---|---|---|--|
| A02FD | 02 | PCC | 21,688 | 7/3/2012 | 88 | 9 | 56 | 35 | Corner Spalling, Joint Spalling, Joint Seal Damage, LTD Cracking, Shrinkage Cracking |

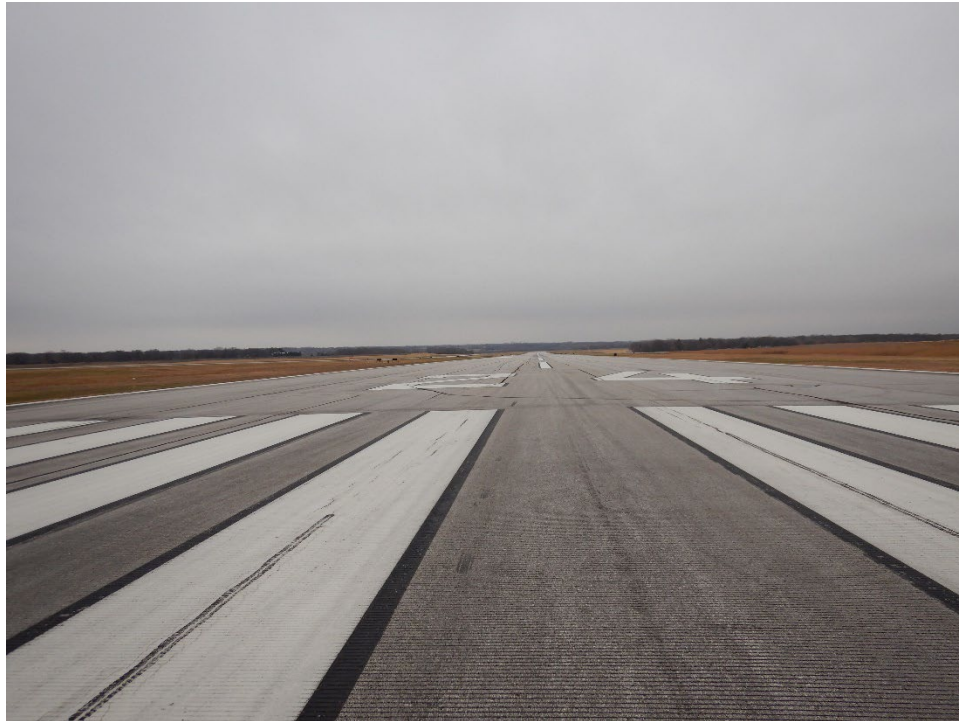
R06FD-01. Overview.

| Branch | Section | Surface Type | Section Area (sf) | LCD | 2022 PCI | % Distress Due to Load | % Distress Due to Climate/Durability | % Distress Due to Other | Type of Distress |
|---|---|---|---|---|---|---|---|---|--|
| R06FD | 01 | AAC | 877,200 | 6/3/2015 | 78 | 0 | 100 | 0 | L&T Cracking, Weathering |

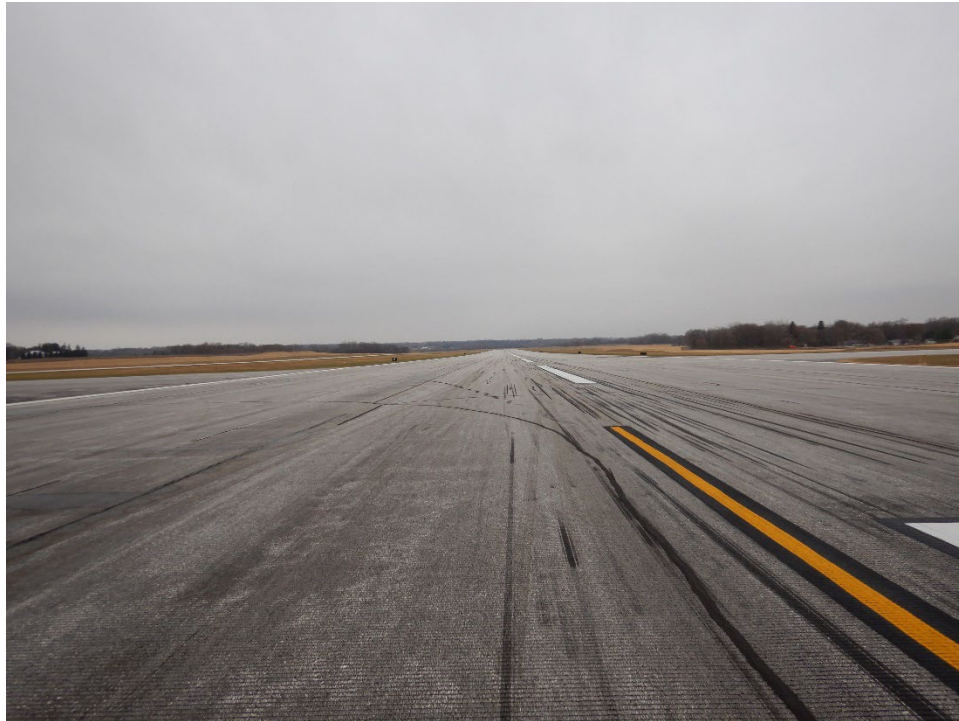
R06FD-02. Overview.

| Branch | Section | Surface Type | Section Area (sf) | LCD | 2022 PCI | % Distress Due to Load | % Distress Due to Climate/Durability | % Distress Due to Other | Type of Distress |
|---|---|---|---|---|---|---|---|---|--|
| R06FD | 02 | AAC | 105,000 | 6/1/2012 | 78 | 22 | 78 | 0 | Alligator Cracking, L&T Cracking, Weathering |

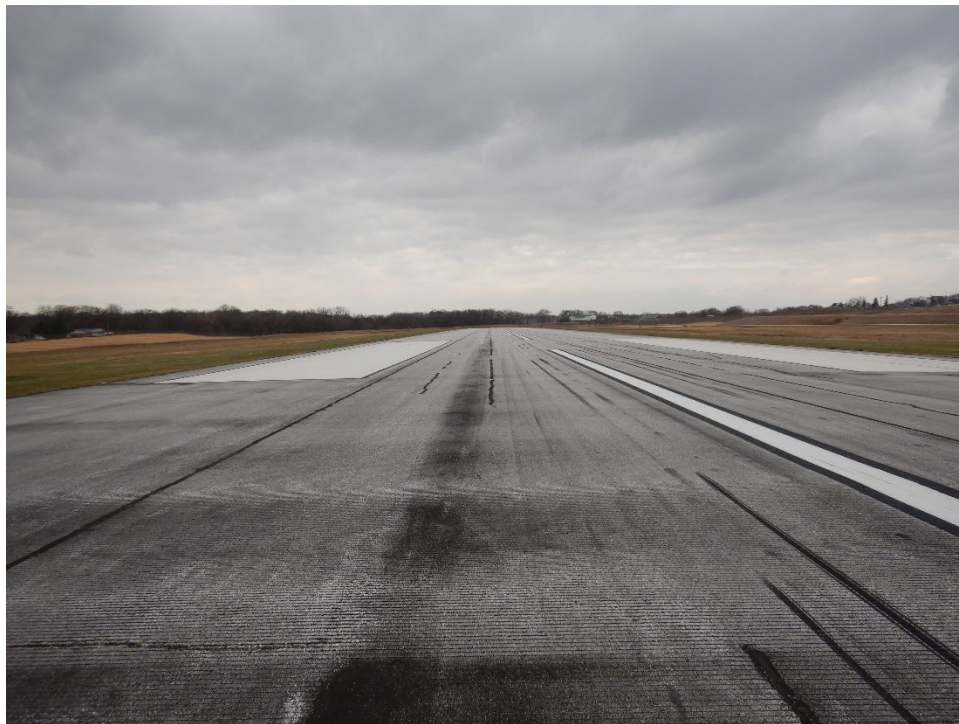
R12FD-01. Overview.

| Branch | Section | Surface Type | Section Area (sf) | LCD | 2022 PCI | % Distress Due to Load | % Distress Due to Climate/Durability | % Distress Due to Other | Type of Distress |
|---|---|---|---|---|---|---|---|---|--|
| R12FD | 01 | APC | 147,855 | 6/1/2012 | 72 | 0 | 100 | 0 | L&T Cracking, Raveling, Weathering |

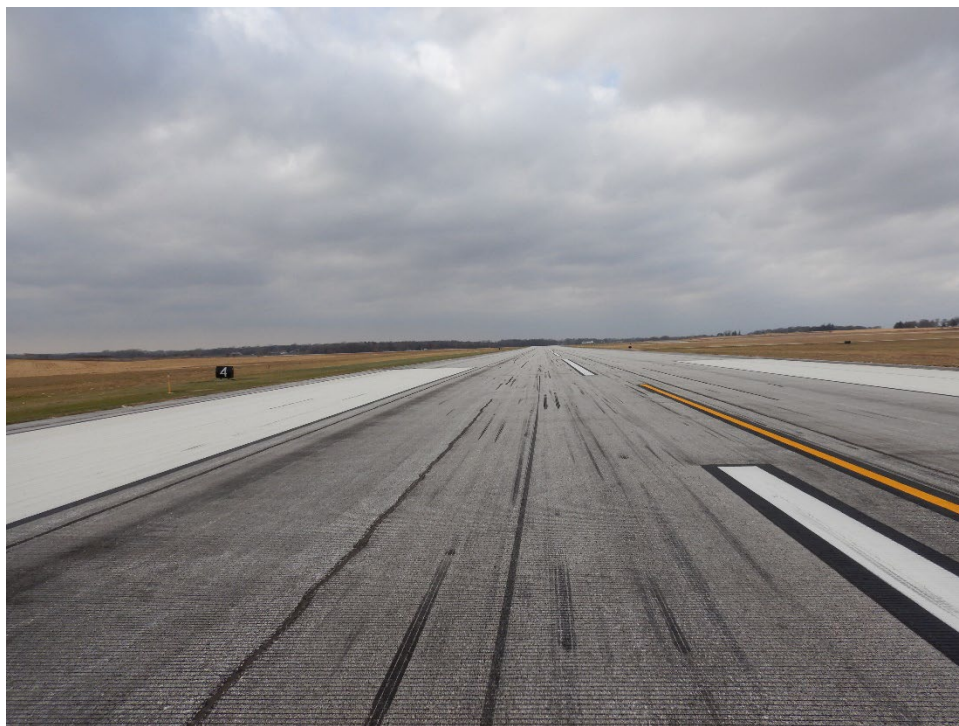
R12FD-02. Overview.

| Branch | Section | Surface Type | Section Area (sf) | LCD | 2022 PCI | % Distress Due to Load | % Distress Due to Climate/Durability | % Distress Due to Other | Type of Distress |
|---|---|---|---|---|---|---|---|---|--|
| R12FD | 02 | APC | 291,412 | 6/1/2012 | 72 | 0 | 100 | 0 | L&T Cracking, Raveling, Weathering |

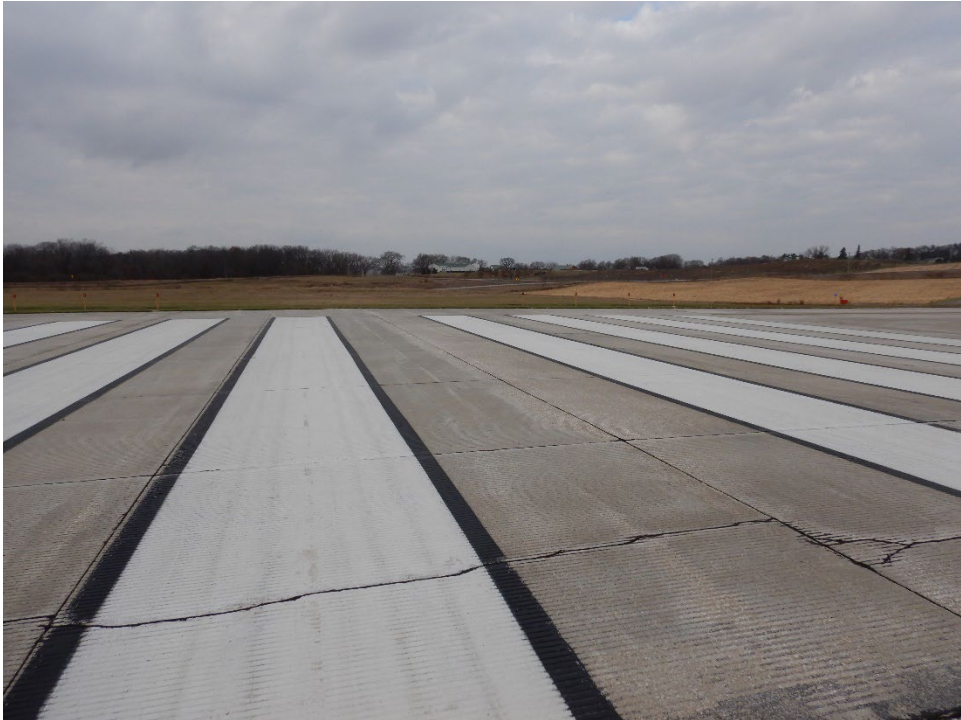
R12FD-03. Overview.

| Branch | Section | Surface Type | Section Area (sf) | LCD | 2022 PCI | % Distress Due to Load | % Distress Due to Climate/Durability | % Distress Due to Other | Type of Distress |
|---|---|---|---|---|---|---|---|---|--|
| R12FD | 03 | PCC | 10,869 | 5/1/2004 | 84 | 85 | 8 | 7 | Corner Break, Corner Spalling, Joint Spalling, Joint Seal Damage, LTD Cracking, Shattered Slab |

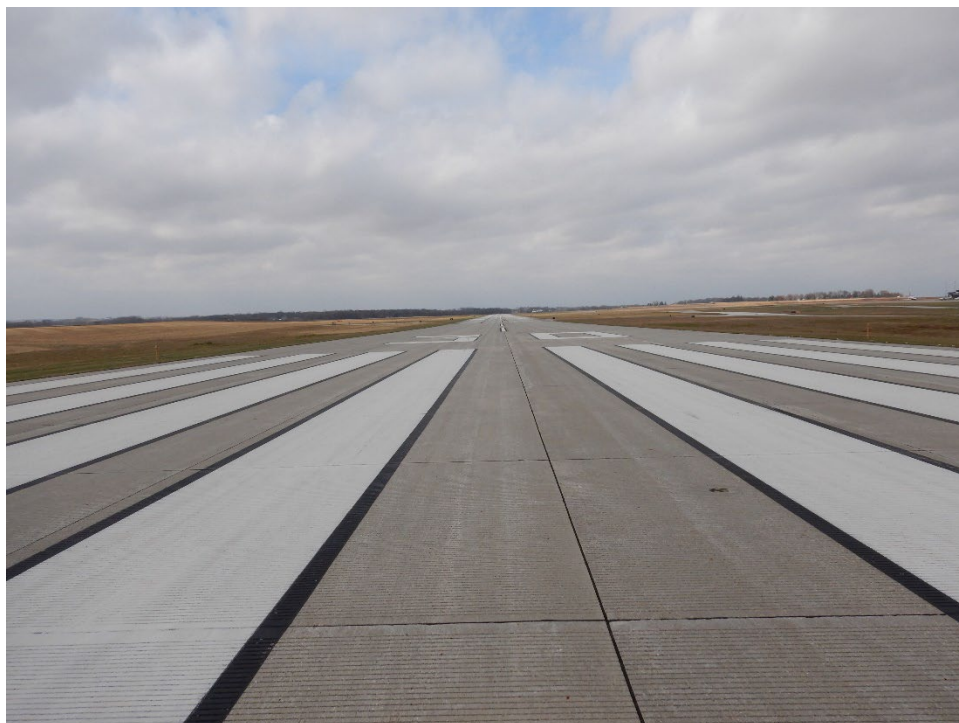
R12FD-04. Overview.

| Branch | Section | Surface Type | Section Area (sf) | LCD | 2022 PCI | % Distress Due to Load | % Distress Due to Climate/Durability | % Distress Due to Other | Type of Distress |
|---|---|---|---|---|---|---|---|---|--|
| R12FD | 04 | PCC | 70,952 | 5/1/2004 | 97 | 31 | 0 | 69 | Corner Spalling, Faulting, Joint Spalling, LTD Cracking |

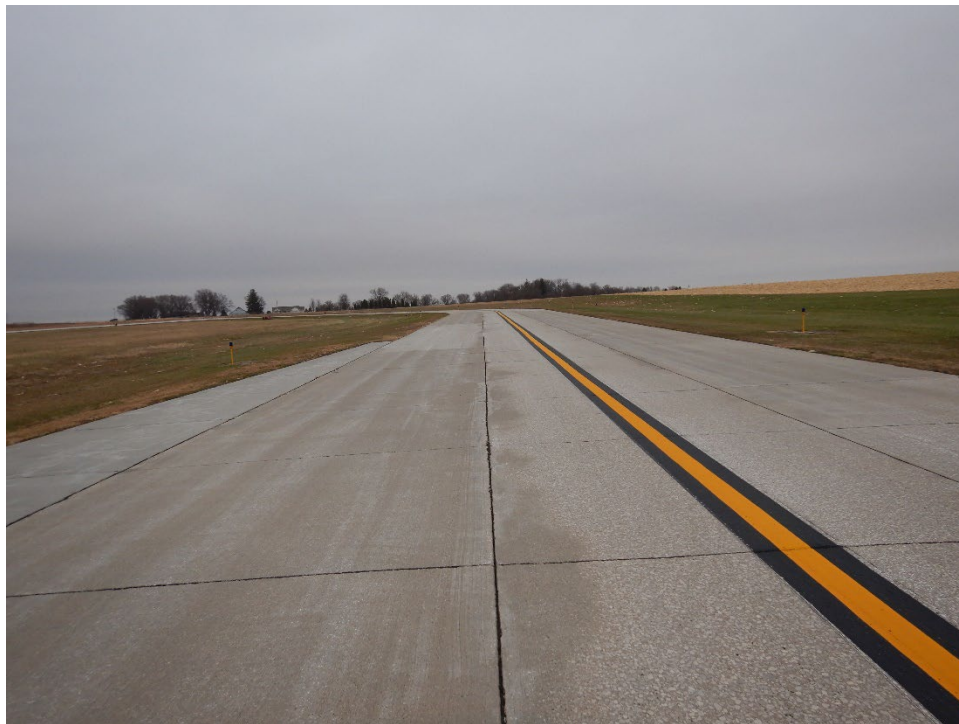
TAFD-01. Overview.

| Branch | Section | Surface Type | Section Area (sf) | LCD | 2022 PCI | % Distress Due to Load | % Distress Due to Climate/Durability | % Distress Due to Other | Type of Distress |
|---|---|---|---|---|---|---|---|---|--|
| TAFD | 01 | PCC | 25,248 | 8/16/2001 | 85 | 25 | 67 | 8 | Corner Break, Joint Spalling, Joint Seal Damage, LTD Cracking |

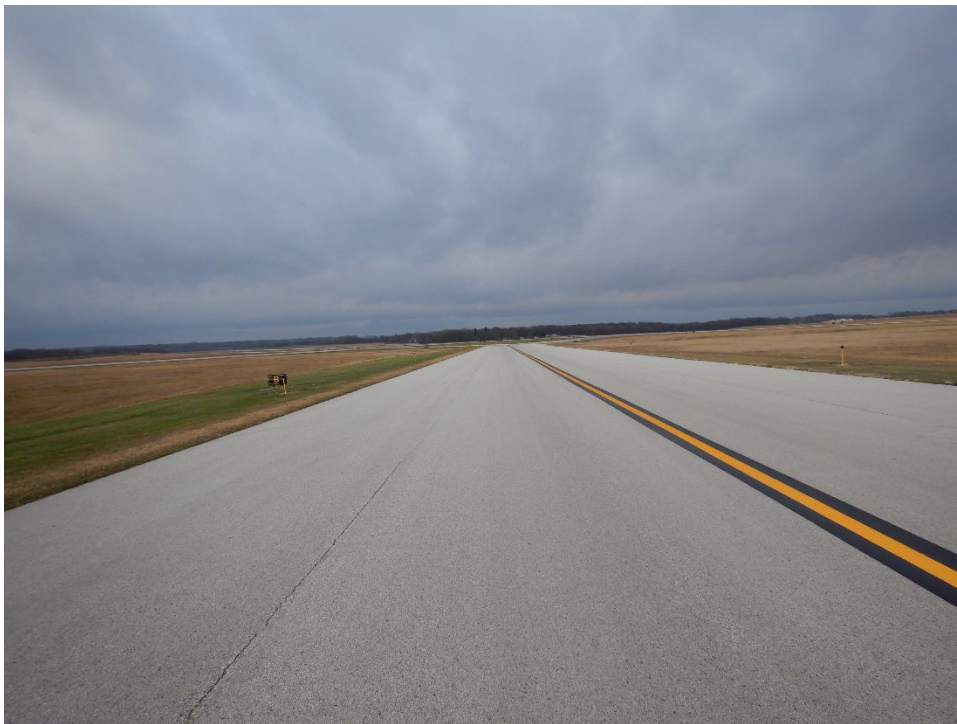
TBFD-01. Overview.

| Branch | Section | Surface Type | Section Area (sf) | LCD | 2022 PCI | % Distress Due to Load | % Distress Due to Climate/Durability | % Distress Due to Other | Type of Distress |
|---|---|---|---|---|---|---|---|---|--|
| TBFD | 01 | AAC | 65,568 | 6/3/2015 | 64 | 0 | 100 | 0 | L&T Cracking, Raveling, Weathering |

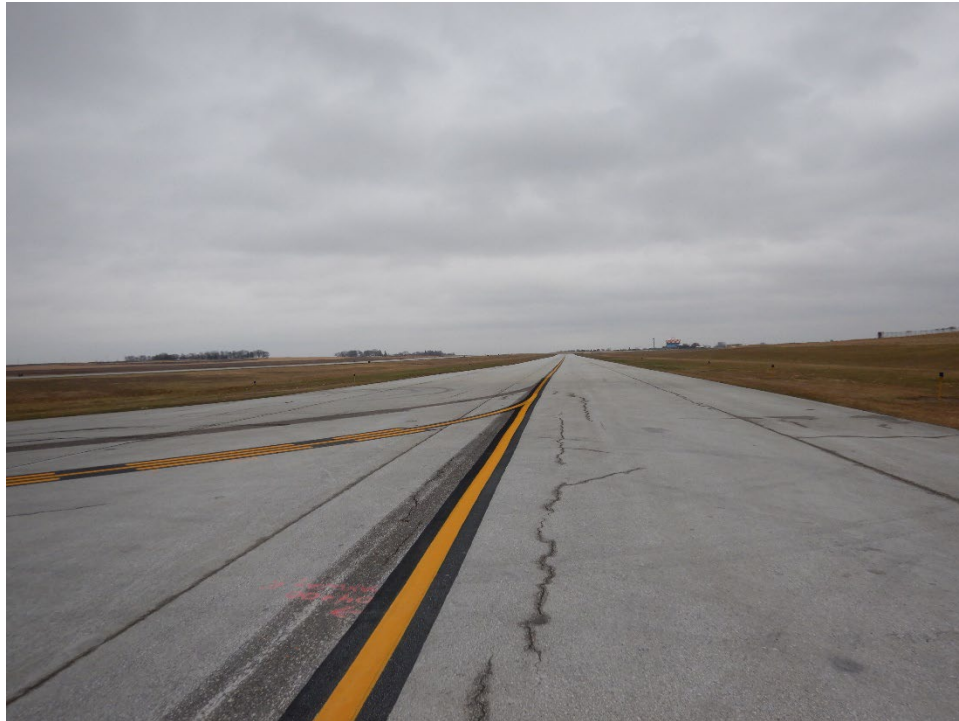
TBFD-02. Overview.

| Branch | Section | Surface Type | Section Area (sf) | LCD | 2022 PCI | % Distress Due to Load | % Distress Due to Climate/Durability | % Distress Due to Other | Type of Distress |
|---|---|---|---|---|---|---|---|---|--|
| TBFD | 02 | AAC | 162,730 | 6/1/2007 | 59 | 0 | 100 | 0 | L&T Cracking, Weathering |

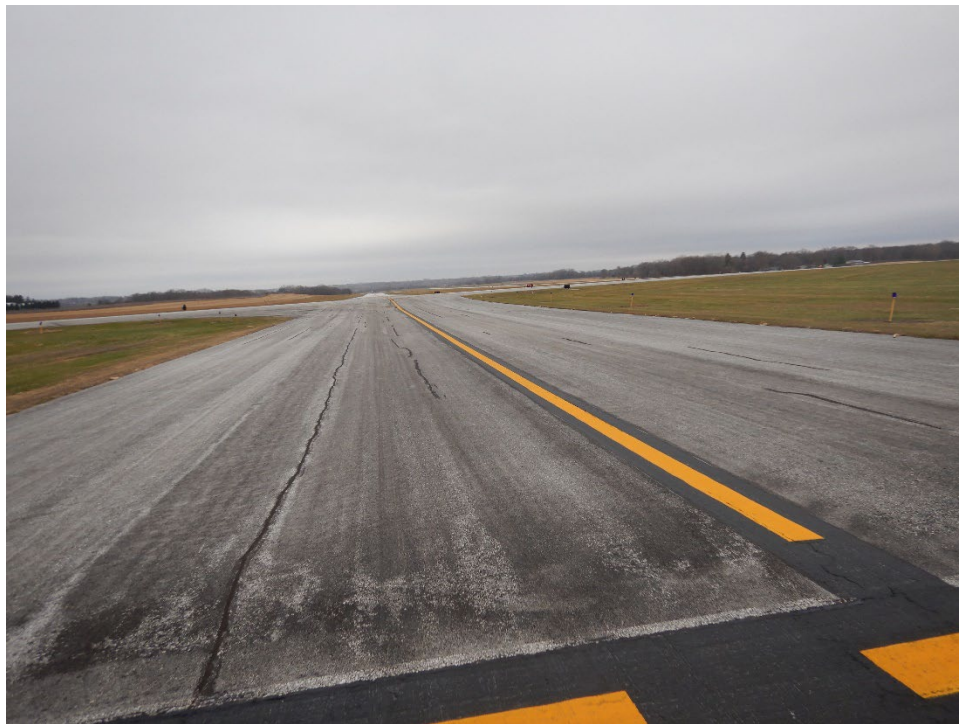
TBFD-04. Overview.

| Branch | Section | Surface Type | Section Area (sf) | LCD | 2022 PCI | % Distress Due to Load | % Distress Due to Climate/Durability | % Distress Due to Other | Type of Distress |
|---|---|---|---|---|---|---|---|---|--|
| TBFD | 04 | AAC | 14,250 | 6/1/2012 | 76 | 0 | 100 | 0 | L&T Cracking, Weathering |

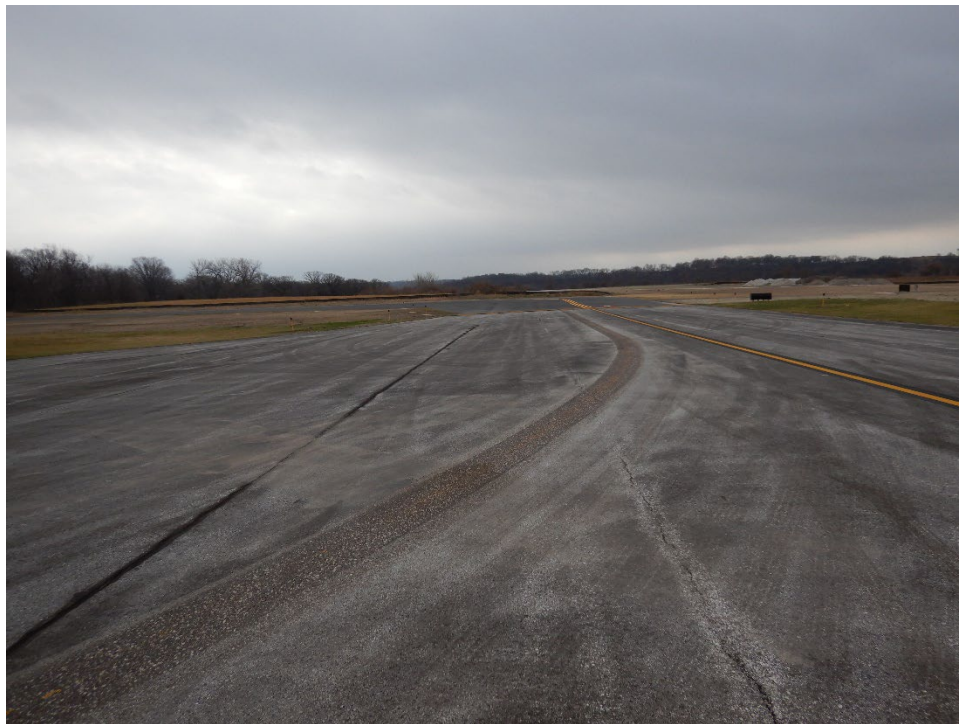
TBFD-05. Overview.

| Branch | Section | Surface Type | Section Area (sf) | LCD | 2022 PCI | % Distress Due to Load | % Distress Due to Climate/Durability | % Distress Due to Other | Type of Distress |
|---|---|---|---|---|---|---|---|---|--|
| TBFD | 05 | AAC | 17,528 | 6/1/2015 | 70 | 0 | 100 | 0 | L&T Cracking, Raveling, Weathering |

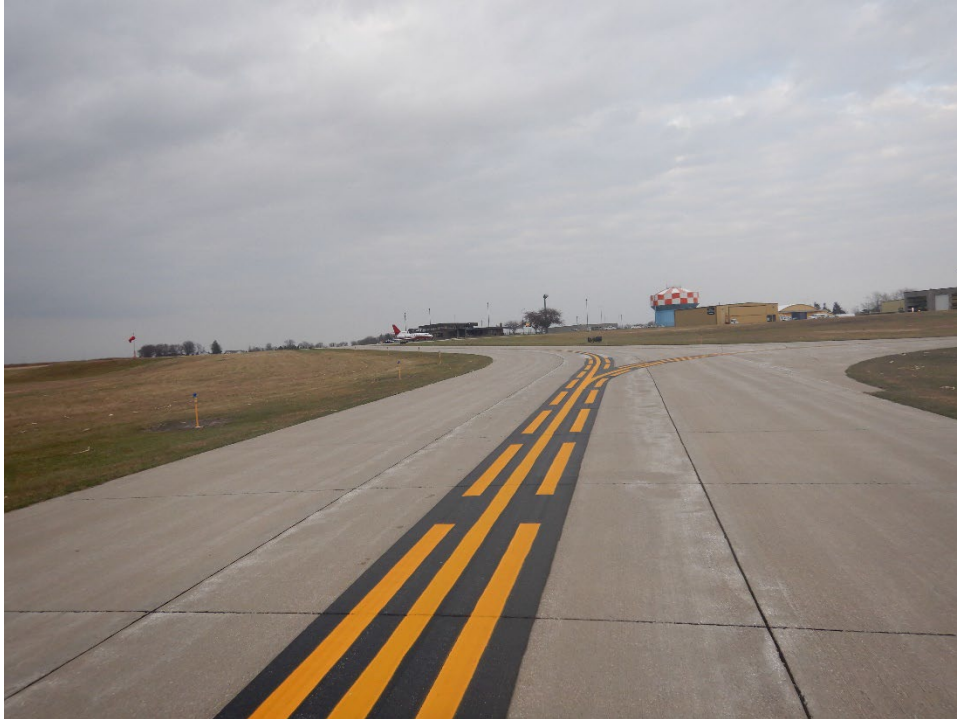
TCFD-01. Overview.

| Branch | Section | Surface Type | Section Area (sf) | LCD | 2022 PCI | % Distress Due to Load | % Distress Due to Climate/Durability | % Distress Due to Other | Type of Distress |
|---|---|---|---|---|---|---|---|---|--|
| TCFD | 01 | PCC | 34,299 | 8/1/2001 | 84 | 4 | 67 | 29 | Corner Break, Corner Spalling, Faulting, Joint Spalling, Joint Seal Damage |

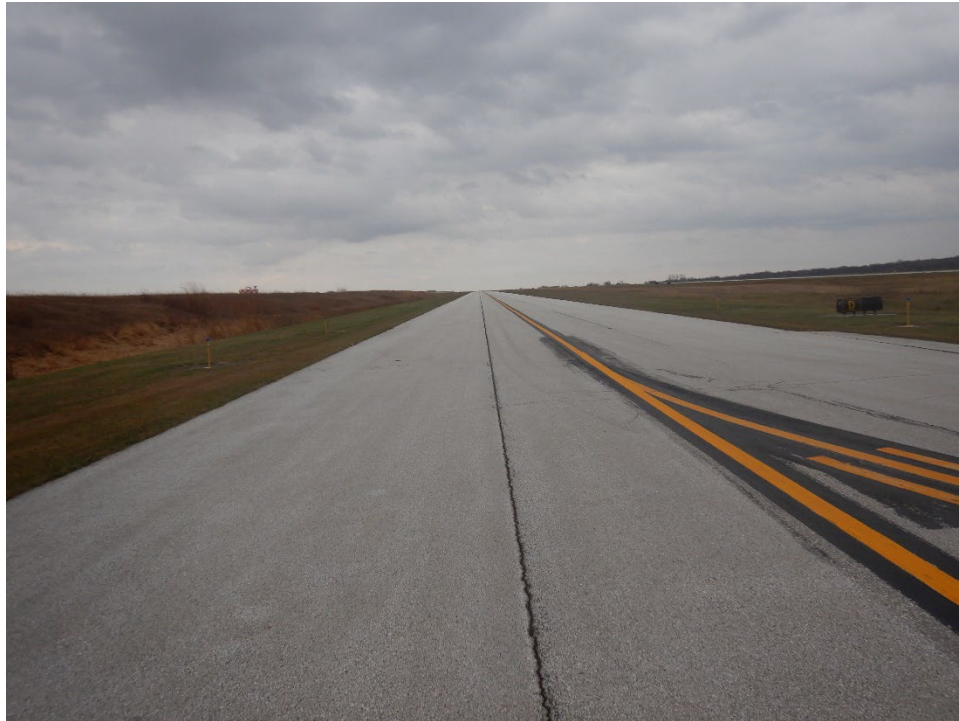
TDFD-01. Overview.

| Branch | Section | Surface Type | Section Area (sf) | LCD | 2022 PCI | % Distress Due to Load | % Distress Due to Climate/Durability | % Distress Due to Other | Type of Distress |
|---|---|---|---|---|---|---|---|---|--|
| TDFD | 01 | AAC | 87,990 | 6/1/2007 | 55 | 0 | 100 | 0 | L&T Cracking, Raveling, Weathering |

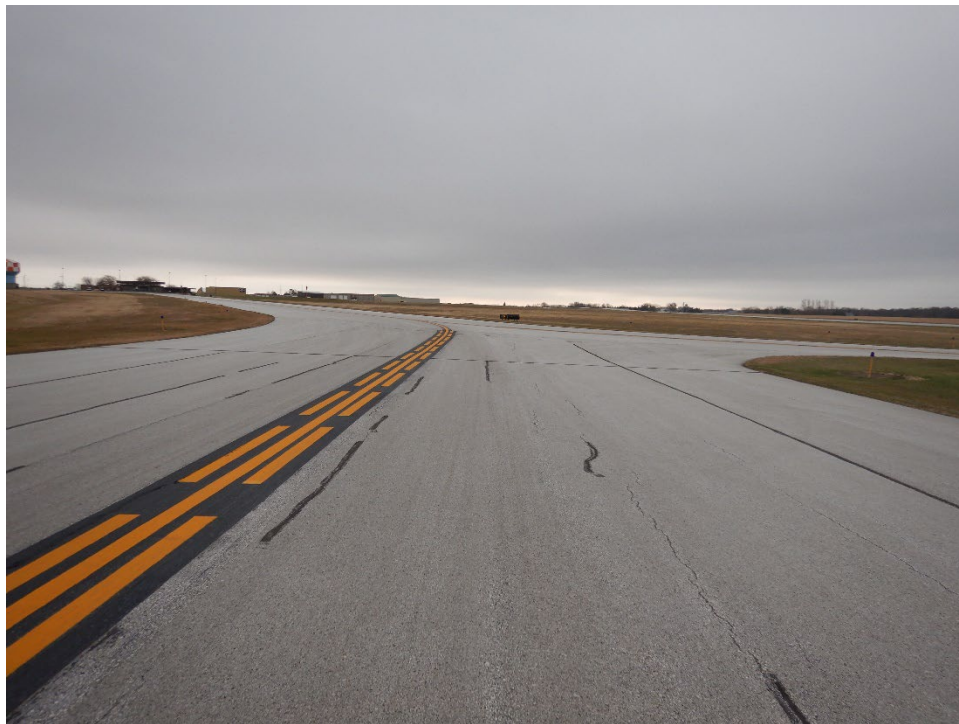
TDFD-02. Overview.

| Branch | Section | Surface Type | Section Area (sf) | LCD | 2022 PCI | % Distress Due to Load | % Distress Due to Climate/Durability | % Distress Due to Other | Type of Distress |
|---|---|---|---|---|---|---|---|---|--|
| TDFD | 02 | AAC | 32,689 | 6/1/2015 | 71 | 0 | 100 | 0 | L&T Cracking, Raveling, Weathering |

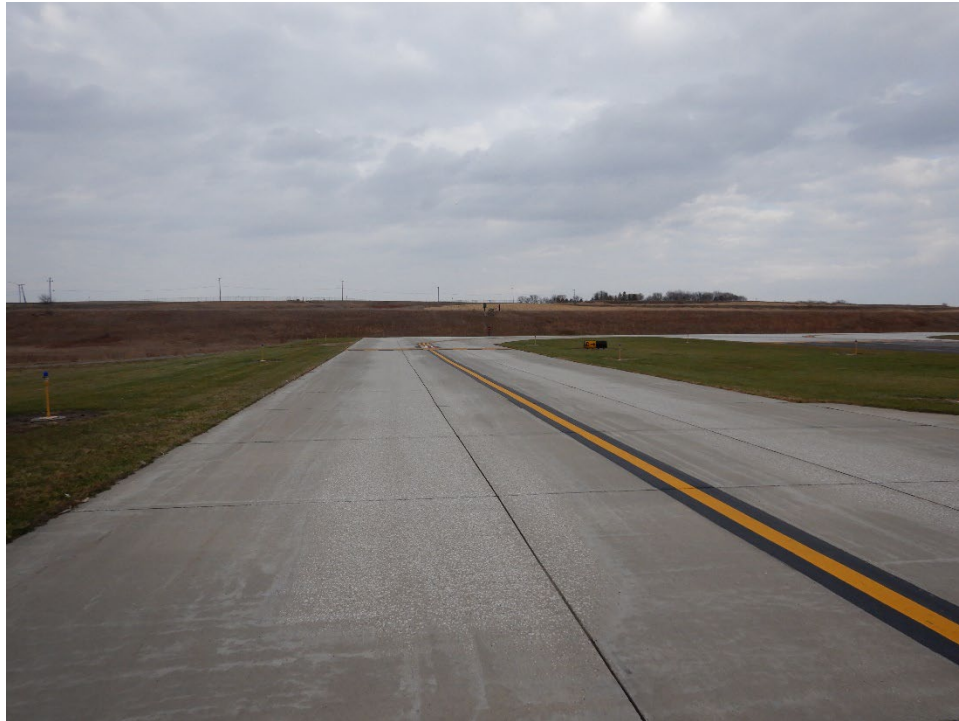
TDFD-03. Overview.

| Branch | Section | Surface Type | Section Area (sf) | LCD | 2022 PCI | % Distress Due to Load | % Distress Due to Climate/Durability | % Distress Due to Other | Type of Distress |
|---|---|---|---|---|---|---|---|---|--|
| TDFD | 03 | PCC | 13,390 | 6/3/2007 | 80 | 42 | 49 | 9 | Corner Break, Joint Spalling, Joint Seal Damage, LTD Cracking |

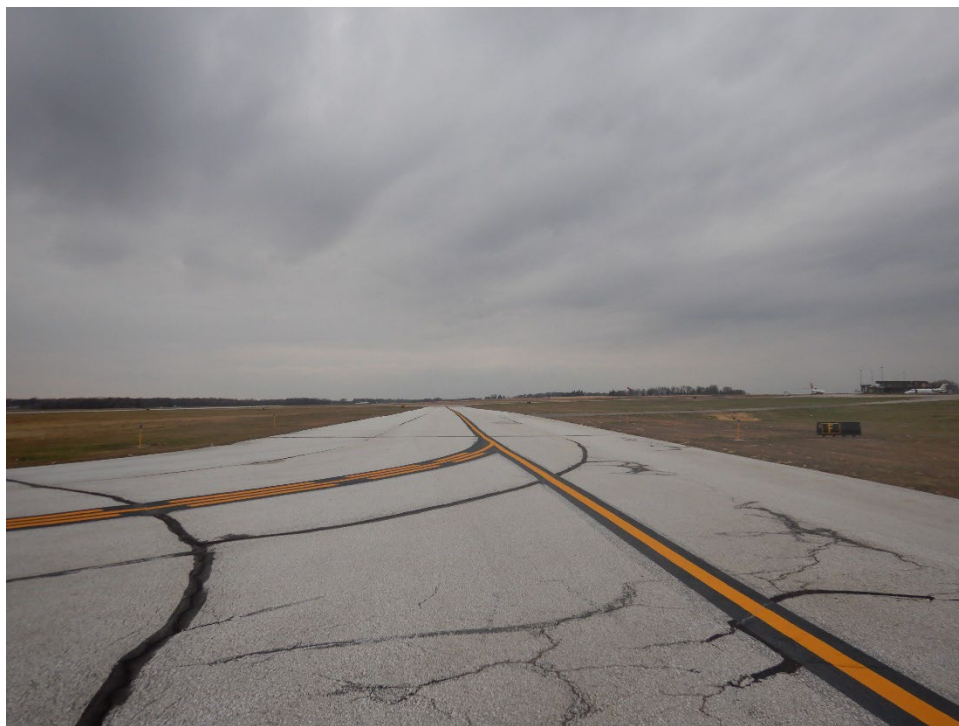
TFFD-01. Overview.

| Branch | Section | Surface Type | Section Area (sf) | LCD | 2022 PCI | % Distress Due to Load | % Distress Due to Climate/Durability | % Distress Due to Other | Type of Distress |
|---|---|---|---|---|---|---|---|---|--|
| TFFD | 01 | AC | 39,481 | 6/5/1991 | 66 | 0 | 100 | 0 | L&T Cracking, Weathering |

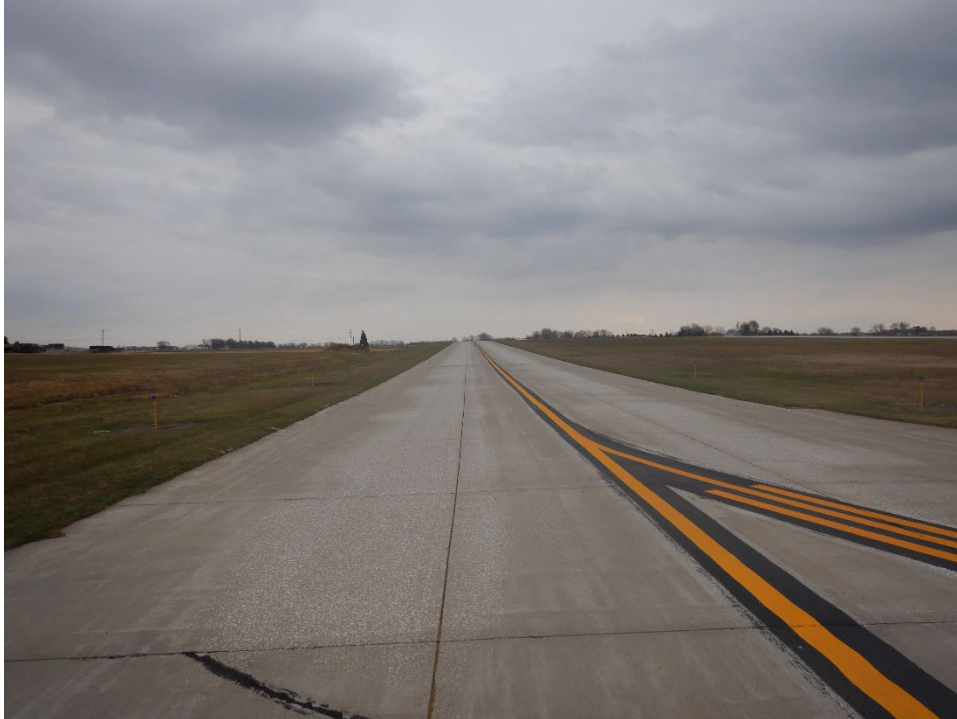
TFFD-02. Overview.

| Branch | Section | Surface Type | Section Area (sf) | LCD | 2022 PCI | % Distress Due to Load | % Distress Due to Climate/Durability | % Distress Due to Other | Type of Distress |
|---|---|---|---|---|---|---|---|---|--|
| TFFD | 02 | PCC | 38,600 | 6/3/2007 | 75 | 58 | 38 | 4 | Corner Break, Corner Spalling, Joint Seal Damage, LTD Cracking |

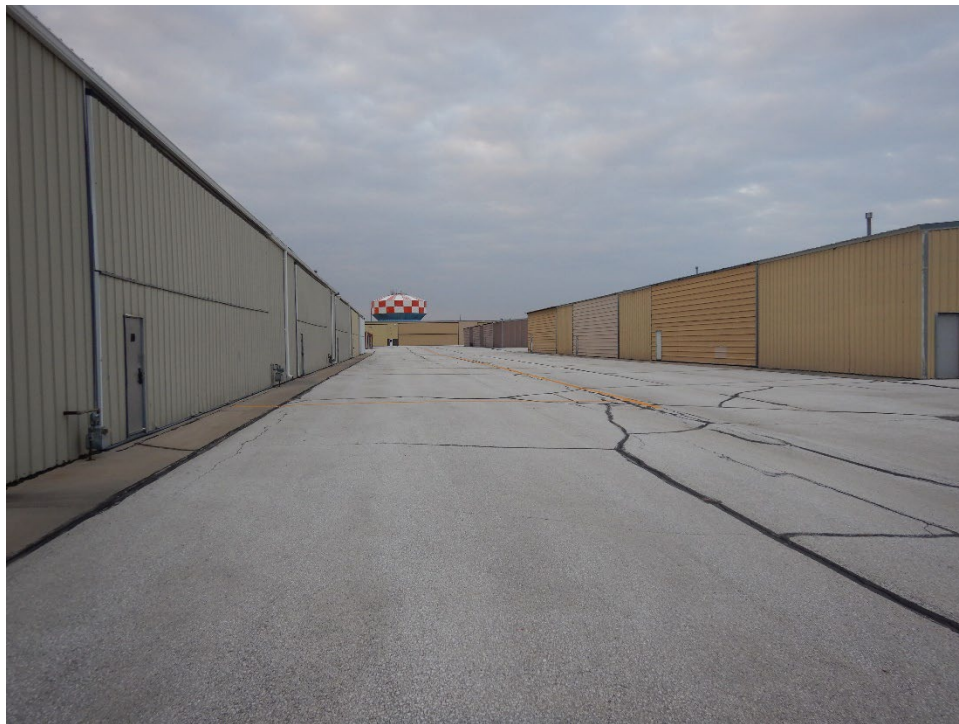
TH01FD-01. Overview.

| Branch | Section | Surface Type | Section Area (sf) | LCD | 2022 PCI | % Distress Due to Load | % Distress Due to Climate/Durability | % Distress Due to Other | Type of Distress |
|---|---|---|---|---|---|---|---|---|--|
| TH01FD | 01 | AC | 44,195 | 6/4/1995 | 30 | 34 | 65 | 1 | Alligator Cracking, Depression, L&T Cracking, Raveling, Swelling, Weathering |

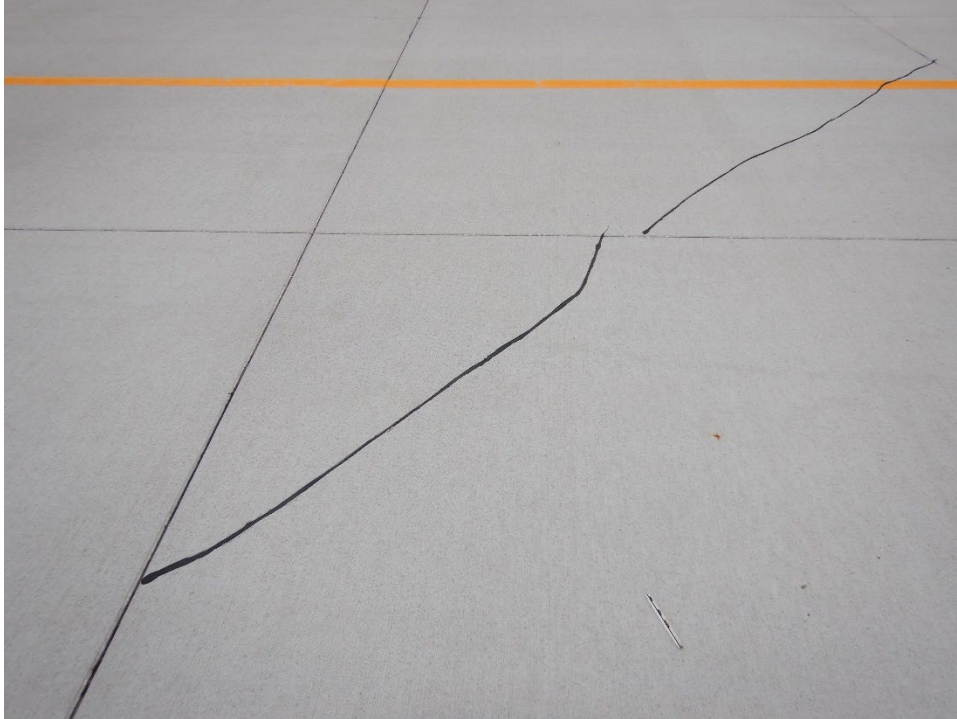
TH01FD-03. Corner Break (Sample Unit No. 04).
