Fort Madison Municipal Airport

PAVEMENT MANAGEMENT REPORT

JULY 2021

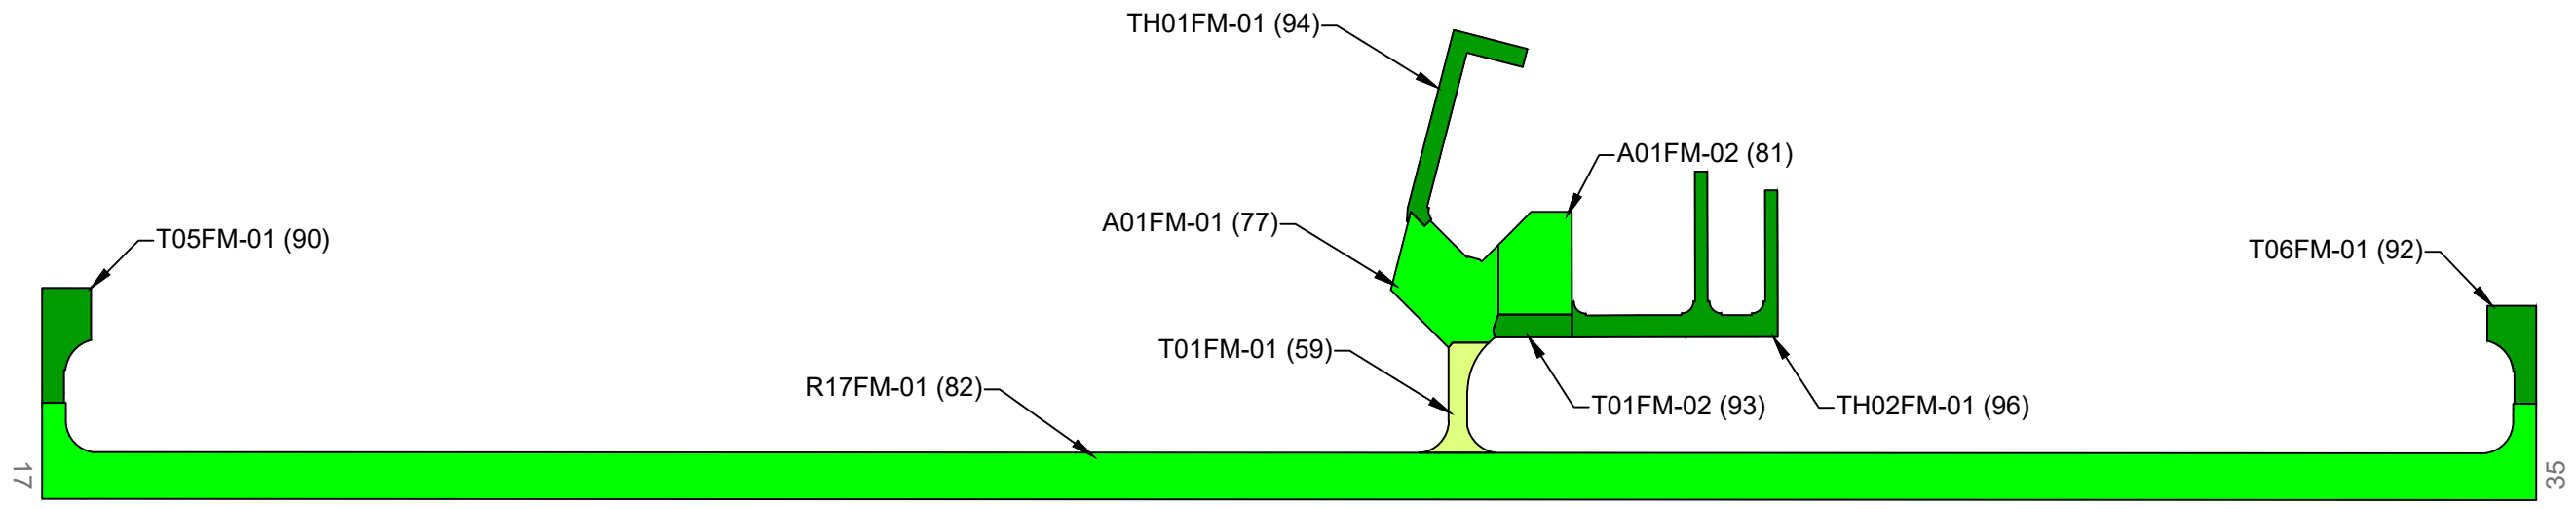
FIGURE 8. PCI MAP.

The pavements at Fort Madison Municipal Airport were inspected in November 2020. The 2020 area-weighted condition of Fort Madison Municipal Airport is 83, with conditions ranging from 59 to 96 (on a scale of 0 [failed] to 100 [excellent]). During the previous pavement inspection in 2017, the area-weighted PCI of the airport was 94.
