# Guthrie County Regional Airport

## Pavement Management Report

**JULY 2024**

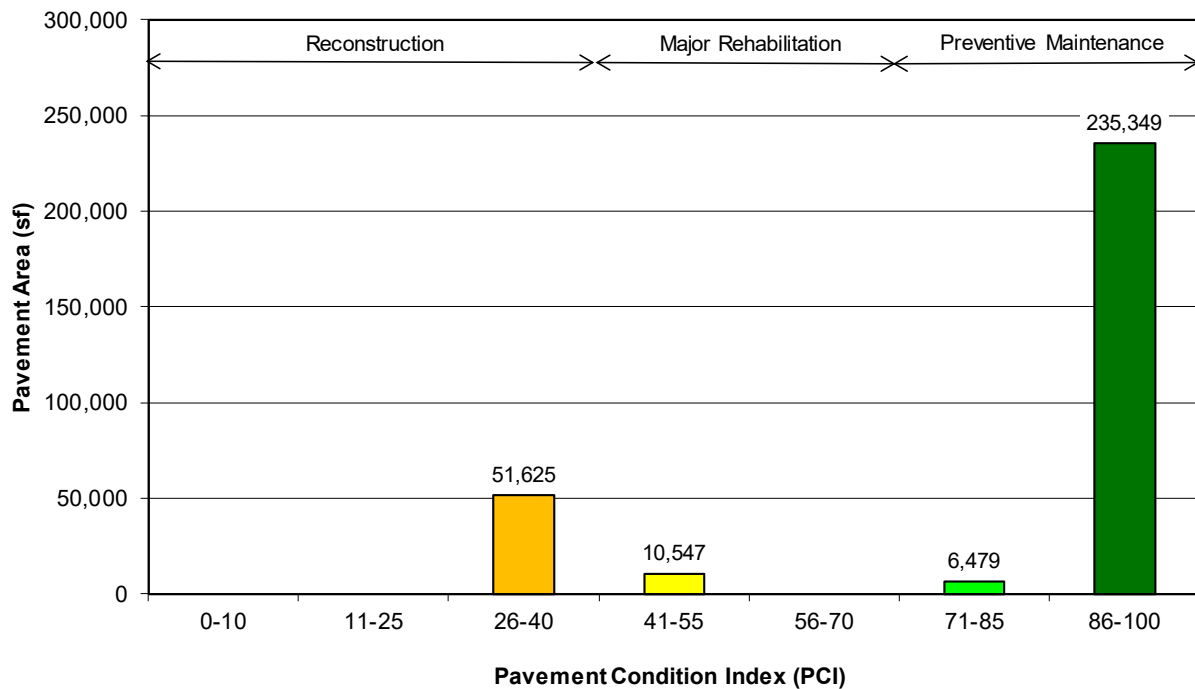
Figure 6. Pavement area by PCI range at Guthrie County Regional Airport.

The pavements at Guthrie County Regional Airport were inspected in November 2023. The 2023 area-weighted condition of Guthrie County Regional Airport is 88, with conditions ranging from 39 to 100 (on a scale of 0 [failed] to 100 [excellent]). During the previous pavement inspection in 2020, the area-weighted PCI of the airport was 90.
