Hampton Municipal Airport

PAVEMENT MANAGEMENT REPORT

JULY 2021

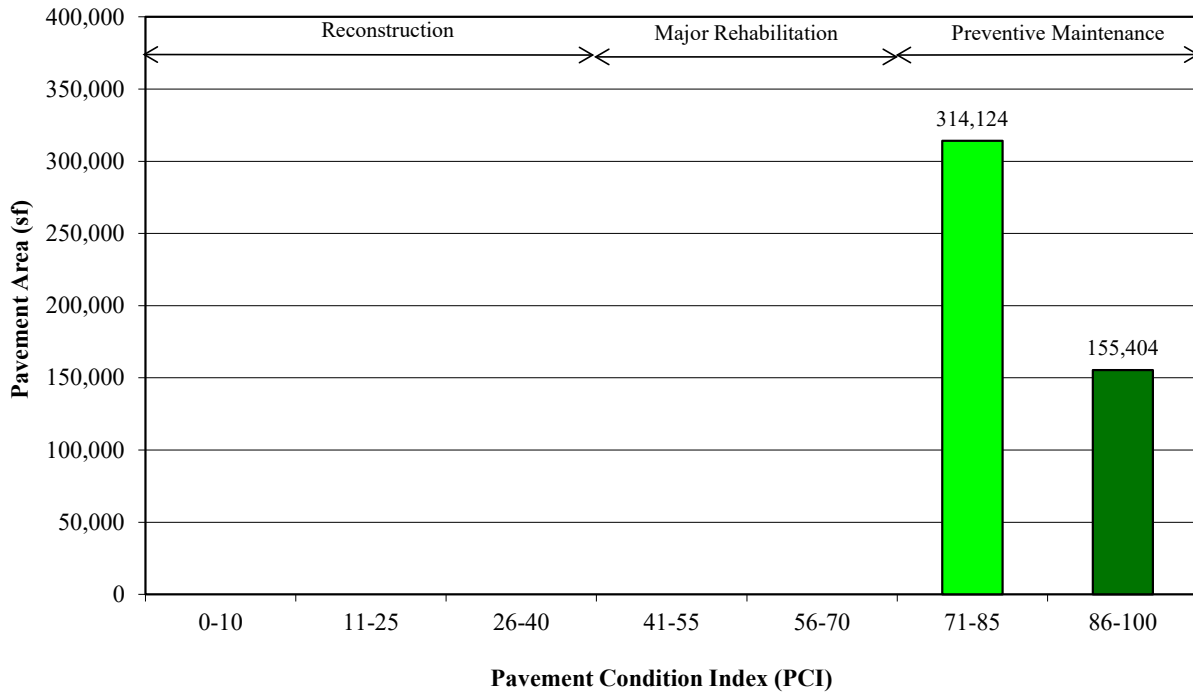
Figure 6. Pavement area by PCI range at Hampton Municipal Airport.

The pavements at Hampton Municipal Airport were inspected in November 2020. The 2020 area-weighted condition of Hampton Municipal Airport is 84, with conditions ranging from 82 to 93 (on a scale of 0 [failed] to 100 [excellent]). During the previous pavement inspection in 2017, the area-weighted PCI of the airport was 87.
