Hampton Municipal Airport

Pavement Management Report

JULY 2024

HAMPTON MUNICIPAL AIRPORT PAVEMENT MANAGEMENT REPORT

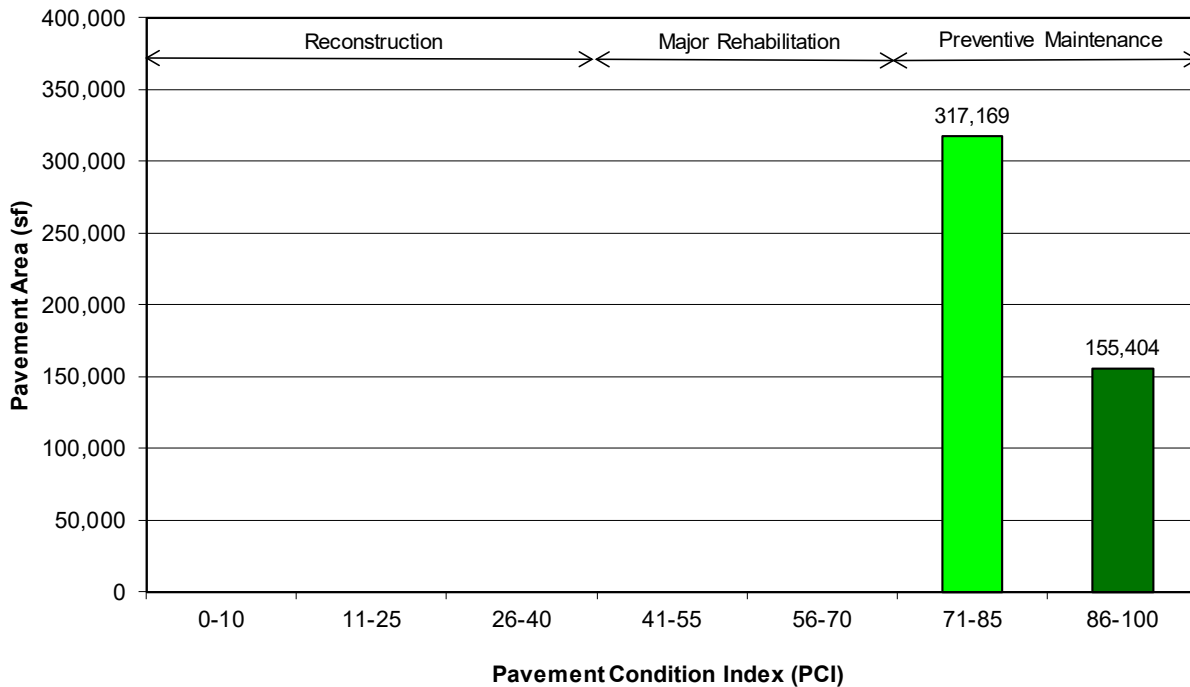
Figure 6. Pavement area by PCI range at Hampton Municipal Airport.

The pavements at Hampton Municipal Airport were inspected in November 2023. The 2023 area-weighted condition of Hampton Municipal Airport is 82, with conditions ranging from 80 to 93 (on a scale of 0 [failed] to 100 [excellent]). During the previous pavement inspection in 2020, the area-weighted PCI of the airport was 84.

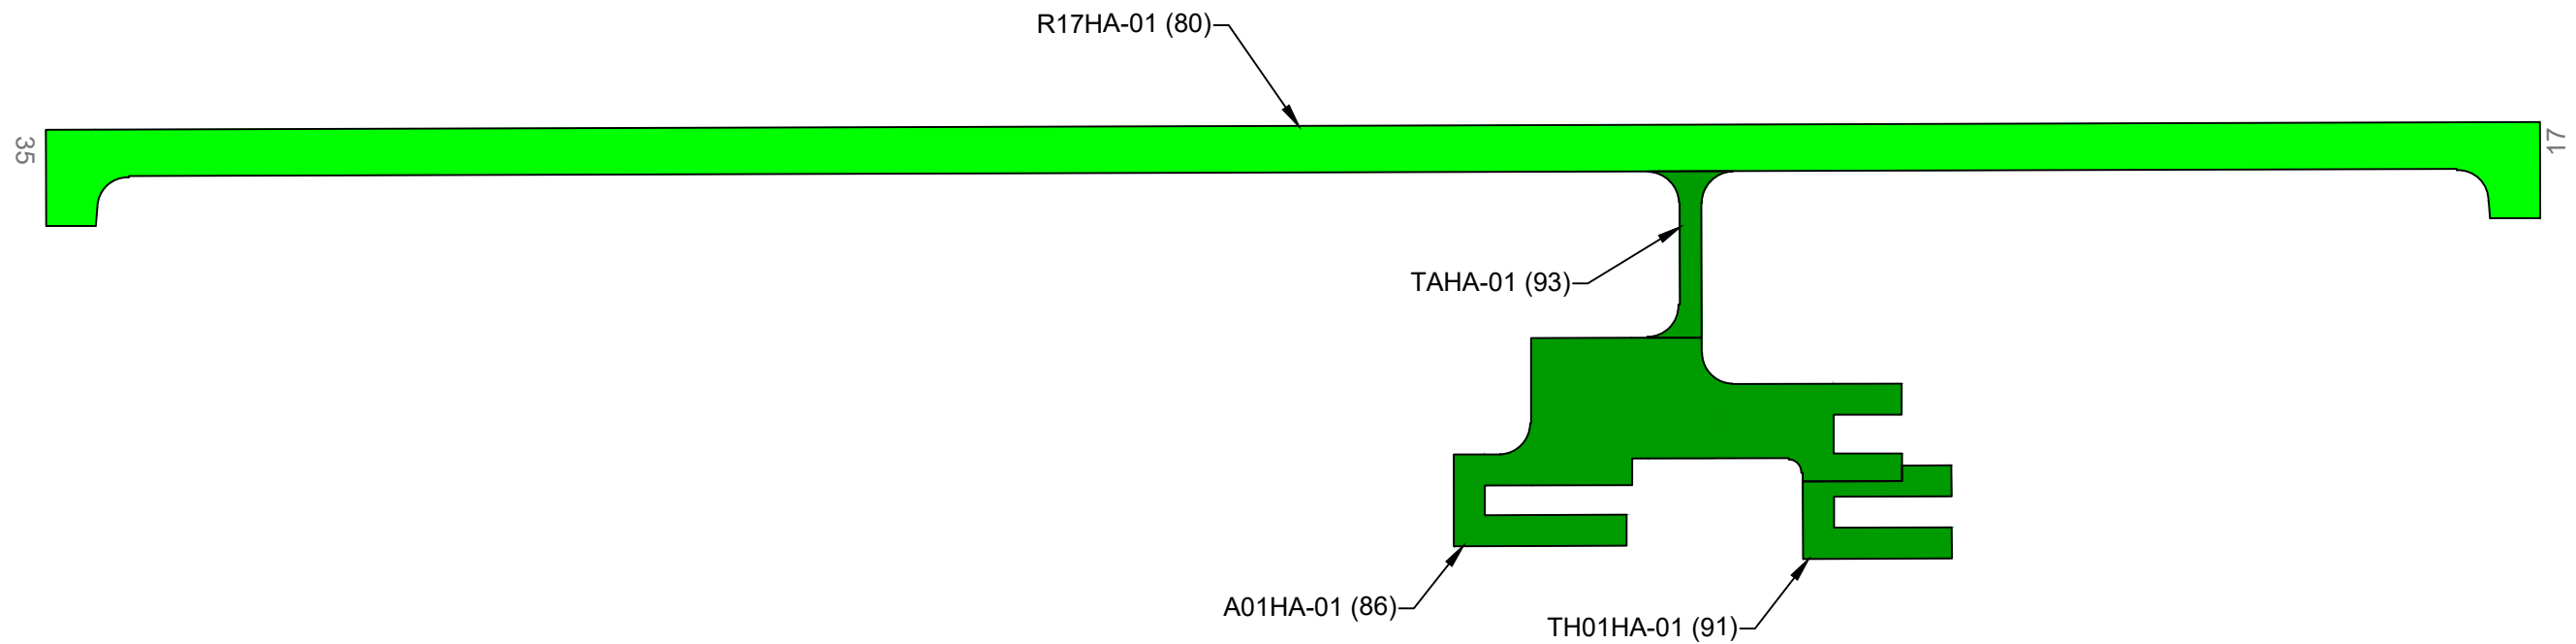
FIGURE 8. PCI MAP.

Figure 6 summarizes the overall condition of the pavements at Hampton Municipal Airport, and Figure 7 presents area-weighted condition (average PCI adjusted to account for the relative size of the pavement sections) by branch use. Figure 8 is a map that displays the condition of the evaluated pavements. Table 1 summarizes the results of the pavement evaluation. Appendix B presents photographs taken during the PCI inspection, and Appendix C contains detailed information on the distress types observed during the visual survey. Appendix D includes detailed work history information that was collected during the record review process.
