# Harlan Municipal Airport

## PAVEMENT MANAGEMENT REPORT

**JULY 2022**

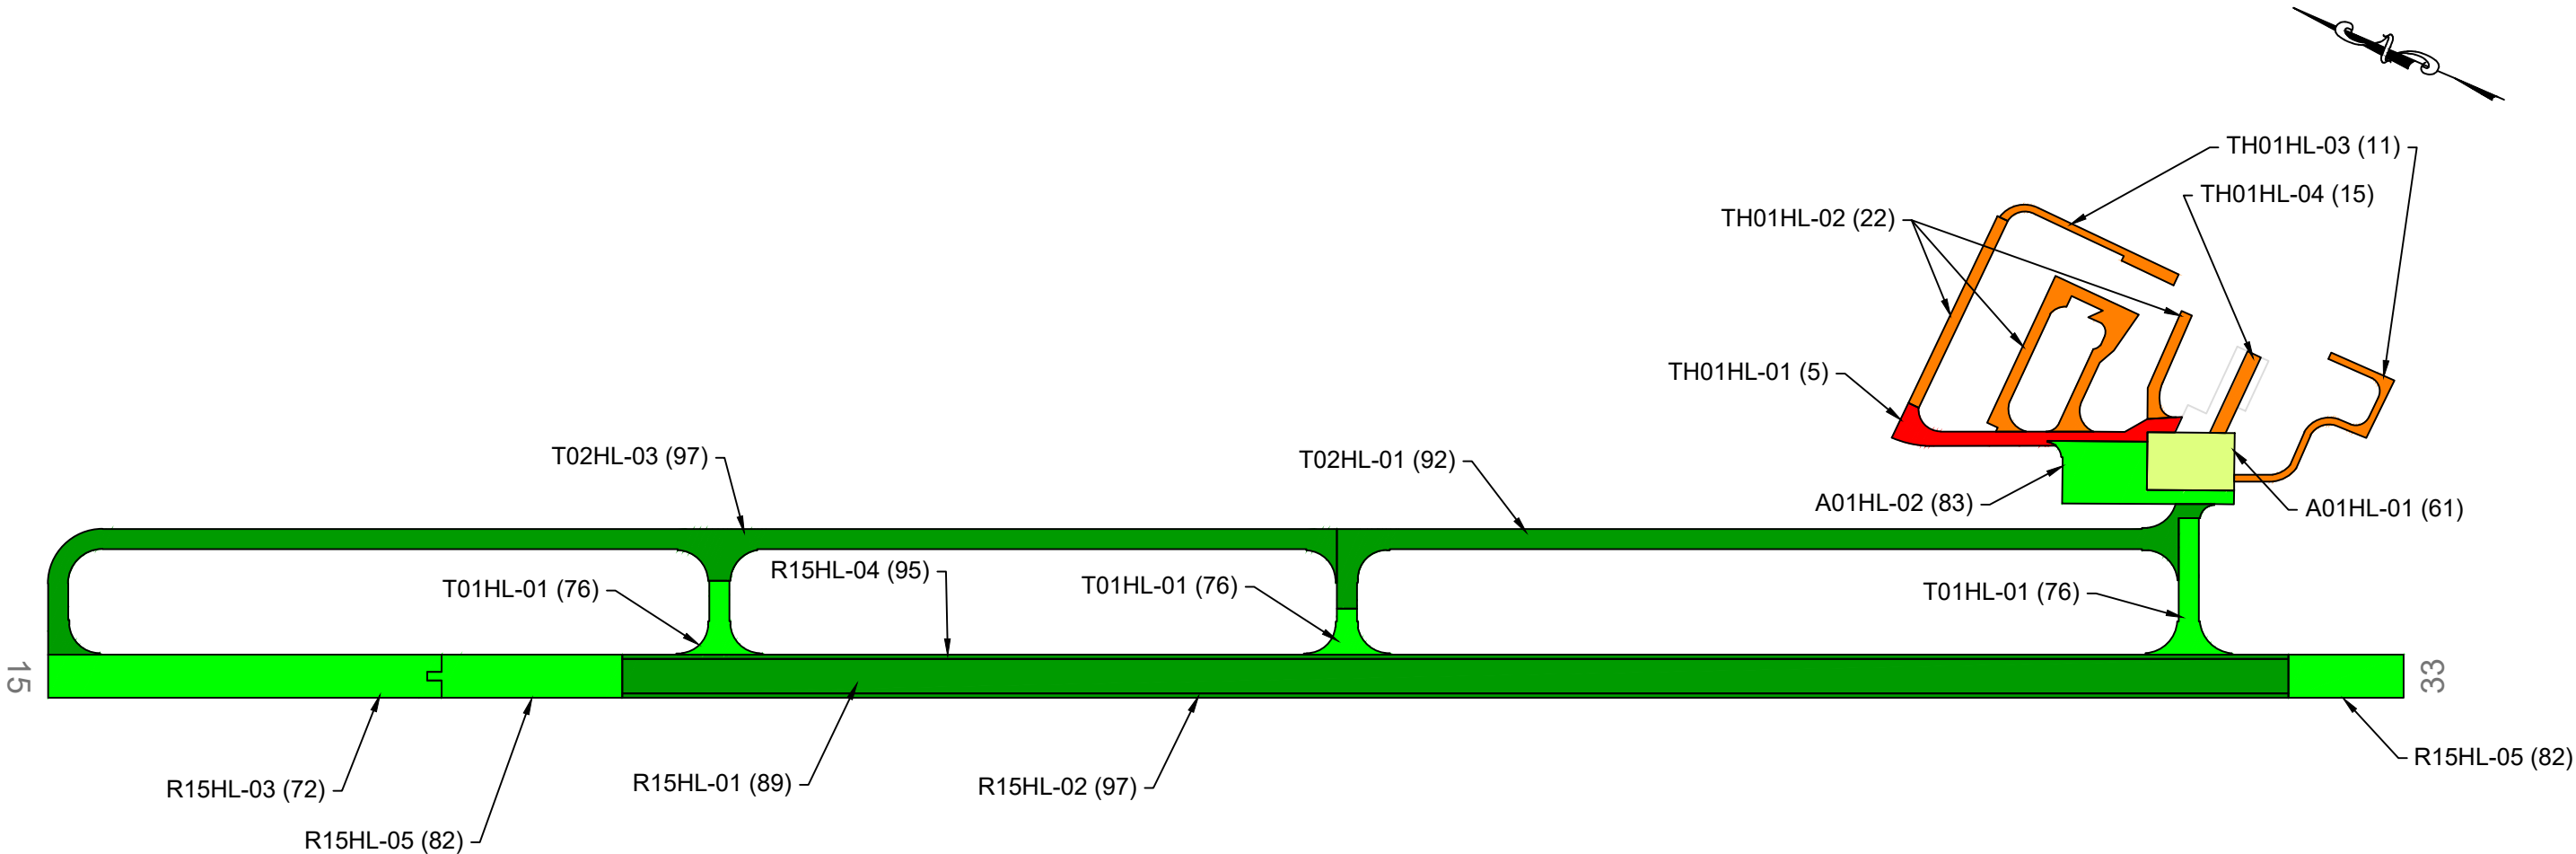
FIGURE 8. PCI MAP.

The pavements at Harlan Municipal Airport were inspected in November 2021. The 2021 area-weighted condition of Harlan Municipal Airport is 80, with conditions ranging from 5 to 97 (on a scale of 0 [failed] to 100 [excellent]). During the previous pavement inspection in 2018, the area-weighted PCI of the airport was 88.

Figure 6 summarizes the overall condition of the pavements at Harlan Municipal Airport, and Figure 7 presents area-weighted condition (average PCI adjusted to account for the relative size of the pavement sections) by branch use. Figure 8 is a map that displays the condition of the evaluated pavements. Table 1 summarizes the results of the pavement evaluation. Appendix B presents photographs taken during the PCI inspection, and Appendix C contains detailed information on the distress types observed during the visual survey. Appendix D includes detailed work history information that was collected during the record review process.

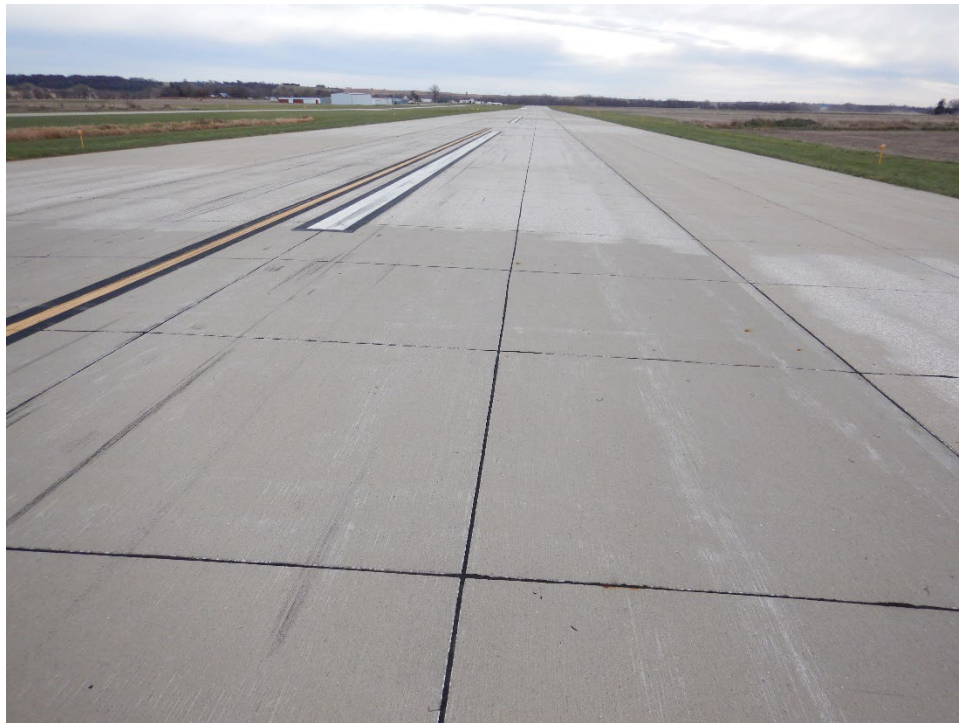
R15HL-01. Overview.

Runway 15/33 was defined by five sections. Section 01 contained low-severity alkali-silica reaction (ASR), corner spalling, joint spalling, faulting, and longitudinal, transverse and diagonal (LTD) cracking; all severities of joint seal damage; and shrinkage cracking. The suspected ASR was recorded in accordance with ASTM D5340-20. It should be noted that laboratory testing in the form of petrographic analysis is the only definitive way to validate the presence of ASR; however, the formation of a precipitate is evidence of a reaction consistent with this type of materials-related distress. Section 02 was in excellent condition with areas of low- and medium-severity joint seal damage and low-severity joint spalling recorded during the inspection. Low-severity corner break, all severities of faulting, medium- and high-severity joint seal damage, and low- and medium-severity LTD cracking were identified in Section 03. Areas of low- and medium-severity joint seal damage and low-severity joint spalling were noted in Section 04. Section 05 contained low-severity corner spalling, low- and medium-severity faulting and LTD cracking, and medium-severity joint seal damage.
