Humboldt Municipal Airport

Pavement Management Report

JULY 2023

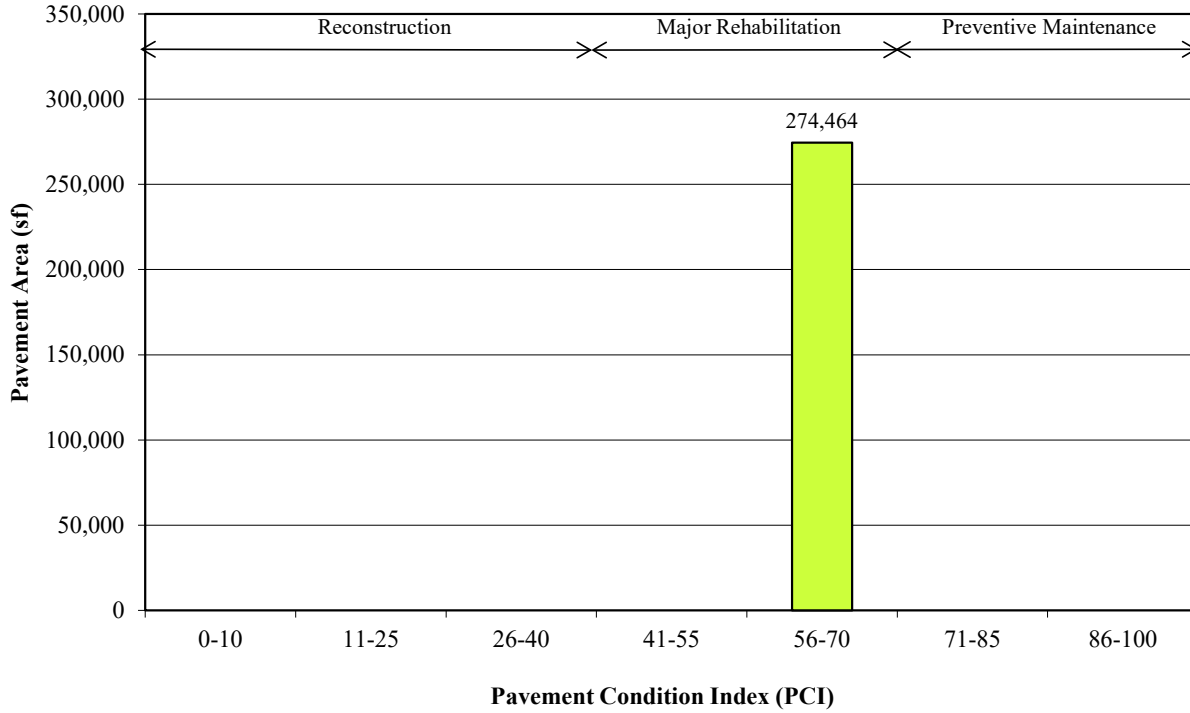
Figure 6. Pavement area by PCI range at Humboldt Municipal Airport.

The pavements at Humboldt Municipal Airport were inspected in November 2022. The 2022 area-weighted condition of Humboldt Municipal Airport is 58, with conditions ranging from 58 to 66 (on a scale of 0 [failed] to 100 [excellent]). During the previous pavement inspection in 2019, the area-weighted PCI of the airport was 53.

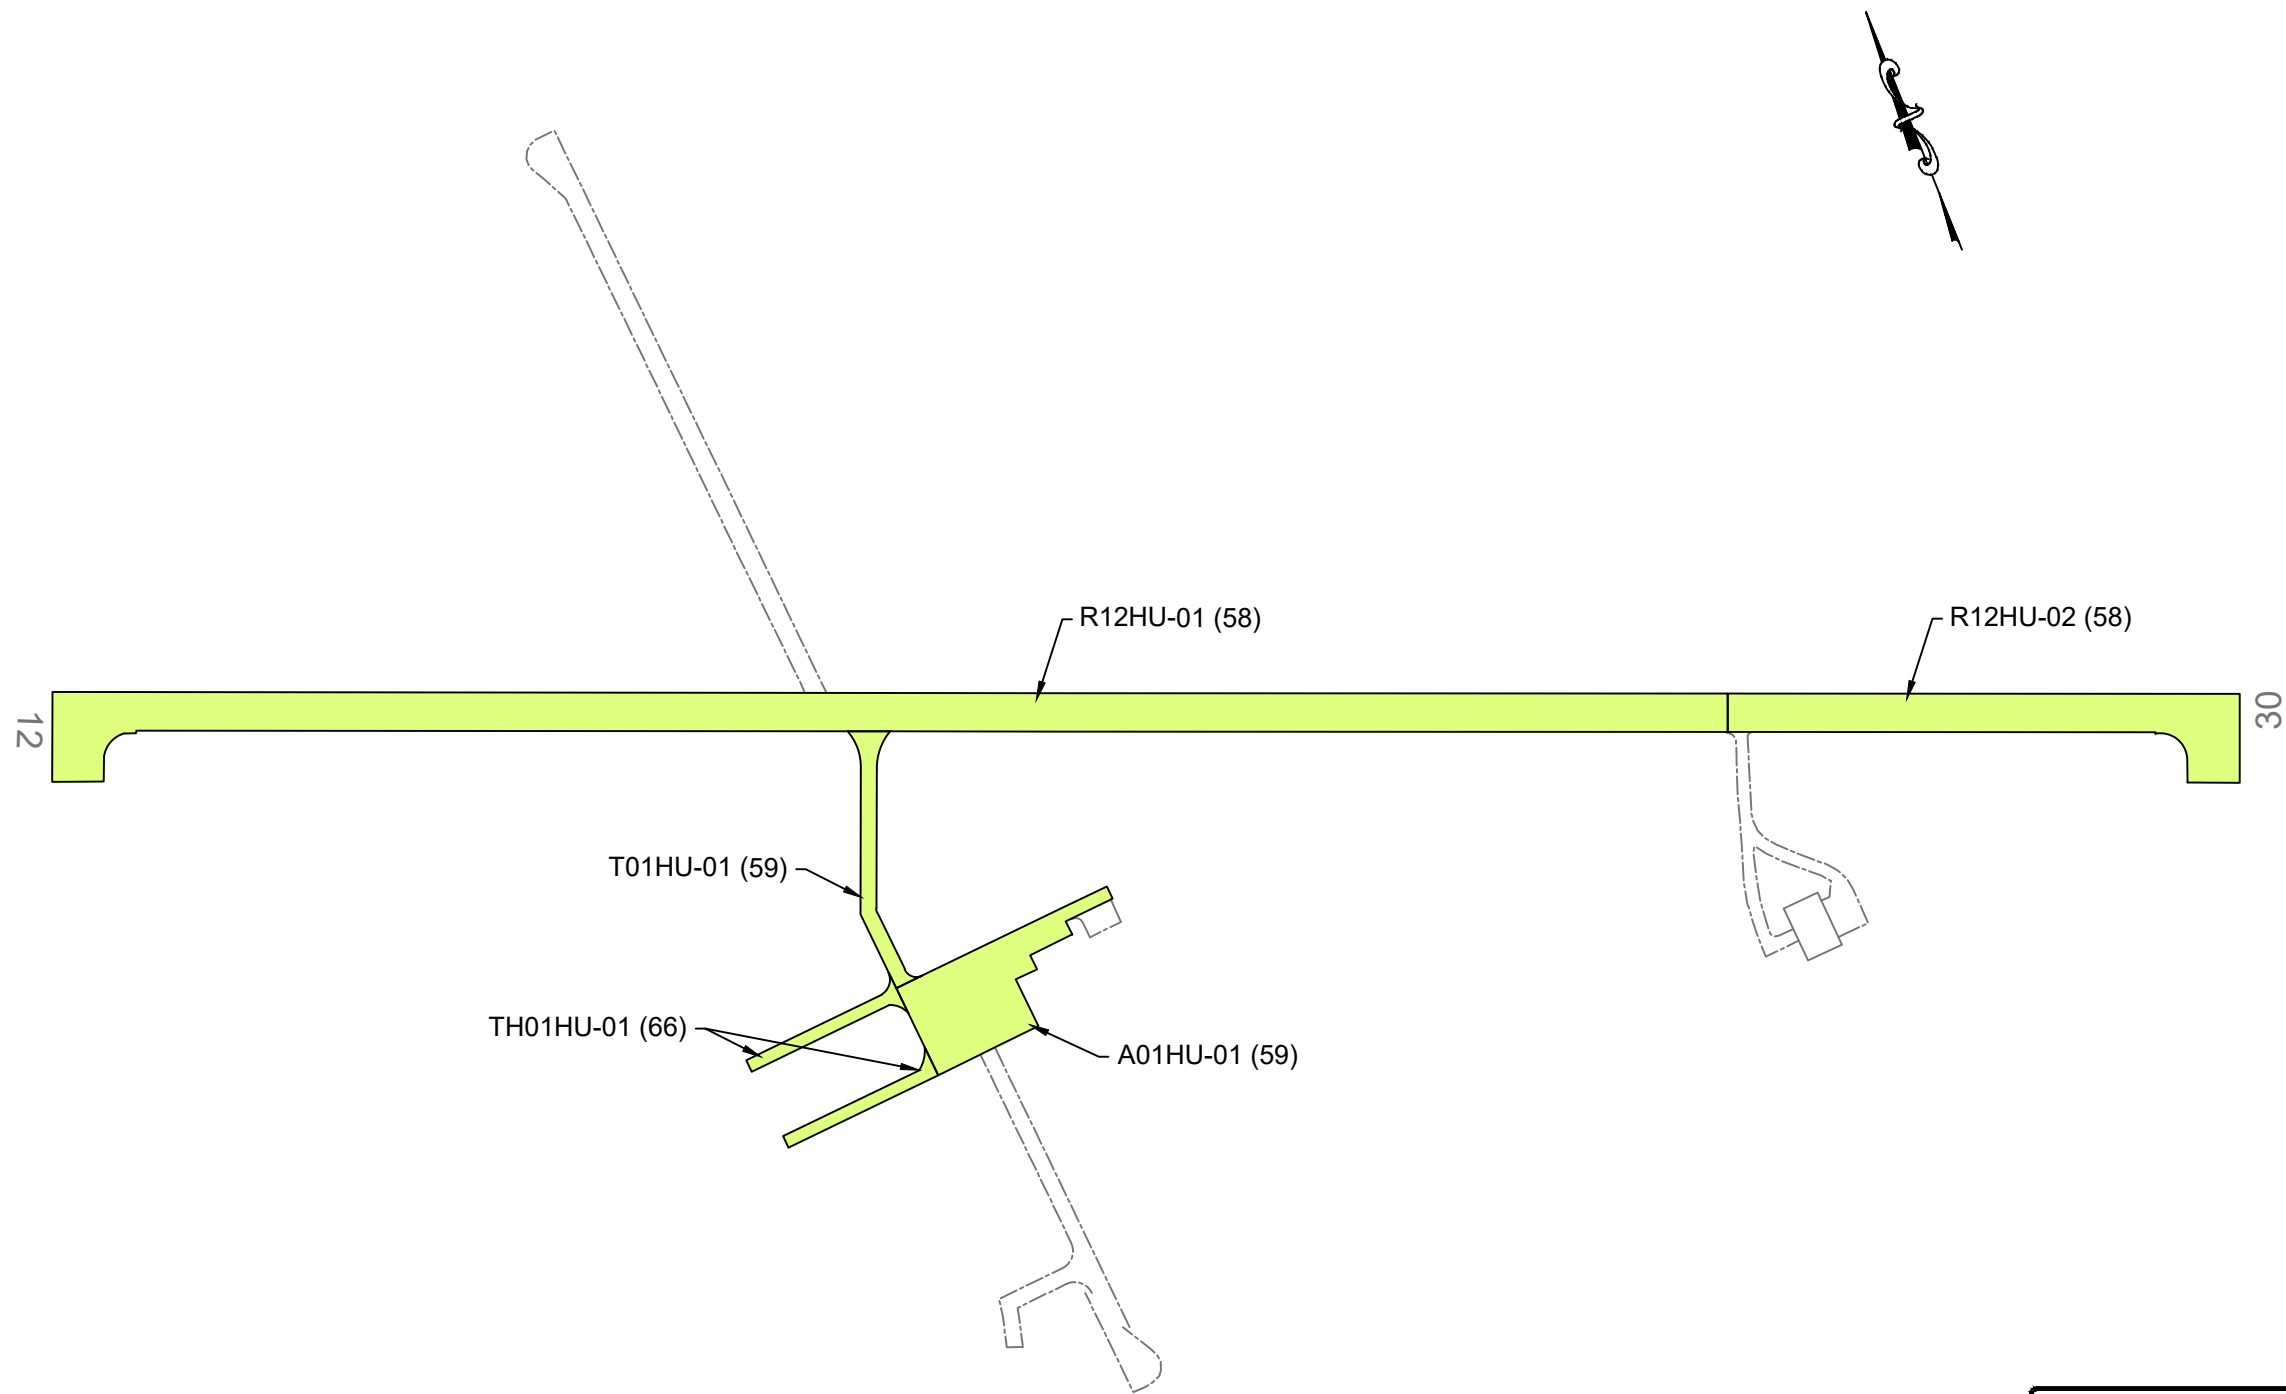
FIGURE 8. PCI MAP.

Figure 6 summarizes the overall condition of the pavements at Humboldt Municipal Airport, and Figure 7 presents area-weighted condition (average PCI adjusted to account for the relative size of the pavement sections) by branch use. Figure 8 is a map that displays the condition of the evaluated pavements. Table 1 summarizes the results of the pavement evaluation. Appendix B presents photographs taken during the PCI inspection, and Appendix C contains detailed information on the distress types observed during the visual survey. Appendix D includes detailed work history information that was collected during the record review process.
