Iowa Falls Municipal Airport

Pavement Management Report

JULY 2024

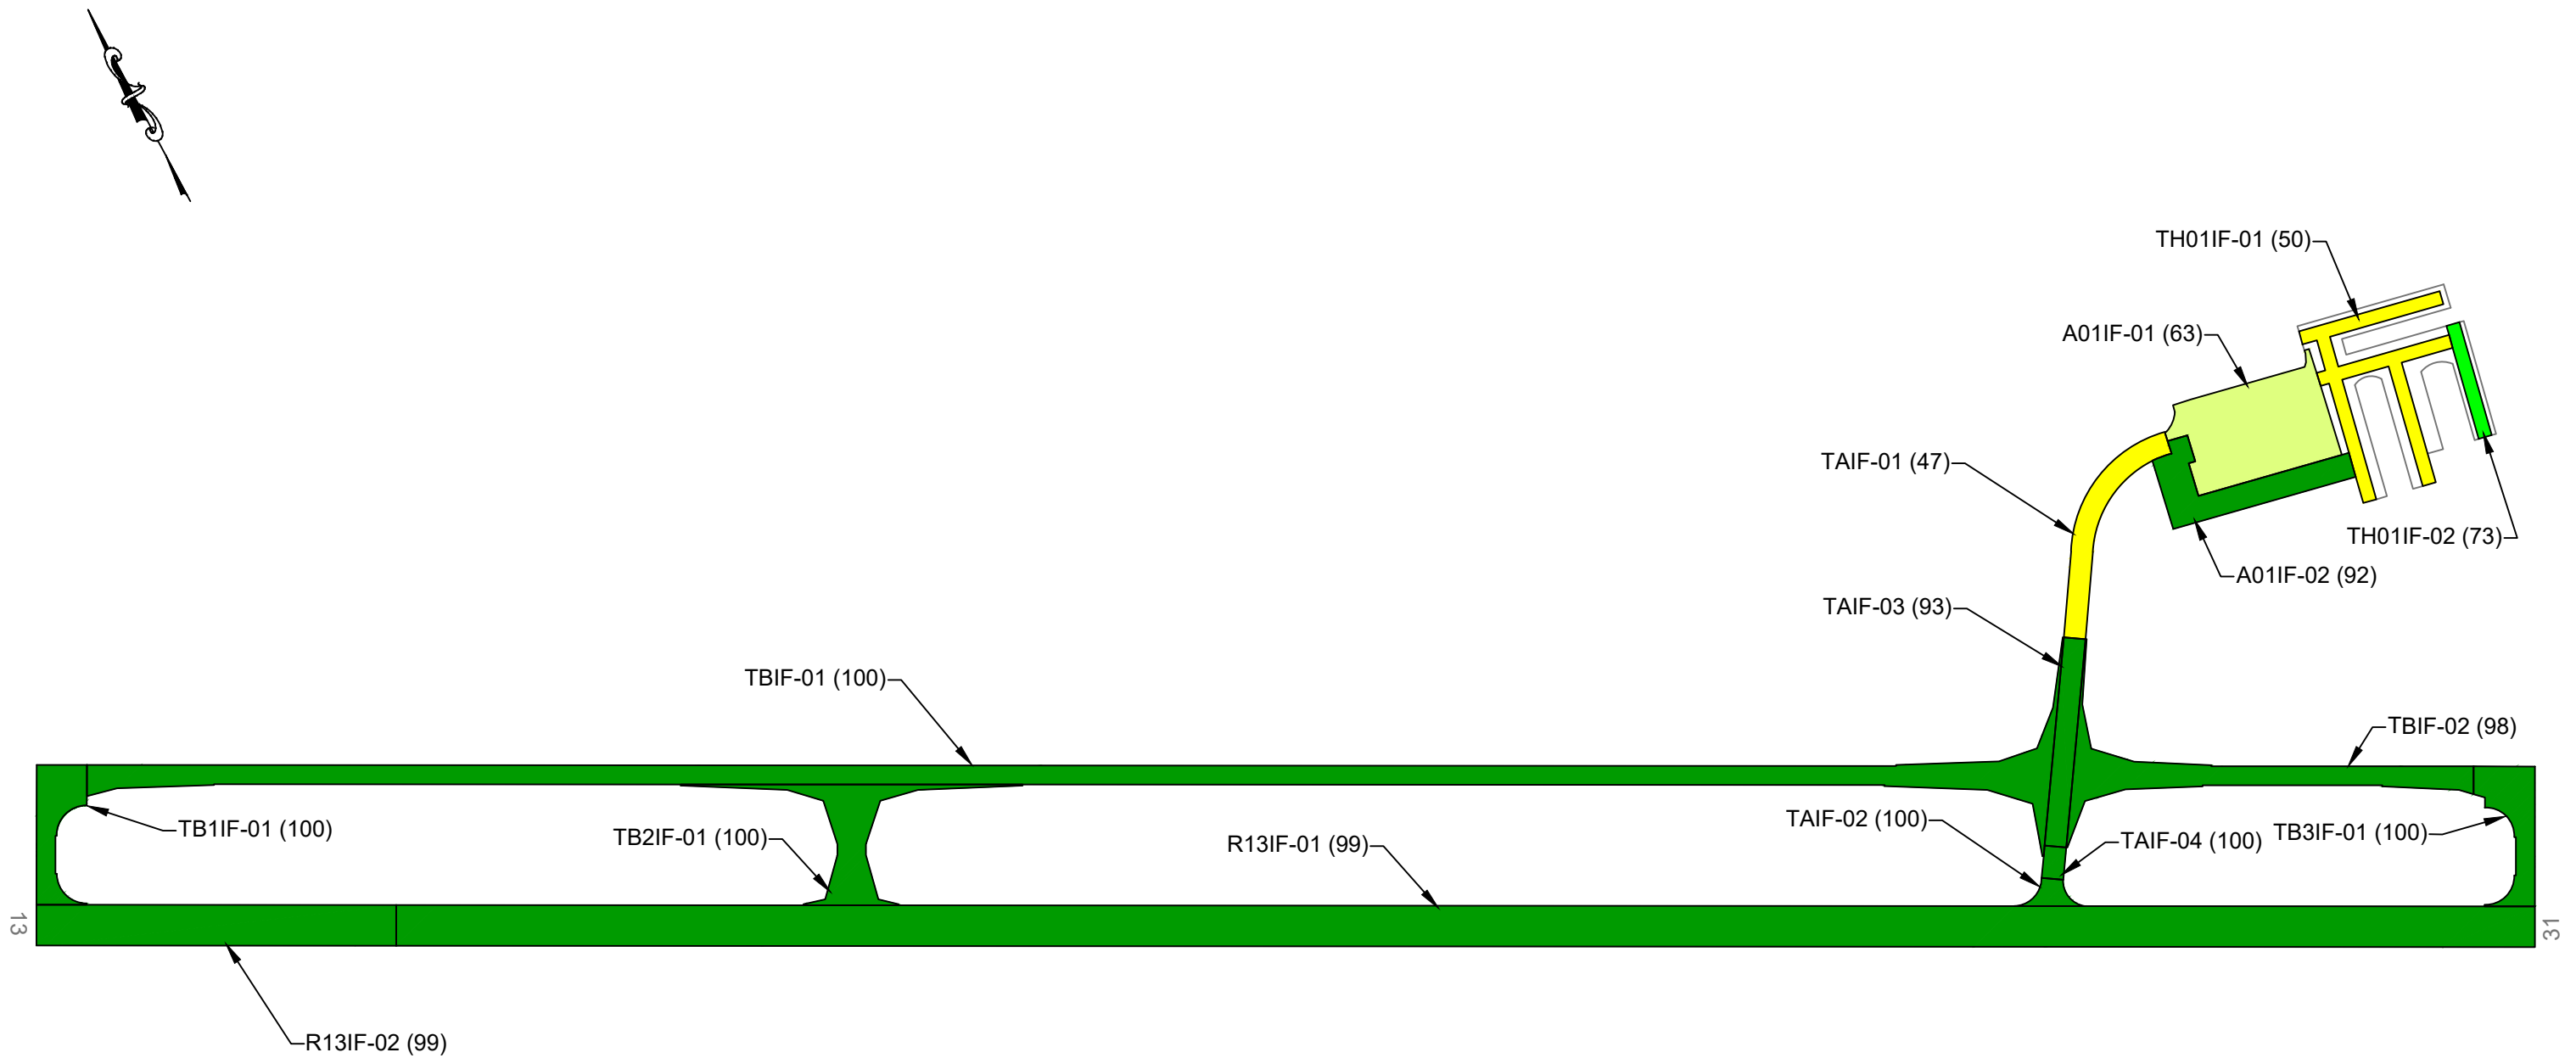
FIGURE 8. PCI MAP.

The pavements at Iowa Falls Municipal Airport were inspected in November 2023. The 2023 area-weighted condition of Iowa Falls Municipal Airport is 93, with conditions ranging from 47 to 100 (on a scale of 0 [failed] to 100 [excellent]). During the previous pavement inspection in 2020, the area-weighted PCI of the airport was 62.

Figure 6 summarizes the overall condition of the pavements at Iowa Falls Municipal Airport, and Figure 7 presents area-weighted condition (average PCI adjusted to account for the relative size of the pavement sections) by branch use. Figure 8 is a map that displays the condition of the evaluated pavements. Table 1 summarizes the results of the pavement evaluation. Appendix B presents photographs taken during the PCI inspection, and Appendix C contains detailed information on the distress types observed during the visual survey. Appendix D includes detailed work history information that was collected during the record review process.
