Keokuk Municipal Airport

Pavement Management Report

JULY 2024

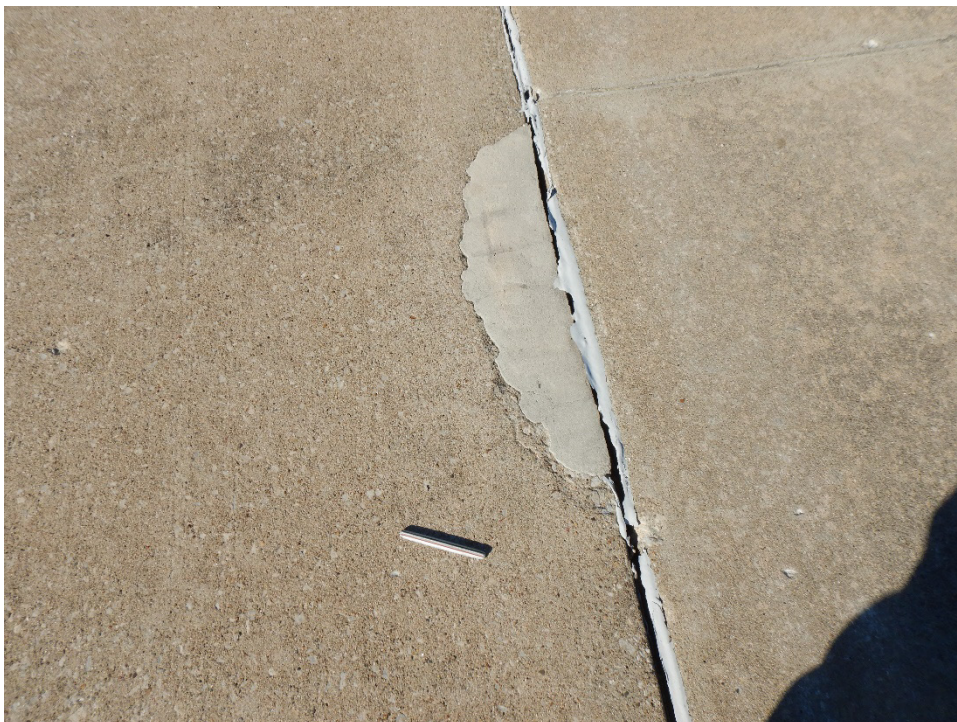
TBKE-01. Small Patching (Sample Unit No. 02).

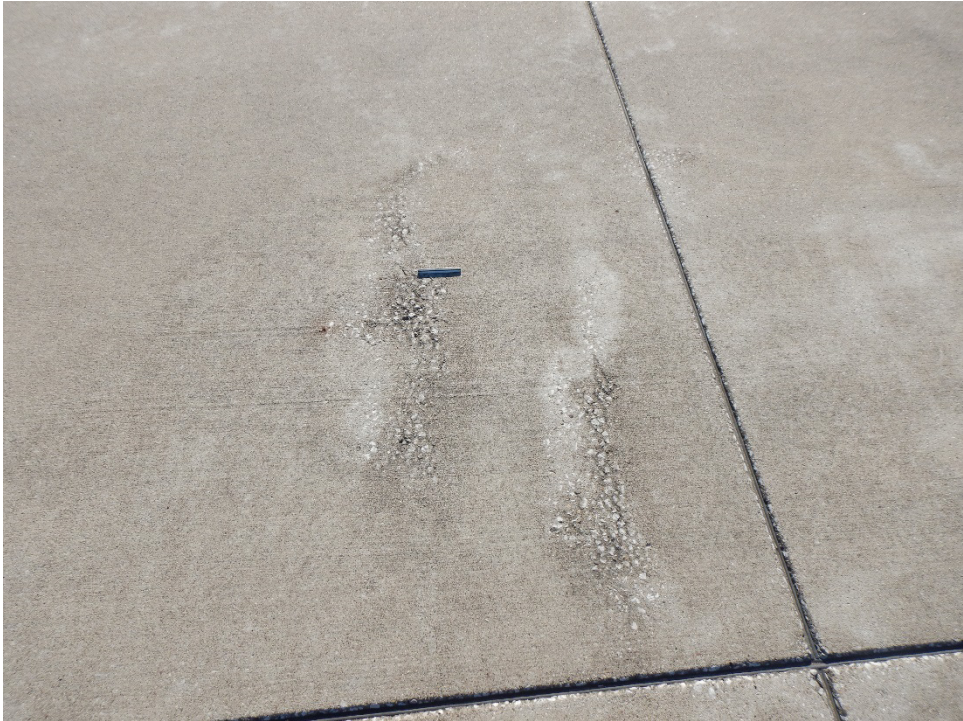
TCKE-01. Scaling (Sample Unit No. 02).

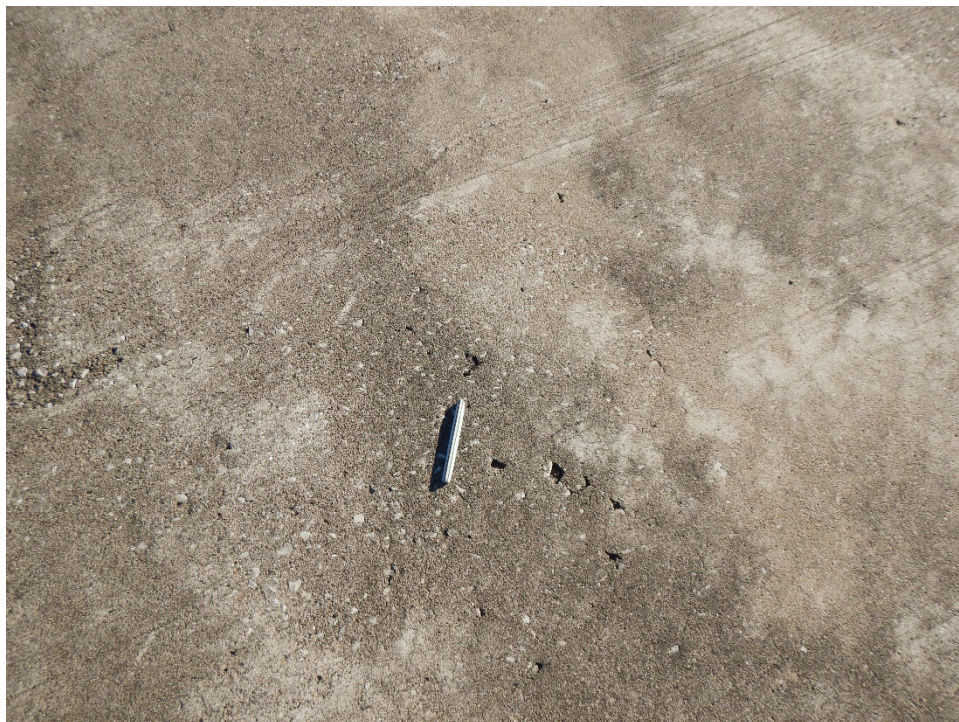
TCKE-03. Scaling (Sample Unit No. 02).
