# Knoxville Municipal Airport

**PAVEMENT MANAGEMENT REPORT**

**AUGUST 2019**

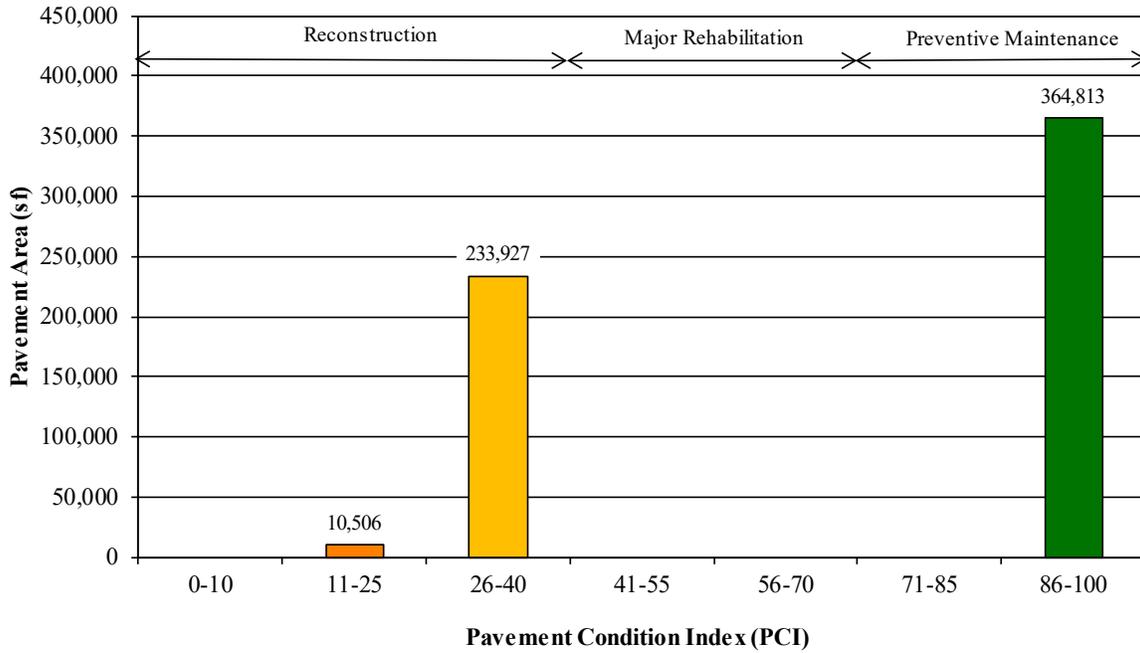
Figure 6. Pavement area by PCI range at Knoxville Municipal Airport.

The pavements at Knoxville Municipal Airport were inspected on November 13, 2018. The 2018 area-weighted condition of Knoxville Municipal Airport is 72, with conditions ranging from 16 to 99 (on a scale of 0 [failed] to 100 [excellent]). During the previous pavement inspection in 2014, the area-weighted PCI of the airport was 81.

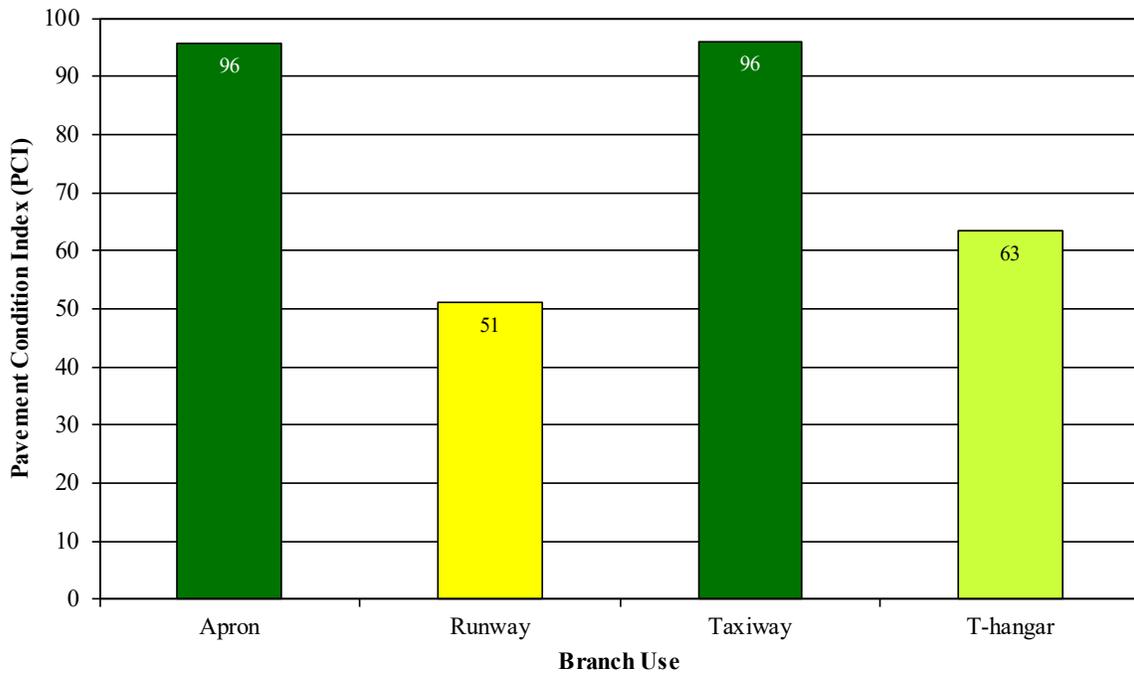
Figure 7. PCI by branch use at Knoxville Municipal Airport.

Figure 6 summarizes the overall condition of the pavements at Knoxville Municipal Airport, and Figure 7 presents area-weighted condition (average PCI adjusted to account for the relative size of the pavement sections) by branch use. Figure 8 is a map that displays the condition of the evaluated pavements. Table 1 summarizes the results of the pavement evaluation. Appendix B presents photographs taken during the PCI inspection, and Appendix C contains detailed information on the distresses observed during the visual survey. Appendix D includes detailed work history information that was collected during the record review process.
