# Knoxville Municipal Airport

## PAVEMENT MANAGEMENT REPORT

**JULY 2022**

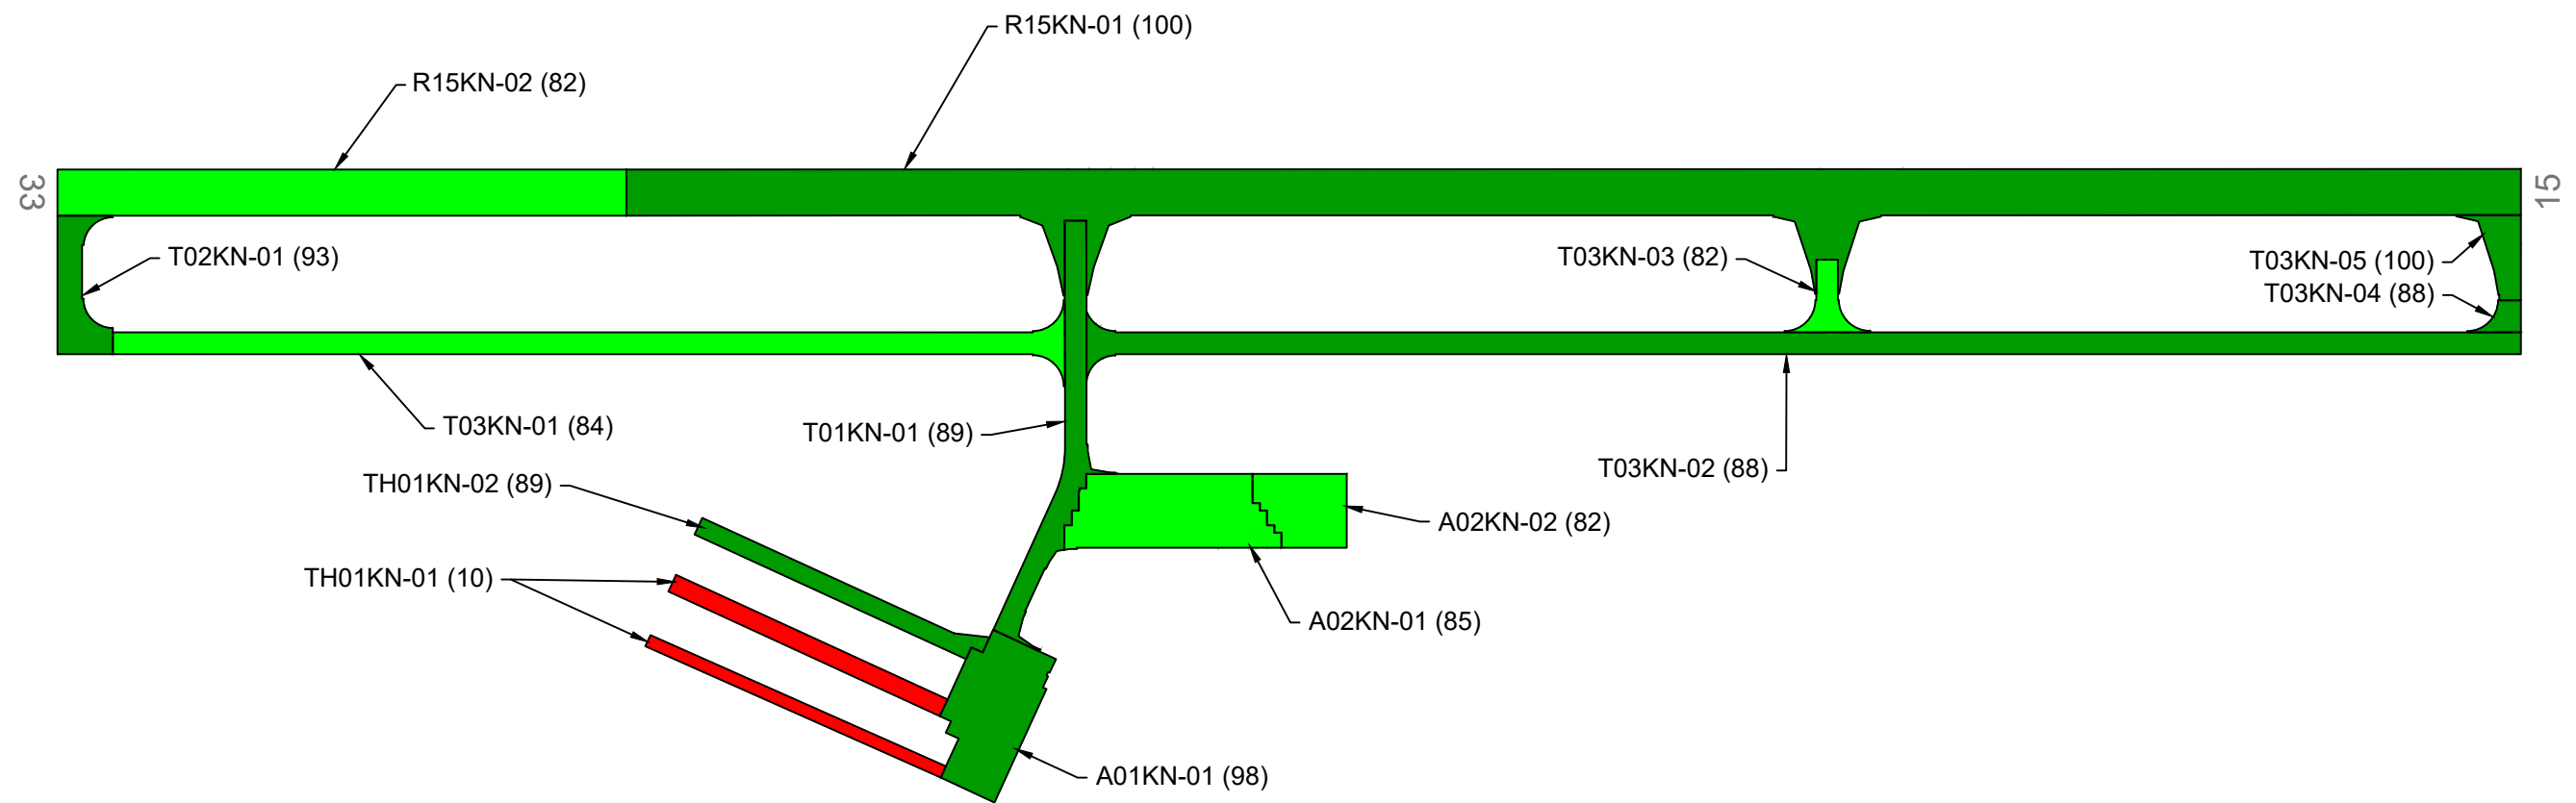
FIGURE 8. PCI MAP.

The pavements at Knoxville Municipal Airport were inspected in November 2021. The 2021 area-weighted condition of Knoxville Municipal Airport is 89, with conditions ranging from 10 to 100 (on a scale of 0 [failed] to 100 [excellent]). During the previous pavement inspection in 2018, the area-weighted PCI of the airport was 72.

Figure 6 summarizes the overall condition of the pavements at Knoxville Municipal Airport, and Figure 7 presents area-weighted condition (average PCI adjusted to account for the relative size of the pavement sections) by branch use. Figure 8 is a map that displays the condition of the evaluated pavements. Table 1 summarizes the results of the pavement evaluation. Appendix B presents photographs taken during the PCI inspection, and Appendix C contains detailed information on the distress types observed during the visual survey. Appendix D includes detailed work history information that was collected during the record review process.

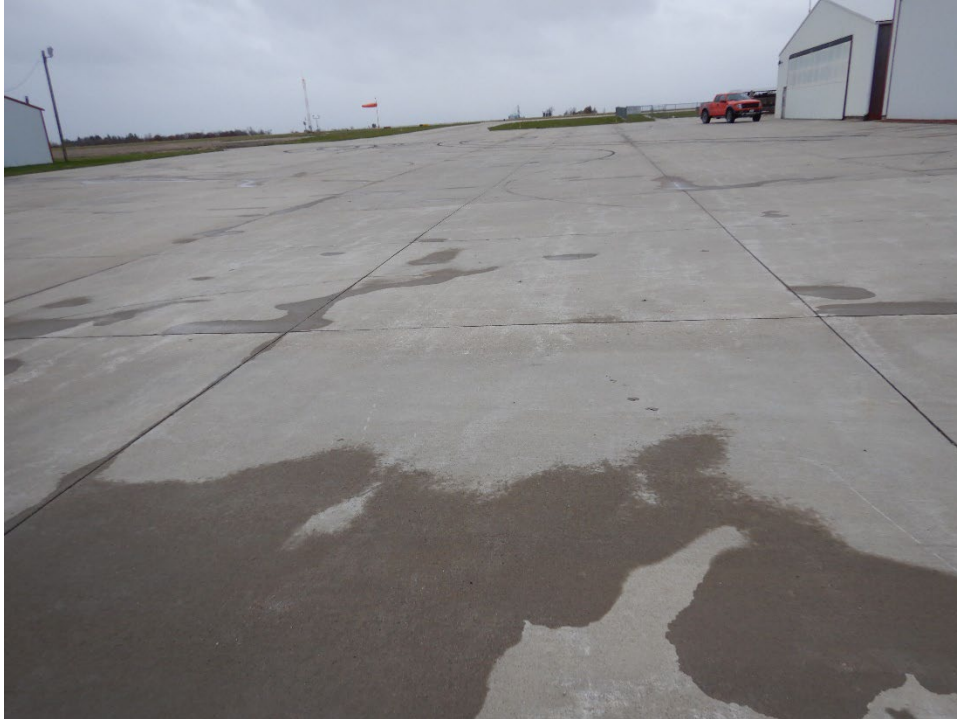
A01KN-01. Overview.

| Branch | Section | Surface Type | Section Area (sf) | LCD | 2021 PCI | % Distress Due to Load | % Distress Due to Climate/<br>Durability | % Distress Due to Other | Type of Distress |
|---|---|---|---|---|---|---|--|---|---|
| A01KN | 01 | PCC | 30,703 | 3/3/2015 | 98 | 76 | 0 | 24 | Joint Spalling, LTD Cracking, Shrinkage Cracking |

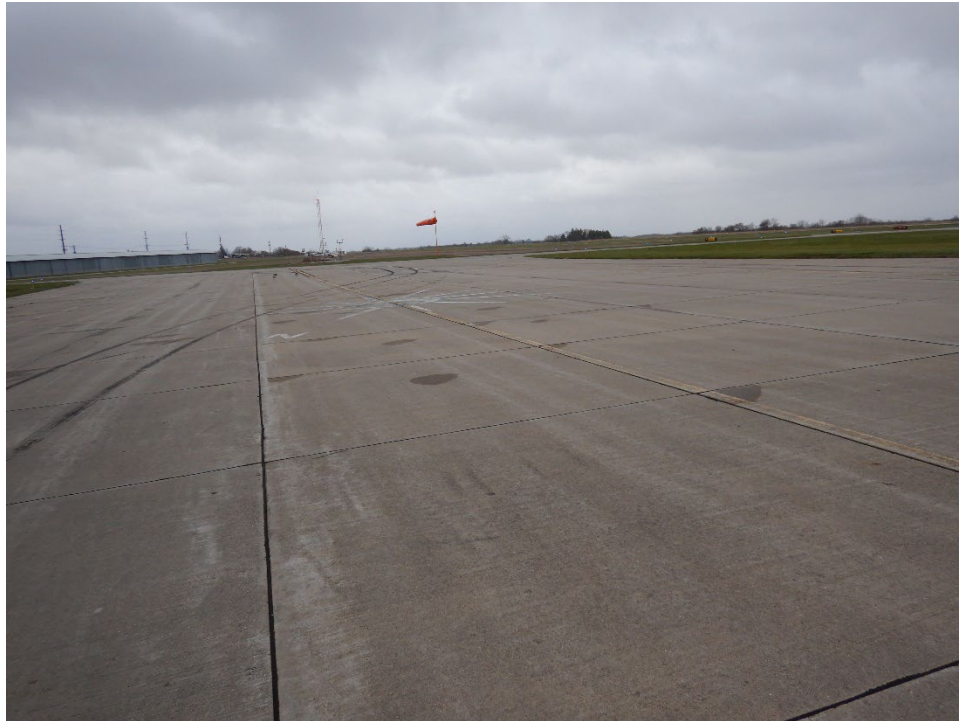
A02KN-01. Overview.

| Branch | Section | Surface Type | Section Area (sf) | LCD | 2021 PCI | % Distress Due to Load | % Distress Due to Climate/<br>Durability | % Distress Due to Other | Type of Distress |
|---|---|---|---|---|---|---|--|---|---|
| A02KN | 01 | PCC | 37,012 | 6/1/1991 | 85 | 14 | 44 | 42 | Corner Spalling, Faulting, Joint Spalling, Joint Seal Damage, LTD Cracking, Shrinkage Cracking |

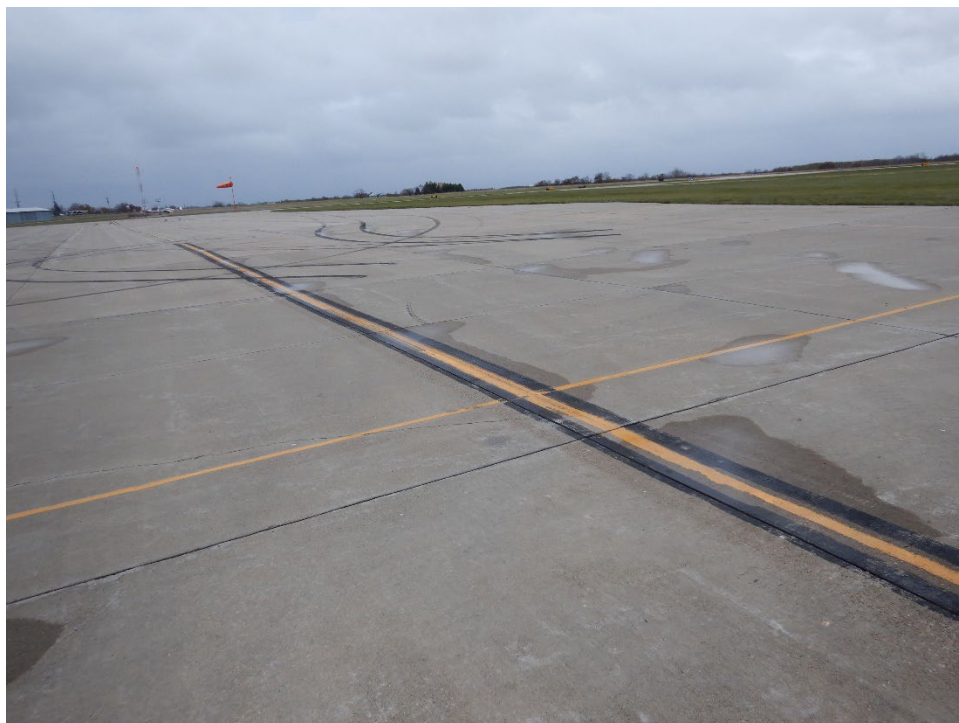
A02KN-02. Overview.

| Branch | Section | Surface Type | Section Area (sf) | LCD | 2021 PCI | % Distress Due to Load | % Distress Due to Climate/<br>Durability | % Distress Due to Other | Type of Distress |
|---|---|---|---|---|---|---|--|---|---|
| A02KN | 02 | PCC | 16,055 | 1/3/2012 | 82 | 67 | 30 | 3 | Corner Break, Joint Spalling, Joint Seal Damage, LTD Cracking, Shattered Slab, Shrinkage Cracking |

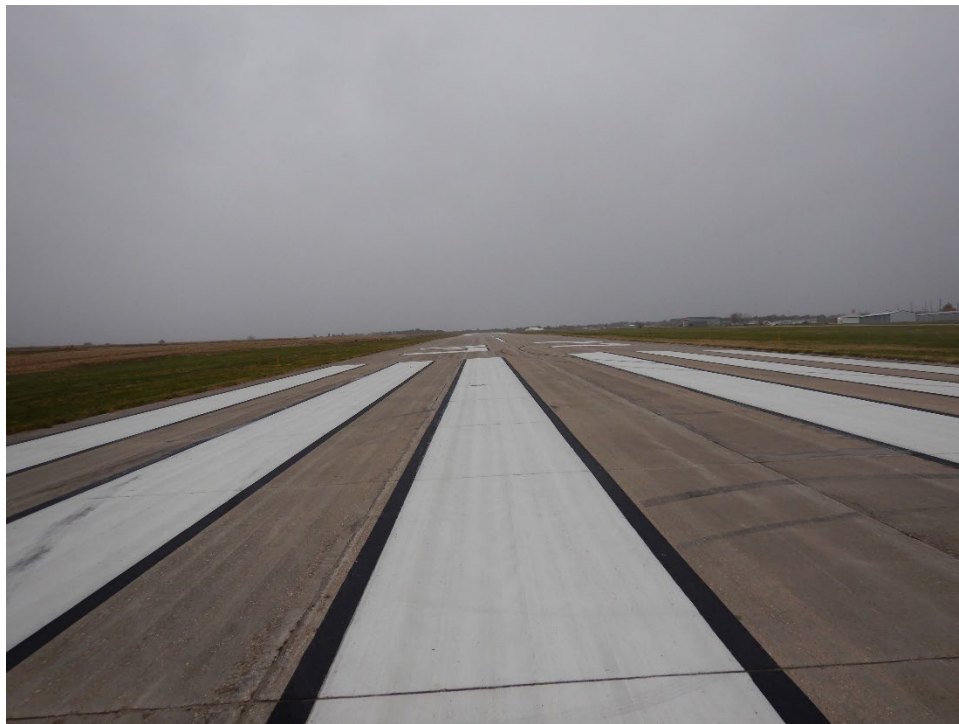
R15KN-02. Overview.

| Branch | Section | Surface Type | Section Area (sf) | LCD | 2021 PCI | % Distress Due to Load | % Distress Due to Climate/<br>Durability | % Distress Due to Other | Type of Distress |
|---|---|---|---|---|---|---|--|---|---|
| R15KN | 02 | PCC | 69,339 | 6/30/1990 | 82 | 9 | 0 | 91 | Corner Spalling, Faulting, Joint Spalling, LTD Cracking, Shrinkage Cracking, Small Patch |

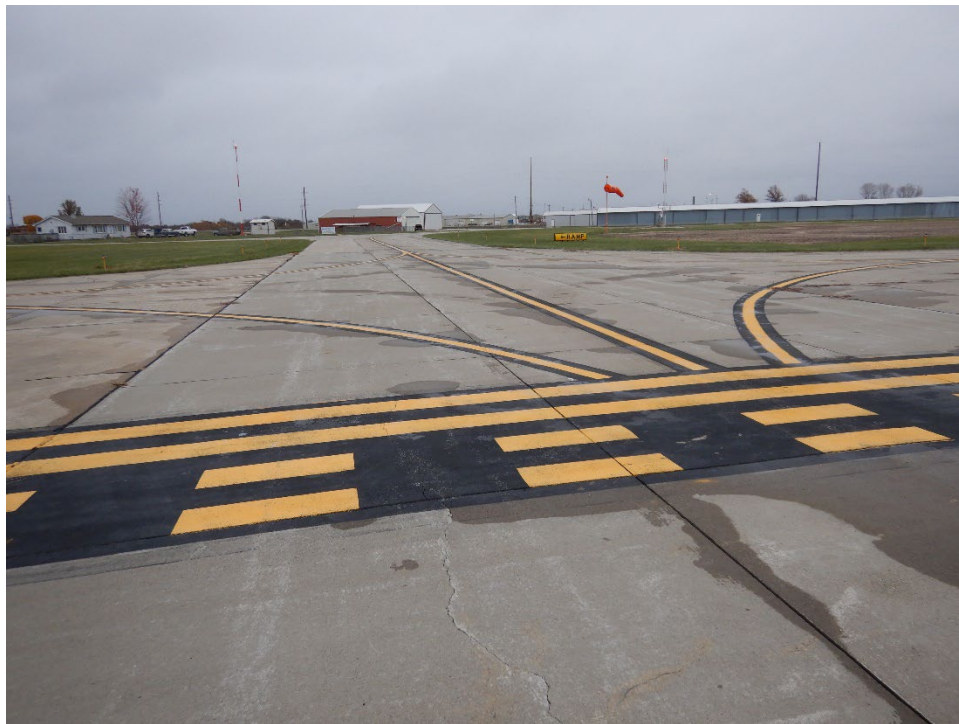
T01KN-01. Overview.

| Branch | Section | Surface Type | Section Area (sf) | LCD | 2021 PCI | % Distress Due to Load | % Distress Due to Climate/<br>Durability | % Distress Due to Other | Type of Distress |
|---|---|---|---|---|---|---|--|---|---|
| T01KN | 01 | PCC | 26,202 | 3/3/2015 | 89 | 64 | 15 | 21 | Joint Spalling, Joint Seal Damage, LTD Cracking, Shrinkage Cracking, Small Patch |

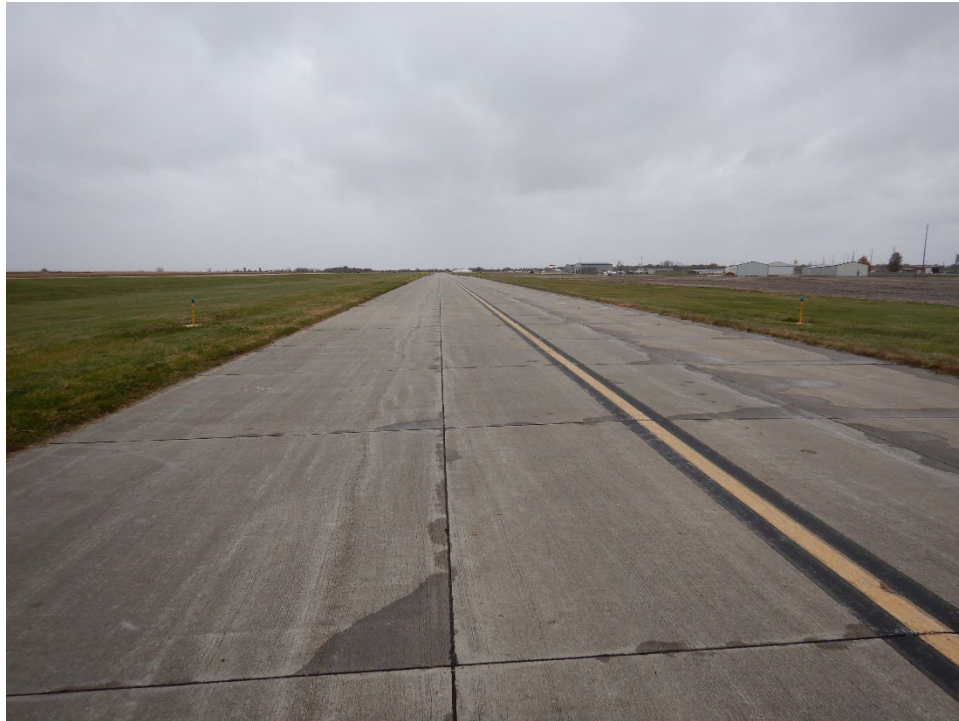
T03KN-01. Overview.

| Branch | Section | Surface Type | Section Area (sf) | LCD | 2021 PCI | % Distress Due to Load | % Distress Due to Climate/<br>Durability | % Distress Due to Other | Type of Distress |
|---|---|---|---|---|---|---|--|---|---|
| T03KN | 01 | PCC | 56,546 | 6/4/1991 | 84 | 47 | 34 | 19 | ASR, Corner Break, Corner Spalling, Joint Spalling, Joint Seal Damage, LTD Cracking |

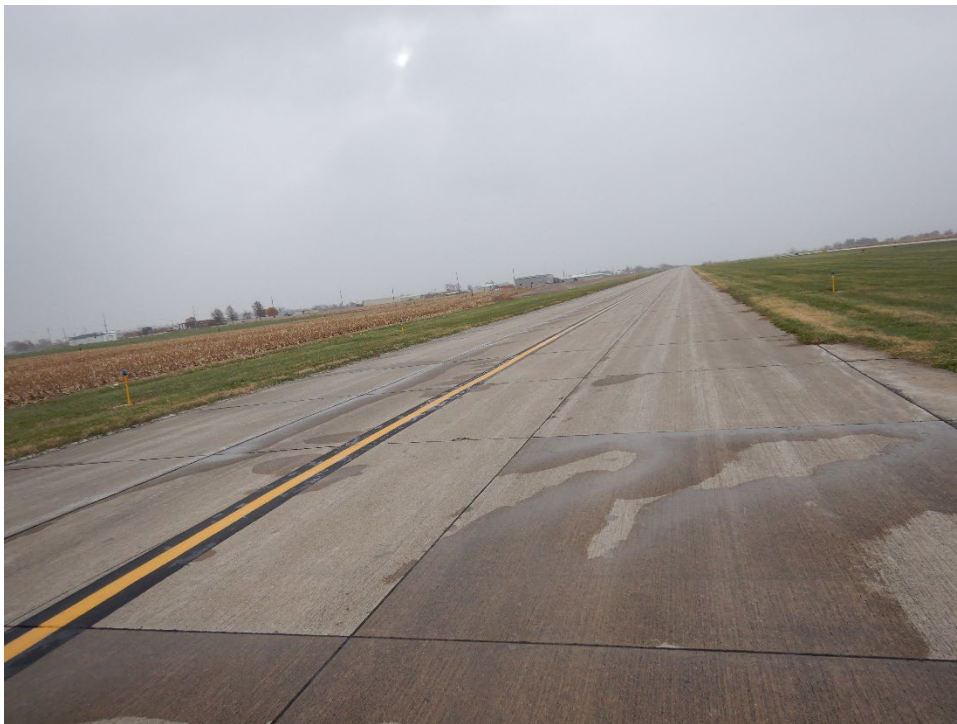
T03KN-02. Overview.

| Branch | Section | Surface Type | Section Area (sf) | LCD | 2021 PCI | % Distress Due to Load | % Distress Due to Climate/<br>Durability | % Distress Due to Other | Type of Distress |
|---|---|---|---|---|---|---|--|---|---|
| T03KN | 02 | PCC | 83,867 | 6/3/1994 | 88 | 0 | 49 | 51 | ASR, Corner Spalling, Faulting, Joint Seal Damage, Small Patch |

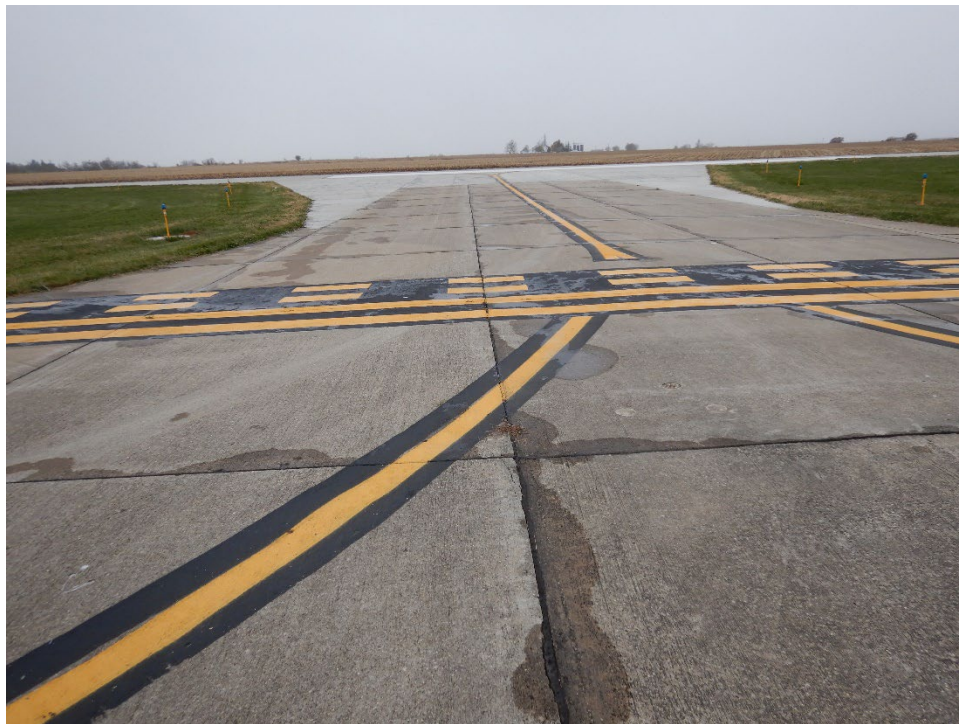
T03KN-03. Overview.

| Branch | Section | Surface Type | Section Area (sf) | LCD | 2021 PCI | % Distress Due to Load | % Distress Due to Climate/<br>Durability | % Distress Due to Other | Type of Distress |
|---|---|---|---|---|---|---|--|---|---|
| T03KN | 03 | PCC | 5,570 | 6/30/1991 | 82 | 0 | 78 | 22 | Durability Cracking, Faulting, Joint Seal Damage, Large Patch |

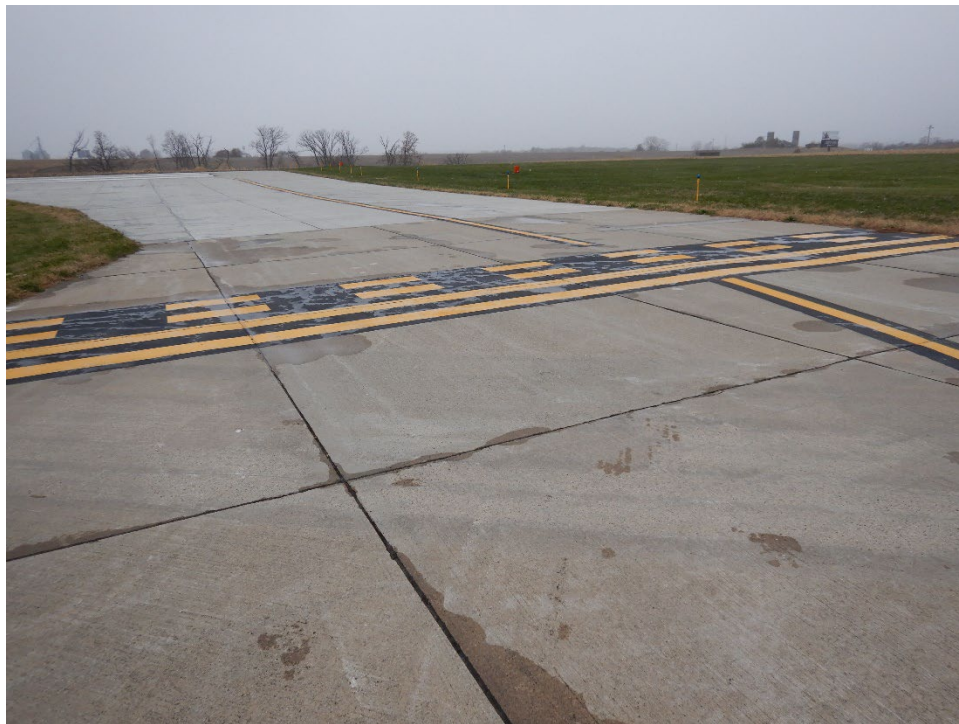
T03KN-04. Overview.

| Branch | Section | Surface Type | Section Area (sf) | LCD | 2021 PCI | % Distress Due to Load | % Distress Due to Climate/<br>Durability | % Distress Due to Other | Type of Distress |
|---|---|---|---|---|---|---|--|---|---|
| T03KN | 04 | PCC | 2,585 | 6/1/1991 | 88 | 0 | 100 | 0 | Durability Cracking, Joint Seal Damage |

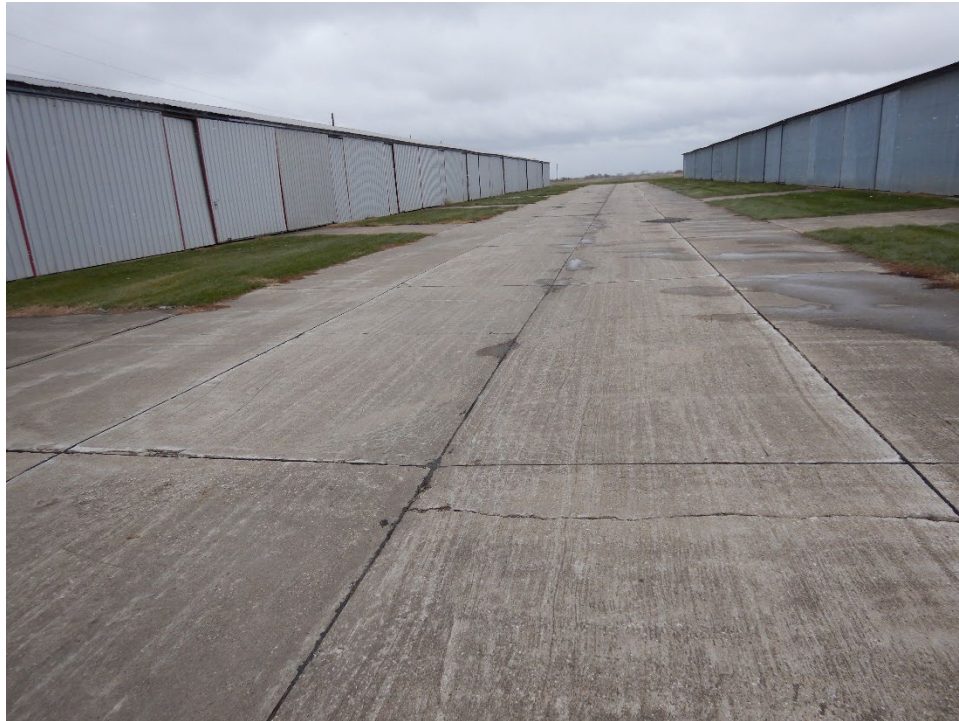
TH01KN-01. Overview.

| Branch | Section | Surface Type | Section Area (sf) | LCD | 2021 PCI | % Distress Due to Load | % Distress Due to Climate/<br>Durability | % Distress Due to Other | Type of Distress |
|---|---|---|---|---|---|---|--|---|---|
| TH01KN | 01 | PCC | 24,950 | 1/1/1967 | 10 | 41 | 9 | 50 | ASR, Corner Break, Joint Spalling, Joint Seal Damage, Large Patch, LTD Cracking, Shattered Slab |

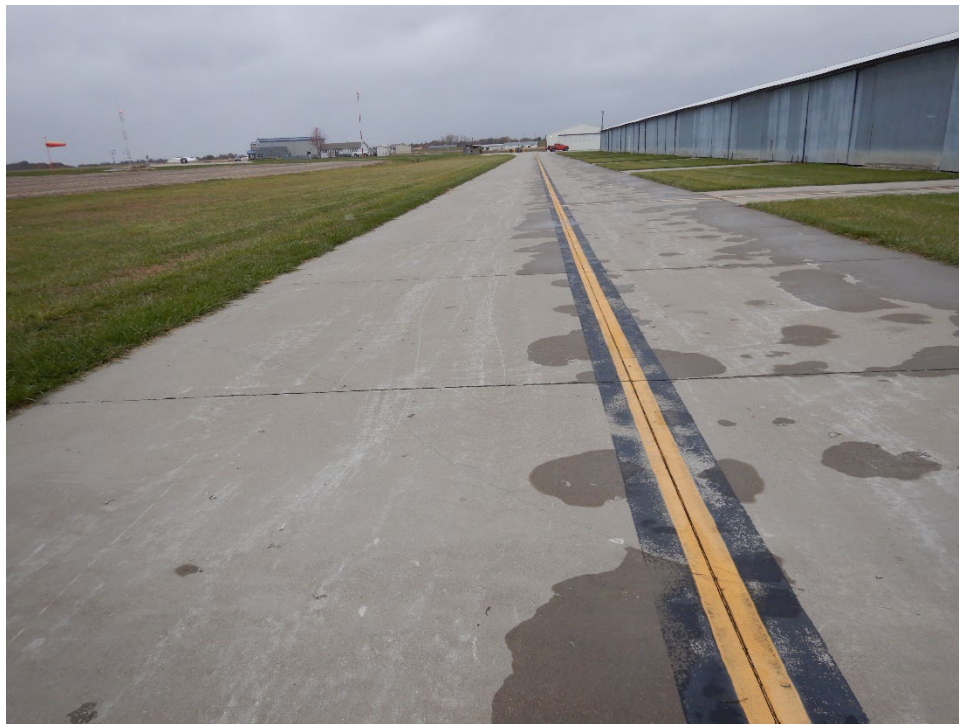
TH01KN-02. Overview.

| Branch | Section | Surface Type | Section Area (sf) | LCD | 2021 PCI | % Distress Due to Load | % Distress Due to Climate/Durability | % Distress Due to Other | Type of Distress |
|---|---|---|---|---|---|---|---|---|---|
| TH01KN | 02 | PCC | 15,227 | 1/1/2016 | 89 | 50 | 50 | 0 | Corner Break, Joint Seal Damage, LTD Cracking |
