# Lamoni Municipal Airport

**PAVEMENT MANAGEMENT REPORT**

**AUGUST 2019**

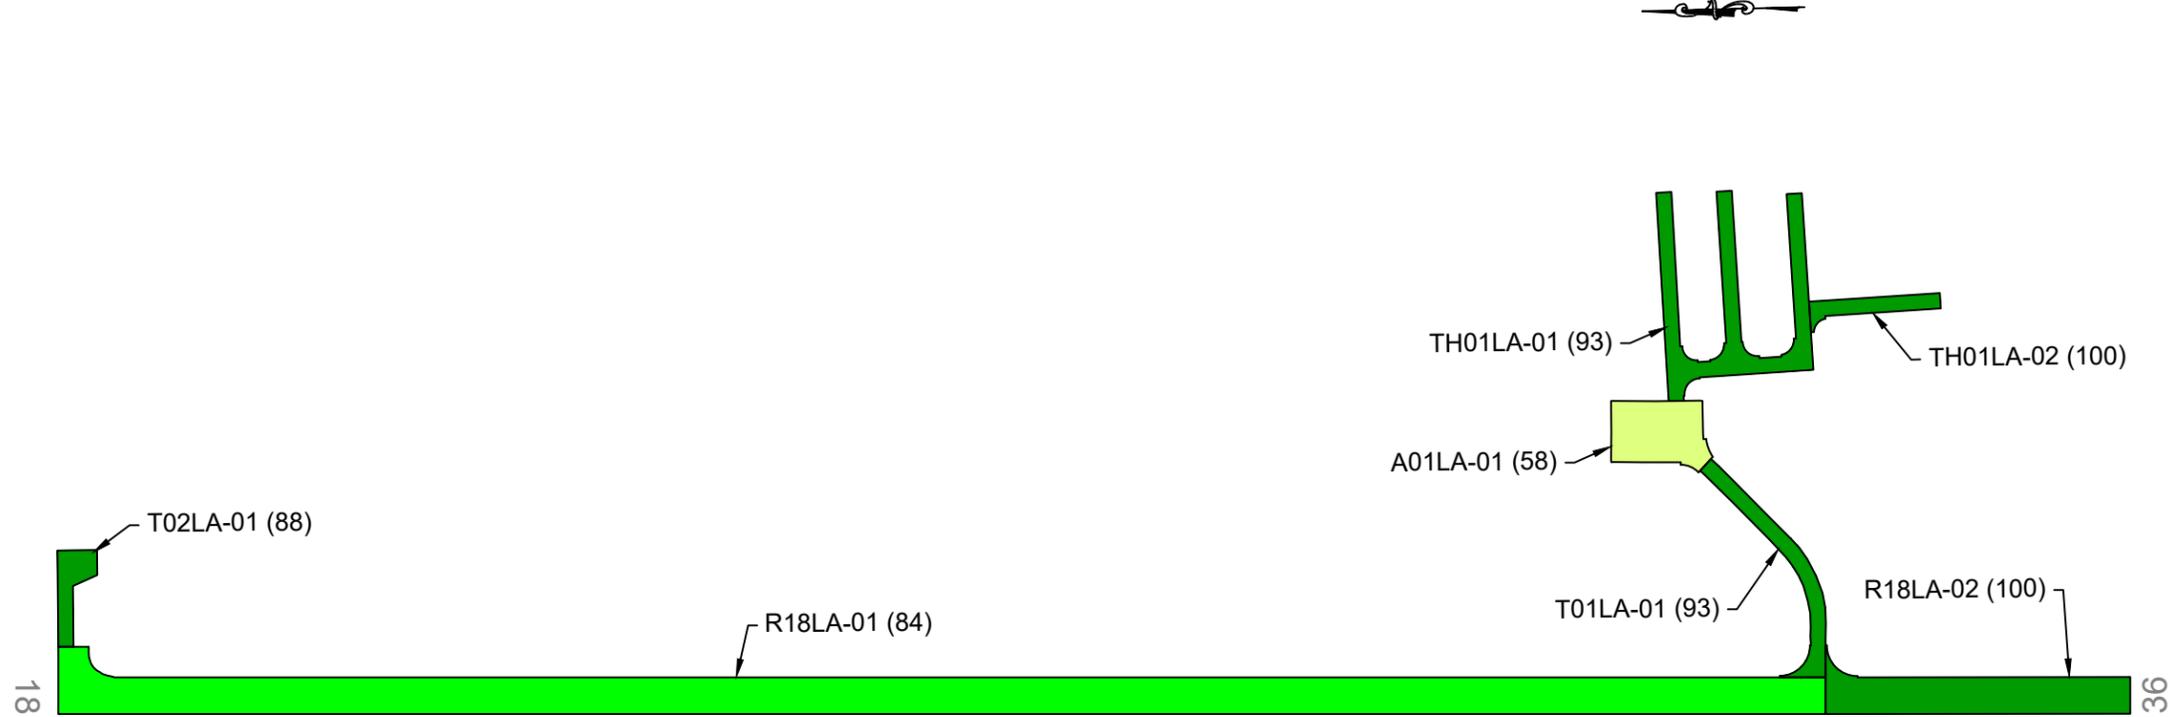
FIGURE 8. PCI MAP.

The pavements at Lamoni Municipal Airport were inspected on December 2, 2018. The 2018 area-weighted condition of Lamoni Municipal Airport is 86, with conditions ranging from 58 to 100 (on a scale of 0 [failed] to 100 [excellent]). During the previous pavement inspection in 2014, the area-weighted PCI of the airport was 94.
