LE MARS MUNICIPAL AIRPORT PAVEMENT MANAGEMENT REPORT

Prepared For:
Iowa Department of Transportation
Office of Aviation

Prepared By:
Applied Pavement Technology, Inc.

April 2016

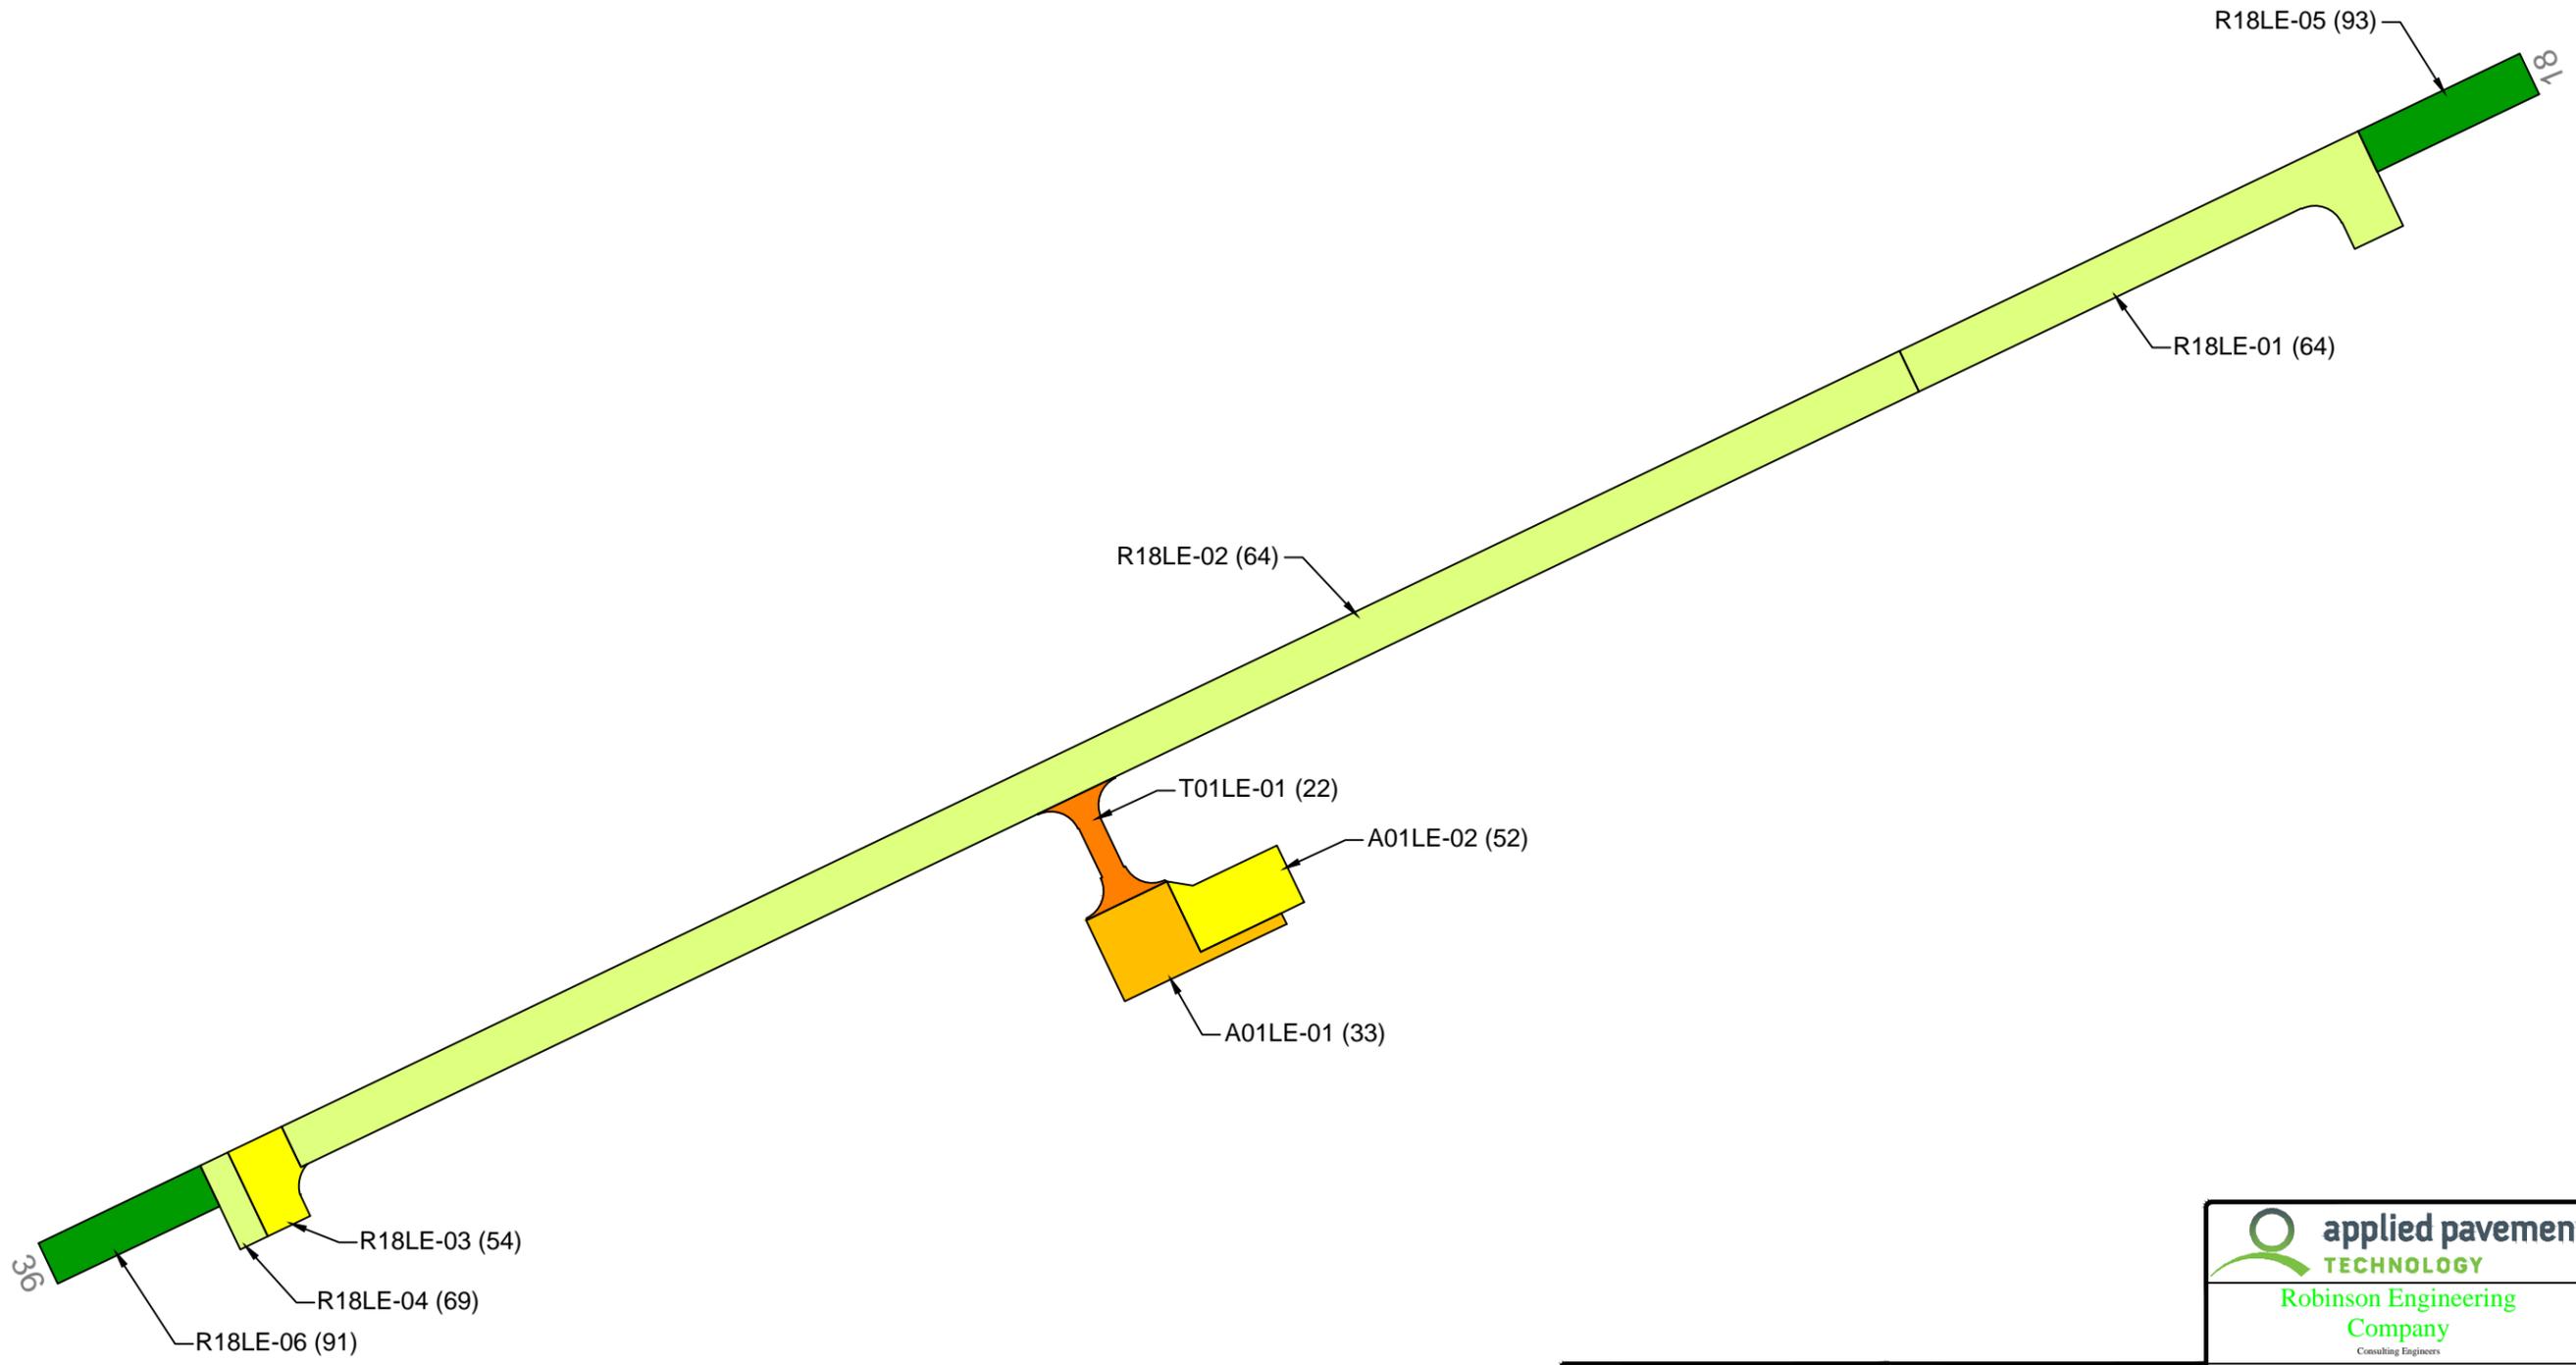
FIGURE 8. PCI MAP.

The pavements at Le Mars Municipal Airport were inspected on November 6, 2015. The 2015 area-weighted condition of Le Mars Municipal Airport is 63, with conditions ranging from 22 to 93 (on a scale of 0 [failed] to 100 [excellent]). During the previous pavement inspection in 2012, the area-weighted PCI of the airport was 76.
