Le Mars Municipal Airport

Pavement Management Report

JULY 2023

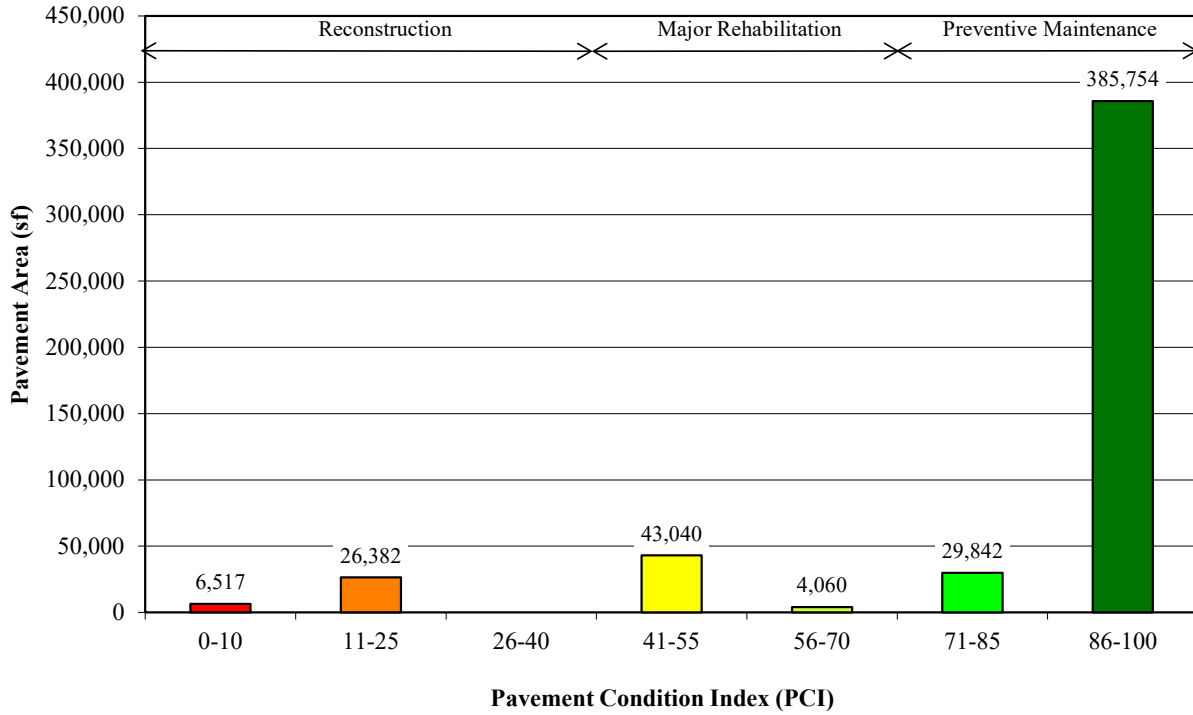
Figure 6. Pavement area by PCI range at Le Mars Municipal Airport.

The pavements at Le Mars Municipal Airport were inspected in November 2022. The 2022 area-weighted condition of Le Mars Municipal Airport is 88, with conditions ranging from 7 to 100 (on a scale of 0 [failed] to 100 [excellent]). During the previous pavement inspection in 2019, the area-weighted PCI of the airport was 89.

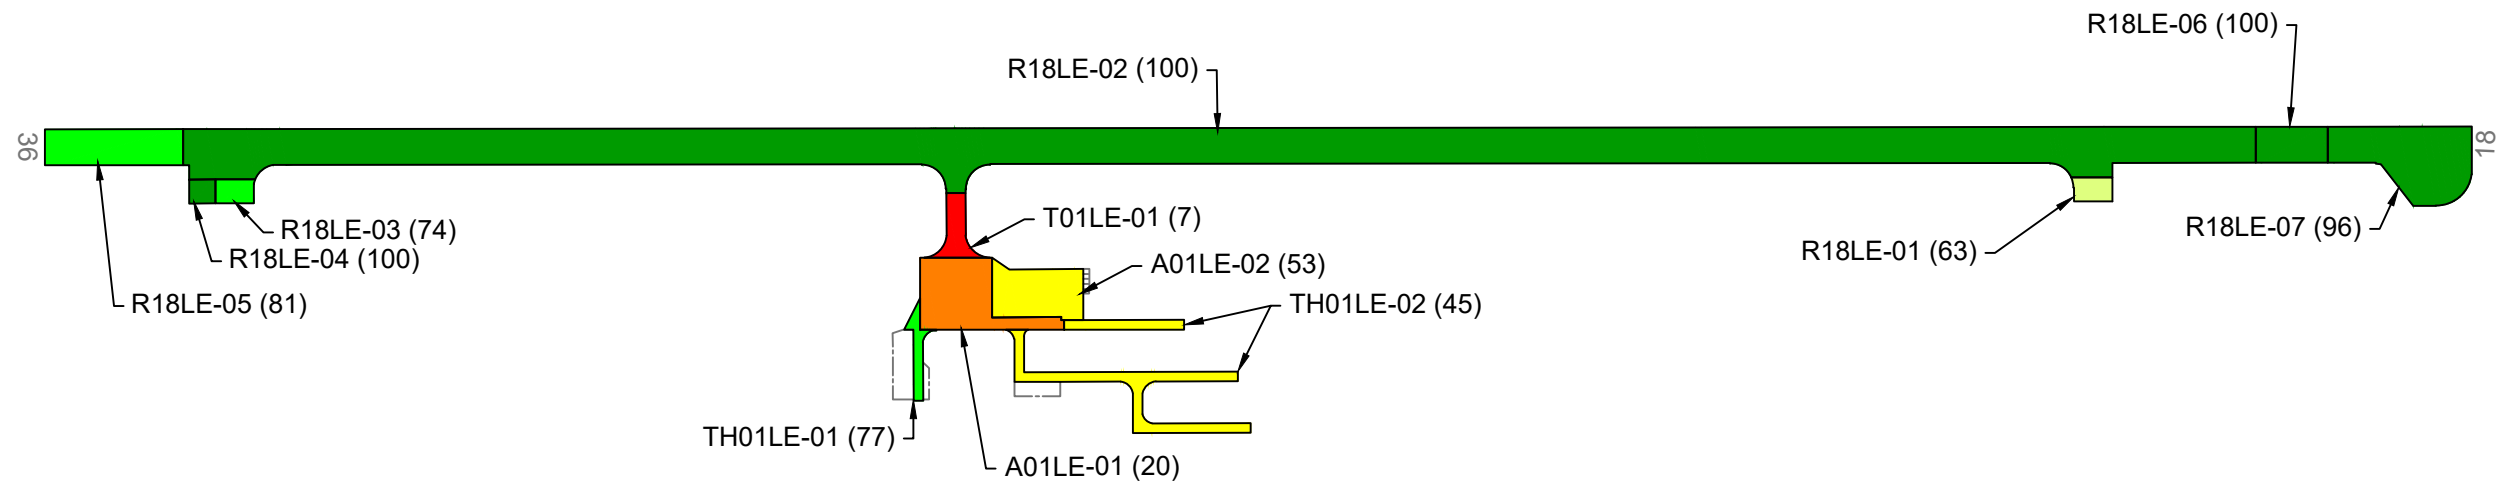
FIGURE 8. PCI MAP.

Figure 6 summarizes the overall condition of the pavements at Le Mars Municipal Airport, and Figure 7 presents area-weighted condition (average PCI adjusted to account for the relative size of the pavement sections) by branch use. Figure 8 is a map that displays the condition of the evaluated pavements. Table 1 summarizes the results of the pavement evaluation. Appendix B presents photographs taken during the PCI inspection, and Appendix C contains detailed information on the distress types observed during the visual survey. Appendix D includes detailed work history information that was collected during the record review process.
