Manchester Municipal Airport

PAVEMENT MANAGEMENT REPORT

JULY 2022

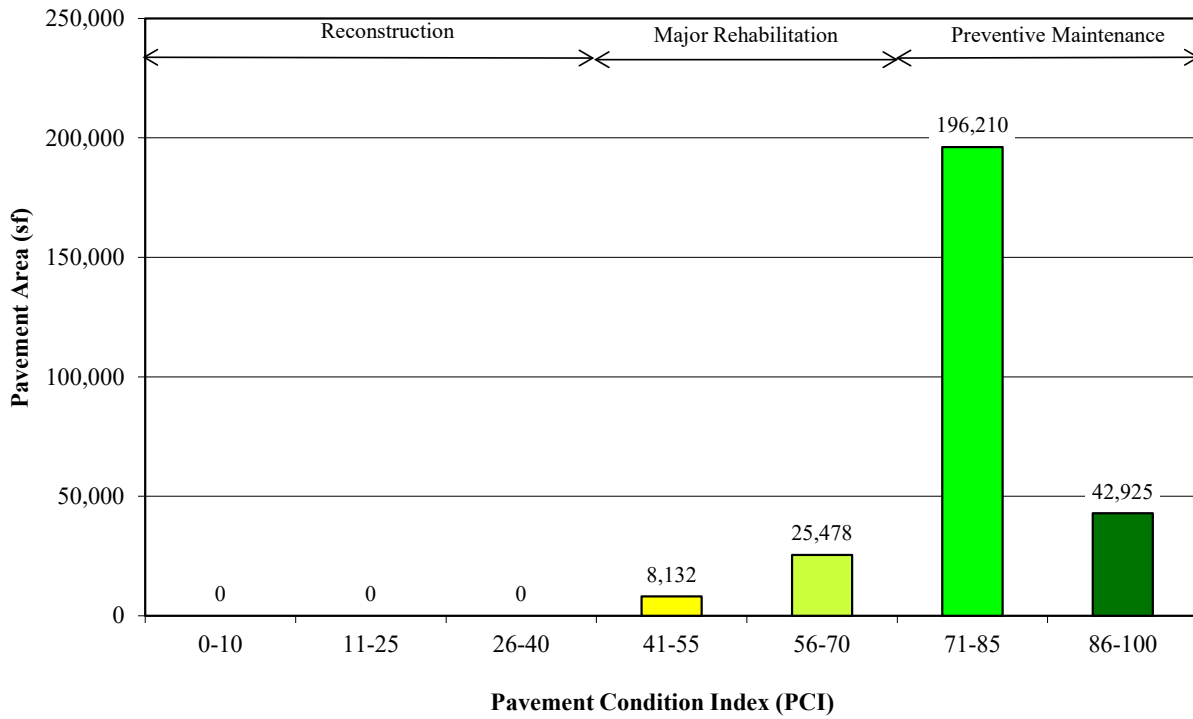
Figure 6. Pavement area by PCI range at Manchester Municipal Airport.

The pavements at Manchester Municipal Airport were inspected in November 2021. The 2021 area-weighted condition of Manchester Municipal Airport is 78, with conditions ranging from 48 to 100 (on a scale of 0 [failed] to 100 [excellent]). During the previous pavement inspection in 2018, the area-weighted PCI of the airport was 73.

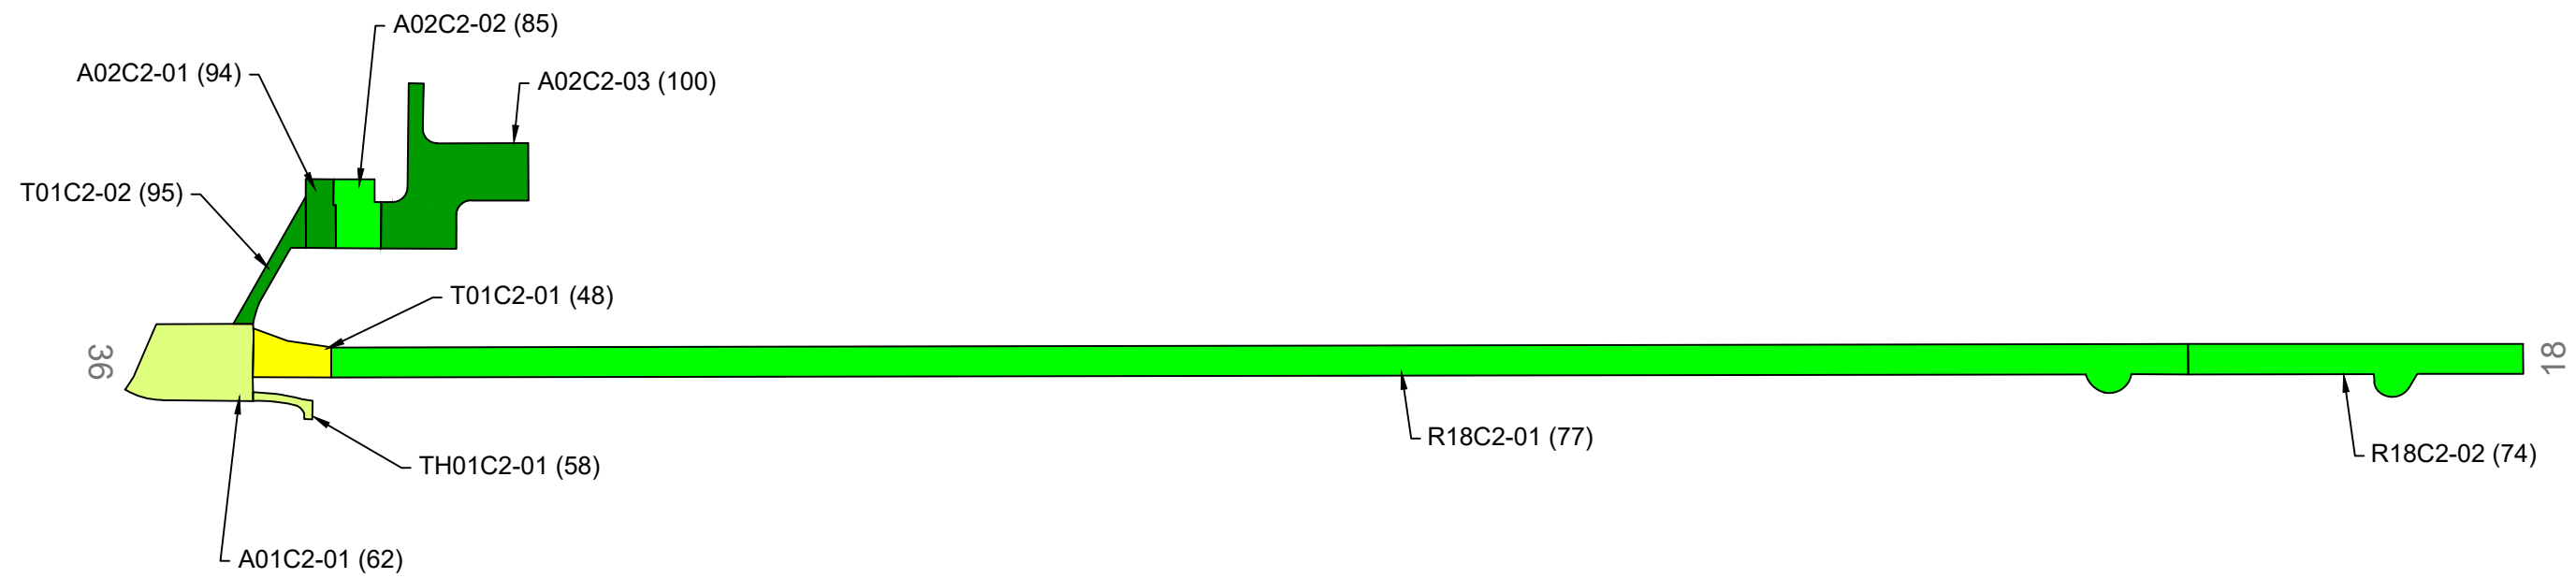
FIGURE 8. PCI MAP.

Figure 6 summarizes the overall condition of the pavements at Manchester Municipal Airport, and Figure 7 presents area-weighted condition (average PCI adjusted to account for the relative size of the pavement sections) by branch use. Figure 8 is a map that displays the condition of the evaluated pavements. Table 1 summarizes the results of the pavement evaluation. Appendix B presents photographs taken during the PCI inspection, and Appendix C contains detailed information on the distress types observed during the visual survey. Appendix D includes detailed work history information that was collected during the record review process.
