Maquoketa Municipal Airport

PAVEMENT MANAGEMENT REPORT

JULY 2021

Applied Pavement Technology, Inc.
115 West Main Street, Suite 400
Urbana, Illinois 61801
217-398-3977

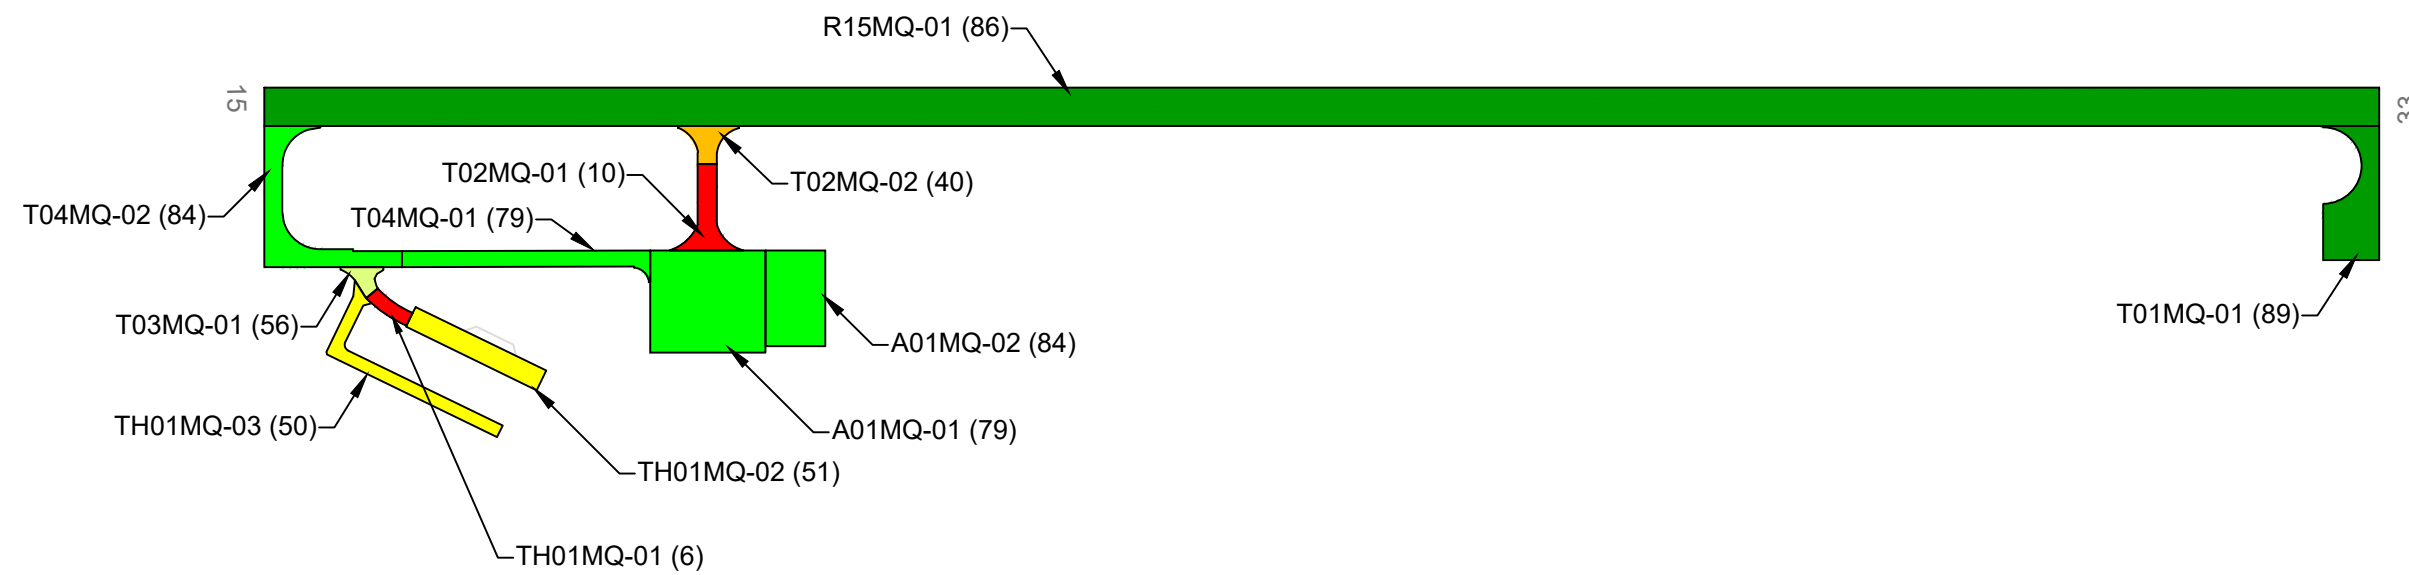
FIGURE 8. PCI MAP.

The pavements at Maquoketa Municipal Airport were inspected in November 2020. The 2020 area-weighted condition of Maquoketa Municipal Airport is 81, with conditions ranging from 6 to 89 (on a scale of 0 [failed] to 100 [excellent]). During the previous pavement inspection in 2017, the area-weighted PCI of the airport was 85.

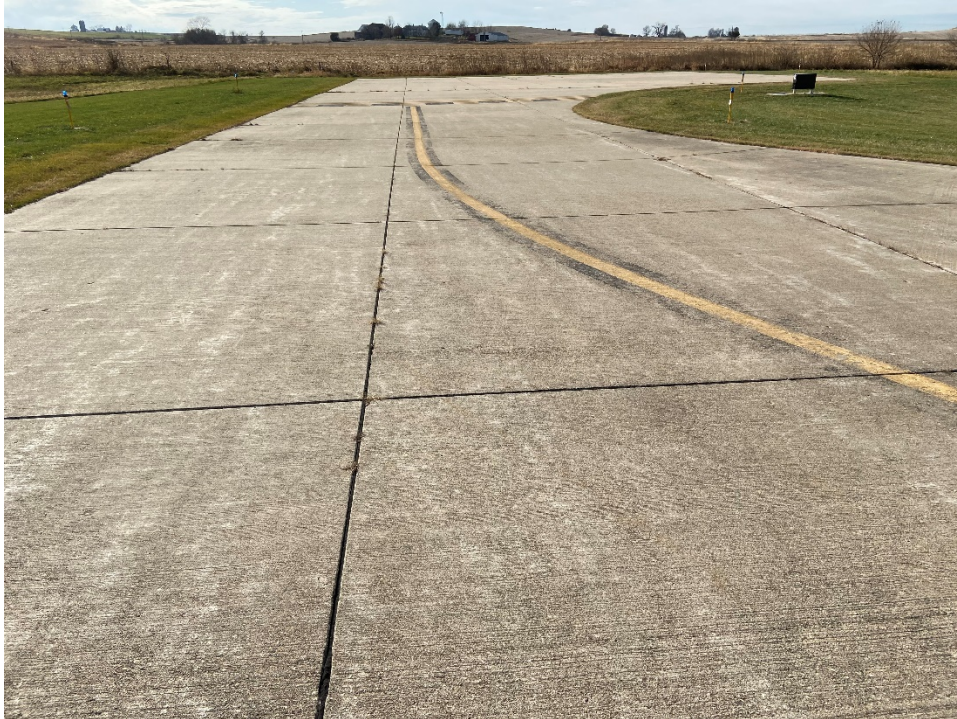
T01MQ-01. Overview.

Taxiway 01 consisted of one section. In Section 01, medium-severity corner spalling and medium- and high-severity joint seal damage were recorded.
