Maquoketa Municipal Airport

Pavement Management Report

JULY 2024

MAQUOKETA MUNICIPAL AIRPORT PAVEMENT MANAGEMENT REPORT

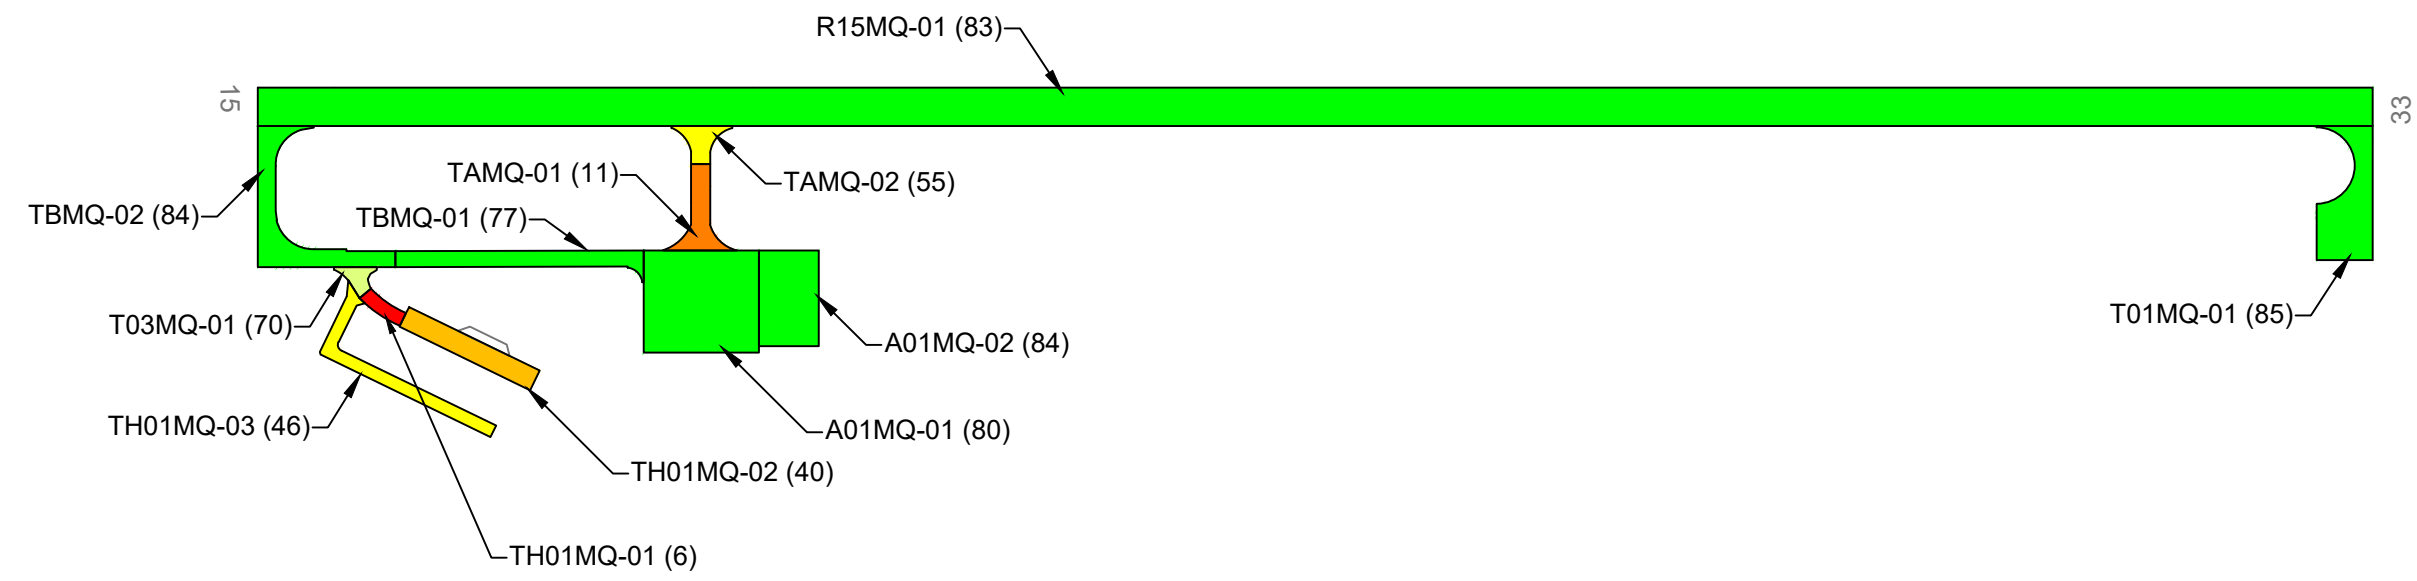
FIGURE 8. PCI MAP.

The pavements at Maquoketa Municipal Airport were inspected in November 2023. The 2023 area-weighted condition of Maquoketa Municipal Airport is 79, with conditions ranging from 6 to 85 (on a scale of 0 [failed] to 100 [excellent]). During the previous pavement inspection in 2020, the area-weighted PCI of the airport was 81.

Figure 6 summarizes the overall condition of the pavements at Maquoketa Municipal Airport, and Figure 7 presents area-weighted condition (average PCI adjusted to account for the relative size of the pavement sections) by branch use. Figure 8 is a map that displays the condition of the evaluated pavements. Table 1 summarizes the results of the pavement evaluation. Appendix B presents photographs taken during the PCI inspection, and Appendix C contains detailed information on the distress types observed during the visual survey. Appendix D includes detailed work history information that was collected during the record review process.
