Monticello Regional Airport

PAVEMENT MANAGEMENT REPORT

JULY 2021

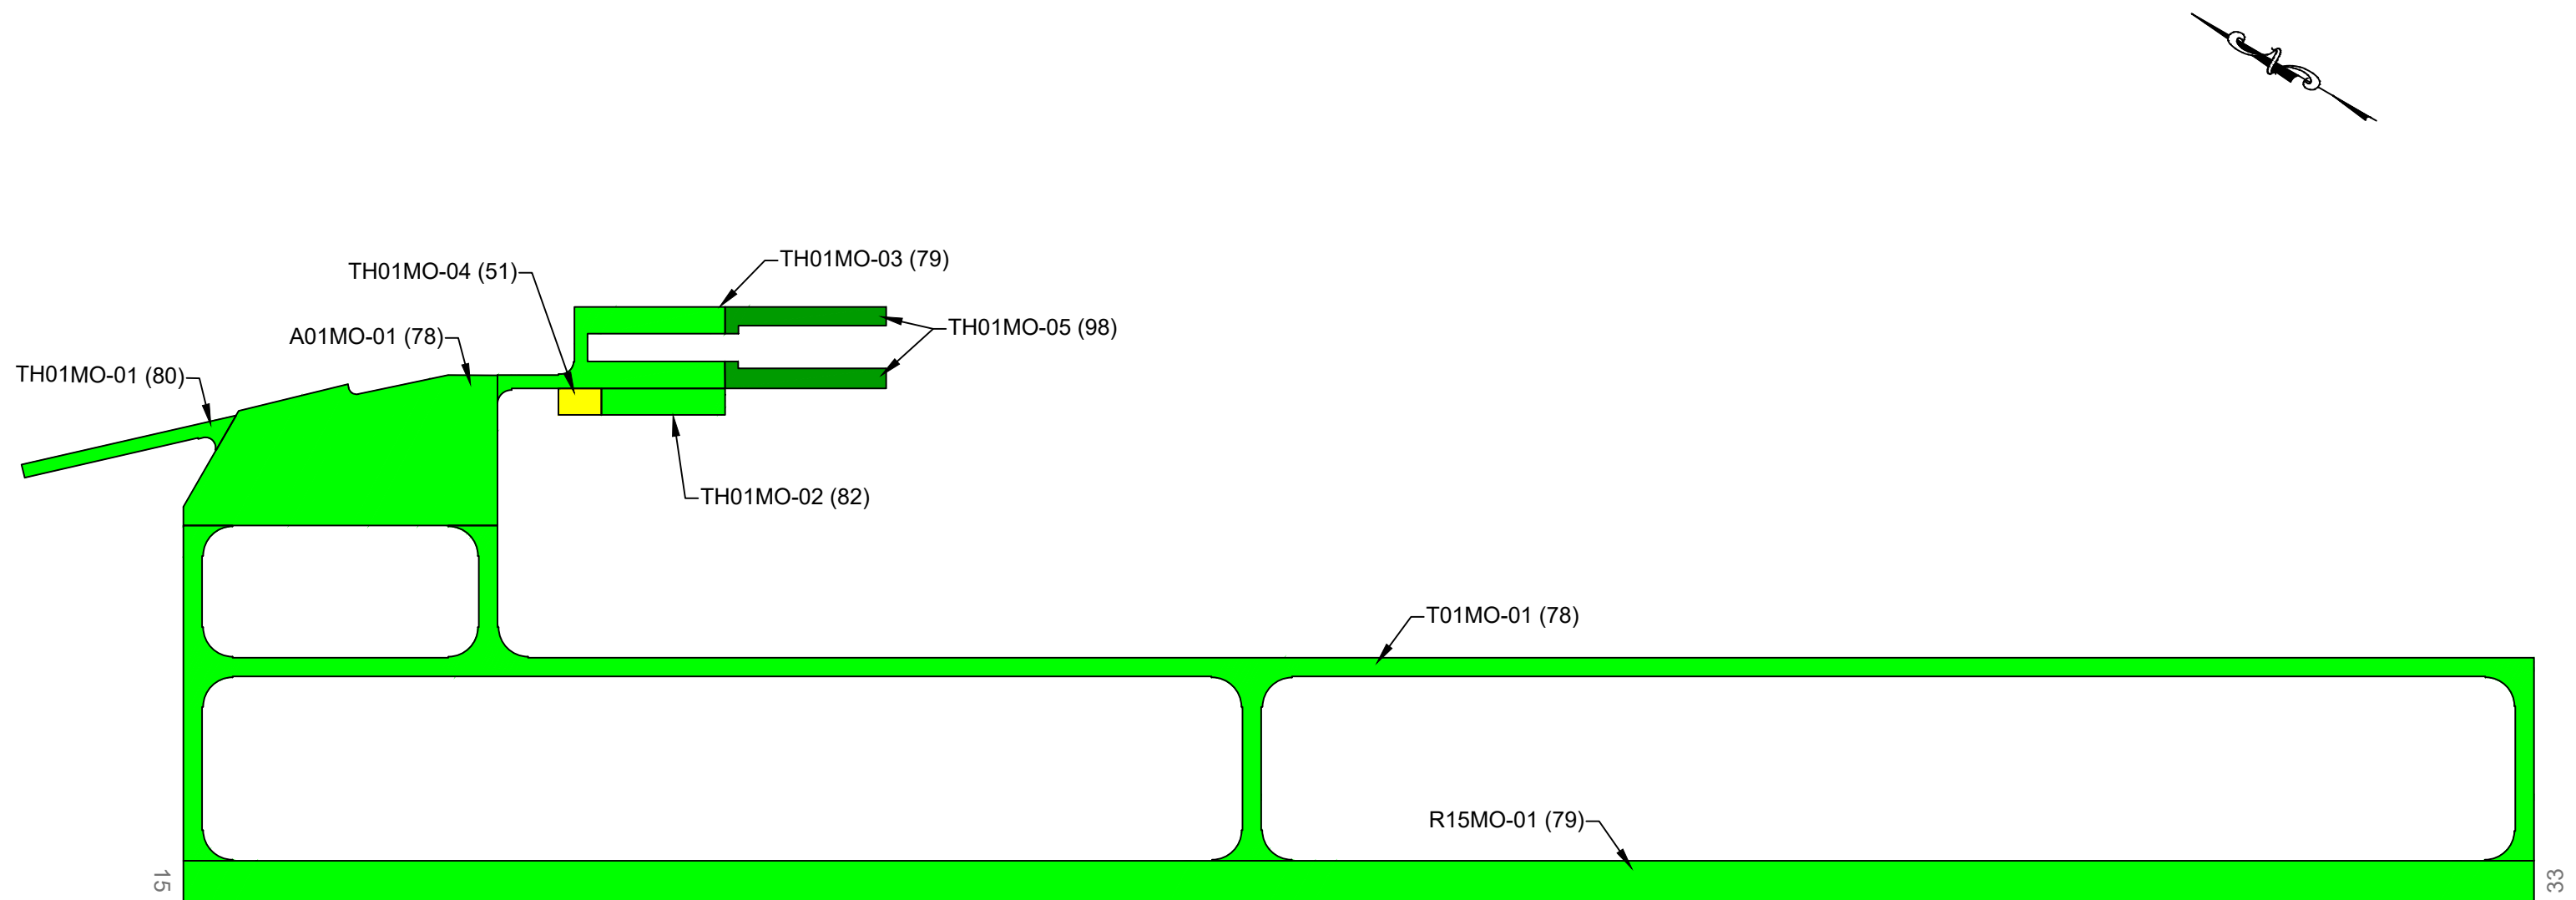
FIGURE 8. PCI MAP.

The pavements at Monticello Regional Airport were inspected in November 2020. The 2020 area-weighted condition of Monticello Regional Airport is 79, with conditions ranging from 51 to 98 (on a scale of 0 [failed] to 100 [excellent]). During the previous pavement inspection in 2017, the area-weighted PCI of the airport was 82.

Figure 6 summarizes the overall condition of the pavements at Monticello Regional Airport, and Figure 7 presents area-weighted condition (average PCI adjusted to account for the relative size of the pavement sections) by branch use. Figure 8 is a map that displays the condition of the evaluated pavements. Table 1 summarizes the results of the pavement evaluation. Appendix B presents photographs taken during the PCI inspection, and Appendix C contains detailed information on the distresses observed during the visual survey. Appendix D includes detailed work history information that was collected during the record review process.
